REPUBLIC OF SERBIA
CENTER FOR INVESTIGATION OF ACCIDENTS IN TRANSPORT
SECTOR FOR INVESTIGATION OF ACCIDENTS IN RAILWAY TRAFFIC
NEMANJINA 11, 11000 BELGRADE

FINAL REPORT ON SERIOUS ACCIDENT INVESTIGATION

Accident type:	Serious accident, Overtaking of a pulled shunting composition on a railway worker
Shunting composition:	Locomotive 441-510 and 6 (six) wagons of series <i>Ea</i>
Place:	Smederevo Municipality, settlement Mala Krsna, area of the railway station Mala Krsna
Date:	03.02.2021.
Time:	08:29

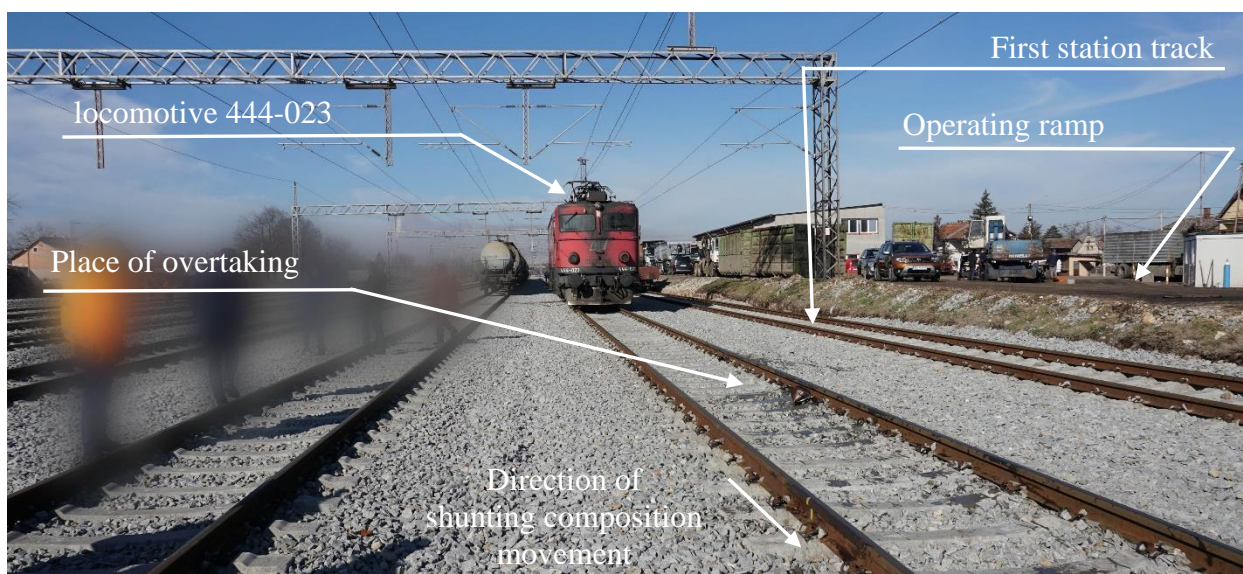
Under these conditions, there occurred an overtaking of the pulled shunting composition on the auxiliary worker. The overtaking occurred in such a way with the head of the locomotive 441-510 (locomotive dozer blade) hitting the auxiliary worker, who fell off the track from the impact, after which the entire shunting composition crossed over him. On that occasion, the auxiliary worker suffered severe bodily injuries, from which he died on the spot.

Figure 2.1.2.1: The appearance of the serious accident site after the overtaking of a shunting composition on a railway worker (view from direction of the switch block 2 to the station facility)

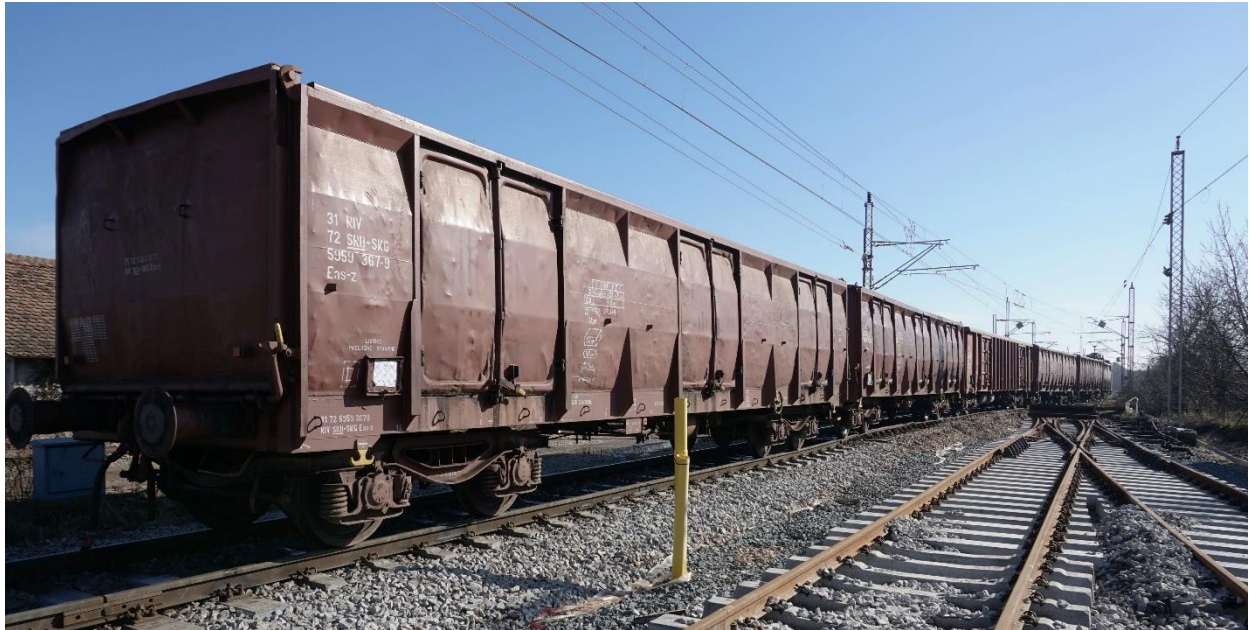
Since the staff on the shunting composition did not notice that there was an overtaking, the pulled shunting composition continued driving until it got off the second station track and stopped at the switch block 2, where it was planned as part of the shunting work. The occurrence of the serious accident in question was first noticed by the train driver and the shunter who were on the locomotive 444-023, which was shunting along the second track from the direction of the train dispatcher's office in the direction of the switch block 2, just behind the shunting composition involved in the serious accident.

Figure 2.1.2.2: The appearance of the place where the shunting composition stopped on the switch block 2 after the serious accident (view from direction of Mala Krsna station to the open track in direction to the stations Požarevac and Osipaonica)

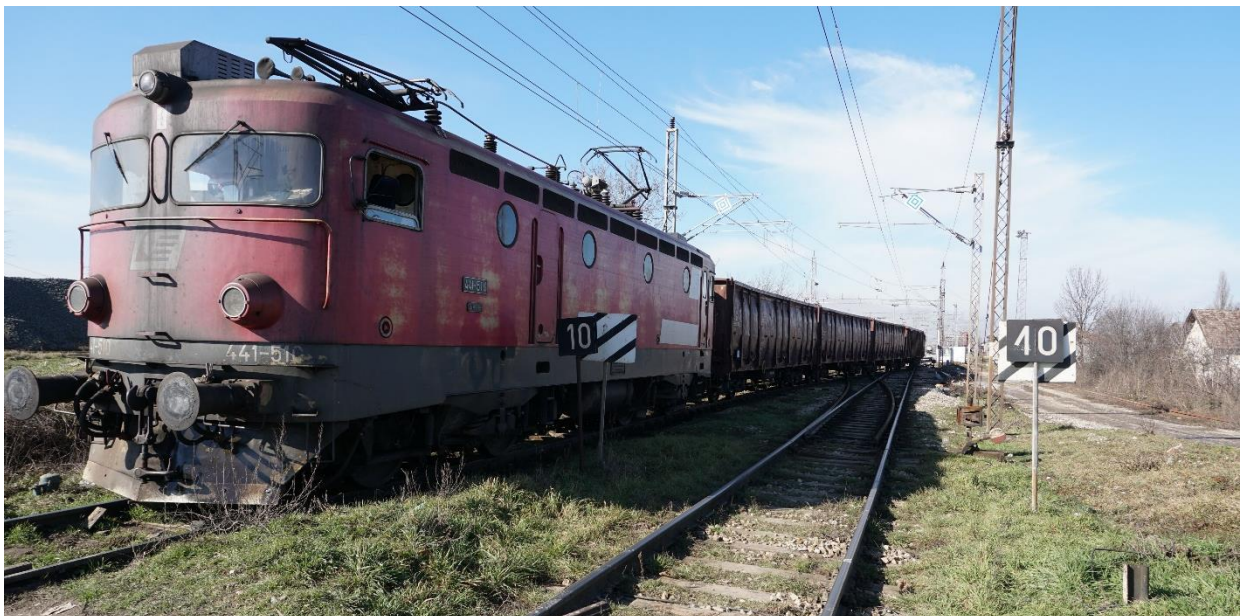
During the on-site investigation of the serious accident, investigative team of CINS stated that the restricted speed running at the Mala Krsna station was signalled on block 2, observed by the Osipaonica and Požarevac stations towards the Mala Krsna station. The restricted speed running of 10 km/h is signalled by the aspect of a signal 97v: "Start of restricted speed running", so that it refers to the 1st, 2nd, 3rd and 4th track, which also should have been stated in the telegram No. 88 from 11.12.2020. The appearance of the aspect of a signal 97v: "Start of restricted speed running" is shown in Figure 2.2.2.6.

Figure 2.2.2.6: Appearance of an aspect of a signal 97v: "Start of restricted speed running" on block 2 of Mala Krsna station (observed by Osipaonica and Požarevac stations towards Mala Krsna station)

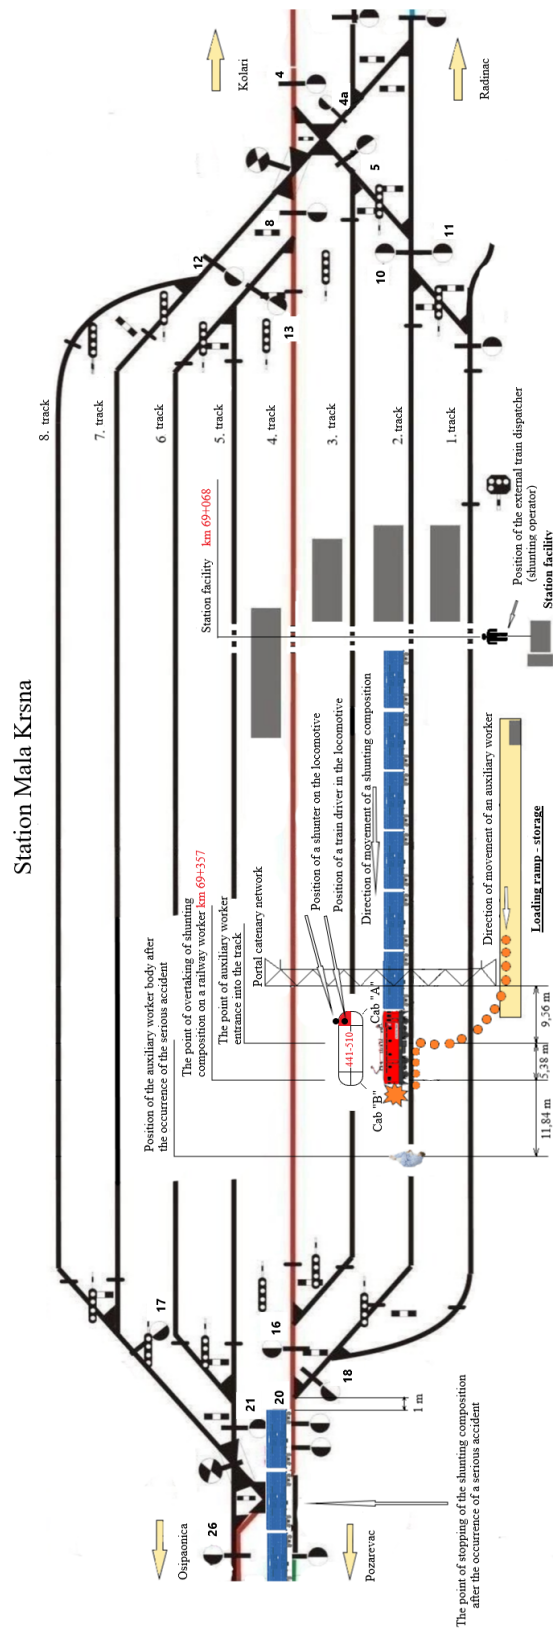
After assembling the shunting composition that took part in the serious accident in question (coupling 6 (six) loaded Ea series wagons to locomotive 441-510), the train driver remained in the same position in locomotive 441-510 in the driver cab “A” on the right in the direction of travel), i.e., in the driver cab, which in relation to the pulled shunting composition was the last driver cab observed in relation to the direction of travel (gross side). The shunter took the position on the steps of the rear driver cab (in the direction of travel, on the gross side) on the side next to the train driver.

Figure 4.1.1: The sketch of a serious accident

Without determining the location of the train driver and the position of the shunter, the external train dispatcher (who performed the duties of the shunting operator) allowed the start of the pulled shunting composition from the second track in the direction of switch block 2. Since the train driver was in the driver cab that was up to the wagon in the pulled shunting composition (in driver cab of the locomotive that was not at the head of the shunting composition), and the shunter was not at the head of the locomotive, i.e., at the head of the pulled shunting composition and having in mind the fact that visibility was reduced due to fog, the drive was carried out in conditions of limited observation of the shunting path of the ride. The driving of the pulled shunting composition was performed at a speed higher than the maximum allowed in the area of the Mala Krsna station. During the driving of the pulled shunting composition, neither the train driver nor the shunter noticed the auxiliary worker moving in the middle of the second station track. Under these conditions, there occurred an overtaking by the pulled shunting composition on the auxiliary worker. The shunting composition stopped after shunting drive in the area of switch block 2.

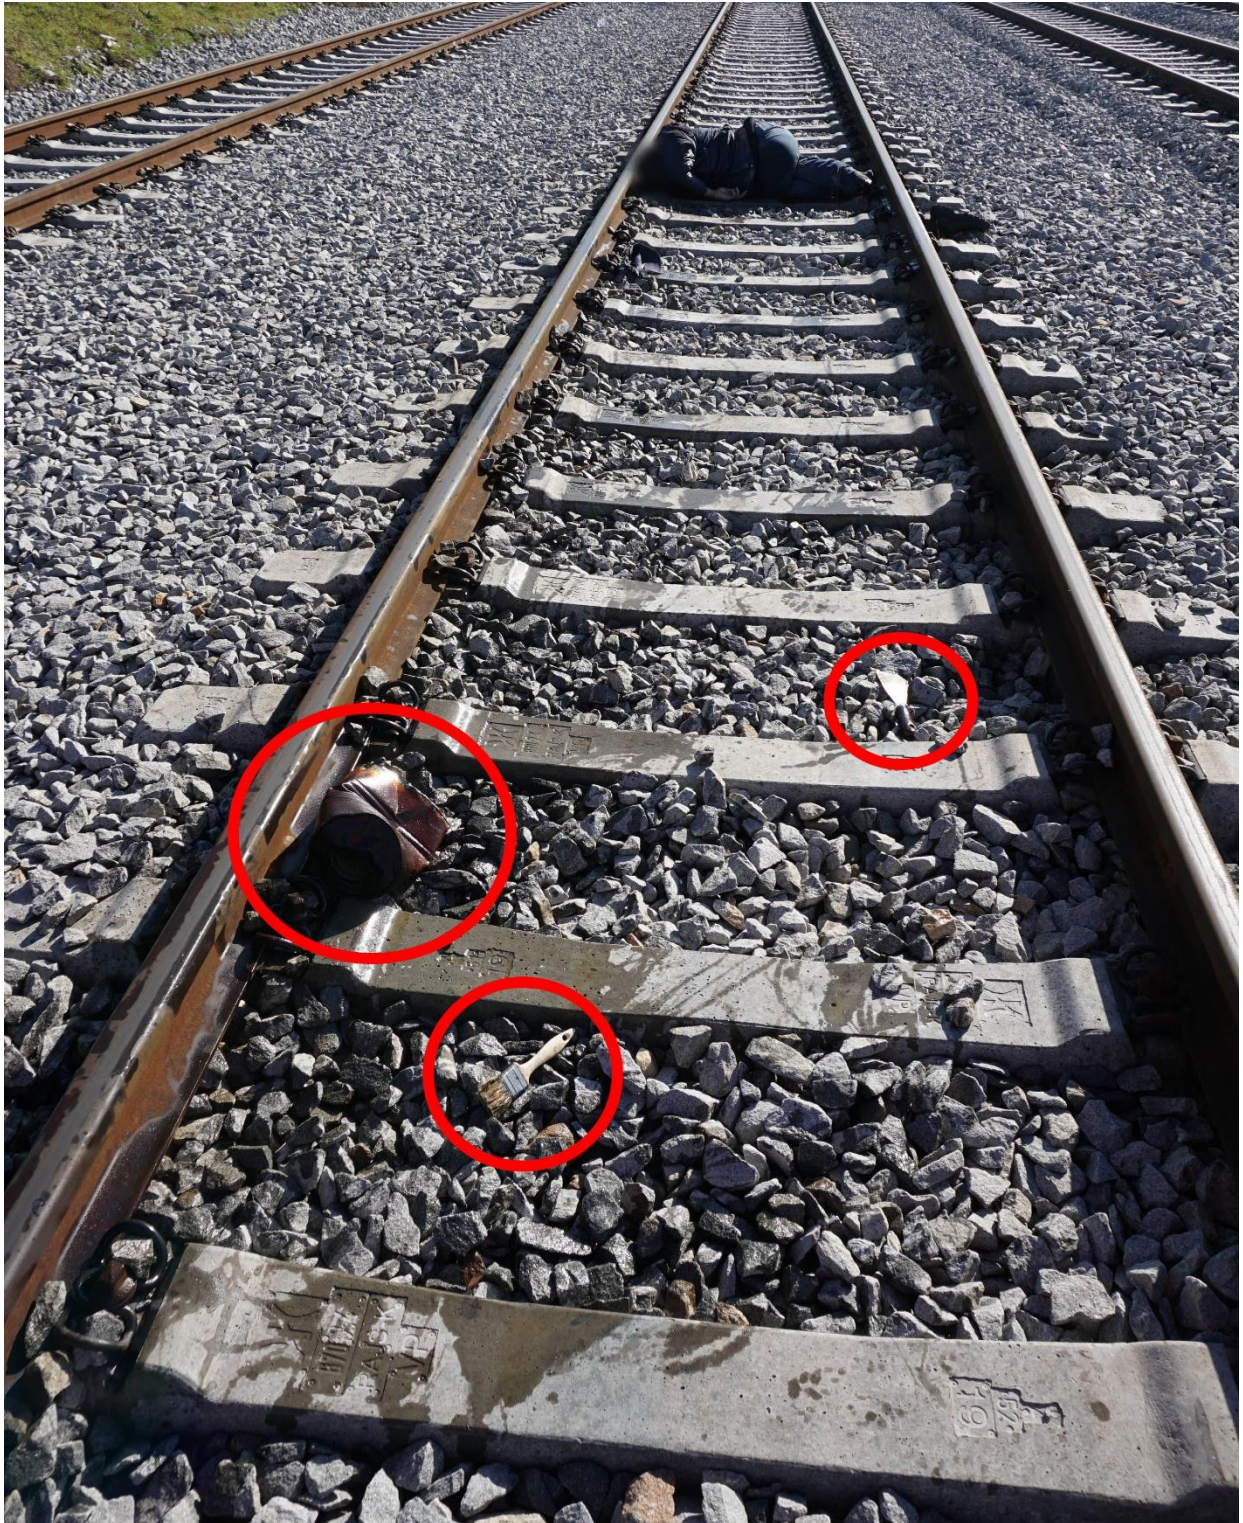
Figure 4.2.1.1: The position of the body of the auxiliary worker and the means he carried with him after the occurrence of a serious accident

The fatally injured auxiliary worker, apart from wearing the safety shoes, did not wear other protective equipment with reflective markings or a signal vest, which is contrary to Article 35 of the Law on Safety and Health at Work (“Official Gazette of RS” No. 101/2005, 91/2015 and 113/2017 - other law), the Risk Assessment Act for all work position in the work environment of “IŽS” a.d. No. 1/2016-4958 of 09.12.2016. and Fourth amendments to the Risk Assessment Act for all work position in the work environment of “IŽS” a.d. No. 4/2019-1848-431 of 04.12.2019. Attached to letter No. 1/2021-679 dated 06.04. 2021. “IŽS” a.d. Excerpt (no No. entered) was submitted on 27.01.2021. for the auxiliary worker of the station Mala Krsna with the stated protective equipment, which was signed by the applicant and the supervisory body, but it was not signed by the auxiliary worker, and based on the above it is not possible to state with certainty that the auxiliary worker indebted the mentioned protective equipment.
