No.: ŽS - 02/21

Date: 01.06.2022.

FINAL REPORT ON SERIOUS ACCIDENT INVESTIGATION

Accident type:	Overtaking of the pushed shunting composition on the railway worker
Shunting composition:	Locomotive 443-06 and 2 (two) wagons of type Arbel, series Faboo
Accident location:	Obrenovac, TENT Obrenovac, area of the station Obrenovac
Date:	12.07.2021.
Time:	07:43

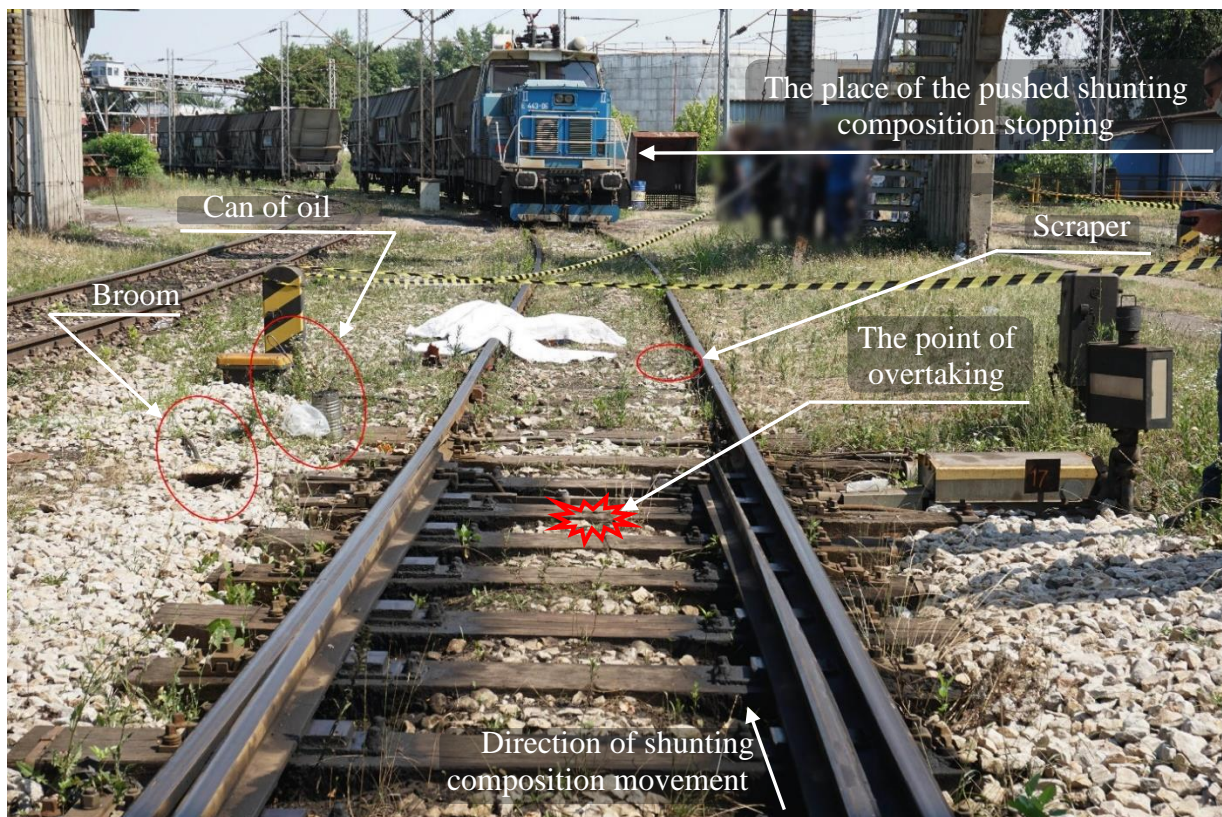
Figure 2.1.2.1: The appearance of the place of the serious accident after the collision of the pushed shunting composition on the railway worker (view from the direction of the second track to the second turnout track)

Under these conditions, there occurred a collision of the pushed shunting composition on the railway worker. The collision occurred when the front of the shunting composition (middle of the front part of the Arbel type wagon, Faboo series individual No. 43 72 6531 314-2) hit a railway worker in the area of his back, who from the impact fell off the track, after which the entire shunting composition crossed over him. On that occasion, the railway worker suffered severe bodily injuries, from which he died on the spot.

Since the train driver on the pushed shunting train did not notice that there occurred a collision, the pushed shunting composition continued driving all the way to the second turnout track, near the place where it was planned as part of the shunting task. The train dispatcher for unloading - “OB1”, was the first to notice the occurrence of the serious accident in question, who was in his office in the facility located between the second and third track near the switch No. 17, ie near the place of occurrence of the serious accident in question.

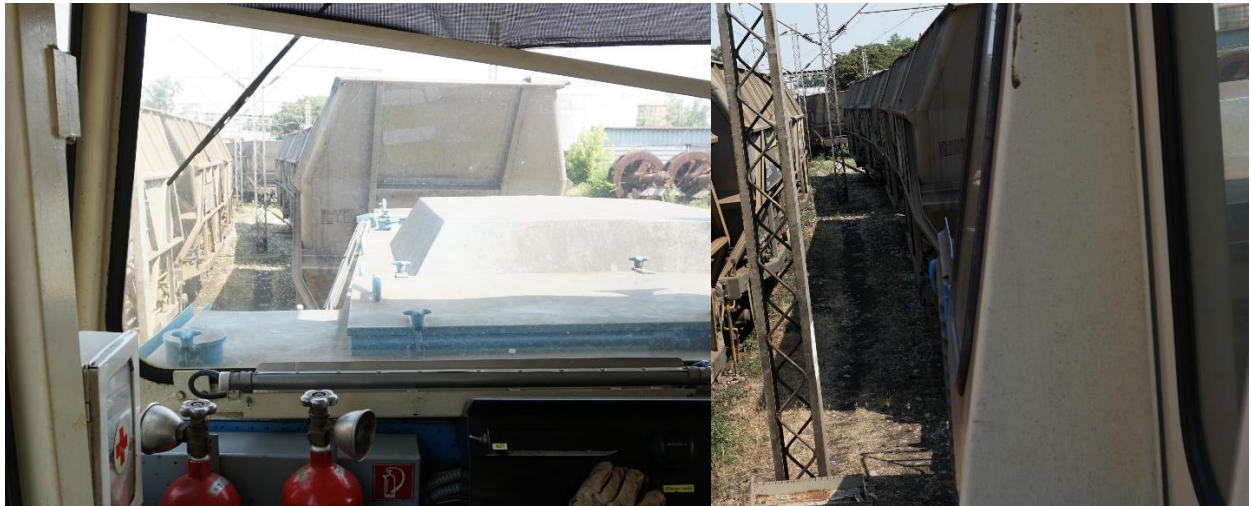
Figure 2.2.2.2: View from locomotive's 443-06 driver cab
in the direction of the pushed shunting composition driving

In the driver cab of the locomotive 443-06 there are two control tables, placed diagonally, so that the train driver when operating the locomotive can see only one longitudinal side of the locomotive, ie the shunting composition. The view of the track directly in front of the locomotive, ie the shunting composition, is limited by the length of the part of the locomotive from the driver cab to the front part of the locomotive, ie the length of the shunting composition. The view from the driver cab of the locomotive 443-06 from the position where the train driver was at the time of this serious accident, is shown in Figures 2.2.2.2. and 2.2.2.3. On the front sides of the locomotive there are platforms with access steps and handrails. The appearance of the platform with handrails on the front side of the locomotive 443-06 is shown in Figure 2.2.2.1.

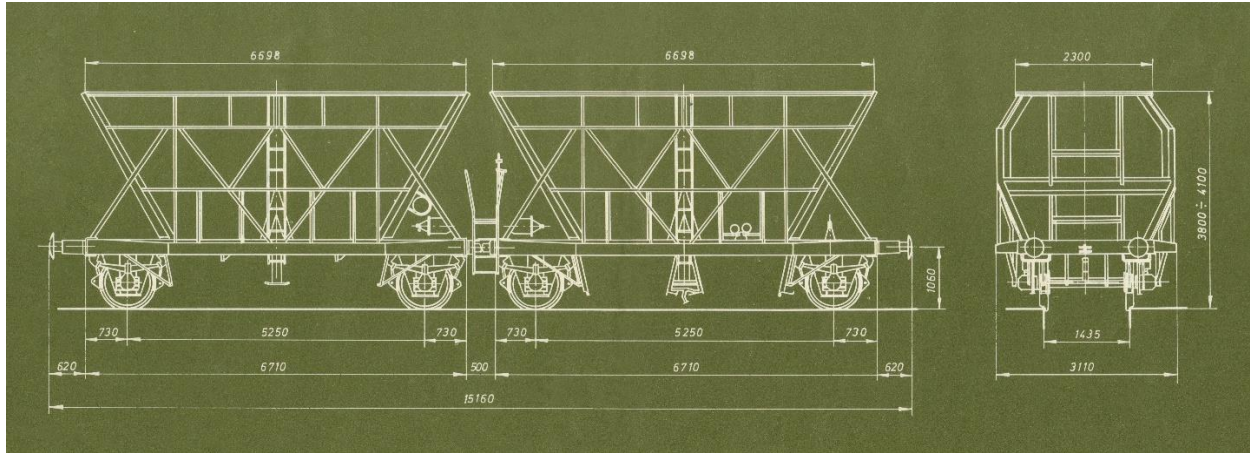
Figure 2.2.2.4: Schematic representation of Arbel type wagon, Faboo series (source: TENT)

On Arbel type wagons, the Faboo series, the installation of steps and handrails for the shunter is not structurally envisaged (see Figure 2.2.2.4).

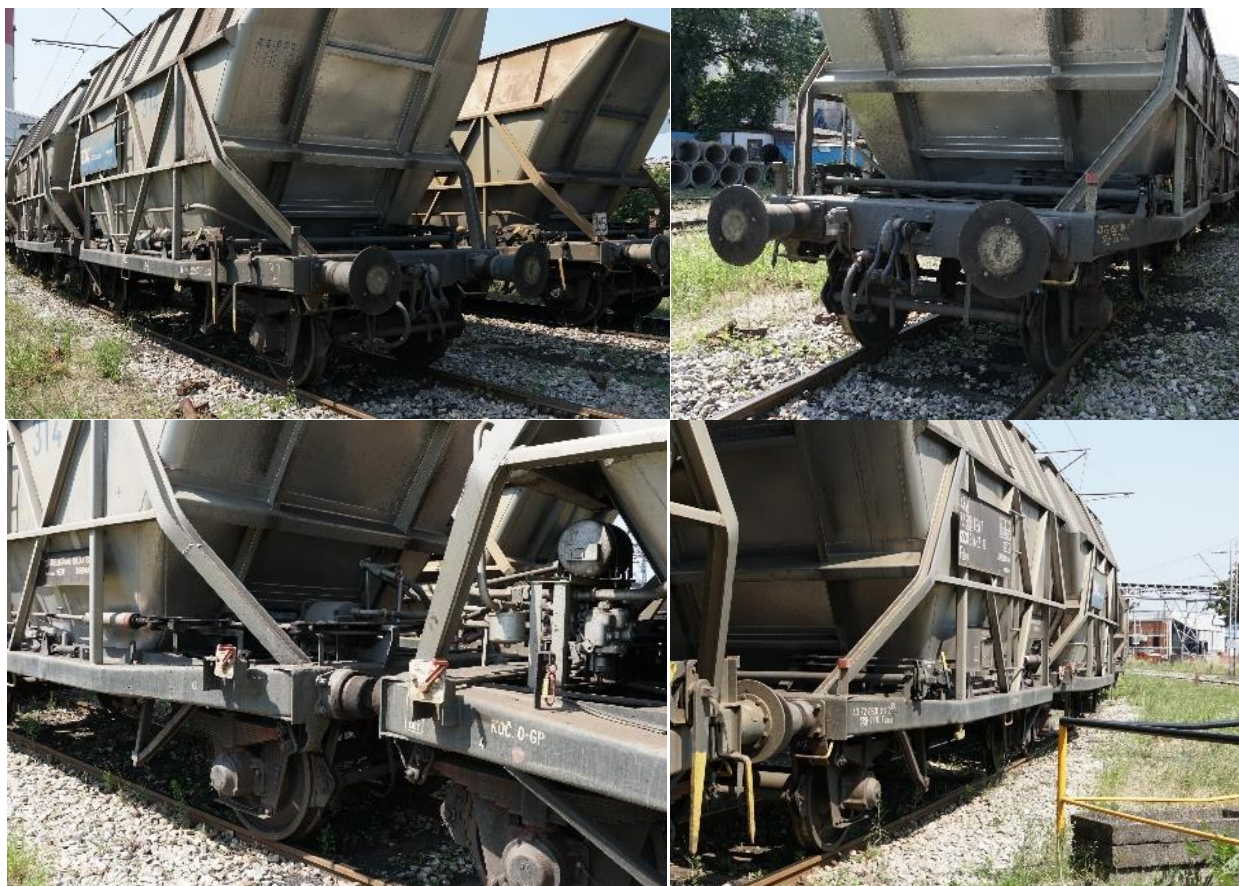
Figure 3.6.3.1: Appearance of wagon parts of individual No. 43 72 6531 314-2

By on-site inspection during the investigation, it was found that on neither side at the end of the wagon of individual No. 43 72 6531 314-2, which was at the head of the pushed shunting composition, observed in the direction of movement of the shunting composition, no steps and handrails were installed (see Figure 3.6.3.1).

On-site inspection during the investigation, on the shunting composition in question on the first wagon to the locomotive of individual No. 43 72 6531 238-3, it was noticed that in the middle of the wagon (between two parts) a cross-connection with steps and access handrails was installed, while on other wagon in the shunting composition of the individual No. 43 72 6531 314-2, there are no such crossings (see Figures 3.6.3.1 and 3.6.3.2).

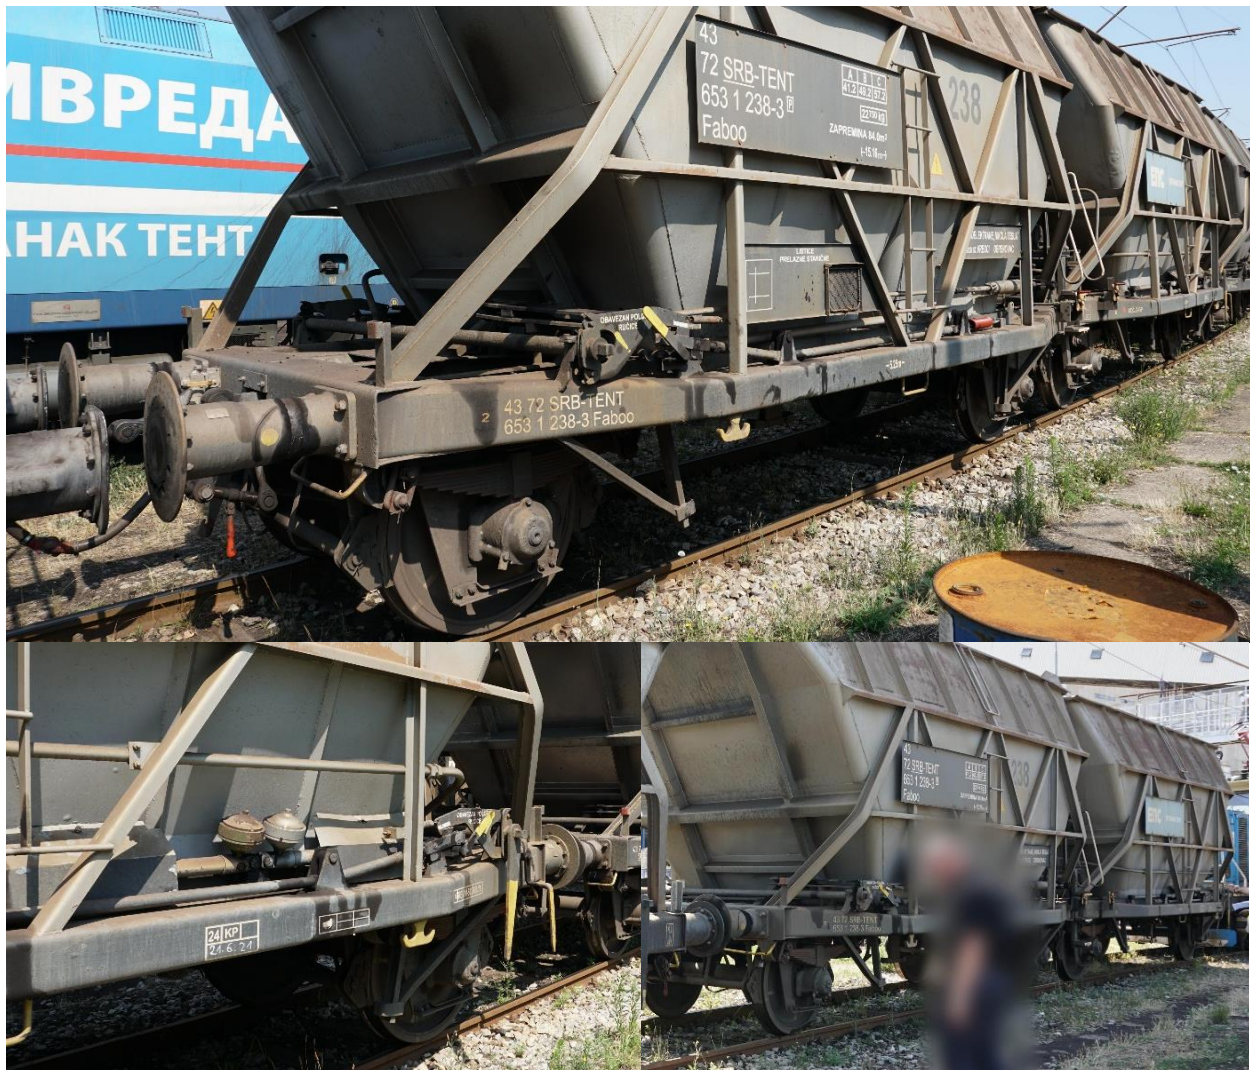
Figure 3.6.3.2: Appearance of wagon parts of individual No. 43 72 6531 238-3

Also, on-site inspection during the investigation, it was found that on the wagon of individual No. 43 72 6531 238-3, which was included in the shunting composition up to the locomotive, on neither side at the ends of the wagon steps and handrails for the shunter were not installed (see Figure 3.6.3.2.).

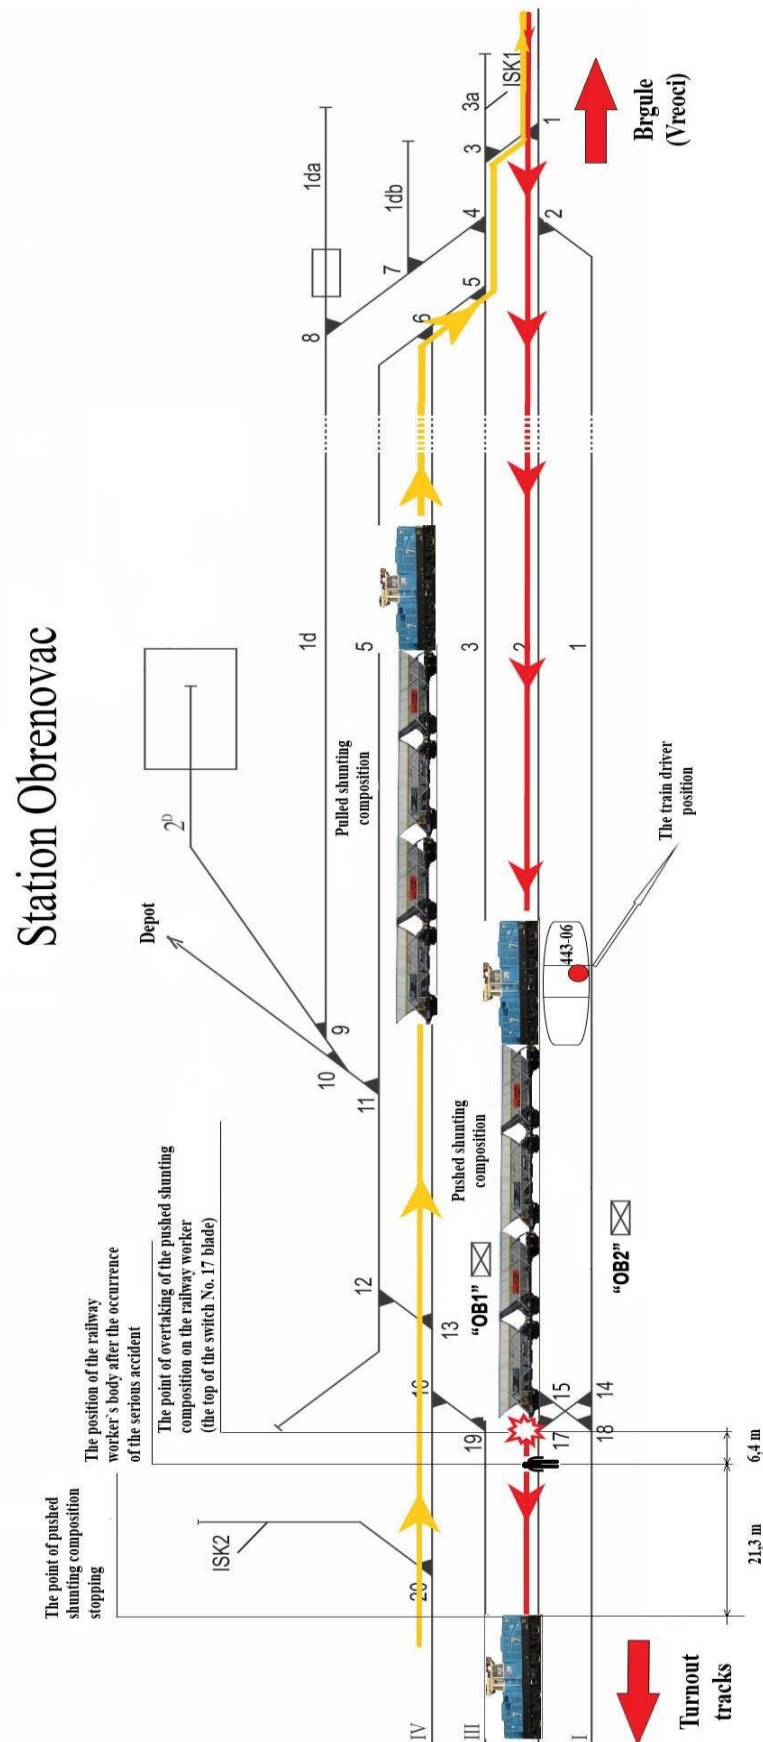
Figure 4.1.1: Sketch of the serious accident

After the shunter (first shunter) formed the shunting composition on the fourth turnout track (coupled 2 (two) Arbel type wagons, Faboo series for locomotive 443-06), the shunting composition was started unaccompanied by the shunter, so that the complete shunting task, consisting of the driving of the pulled and then the driving of the pushed shunting composition, was performed without the presence of the shunter. Also, taking into account that the shunting route of the pulled and pushed shunting composition predicted crossing the unoccupied level crossing in the station area without traffic provision device, a worker was not hired to perform the function of providing traffic at the level crossing.

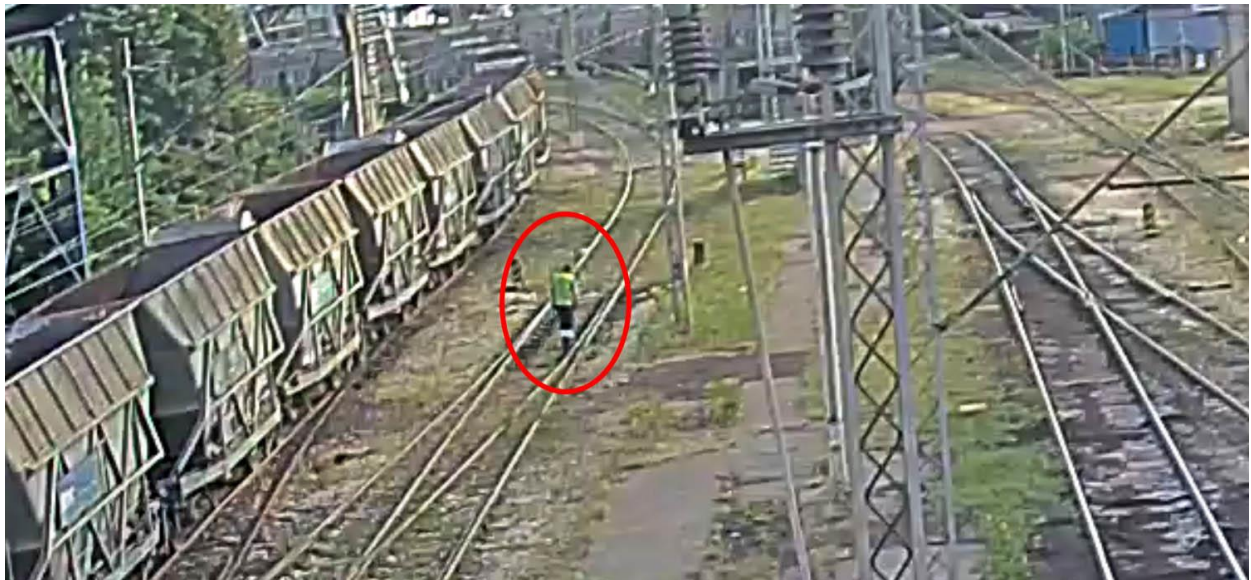
Figure 4.2.1.1: The position and appearance of the railway worker on the switch No. 17 immediately before the occurrence of a serious accident (source: video surveillance of JP “EPS” Branch TENT from Obrenovac)

At the time of overtaking of the pushed shunting composition on the railway worker, he was inside the second track at the top of the switch No. 17 blades. The fatally injured railway worker was wearing protective equipment (work suit with reflective material, protective shoes and reflective vest) in accordance with the Risk Assessment Act for all workplaces in the work environment of “Pro Tent” d.o.o. No. 25635 of 28.09.2012. The railway worker performed his duties in accordance with the employment contract.

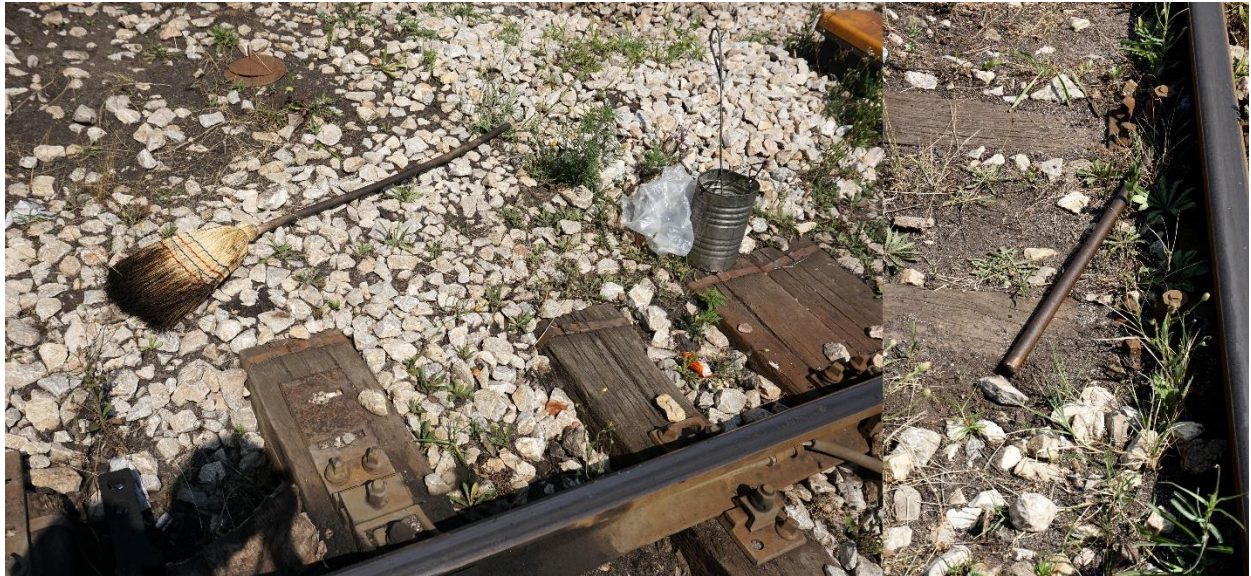
Figure 4.2.1.2: Tools for cleaning and lubricating the switches

At the time of overtaking of the pushed shunting train on the railway worker, he had tools for cleaning and lubricating the switches (metal can with oil, scraper and broom).

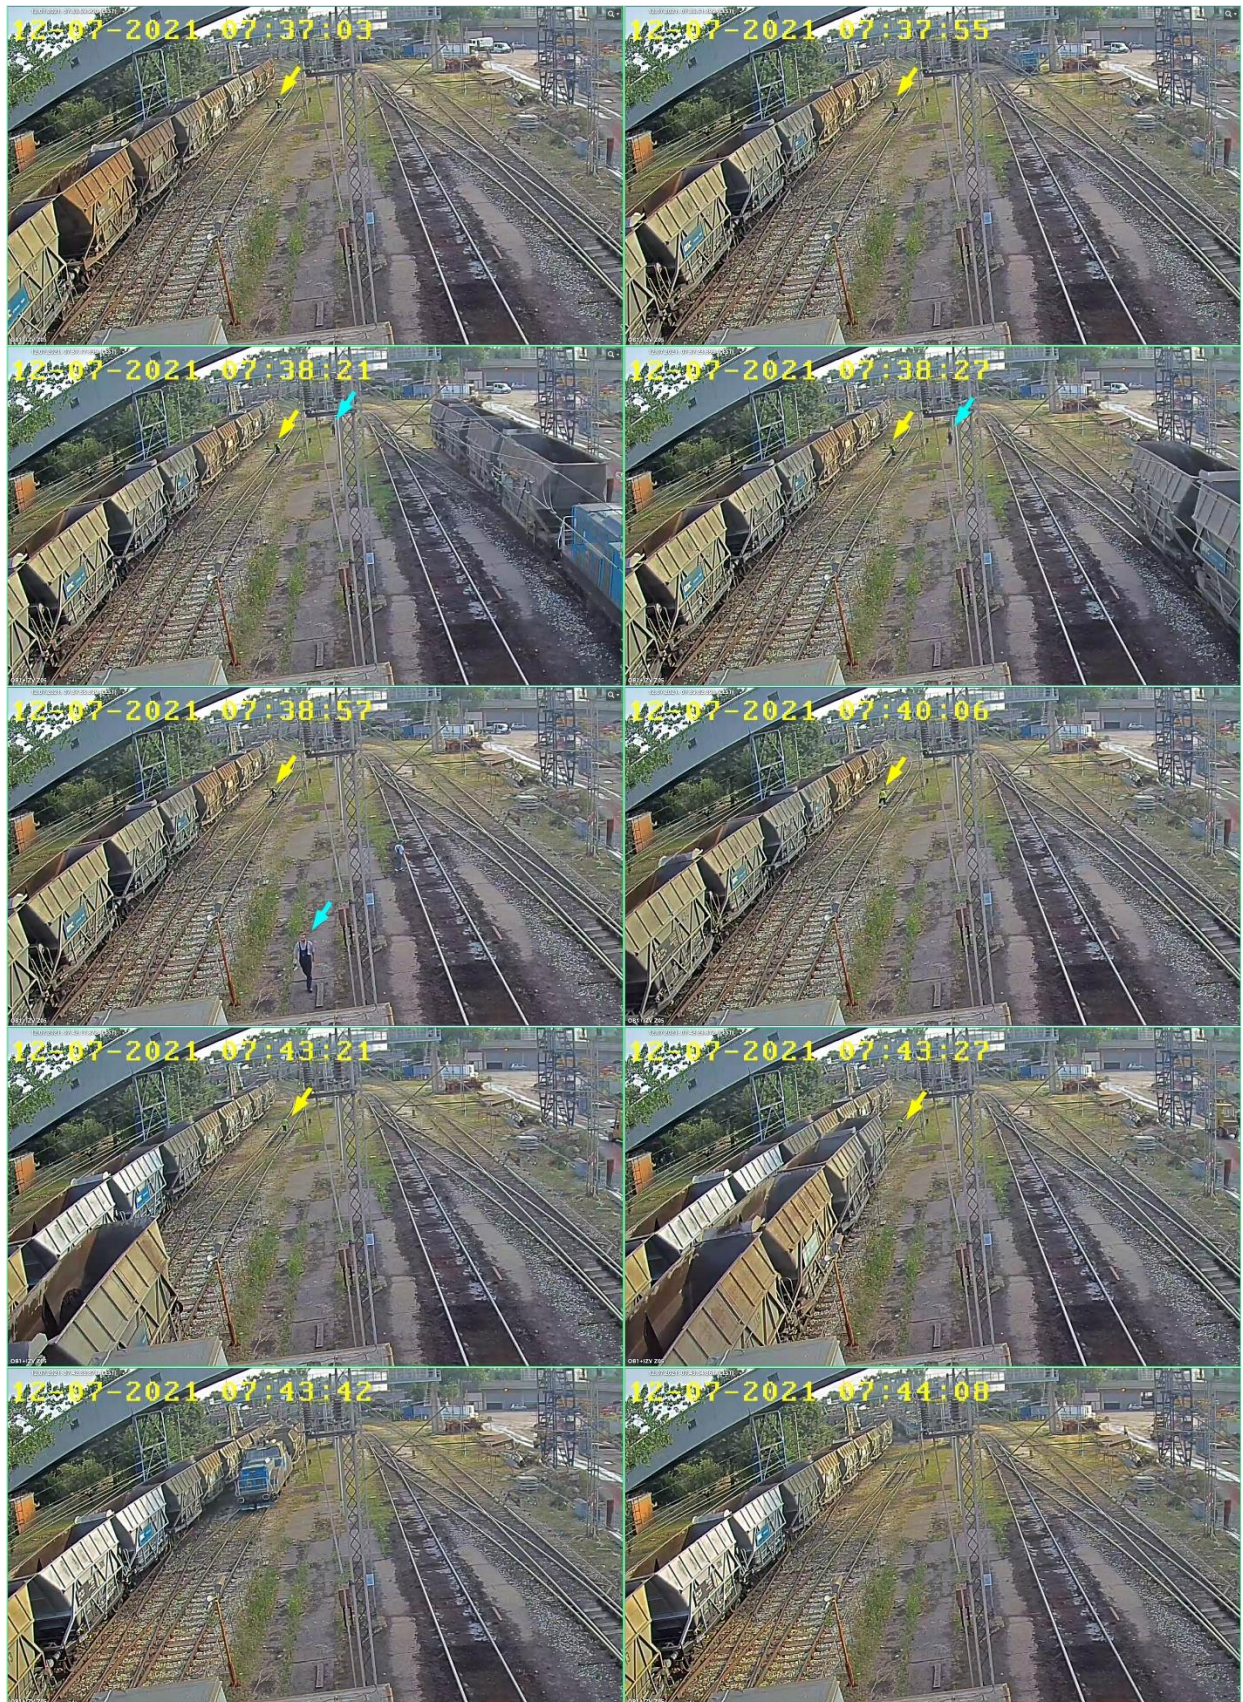
Figure 4.2.1.3: The video surveillance sequences (source: JP “EPS” Branch TENT from Obrenovac)

The video shows that in the period from the start of the pulled shunting composition from the fourth turnout track to the overtaking of the pushed shunting composition on the railway worker on the second track at the switch No. 17, the coal was unloaded on the first track. Also, in the video, in the frame on the right, you can see the place where the works on the flue gas purification on the plants are done, which is located outside the area of the station.

The layout of the video surveillance sequences is shown in Figure 4.2.1.3. The yellow arrow marks the railway worker who was cleaning the switch No.17, and the blue arrow marks the shunter (first shunter) of the Obrenovac station who coupled the 443-06 locomotive for two Arbel type wagons of Faboo series on the fourth turnout track.

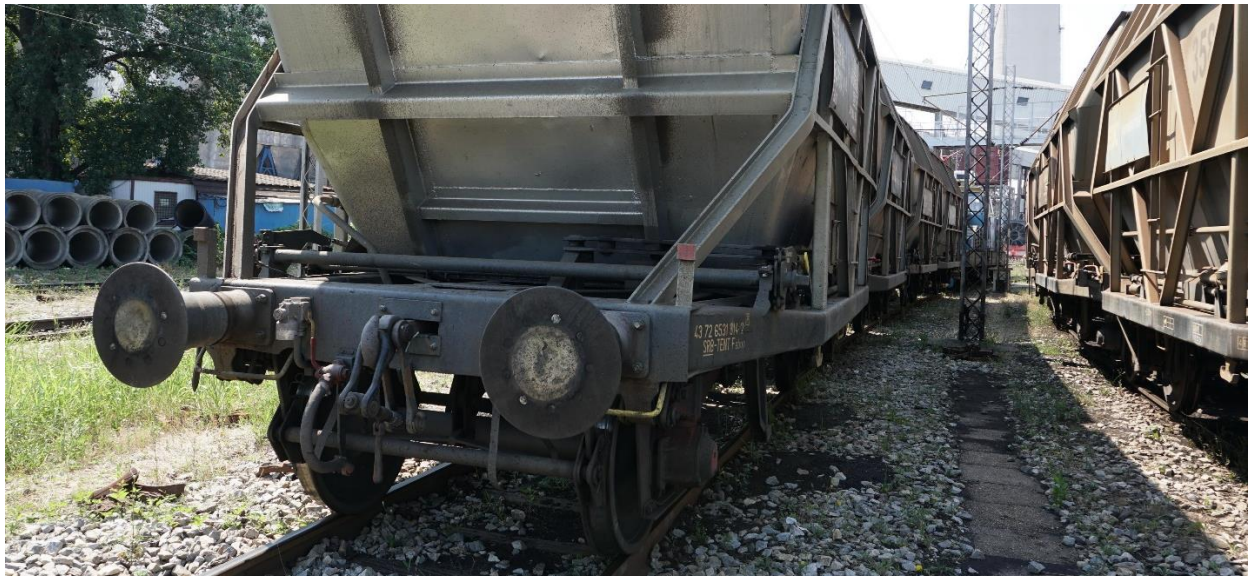
Figure 4.2.2.1: Appearance of the pushed shunting composition observed from the front ie the wagon of the individual No. 43 72 6531 314-2 towards the locomotive 443-06

Having in mind the technical characteristics (see point 2.2.2), of the Arbel type wagons of the Faboo series, the installation of steps and handrails for the shunter is not constructively envisaged. By on-site inspection during the investigation, it was concluded that on neither side at the end of the wagon of individual No. 43 72 6531 314-2, that were at the head of the pushed shunting composition, observed in the direction of movement of the shunting composition, no steps and handrails for the shunter were installed (see point 3.6.3), so there was no possibility for the attendant or shunter to follow the pushed shunting composition. There was a possibility for the attendant or shunter to follow the pulled shunting composition during the shunting drive from the driver cab or from the platform of the locomotive 443-06.

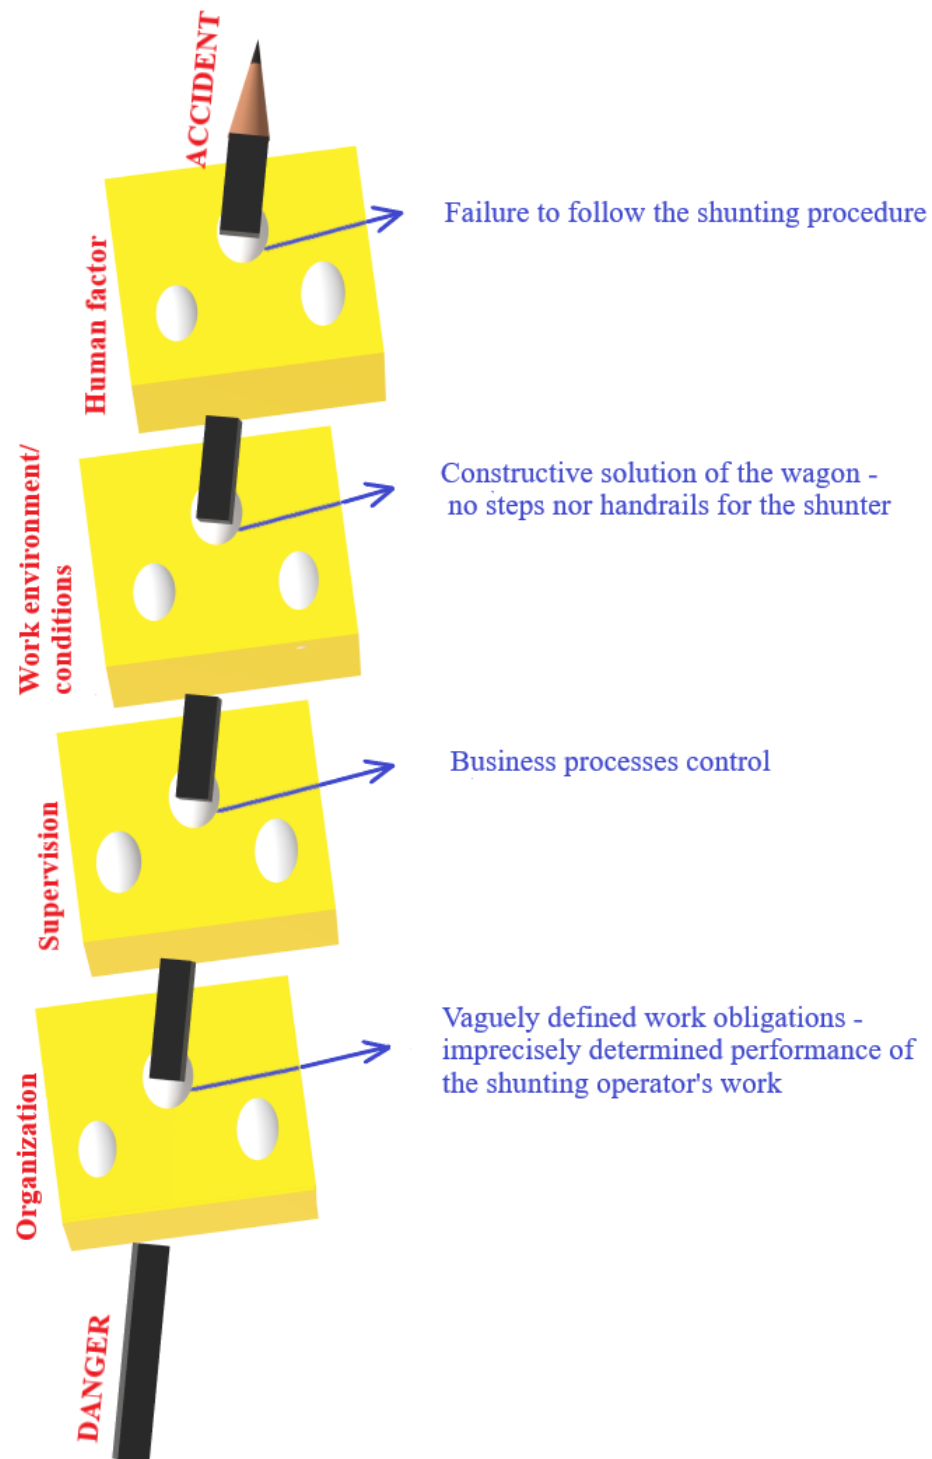
Figure 4.2.4.1: “Swiss Cheese Model” regarding the serious accident in question

According to the Swiss Cheese Model, accidents are not just the result of one mistake by one person, but are the result of multiple errors in the business system or organization. Cheese slices represent barriers, that is, protection or defence against the danger of occurrence of an accident, and the holes on them represent the shortcomings of the system, that is, failures in the system, the overlap of which leads to the occurrence of accidents.

Taking into account the available facts described in the analysis in section 4.2.1. and section 4.2.2., the occurrence of the serious accident in question is the result of overlapping of several irregularities in the business system or organization in JP “EPS” Branch TENT, which is shown in Figure 4.2.4.1.
