Rail Accident Report

Freight train derailment near Gloucester 15 October 2013

Report 20/2014
October 2014

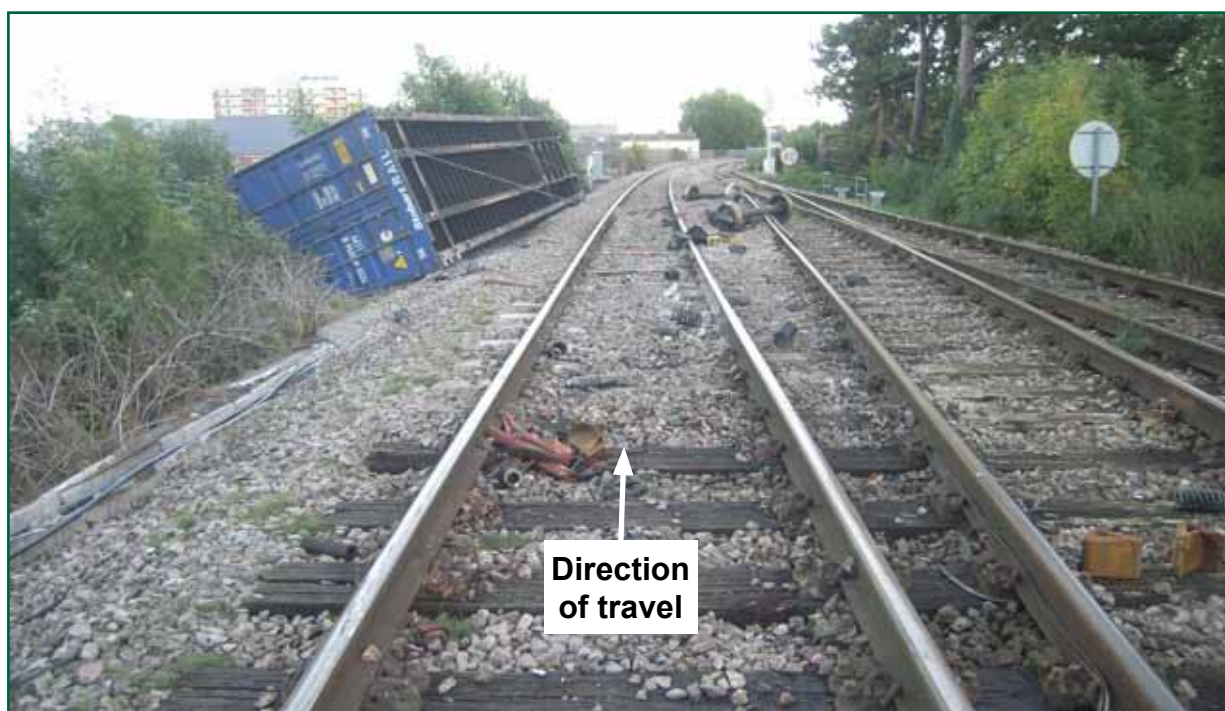
Figure 3: The debris and dislodged container at Gloucester West Junction

- 29 After about 3 miles (4.8 km), while travelling at 45 mph (72 km/h), the derailed wheelset struck a *check rail* at Over Junction which is located at 115 miles 43 chains. No other wheels derailed as a result of this impact and the train continued for just over a mile to Gloucester West Junction, which is located at 114 miles 40 chains. Here, the permitted speed on the up main lines further reduces to 40 mph (64 km/h) and while travelling at 22 mph (35 km/h), the derailed wheelset again struck a check rail. This time the impact caused both wheelsets from the rear bogie and various suspension components to be ejected. The impact also dislodged the container on the rear vehicle, which landed in the cess at the top of an embankment (figure 3).

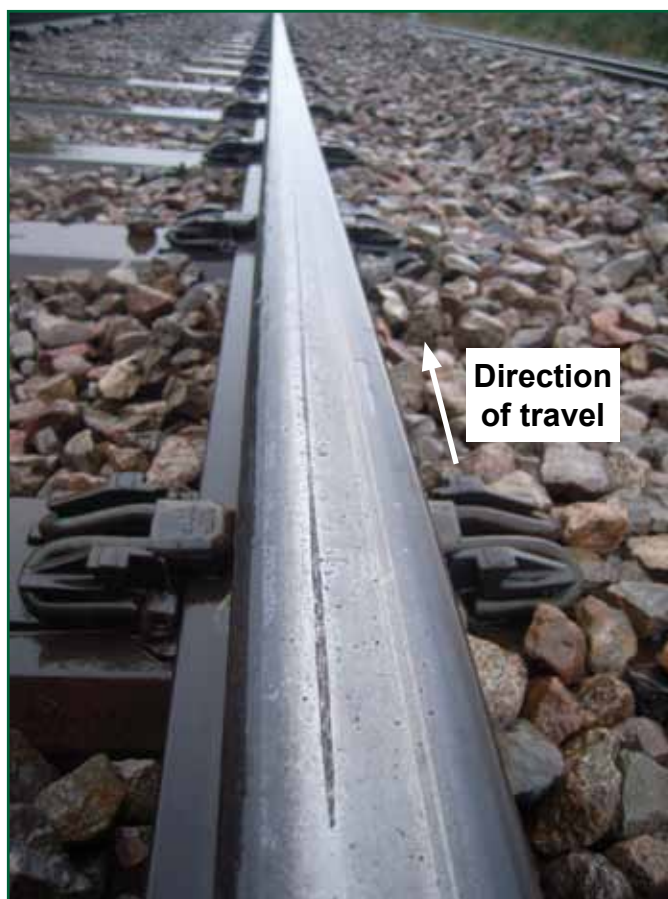
- 26 The train passed over the section of track containing cyclic top while travelling at 69 mph (111 km/h). The locomotive and following 27 vehicles did not derail but the rear wheelset of the 28th vehicle, at the rear of the train, lifted clear of the rail. Marks found on the head of the six foot rail show the flange of its right-hand wheel landed on top of this rail at 118 miles 46.64 chains (figure 6).

Figure 6: The flange mark on the head of the six foot rail

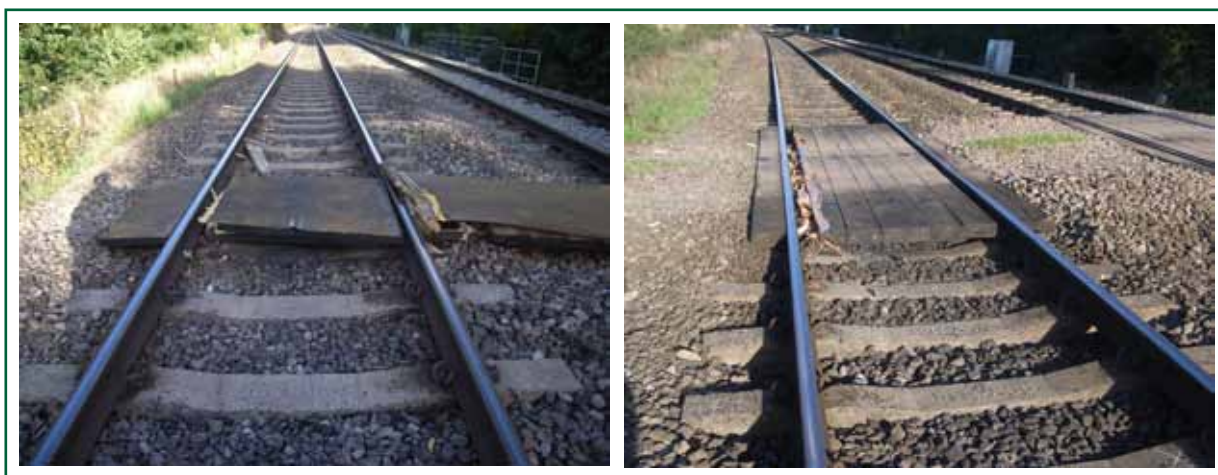
Figure 7: Examples of the damage caused by the derailed wheelset to level crossing surfaces

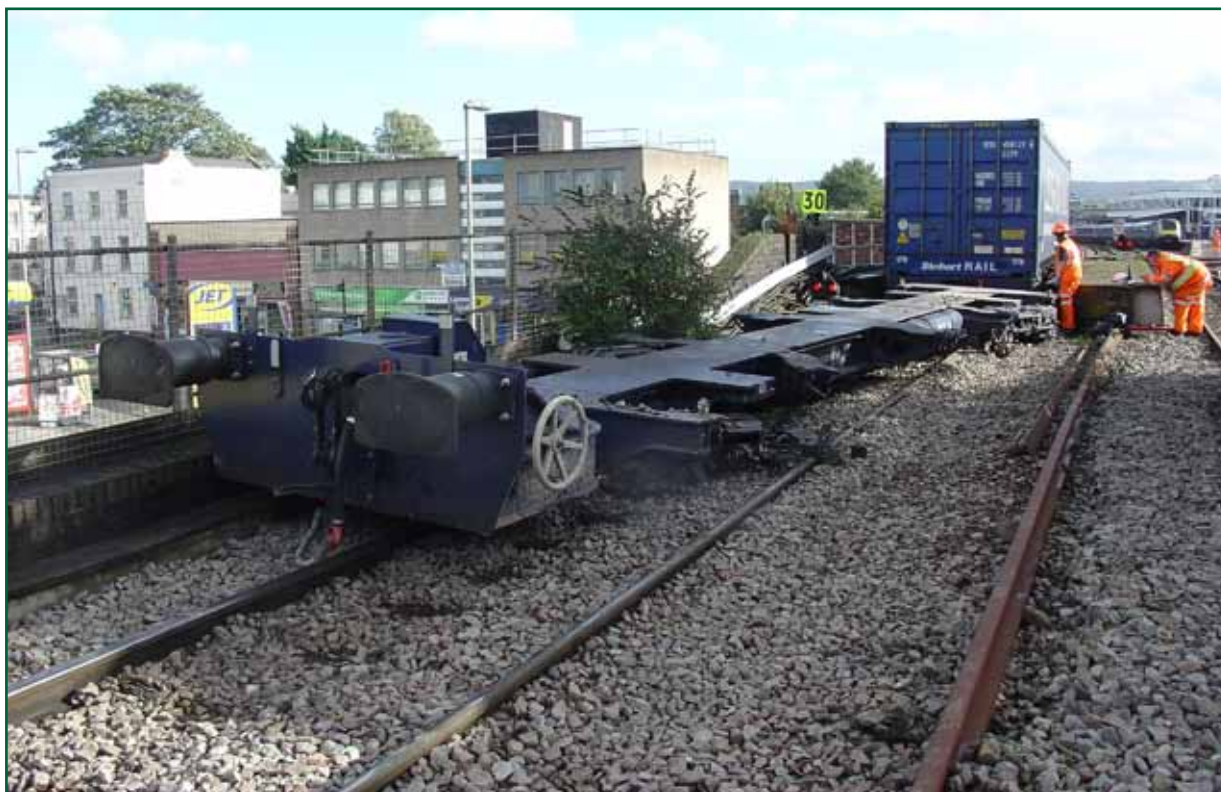
Figure 8: The severely damaged vehicle at the rear of train 4M36

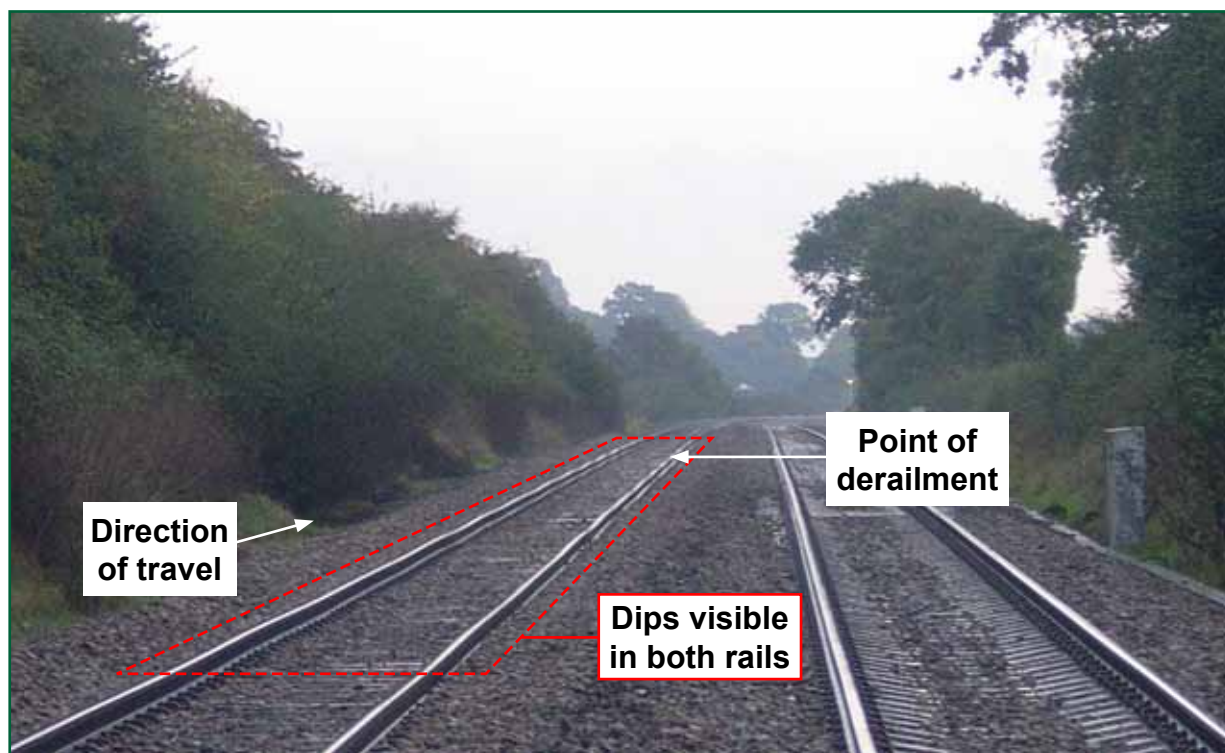
Figure 9: The cyclic top track defect on the up main line

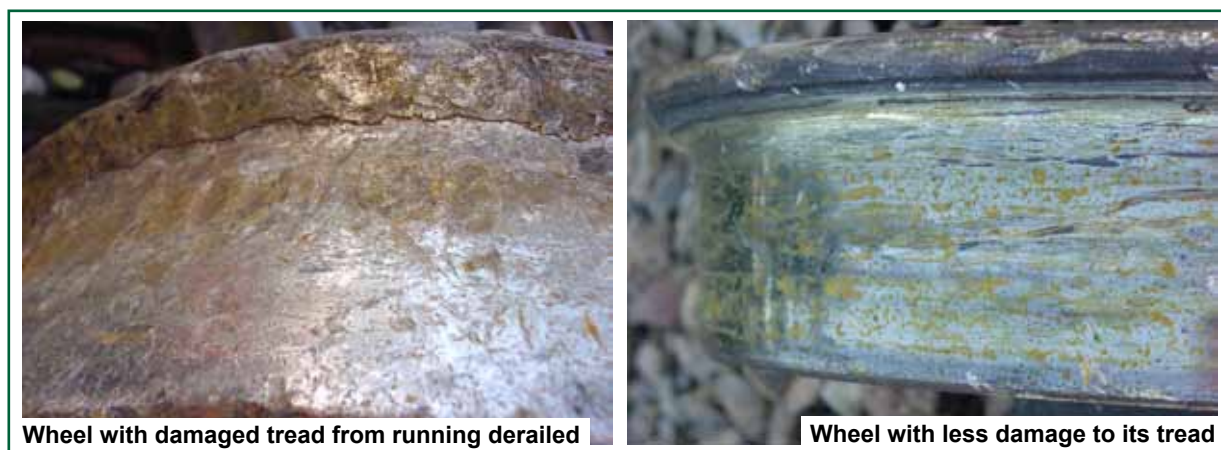
Figure 11: The treads of wheels from the rear bogie

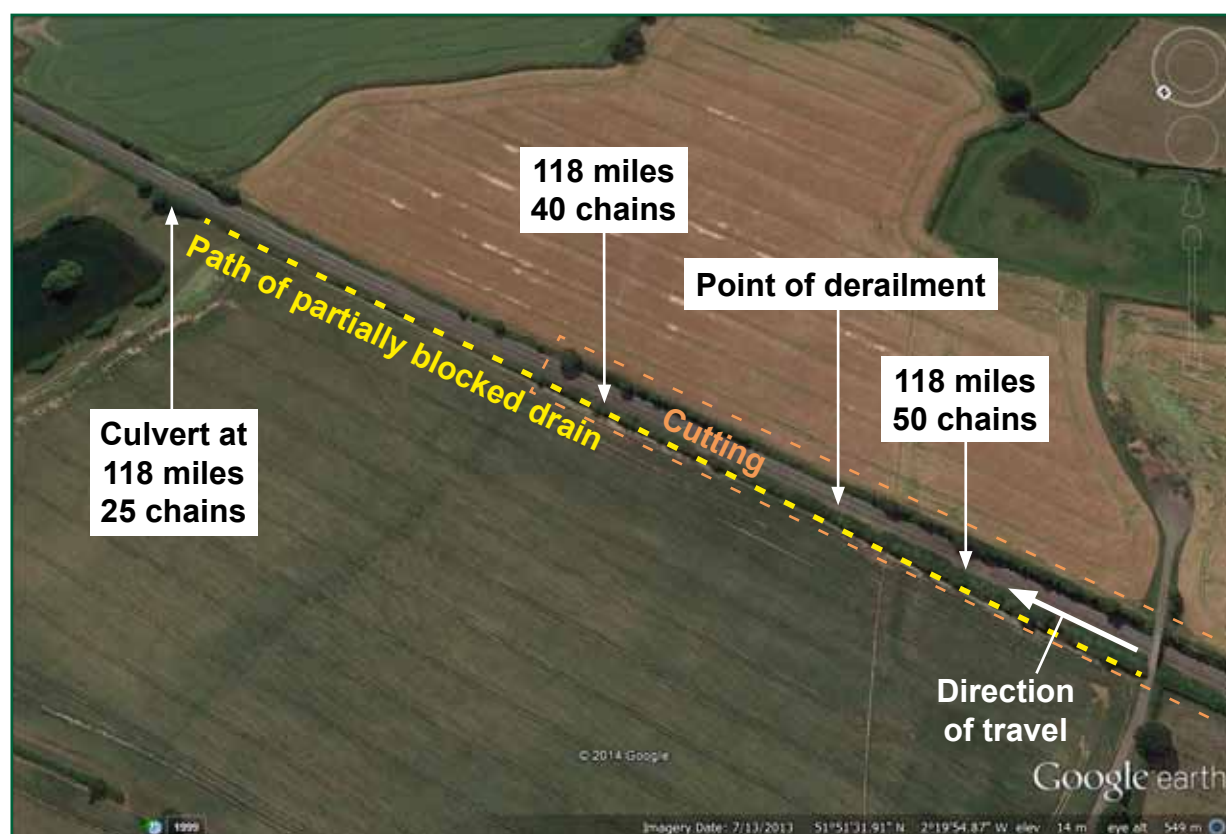
- 73 The only drainage present was a drain running along the top of the cutting which might have intercepted some surface water from the adjacent field (figure 14). This drain was partially blocked by vegetation (paragraph 180). However, even if it had been fully functional, due to its position at the top of the cutting, it would not have intercepted the water in the local water table that was flowing downhill under the cutting and beneath the up main line.

Figure 14: Location of the drain running along the top of the cutting

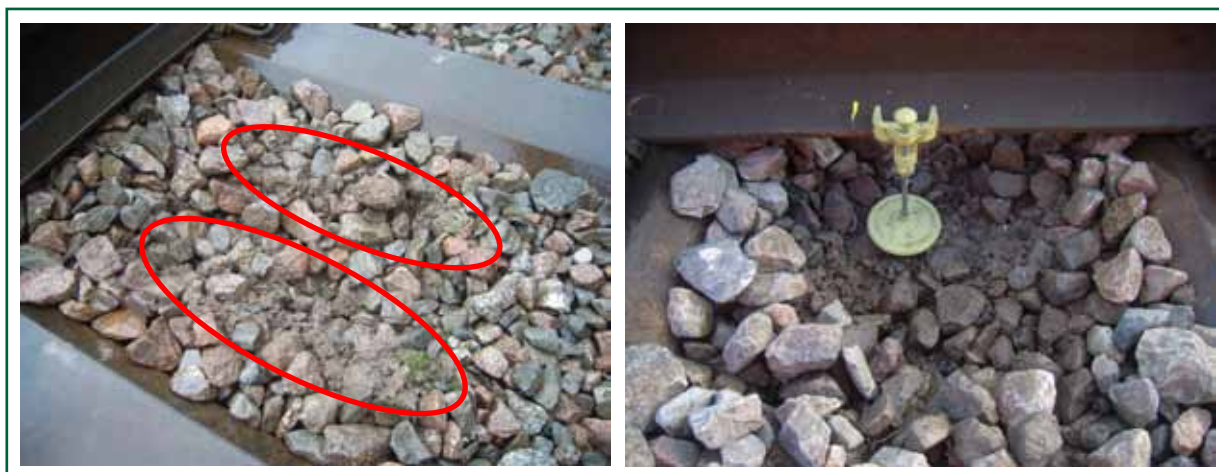
- 74 The RAIB examined the track in the cutting and noted mud from the formation on the surface of the track throughout the cutting (figure 15). When the top 100 mm of ballast was removed to measure the amount of voiding (paragraph 64), contaminated ballast and mud was found just below the surface (figure 15). The places where the ballast was the most contaminated coincided with the location of the dips in the track.

Figure 15: Mud on the surface and contaminated ballast just below the surface

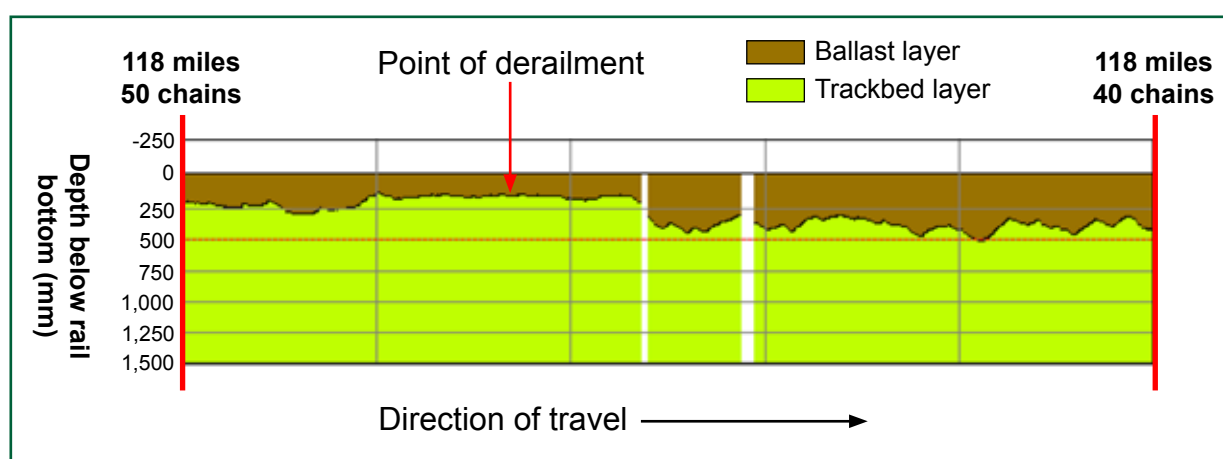
- 75 To understand the extent of the ballast contamination, the RAIB obtained data from one of Network Rail's trains that is fitted with ground penetrating radar. The data recorded when the train last ran over the up main line on 25 July 2013 showed that the ballast was contaminated with mud in a number of places near to where the train derailed (figure 16). The depth of clean ballast is very shallow; it was as shallow as 100 mm in places, which again coincided with the location of the dips in the track.

Figure 16: Ground penetrating radar data processed to show the ballast depth where the train derailed

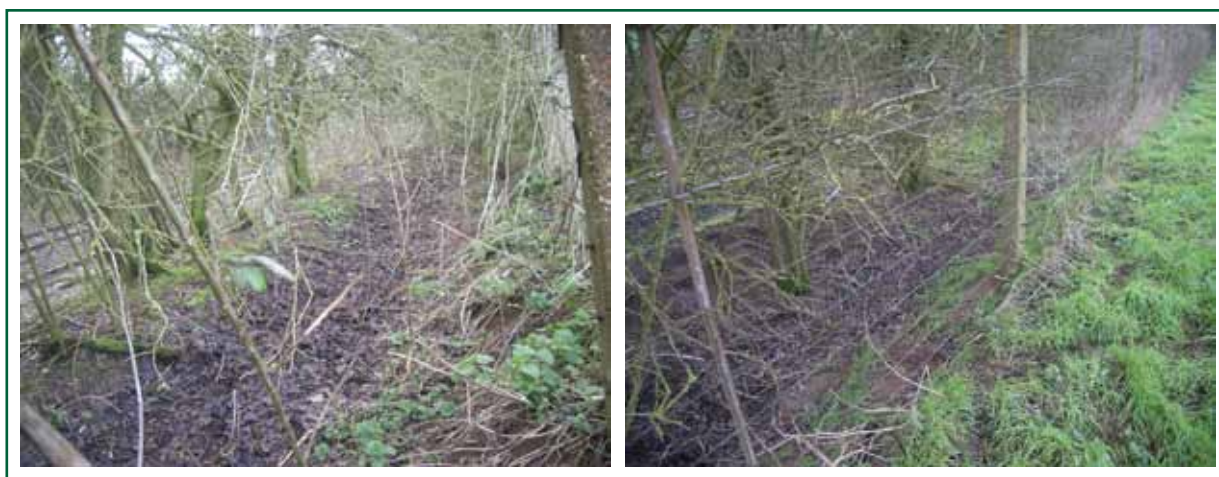
180 The only drainage near to the point of derailment was a drain running along the top of the cutting on the up main line side (paragraph 73). It was blocked by vegetation (figure 31). During an examination of the cutting in 2009, the examiner noted that this drain was partially blocked. However, the examiner did not record that the drain was affecting the stability of the cutting, so the Network Rail team responsible for managing this cutting did not initiate any maintenance action to clear the drain out. Based on the examiner's findings, the team classified the cutting's condition as marginal¹⁹. This classification meant Network Rail did not consider including the cutting in a program of works to rectify drains at the top of cuttings before they caused a problem. This work had started in 2010, after a number of cutting failures due to blocked drains, but only included cuttings which were classified as poor¹⁹.

Figure 31: The drain along the top of the cutting (as recorded on 14 January 2014)
