# Rail Accident Report

**The fatality at Barratt's Lane No.1 footpath  
crossing  
21 November 2005**

# **The fatality at Barratt's Lane No.1 footpath crossing, 21 November 2005.**

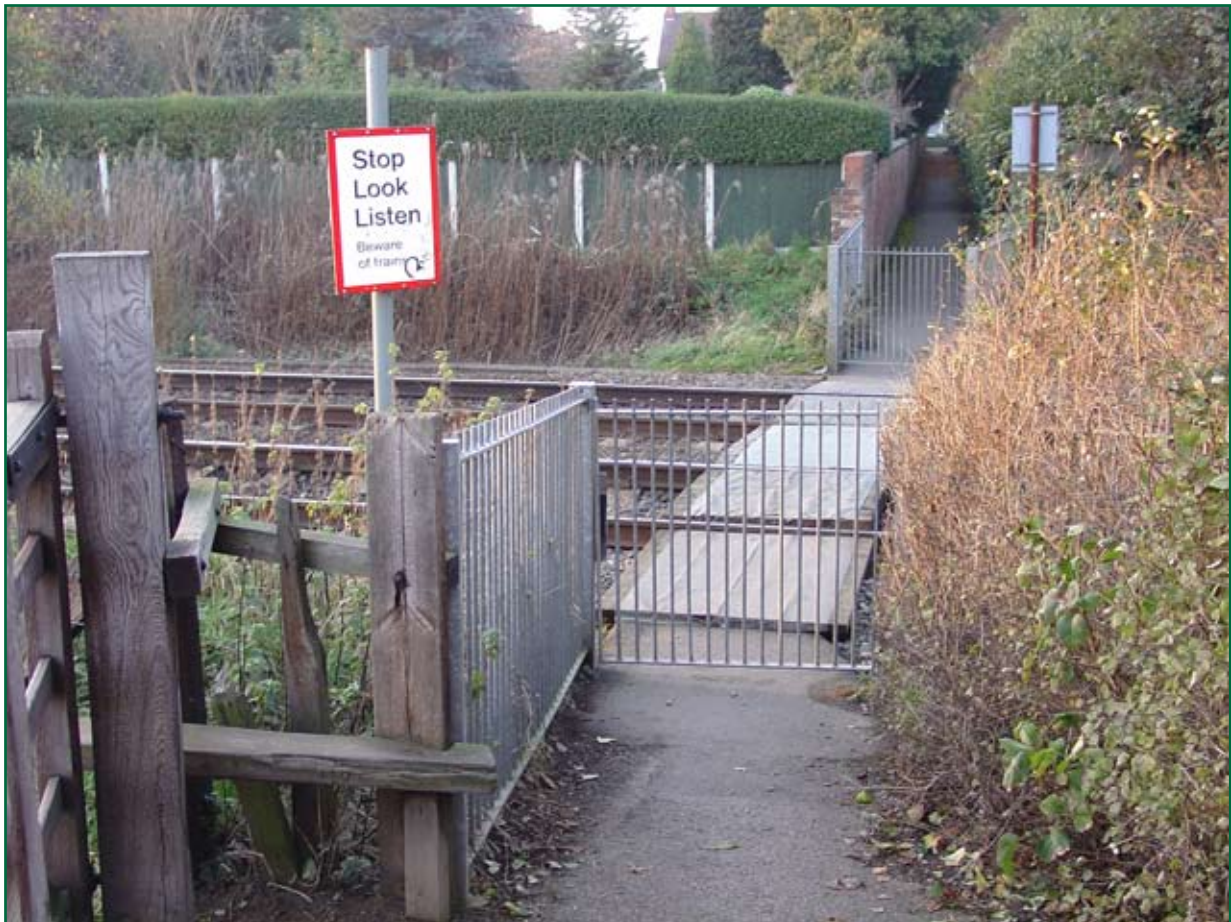
*Figure 3: Barratt's Lane No.1 crossing as seen from the approach from the St Mary's Close side, as used by the pedestrian.*

- 25 Figure 3 shows the footpath to Barratt Lane leading away from the far side of the crossing. The train that struck the pedestrian travelled from the left to the right on the far track (the down line) as seen in Figure 3 and Figure 4.

- 84 The maintenance records showed repairs to the non-slip surface were requested in late August 2005. These were completed before the date of the accident. No other issues were raised by the inspection report bar graffiti on one of the warning signs. A visual inspection of the crossing by the RAIB on 23 November 2005 found it to be in excellent working order with all of the required facilities and furniture provided. The graffiti mark found on the sign on the approach side used by the pedestrian did not make it illegible (see Figure 3).

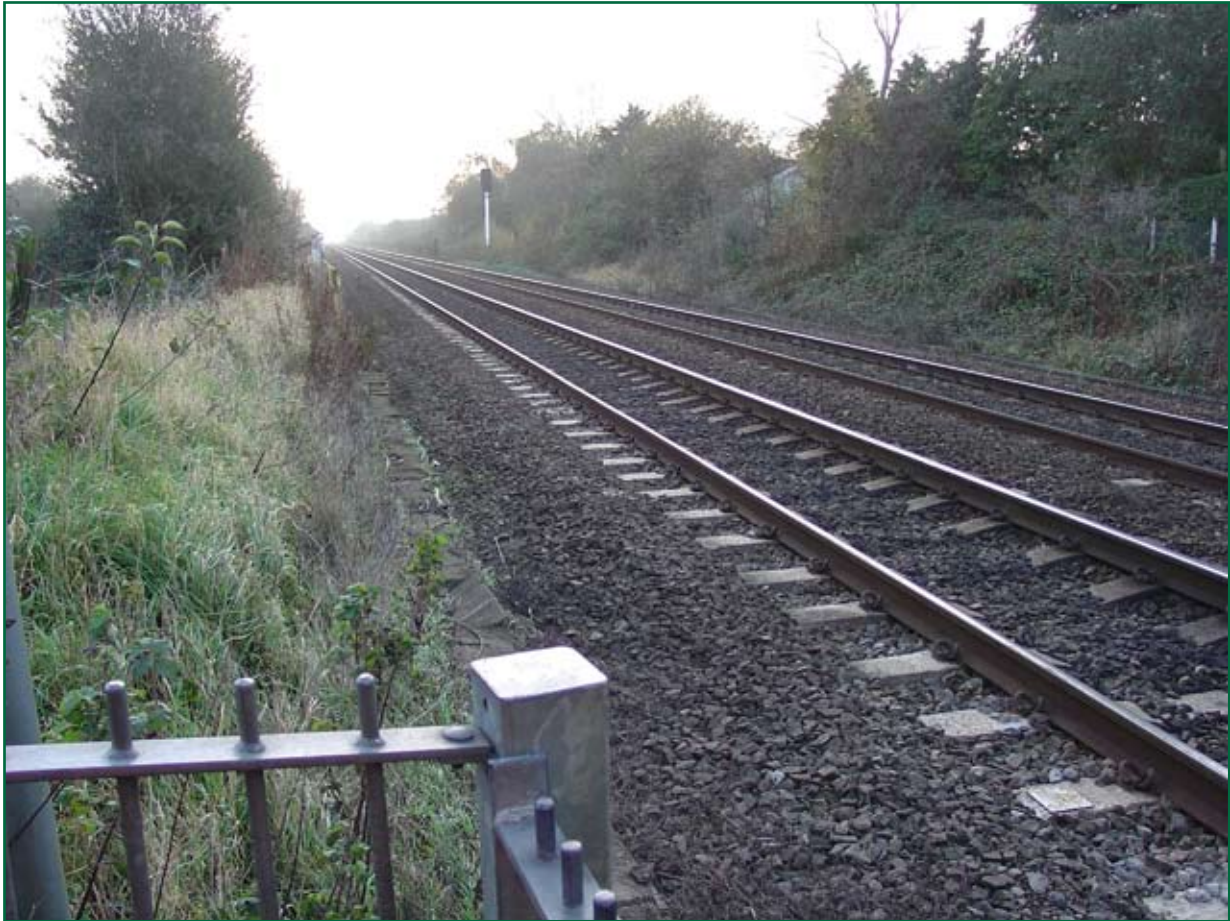
Figure 4: View from inside the wicket gate at Barratt's Lane No.1 footpath crossing looking towards London from the side the pedestrian crossed from (St Mary's Close)

- 26 Figure 4 shows the view the pedestrian would have had to the southwest when making a final decision whether to cross or not, except it was foggy on the day. The nearest track is the up line to London; the furthest is the down line on which train 1 approached. The signal is located 66 metres from the crossing.

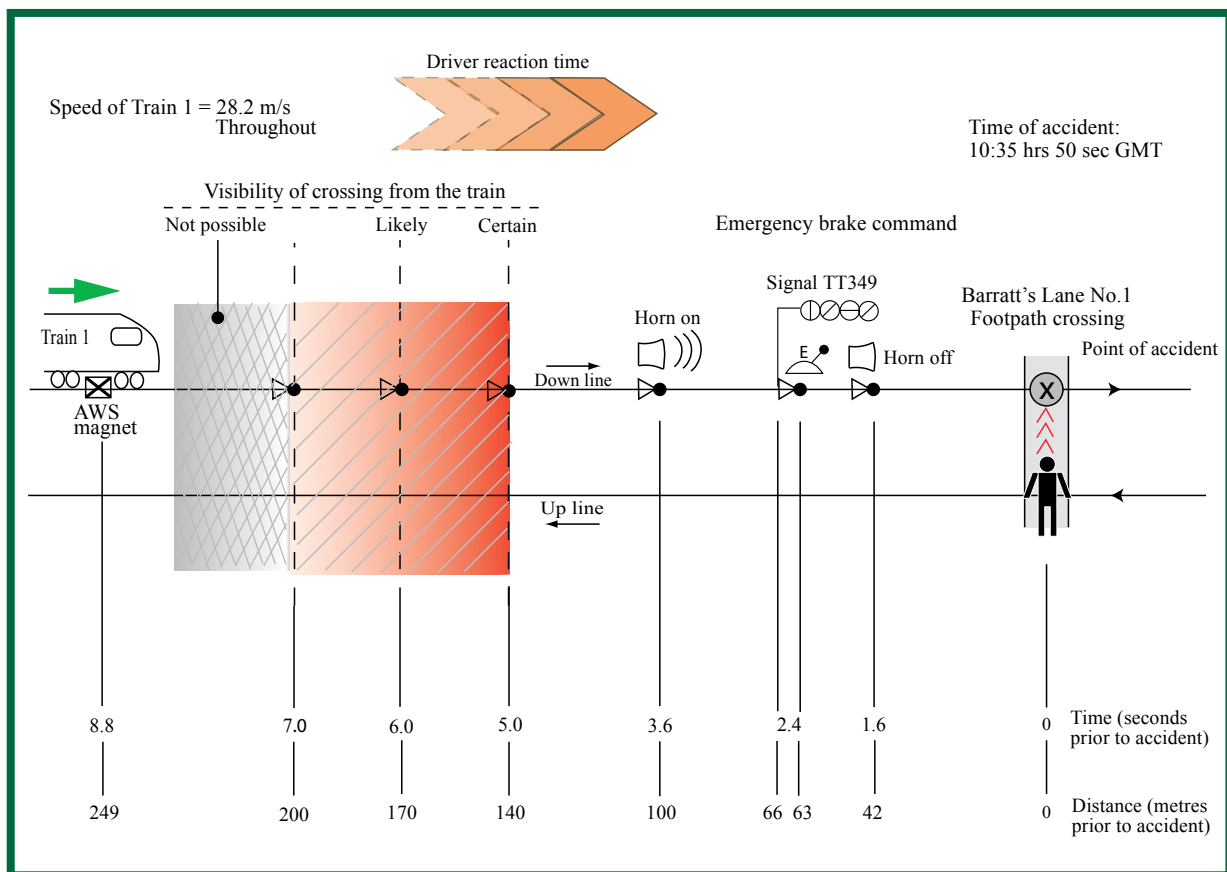
- 62 Figure 5 gives a schematic representation of the sequence of events derived from data records starting with Train 1 passing the AWS magnet for Signal TT349 (and therefore at that point still in fog and invisible to anyone looking from Barratt's Lane No. 1 crossing) to the moment of impact on the crossing. These events are described in more detail in the paragraphs that follow.

Figure 5: Schematic representation of the sequence of events leading up to the accident derived from the data records

- 63 Train 1 passed the *AWS magnet* for TT349 signal, receiving a bell-sound indicating a green signal, at 10:35 hrs and 41.2 seconds GMT (10:38 hrs and 8.3 seconds according to train 1's data recorder clock time Tr1). This magnet is a feature fixed in the railway infrastructure and passage over it is picked up by each train's data recorder. Such time-records in a data recorder combined with measurement of the location of the magnet allows the time of passage of the train past other fixed features to be calculated. This is done using the distance of the feature from the known magnet and the recorded time-speed data of the train relative to the time the train passed the magnet.

- 64 At 10:35 hrs and 46.4 seconds the driver started sounding the warning horn after observing the person on the crossing. At 47.1 seconds he started to move the power brake controller from notch 3 throttle (maximum power) into emergency brake. At 47.6 seconds the emergency brake demand was activated. It took a further 3.5 seconds for the brake system to respond and generate a significant part of the full brake effort.
