# Rail Accident Report

## Tram, Pedestrian Collision at Staniforth Road, Sheffield, 27 October 2005

This report is published by the Rail Accident Investigation Branch, Department for Transport.

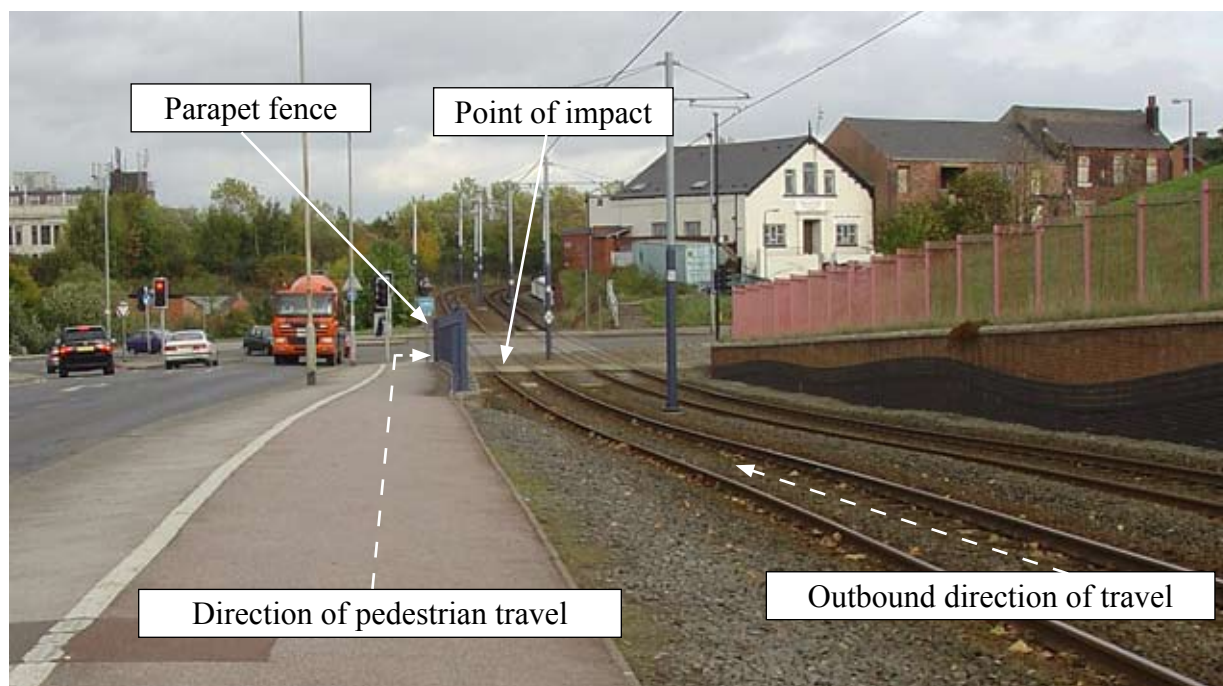
Figure 1: Site layout

- 12 The line to Meadowhall is made up of two tracks running south-west/north-east. They are designated as “outbound” running towards Meadowhall and “inbound” towards the City Centre. Trams travelling “outbound” leave the Woodbourn Road tramstop and run parallel to Woodbourn Road on the left. This is shown in Appendix B Figure 1. Between the carriageway and the tramway is a wide pavement forming both a footway and a cycleway.

- 13 Staniforth Road crosses Woodbourn Road and the tramway on the level. There are separate pedestrian crossings of the tramway immediately to the north-east and south-west of Staniforth Road. The incident took place on the south-west crossing.

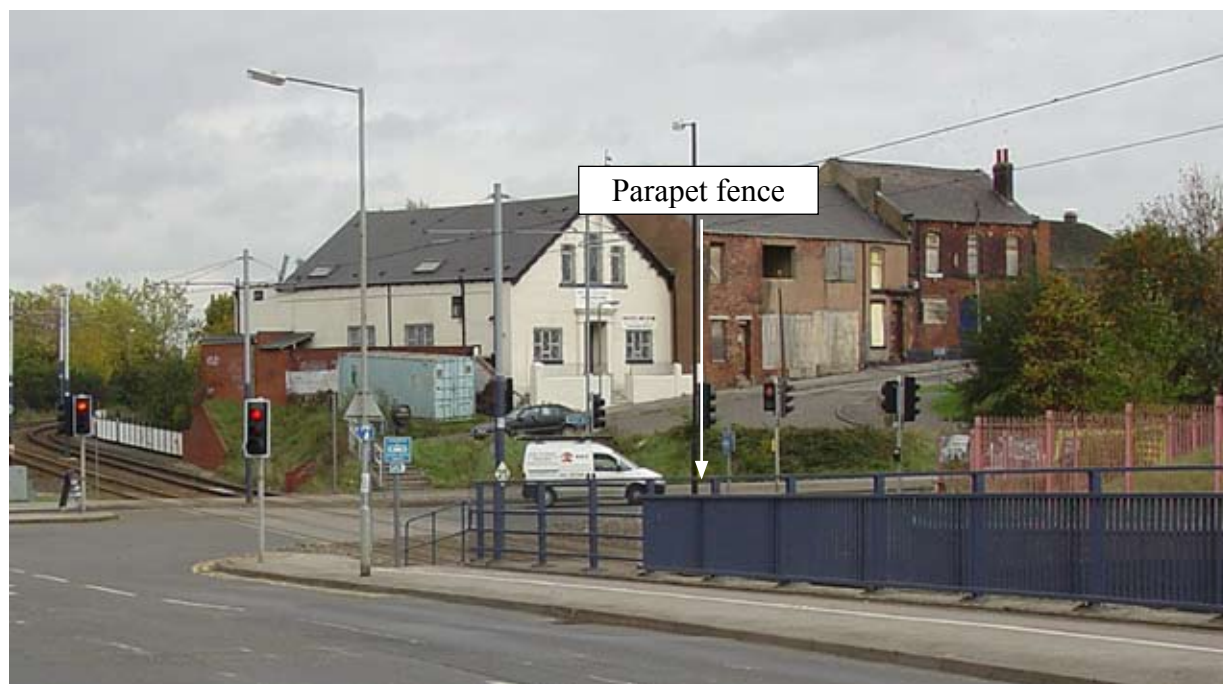
Figure 2: Parapet fence

- 17 The fencing has three distinct sections as shown in Appendix B Figure 2 and described below:
  - The 4.5 metres of fence adjacent to the crossing is of a type normally associated with a pedestrian crossing. It provides little impediment to visibility.

- The next three fence panels are of a parapet design, 1.4 metres high, designed to restrain pedestrians, cyclists and motor vehicles. The design comprises substantial vertical posts with horizontal bars and mesh to aid through visibility.

- The remainder of the fence is of a parapet design comprising substantial vertical posts and closely spaced vertical bars that when viewed from the angle of a tram approaching the crossing, block the tram driver’s view of the pavement.

- 18 The parapet fence partly obstructs the tram driver's view of pedestrians, particularly when they are in the last few metres before reaching the crossing when the pavement slopes downwards to meet the level of the tramway at the crossing.

- 34 The design and positioning of the fence separating the tramway from the pavement affected the driver's view of the pedestrians. It is a Supertram requirement to sound an audible warning if the driver believes it is necessary to draw the attention of pedestrians and road users to the presence of a tram. Rule book section D paragraph 9.1 refers. Driver training and assessment records that were examined suggest that the tram driver is generally cautious and uses audible warnings in an appropriate manner. It is therefore quite possible that had he had better sight of the pedestrians as they approached the crossing, he would have used the bell or horn earlier than he in fact did, and given the pedestrian more warning of the danger. Assuming that the pedestrian would have then reacted differently and not walked in front of the tram, the accident would have been avoided. Such a scenario is not a certainty but is reasonably likely. As such, the effect of the fence on the driver's view of the pedestrians may have been a contributory factor in this incident. The recommendations in this report relate to restricted visibility of pedestrians at or near to tram crossings.

- 35 The immediate cause of the accident was the pedestrian stepping directly in front of the oncoming tram.
- 36 The design and positioning of the parapet fence separating the foot and cycleways from the tramway on the approach to the crossing may have been a contributory factor.

- 37 Stagecoach Supertram, South Yorkshire Police and Sheffield City Council have started discussions on the replacement of the fence adjacent to the crossing.
- 38 Stagecoach Supertram have introduced a compulsory audible warning by all trams at this location as an interim measure.
- 39 Stagecoach Supertram have carried out an assessment of the entire route and have identified a number of locations where similar conditions exist. They have begun to fully assess all the identified locations and, where necessary, will introduce measures to reduce the chance of a similar event occurring.

- 1 Stagecoach Supertram should either replace the fence with a design that provides the tram driver with better visibility of pedestrians as they approach the crossing, introduce compulsory audible warnings and/or take other appropriate measures so as to reduce the likelihood of such an event reoccurring (paragraph 34).

Until this has been done, the interim use of compulsory audible warnings (see paragraph 38) should be maintained.

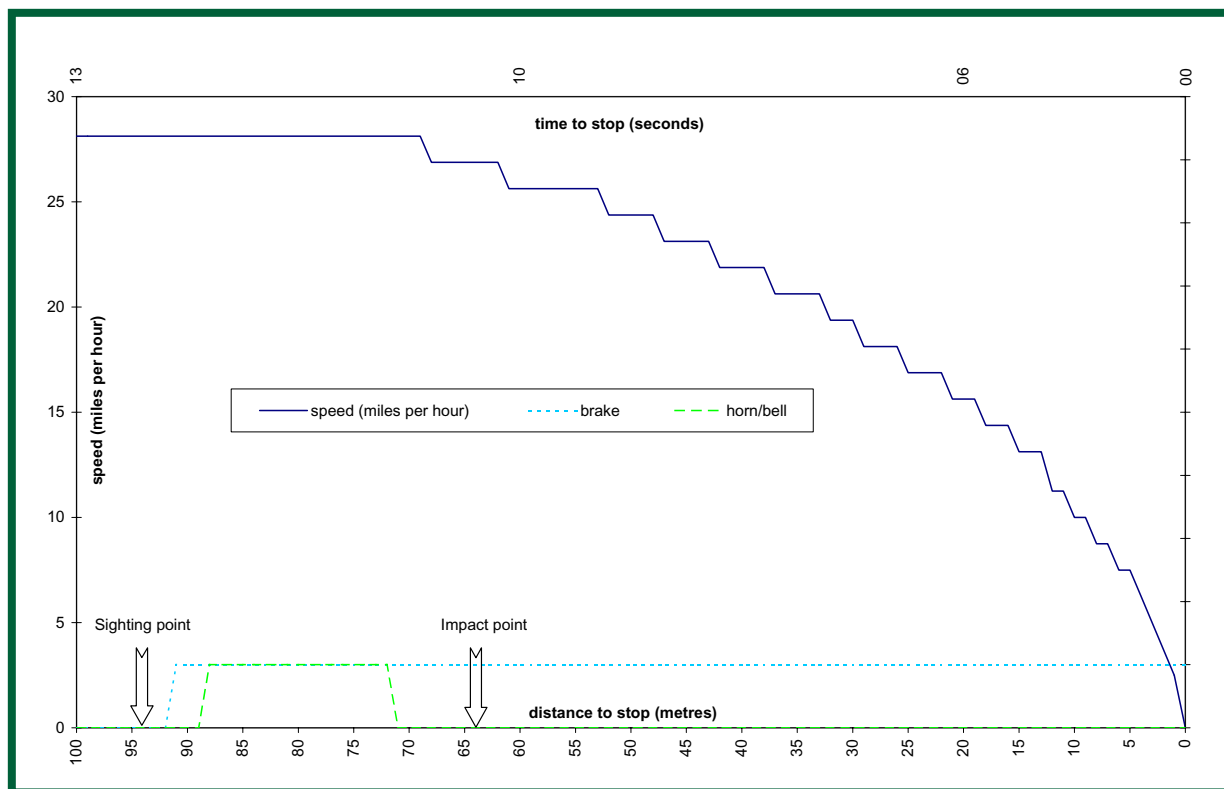
Figure 3: Graph of tram braking and use of horn / bell (NOTE: The distance scale is linear, the time scale is not)

- 26 As the tram approached the foot/cycle crossing, the pedestrian turned right towards the crossing and was first noticed by the tram driver beyond the end of the fencing. At around that time, the driver started braking. He then sounded the horn and increased the brake rate to full service brake within around a second. The tram slowed and collided with the pedestrian around 2.5 seconds after he had become visible to the tram driver beyond the end of the fence. See Appendix C for information on speed, braking, audible warnings and distance travelled through the stop.

- 29 The application of the brake by the tram driver at around the same time as the pedestrians came into view was most likely a response to his rising speed rather than to the presence of the pedestrians. As such, the initial brake rate was low. On perceiving the risk, the driver sounded the horn and increased the brake rate to full service brake. The tram began to slow and struck the pedestrian a short time later at a speed of around 26 mph. This is shown on the diagram in Appendix C.
