Rail Accident Report

**Road vehicle incursion onto the railway at
Aspatria, Cumbria
26 October 2013**

Report 14/2014
June 2014

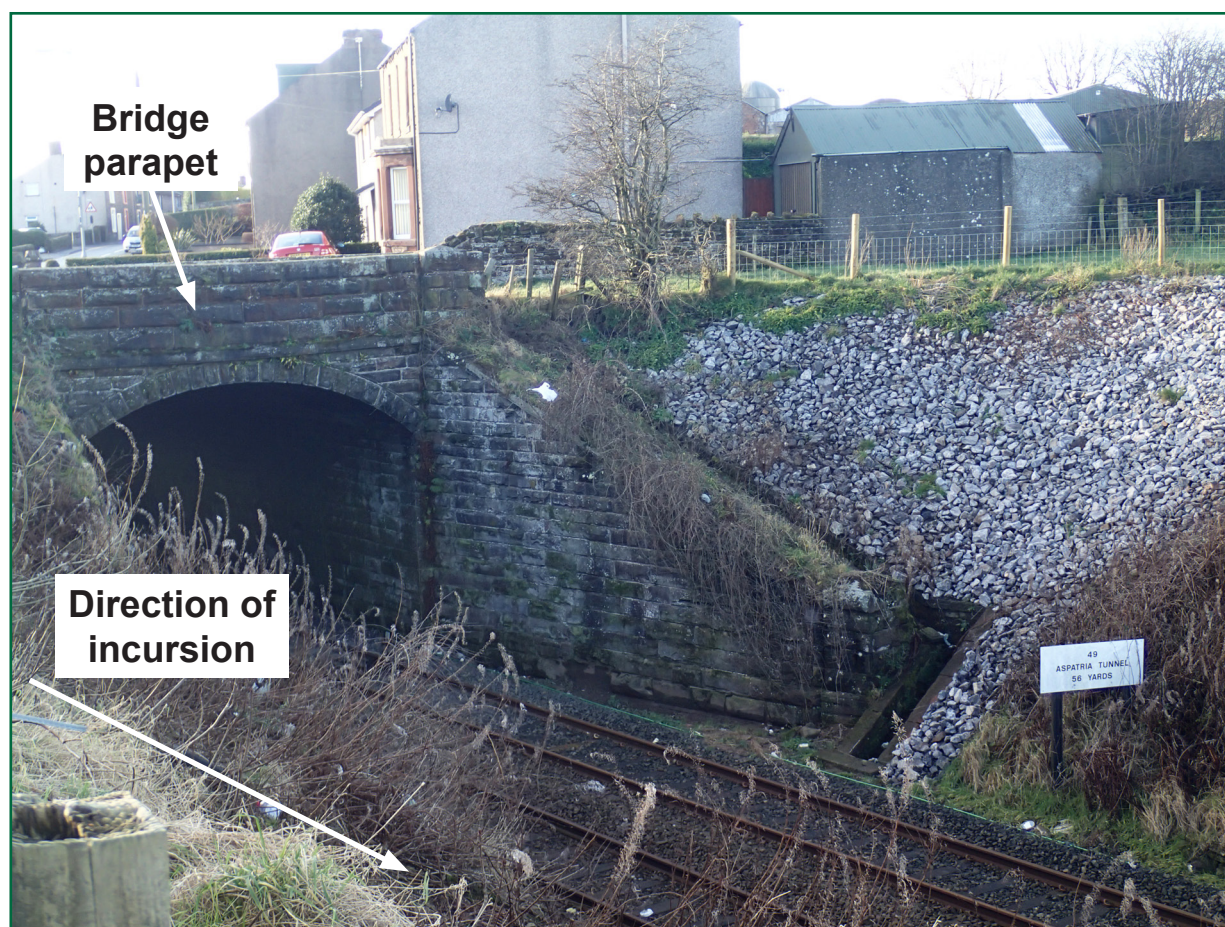
Figure 2: Bridge 49 at Aspatria

- 12 The incident occurred at Aspatria immediately to the east of bridge 49 (otherwise known as Aspatria tunnel) (figure 2) at 8 miles 40 chains¹ on the double track railway from Workington to Carlisle. This line is in Network Rail's London North Western *Route* and is mainly used by passenger trains operating a service at roughly hourly intervals in each direction. A few freight trains also operate on the route. The maximum permitted speed of passenger trains is 60 mph (90 km/h). Freight trains can also travel at a maximum speed of 60 mph (90 km/h) approaching Aspatria, but there is a *permanent speed restriction* requiring them to slow to 20 mph (32 km/h) between 8 miles 40 chains and 7 miles 68 chains in each direction because of the condition of the track.

- 15 Bridge 49 carries the A596 road over the railway at a significant skew resulting in the width of the bridge between the *parapets* being 51.2 metres (56 yards). The A596 road runs from Thursby, just outside Carlisle, to Maryport and Workington and approaches the bridge from the north-east running broadly parallel to the railway until it crosses over it. It was classified as a *trunk road* until it was formally *detrunked* on 1 April 2003. Just before the road crosses the railway, there is a junction with the B5299 Brayton Road, approaching from the east (figure 3).

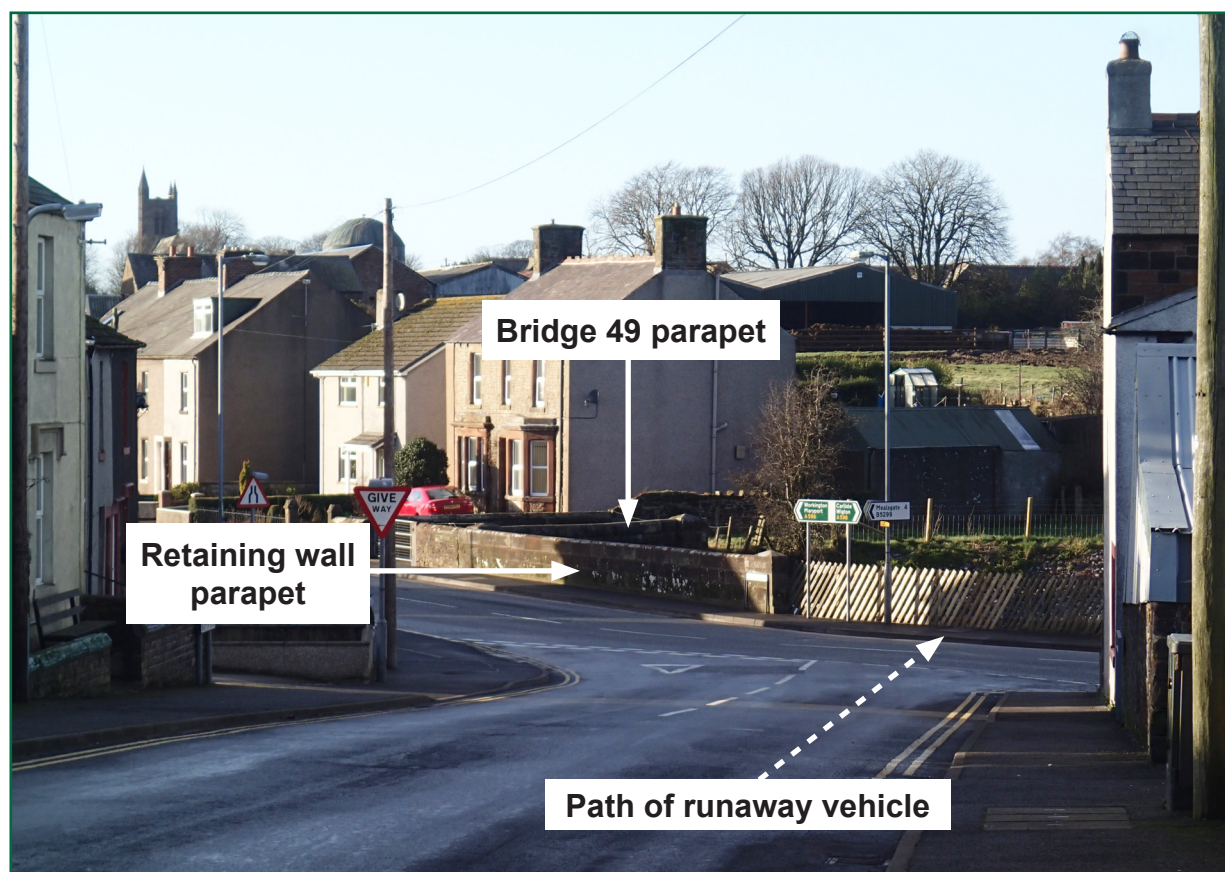
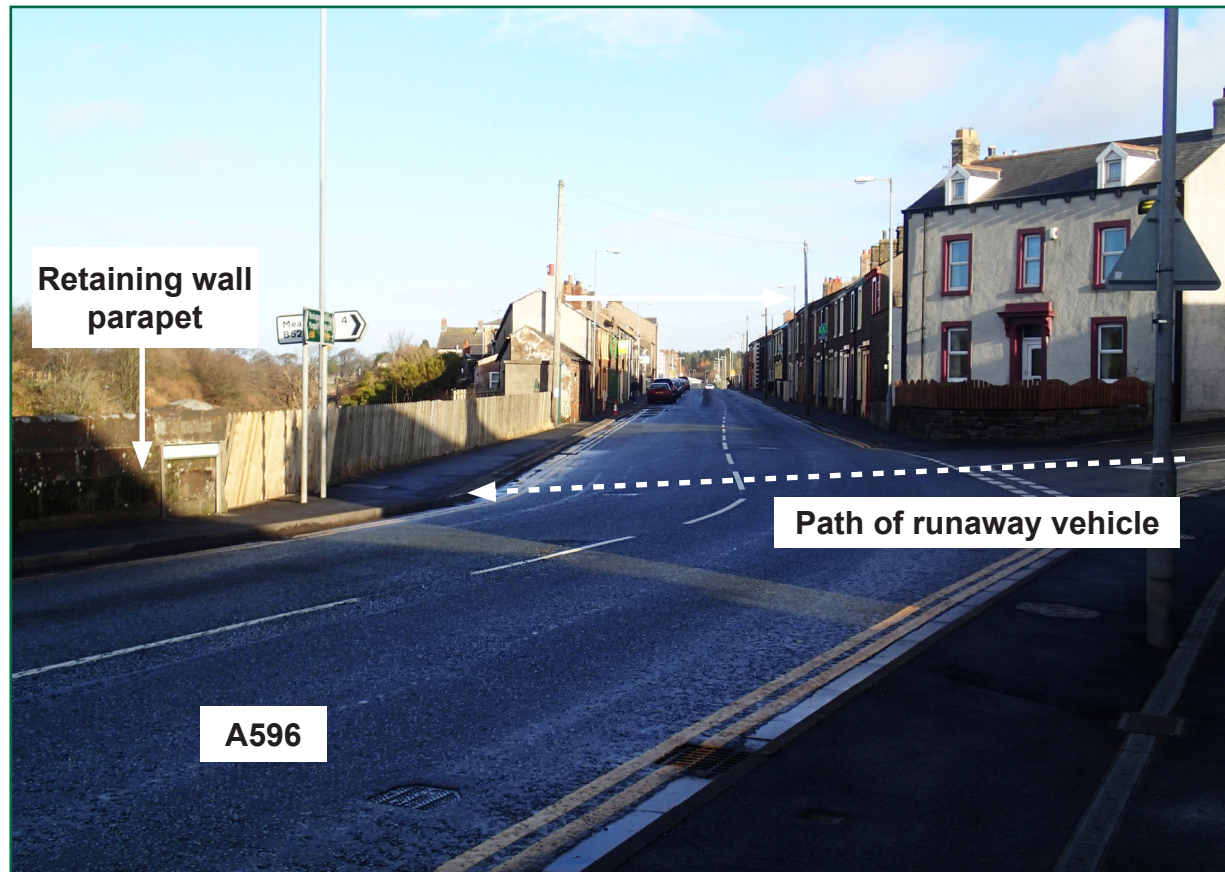
- 16 Brayton Road approaches the junction with the A596 on a downward gradient of about 3% (1 in 33) and directly opposite the junction the railway boundary is protected by a wooden fence. Beyond the fence, the railway lies in a cutting immediately before bridge 49. Between the end of the wooden fence and the bridge parapet there is a section of parapet laid on top of the cutting's *retaining wall* (figures 4a, 4b, 5a and 5b).

Figure 4a: The wooden fenced boundary opposite the A596/B5299 junction

Figure 4b: The wooden fenced boundary opposite the A596/B5299 junction

- 43 The RAIB has concluded that the approach adopted was inappropriate, because the wooden section of fence, forming the boundary between the A596 road and the railway, is not part of the bridge 49 parapets. The wooden fence adjoins the section of the parapet built on the cutting's retaining wall before the bridge is reached (paragraph 16 and figure 4a).

- 63 At the time of publication, Network Rail was working on the design of a safety barrier to be implemented to reduce the risk of vehicle incursion opposite the B5299/A596 junction. The funding for this would be shared between Network Rail and the highway authority.

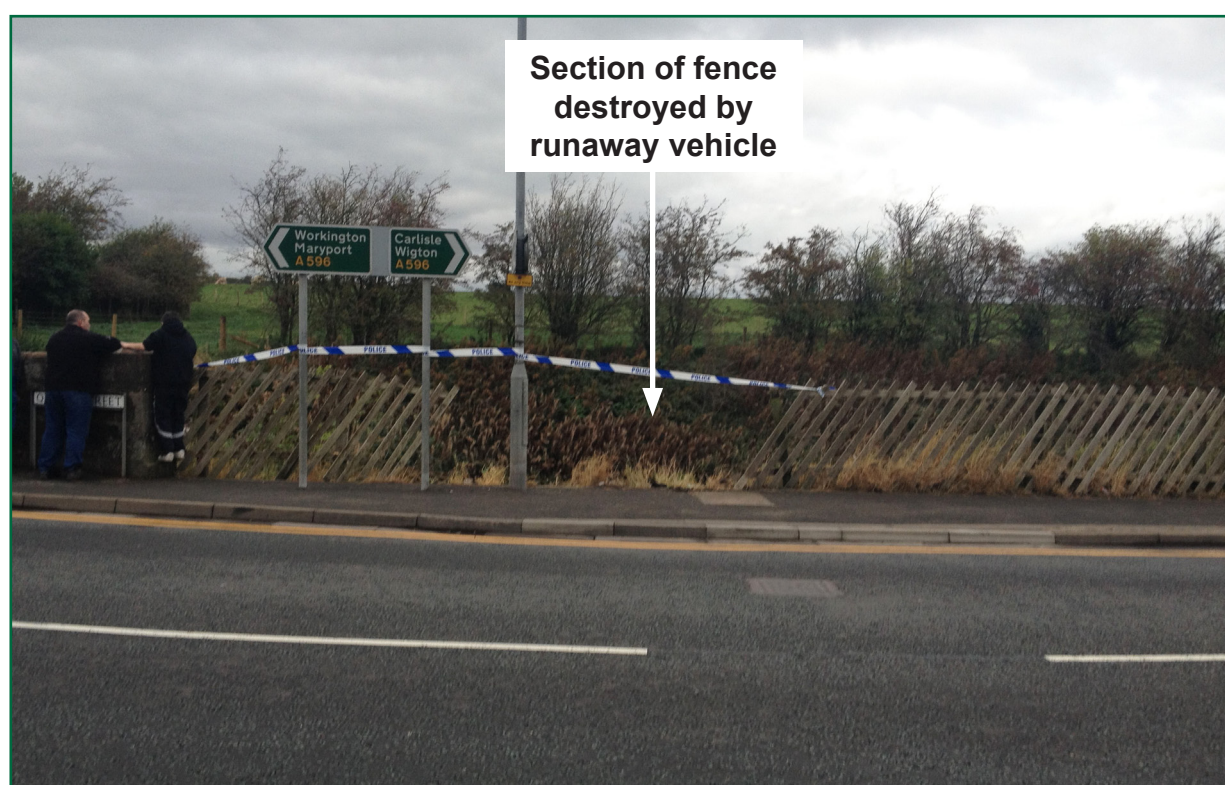
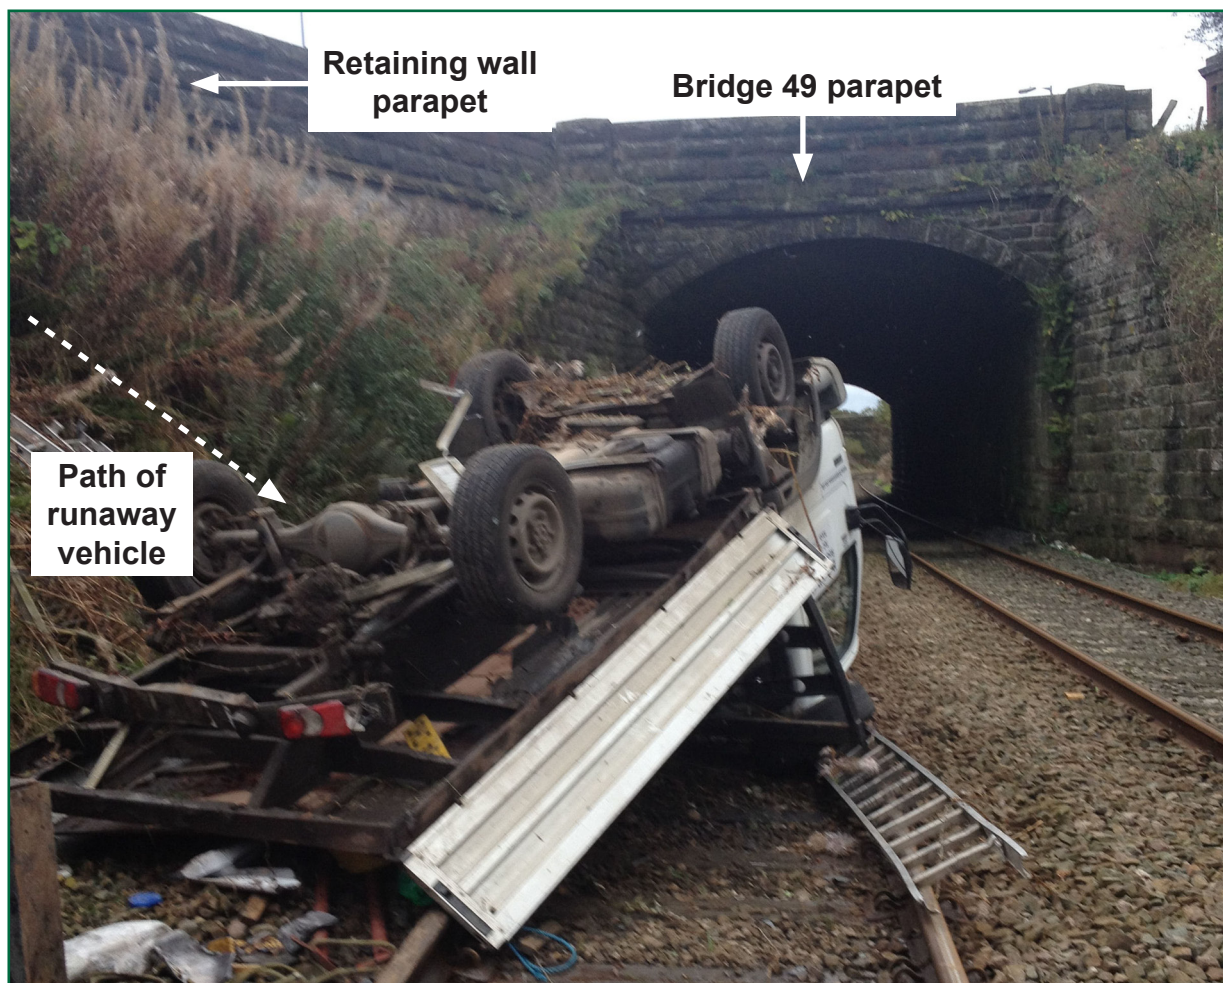
- 22 The vehicle driver parked the Nissan Cabstar on the offside of Brayton Road, facing uphill, about 100 metres from its junction with the A596, shortly before 10:00 hrs on 26 October.
- 23 About two minutes later, according to its driver, the vehicle ran away onto the railway (figures 5a and 5b). The police reported that it appeared part of the handbrake had failed, although it was not possible to determine which part because of the damage caused to the vehicle.

Figure 5a: The consequences of the runaway from the B5299/Brayton Road (courtesy of Network Rail)

Figure 5b: The consequences of the runaway from the B5299/Brayton Road (courtesy of Network Rail)

- 48 The unattended road vehicle ran away down the B5299 Brayton Road towards the railway and neither the roadside kerb nor the wooden fence forming the railway boundary opposite the road junction with the A596 Lawson Street prevented the road vehicle entering the railway infrastructure.

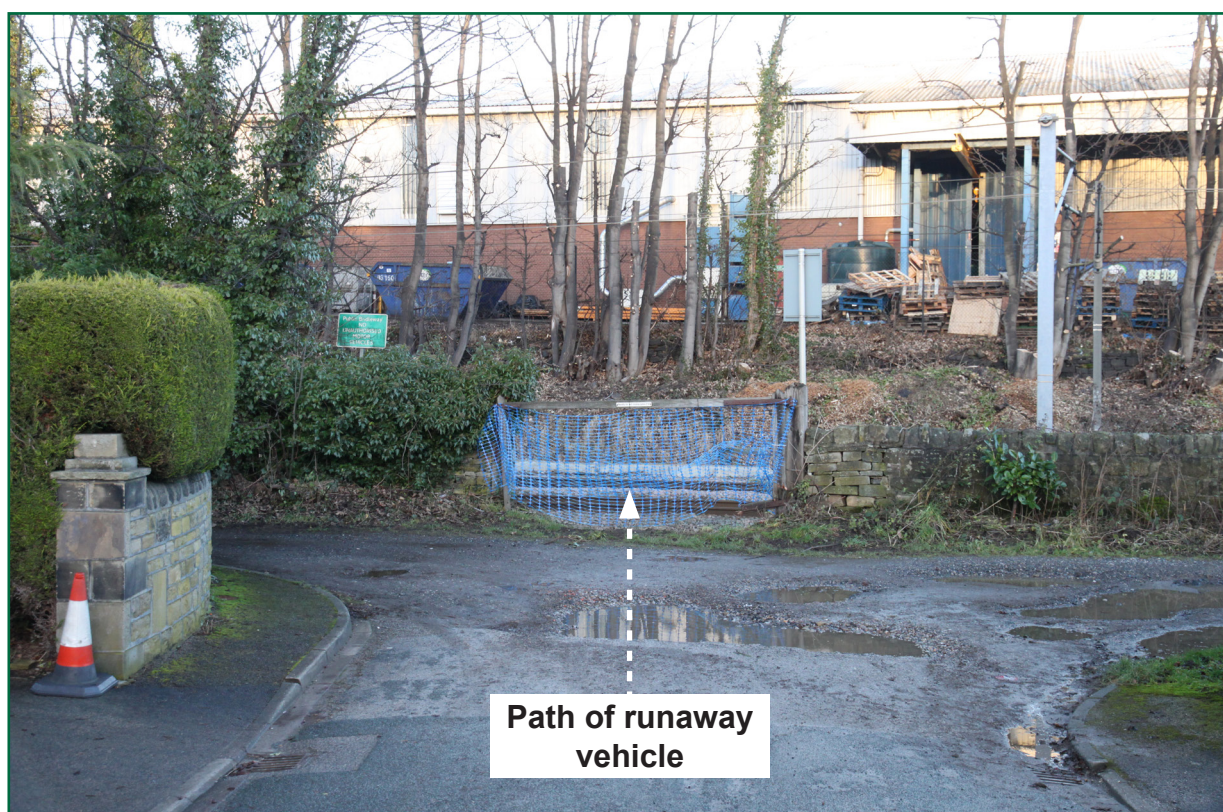
- 56 A vehicle incursion incident occurred at Bingley, West Yorkshire, on 11 November 2013, which was similar in nature to the incident at Aspatria. Just before 20:43 hrs, an unattended Vauxhall Corsa car parked on Healey Avenue ran away down the hill and, at a T-junction with an unmade road, carried straight on through a wooden gate in the railway boundary wall and ended up on the railway track (figure 6). The vehicle was subsequently struck by train 2H70, the 20:26 hrs from Leeds to Skipton (figure 7). There were no injuries and the train was not derailed.

Figure 6: The location of the vehicle incursion incident from Healey Avenue, Bingley, on 11 November 2013
