**REPUBLIC OF BULGARIA**  
**NATIONAL AIR, MARITIME AND RAILWAY TRANSPORT, ACCIDENTS**  
**INVESTIGATION BOARD (NAMRTAIB)**

**FINAL REPORT**  
**from**

**investigation of railway accident – fire in fast train № 2613 during motion between the stations**  
**Kaspitchan and Provadiya on 03.11.2022**

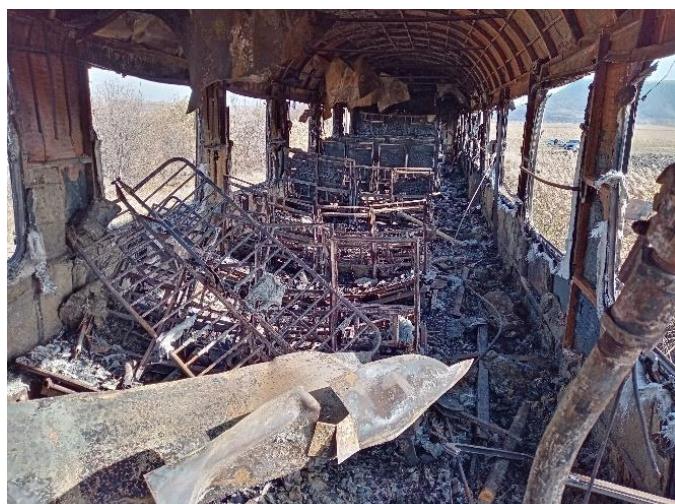
**Fig. 1.5.** Condition of the internal part of passenger coach № 50522974242-2 after the fire.

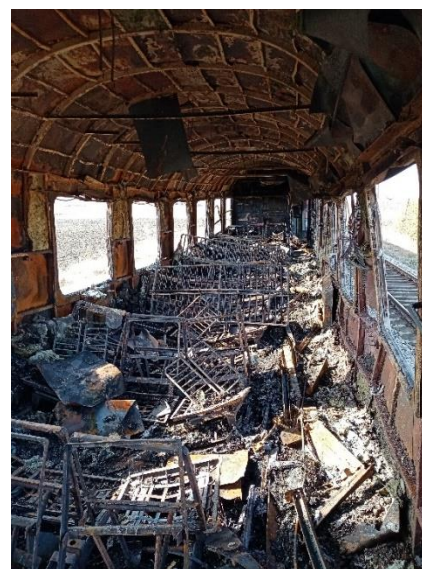
**Fig. 1.8.** Condition of the internal part of coach № 50521974003-0.

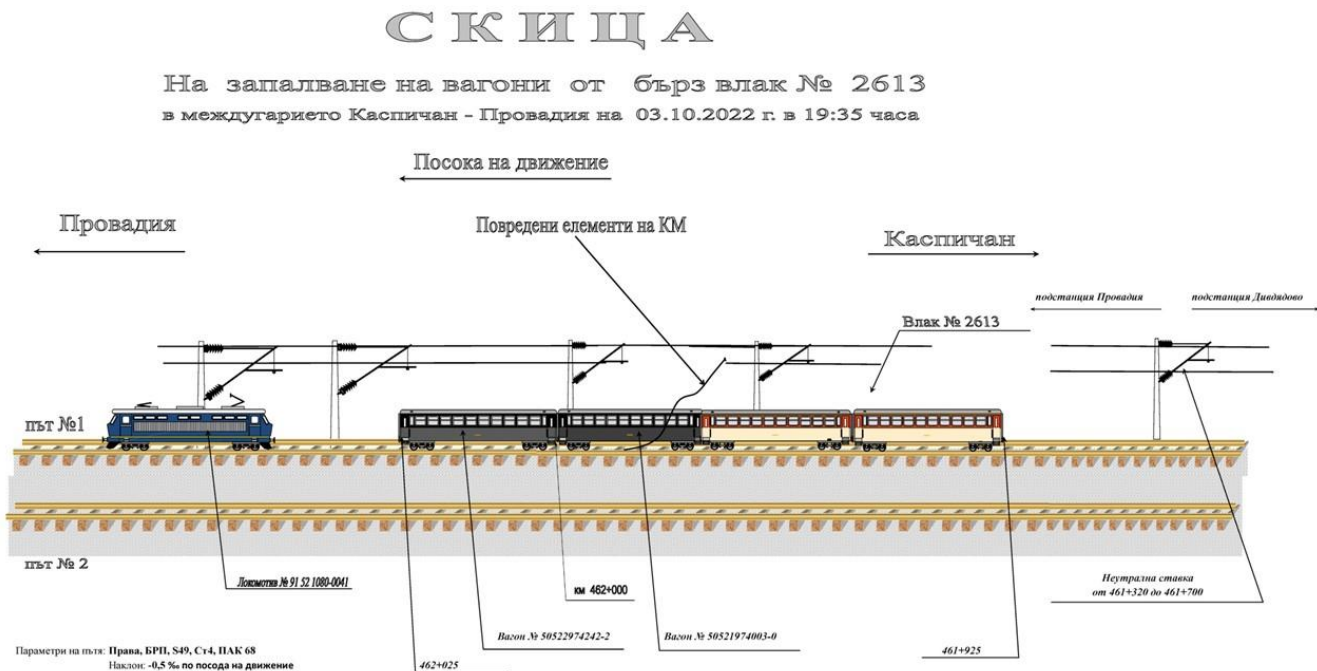
Along Kaspitchan - Provadiya interstation on track No. 1 at km 462+000 at 19:35 p.m. during the movement of FT No. 2613, a fire broke out in the second coach (first class) and subsequently spread to the first coach (second class) next to the locomotive, as well as on the two coaches, the equipment in the salons burned completely (fig. 1.9).

**Fig. 1.9.-Scheme of burning of the coaches of FT 2613 along Kaspitchan-Provadiya interstation**

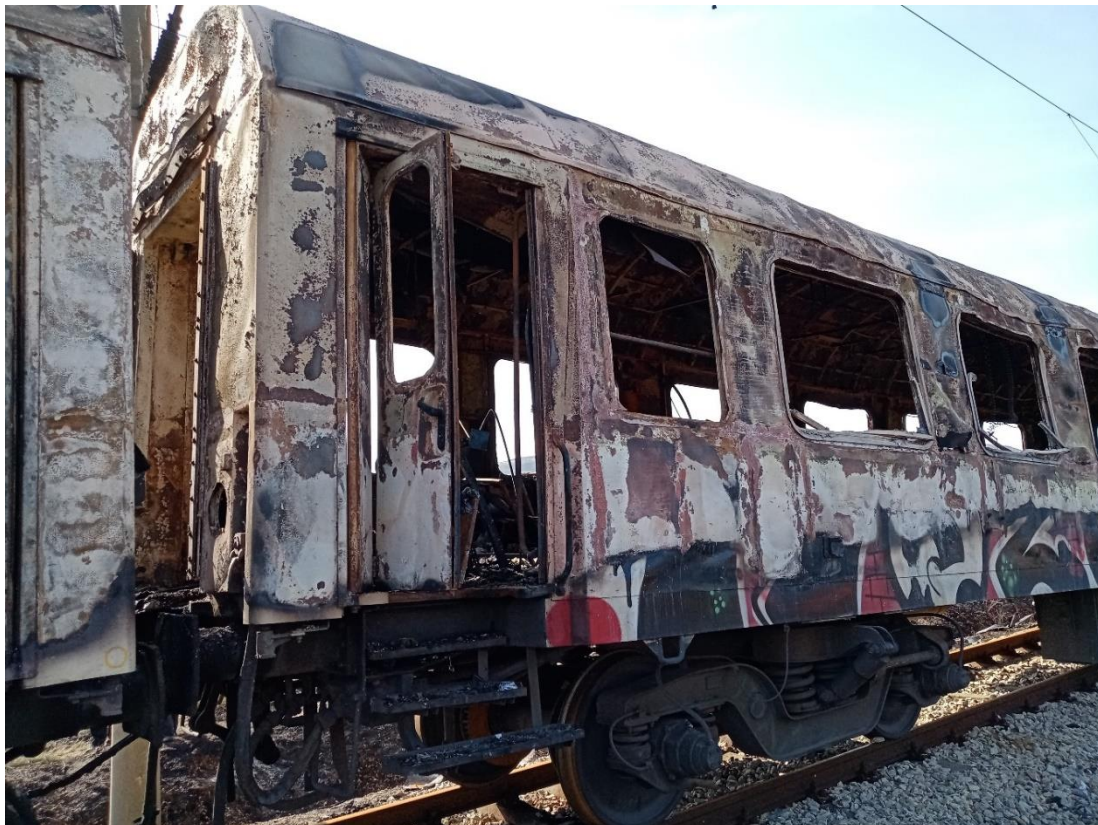
**Fig. 4.10.**

Based on the clues found at the ignition site, it was established that the source was located in the area of the first toilet in the direction of travel of the second coach of the train (the first-class coach No. 50521974003-0 - Fig. 4.10).

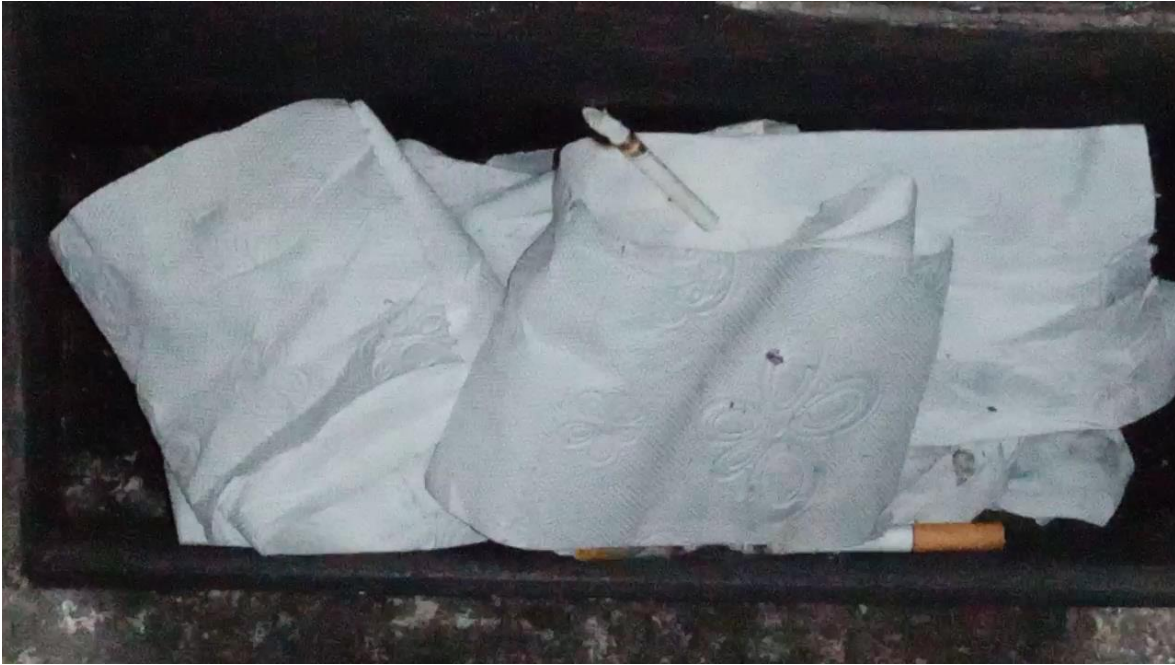
**Fig. 4.11.**

During the inspections, all possible options were investigated and analysed, including intentional or unintentional ignition from an external source of the toilet paper in the bin. The last version was categorically rejected after experiments involving elements of the sanitary unit device (Fig. 4.11).

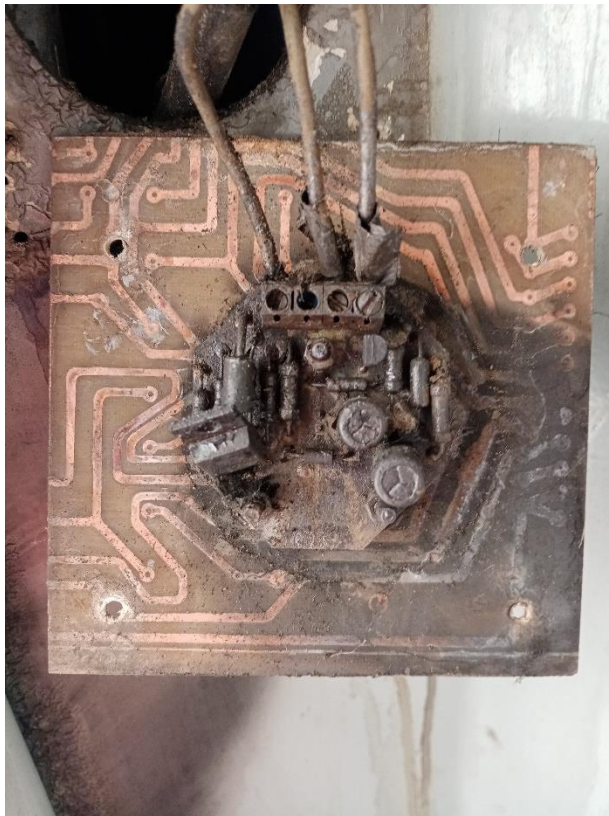
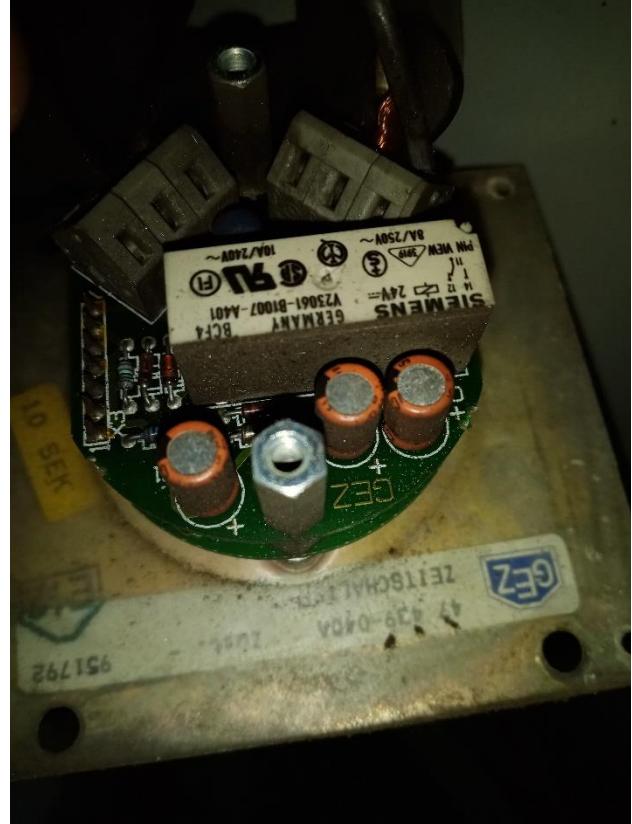
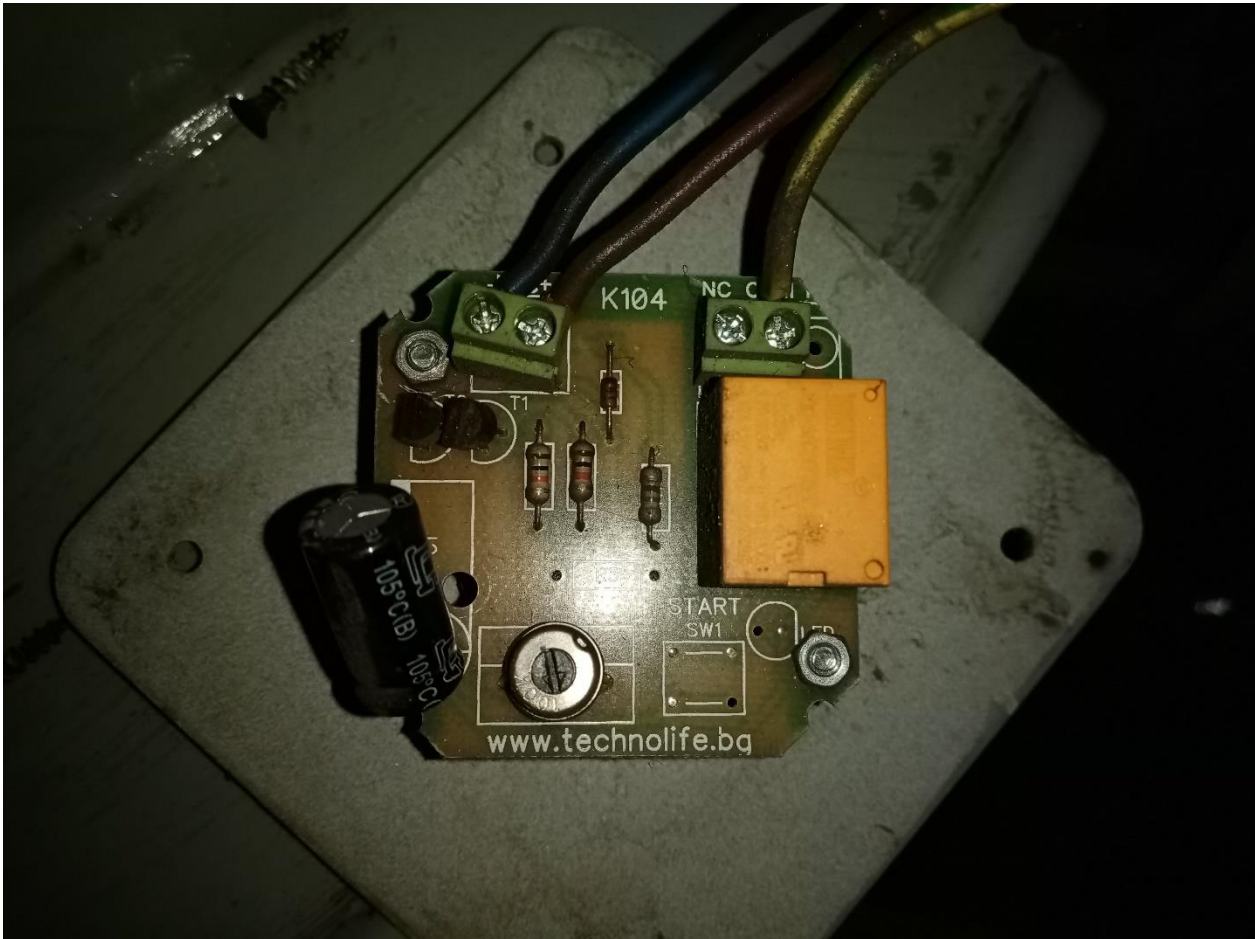
the device and functions of the control buttons, as well as the condition of the buttons in the burned coach No. 50521974003-0 and found that the probability of ignition from them was minimal. These buttons were activated relatively rarely and their duration of operation was short – on the order of a few seconds (20 seconds for the sink and 15 for the toilet). It is necessary to add that very small currents passed through them (of the order of 0.4-0.5 A), as well as the fact that when inspecting that node at the opposite end of the burned coach and in other coaches no traces of heating and operation with increased currents and temperatures were found (Fig. 4.16, 4.17, 4.18);

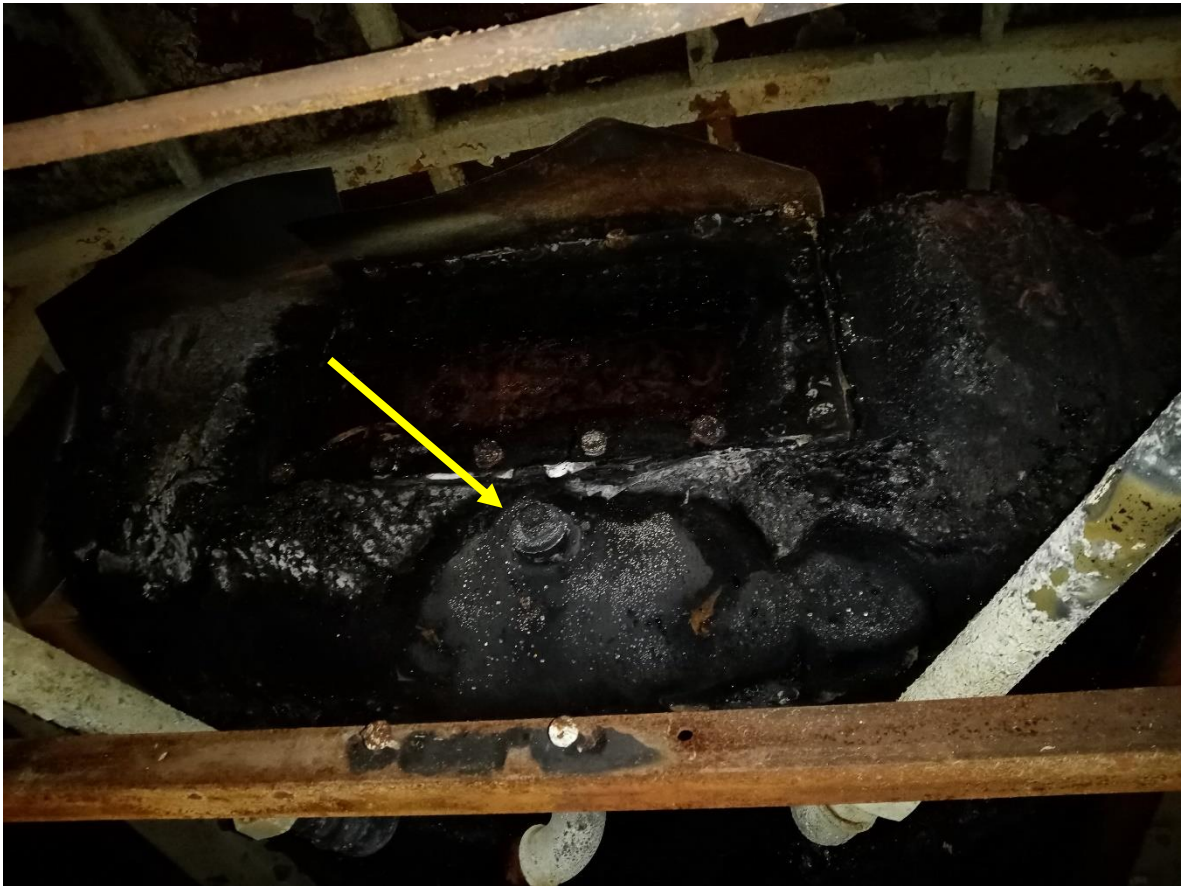
- **Water tank heater** - that tank was located directly under the roof of the coach and it stored water for the toilet unit - toilet and sink. It is one of the largest consumers of electrical current and a potential source of ignition. It is powered by a voltage of 220 V and a current of about 0.2 A flows through it. The Investigation Commission carried out detailed inspections of the burned coach and found that its tank was not equipped with a heater, therefore, in that case, the cause was automatically eliminated (Fig. 4.19);

**Fig. 4.19. The arrow shows the shows outlet in which the heater is installed. In the specific case the outlet is closed with plug, because no heater was installed.**

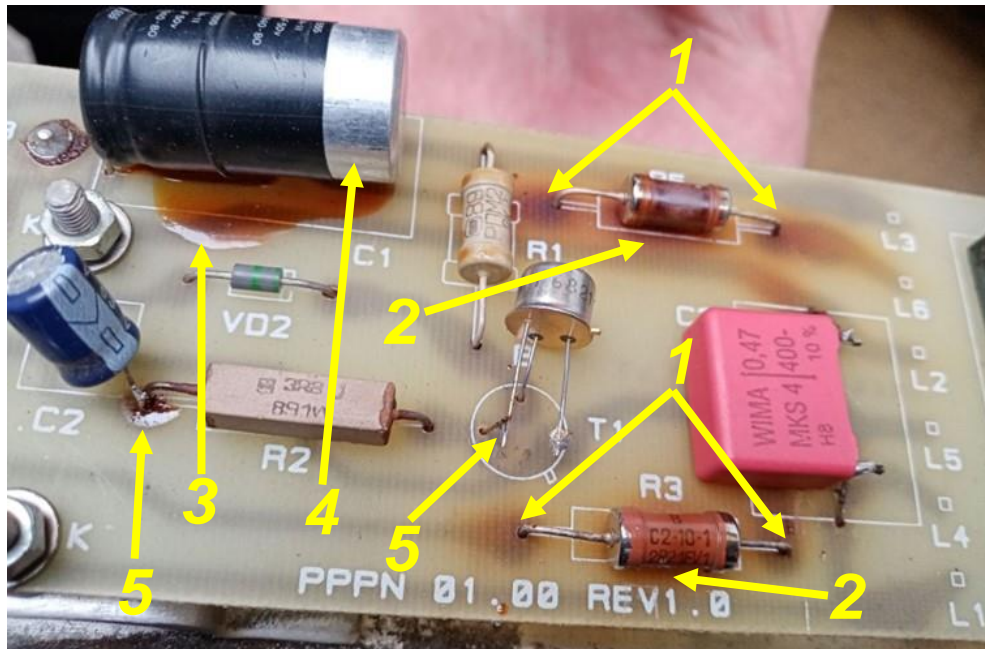
**Fig. 4.22. Power supply board**

- In the area of connection of resistors R3 and R5 to the board, unacceptable overheating was detected, detected by the dark brown colour at the soldering points and under the resistors themselves (Fig. 4.22, pos. 1 and 2)

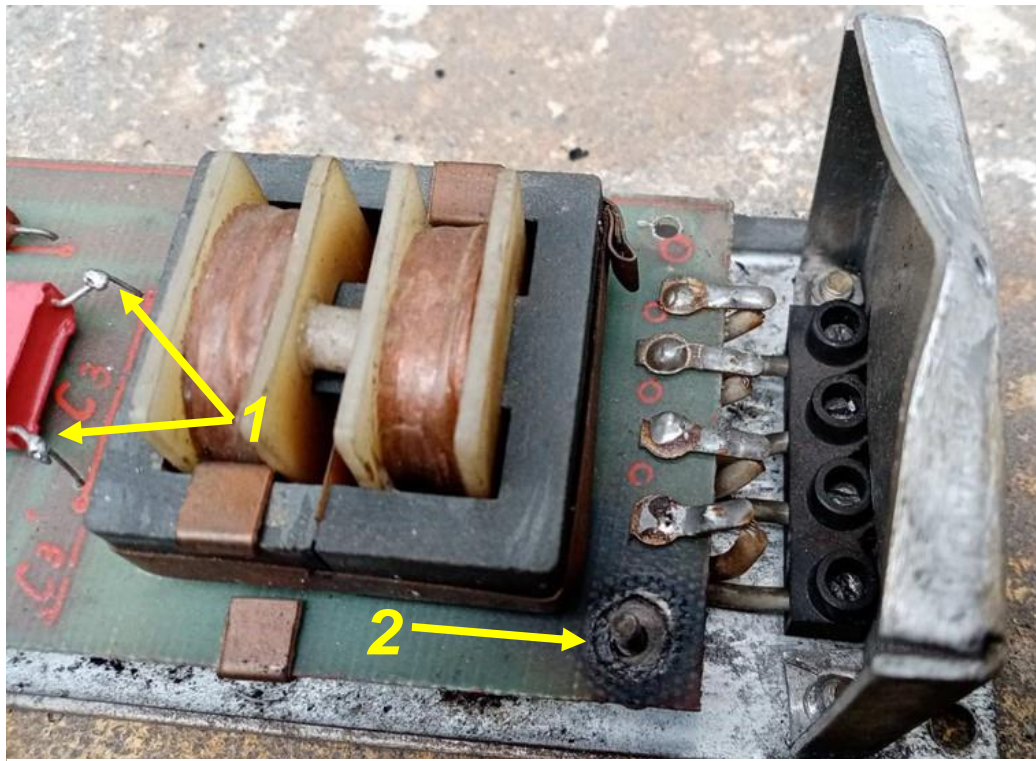
**Fig. 4.23. Power supply unit board**

- The strong burning of the hole for attaching the board to the housing of the power supply unit, which is a sign of the flow of large currents and heating to high temperatures.

- Condenser C1 has apparently punctured and its electrolyte has leaked, and its aluminium case has moved out of the insulating body, most likely due to improper technical specifications.

- The Condenser C1 has apparently punctured and its electrolyte has leaked (fig. 31, item 3) and its aluminium housing has moved out of the black insulating body (fig. 31, item 4).
- During the inspection, it was found that when replacing individual elements of the power board, soldering was not done in the holes of the board (which is the correct way of soldering), but to the terminals of the removed damaged elements (fig. 4.22, pos. 5, Fig. 4.23, item 1).
- A strong scalding of the hole for attaching the board to the power supply unit housing was found. That again was a sign of large currents flowing, and heating to high temperatures (Fig. 4.23, item 2).

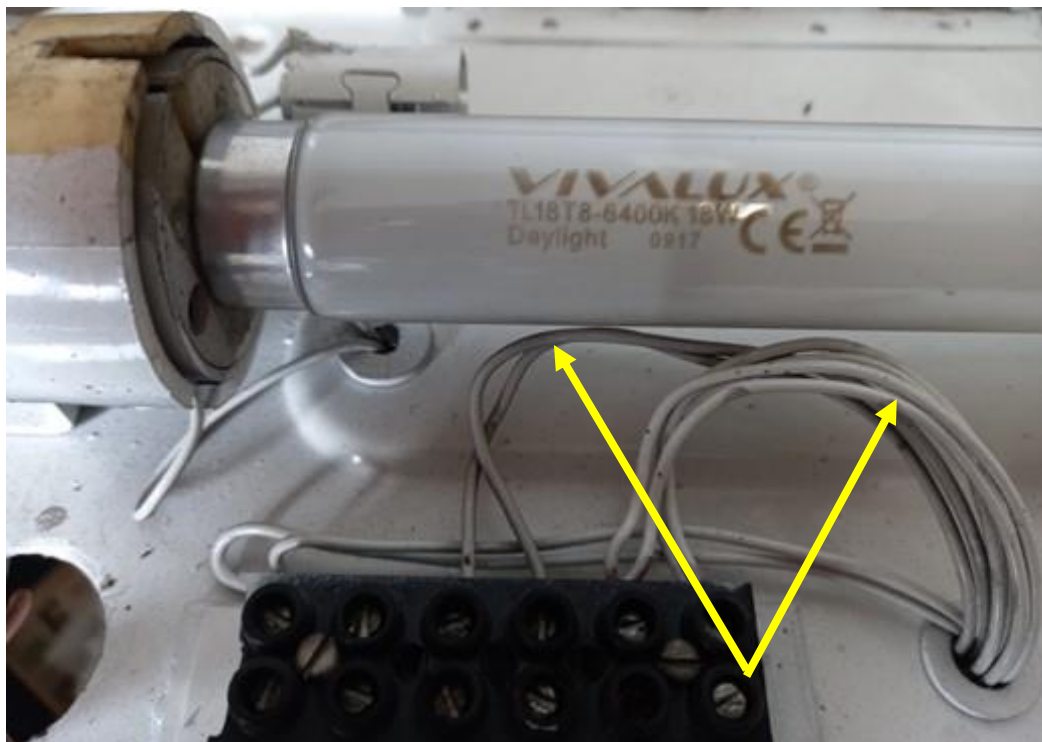
**Fig. 4.24. Lighting fixture**

- During the installation of the lighting unit, the bundle of wires was not flanged (bandaged), but was also painted with white paint, which on the one hand worsened their normal heat exchange, and on the other led to a deterioration of their insulating qualities due to the aggressive components contained in the paint.

- During the installation of the light fixture, the bundle of wires was not bandaged, but was also painted with white paint, which on the one hand impaired their normal heat exchange, and on the other hand led to a deterioration of their insulating qualities due to the aggressive components contained in the paint (Fig. 4.24).
