REPUBLIC OF BULGARIA
NATIONAL AIR, MARITIME AND RAILWAY TRANSPORT, ACCIDENTS
INVESTIGATION BOARD (NAMRTAIB)

FINAL REPORT
from

Investigation of railway accident – derailment of wagons of the IDFT № 40832 in Banya station
on 26.02.2023

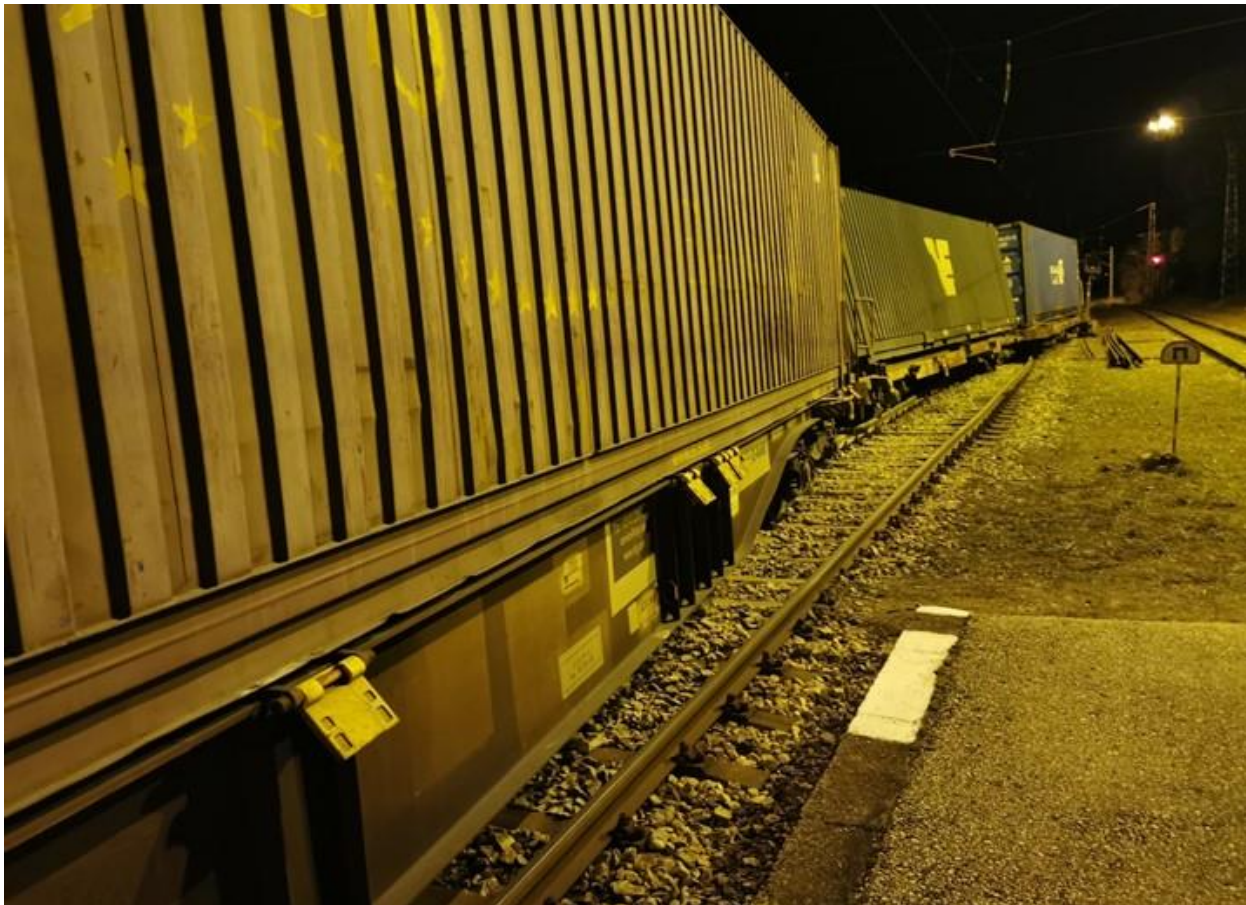
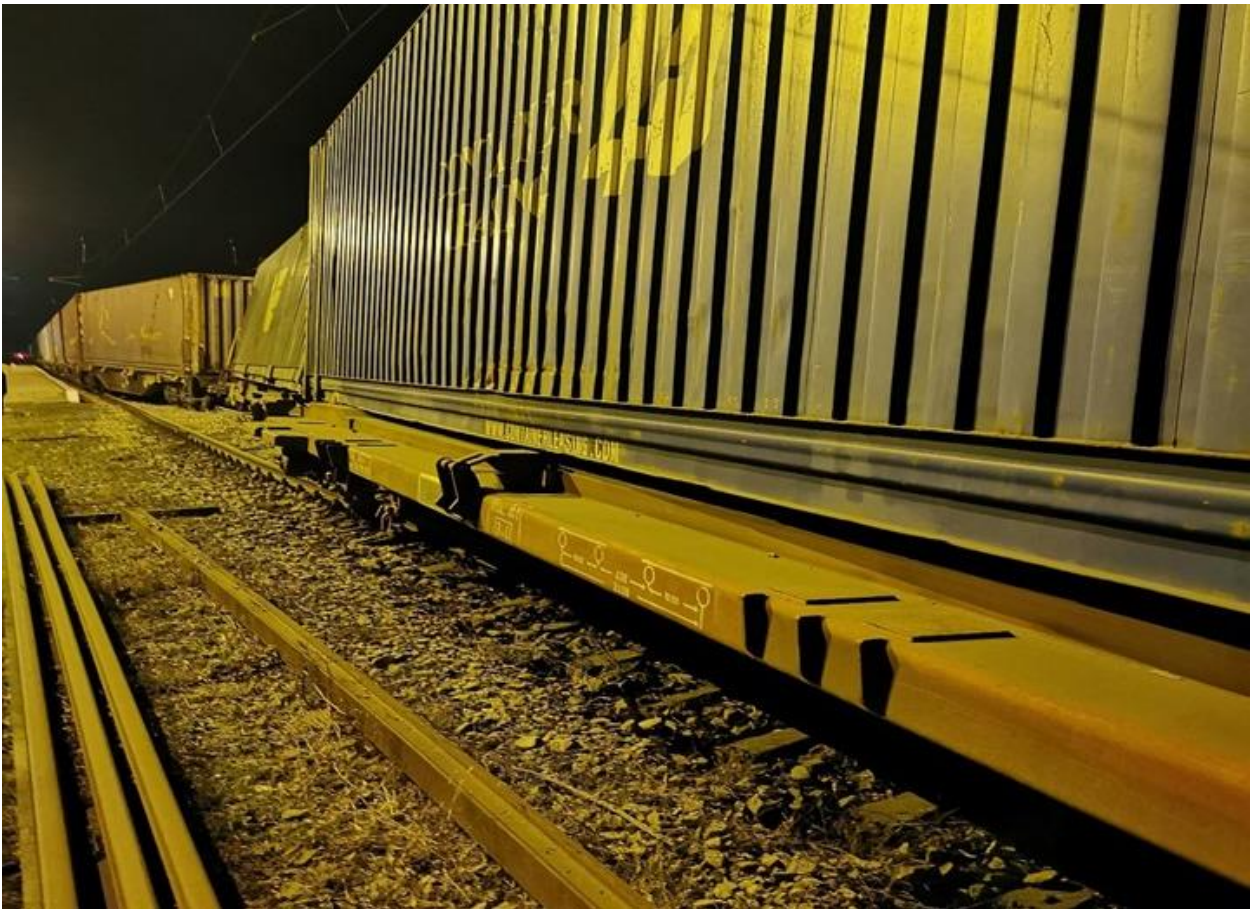
Fig. 1.1.

For accepting IDFT No. 40832 at Banya station at 00:30 a.m. on 26.02.2023, the traffic manager on-duty ordered a route for the train to cross the second main track without stopping at the station. When the train entered in Banya station, the traffic manager on duty noticed sparks coming from the wheels of the last wagons and the train stopped. The locomotive crew felt the train pulled and noticed that the pressure in the main air duct dropped to 0.0 bar and the train stopped on the second track at 00:41 a.m. The Locomotive Driver and the traffic manager on-duty inspected the train and found that there have been derailed the last two wagons of the train, 16th wagon No. 37804953012-4 Series Sggrms has derailed with both wheelsets of the third bogie and 17th wagon No. 43714378583-4 Series Saagrss derailed with all four wheel-sets of the wagon (Fig. 1.1 and Fig. 1.2).

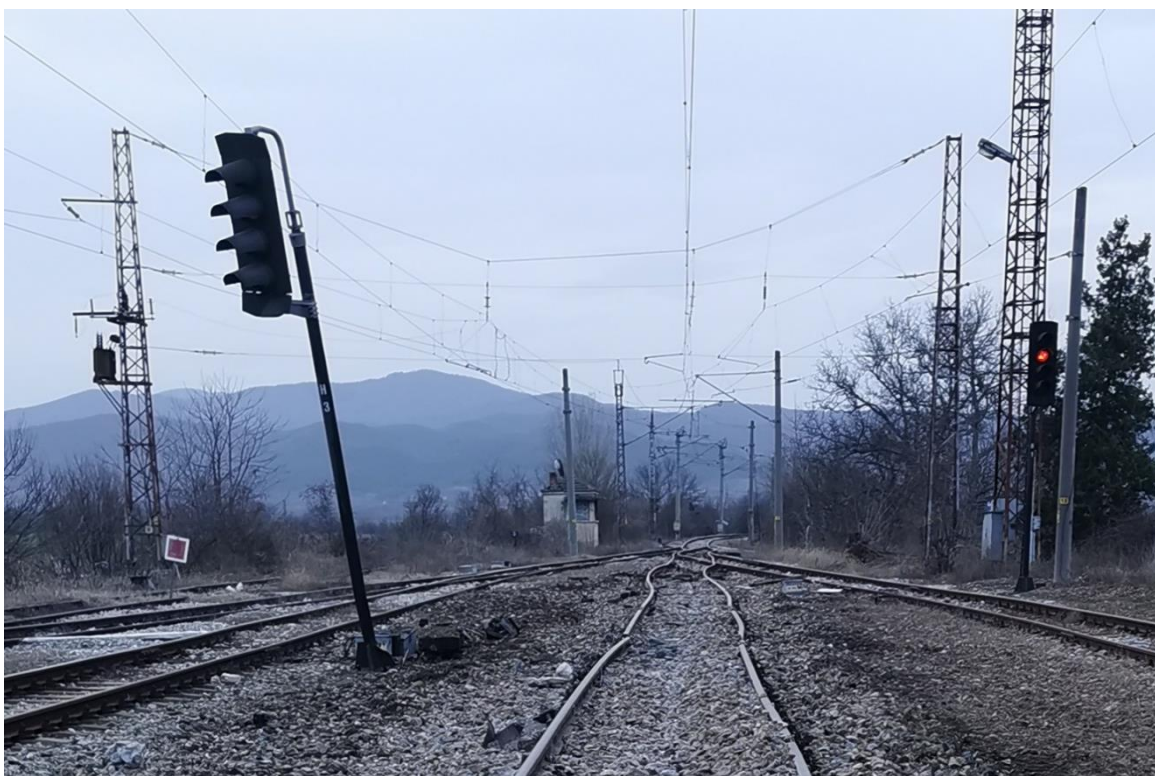
Fig. 3.6.

In Banya station the entrance and exit semaphores are under speed signalling – functioning before the accident and with caused damages after it (fig. 3.6);

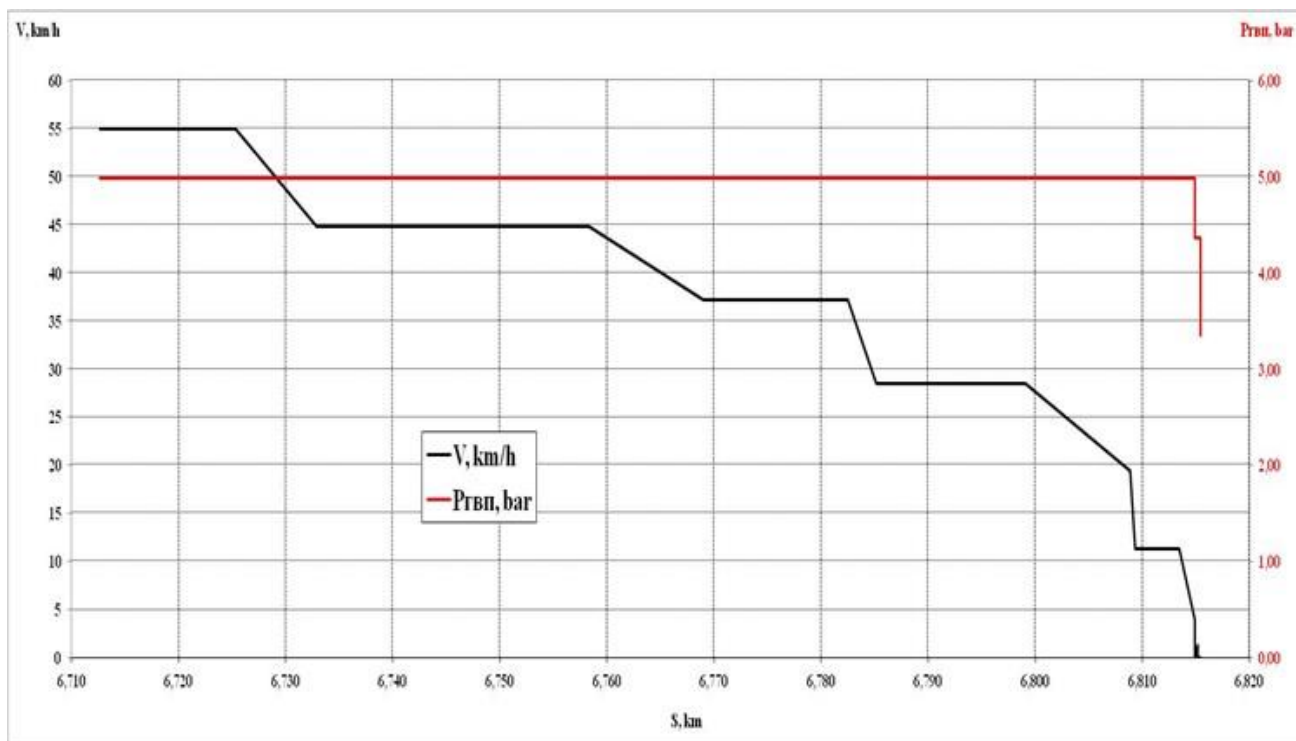
Fig. 4.3.

Figure 4.3 shows the running speed and command pressure of the automatic train brake in the last 100 meters or so before the stopping point after the accident. On the left ordinate axis, a step with a speed of 5 km/h is selected, and on the right ordinate axis, the pressure in the MAD is depicted as a function of the travelled path S. The image is shown in Fig. 4.3, and for the same reasons, the step along the travelled path S is chosen 0.01 km (i. e. 10 meters)

The deceleration started at 00:41:37.30 a.m. from km 3333.704346 and the train stopped at 00:41:54.10 a.m. at km 3333.794434 according to the Table. The process took 16.8 seconds, and the distance travelled was 90 meters.

From the above graphs, no over speeding by the locomotive during the movement of IDFT No. 40832 was found, therefore it had no relation to the accident that occurred.

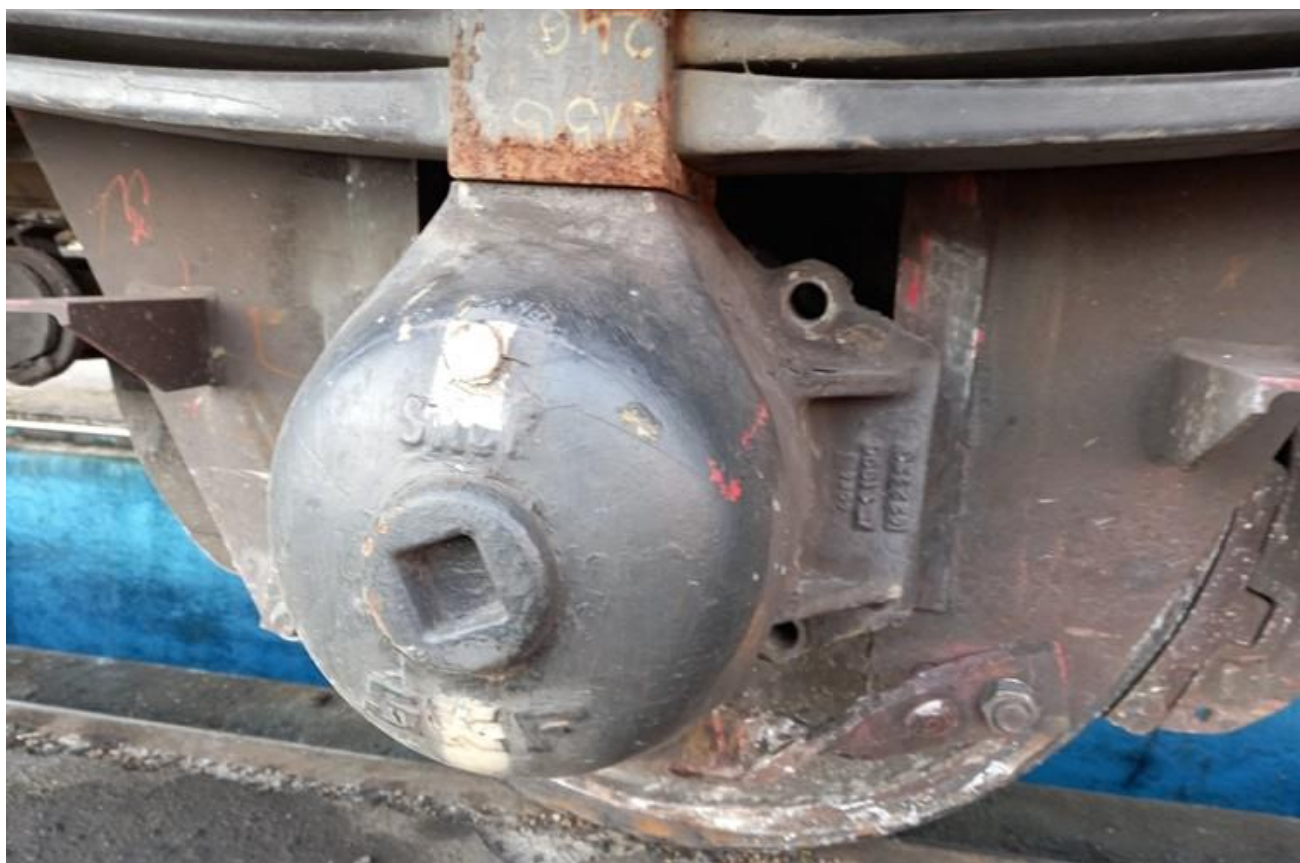
Fig. 4.6.

On figure 4.6 is shown a photo of the box in the left wheel of the first wheel-set of wagon №43714378583-4.

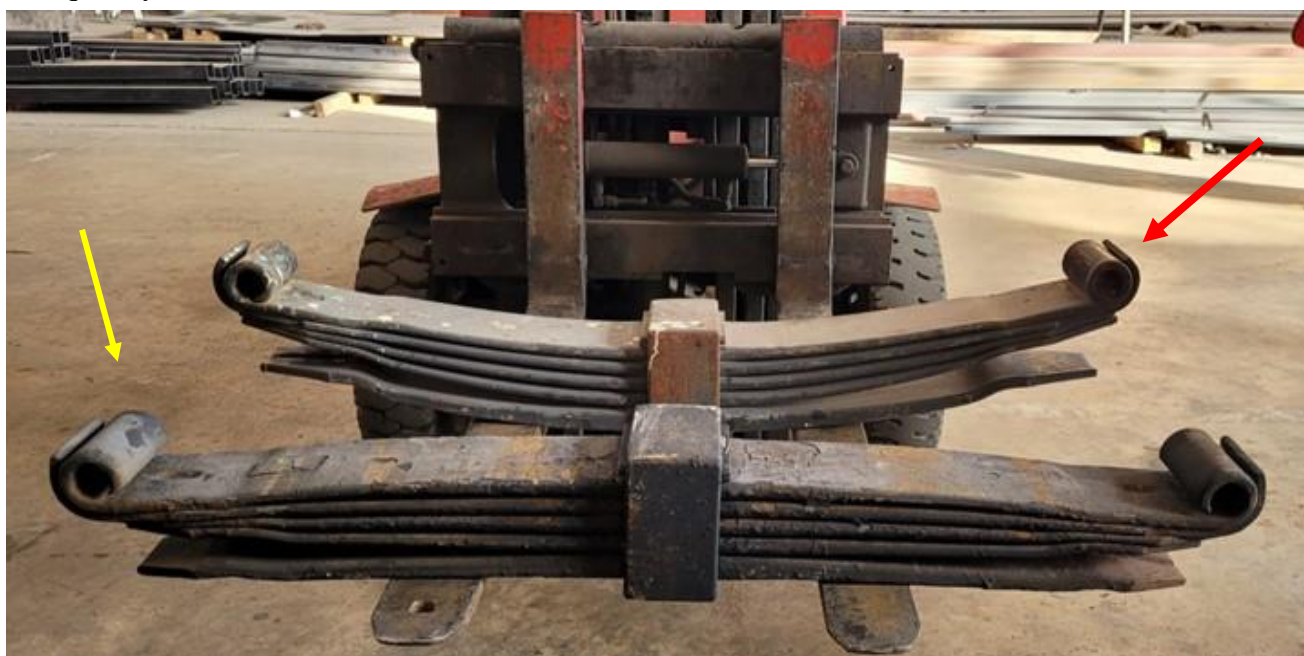
Fig. 4.7.

On fig.4.7 is shown a picture of the dismantled leaf spring (marked with arrow in red colour) from the left wheel of first wheel-set of wagon № 43714378583-4 and the leaf spring in the original structure of the wagon (marked with arrow in yellow colour).

It is evident that the two leaf springs differ significantly on geometric size and form, and consequently under force-deformation characteristic.

In the course of the investigation, it was found that the original leaf spring of the first wheel-set, left wheel in the direction of train movement of wagon No. 43714378583-4 was replaced by the Turkish national railway carrier at Kapikule Station with a non-conforming one due to the breakage of the original one and moved to Banya station, where the accident occurred.

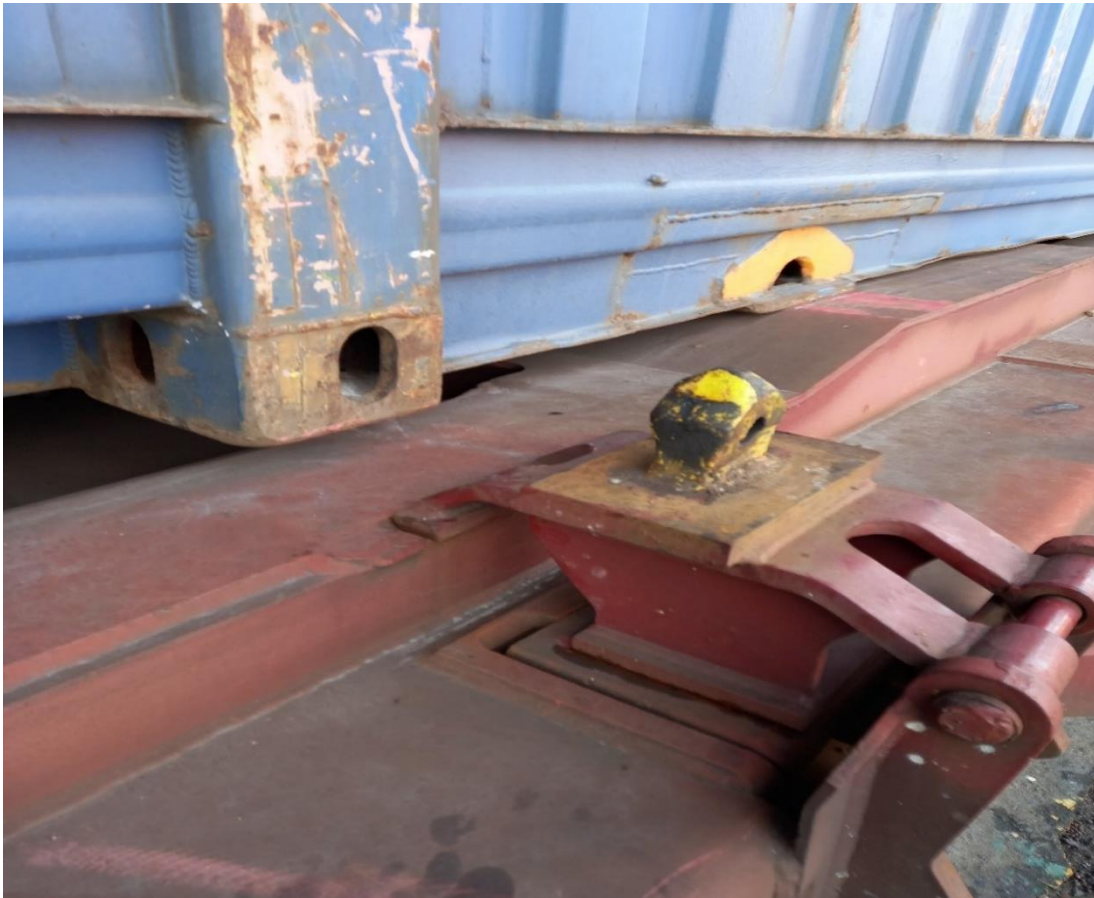
Fig. 4.13. Displaced container from the heel of the wagon.

- During the inspection of wagon No. 43714378583-4, it was found that the transported second container No. CLXU4517719 had a smaller gross mass than the first container, it had shifted and came out of the fixing heels of the wagon, which was a consequence of the derailment (fig. 4.13);

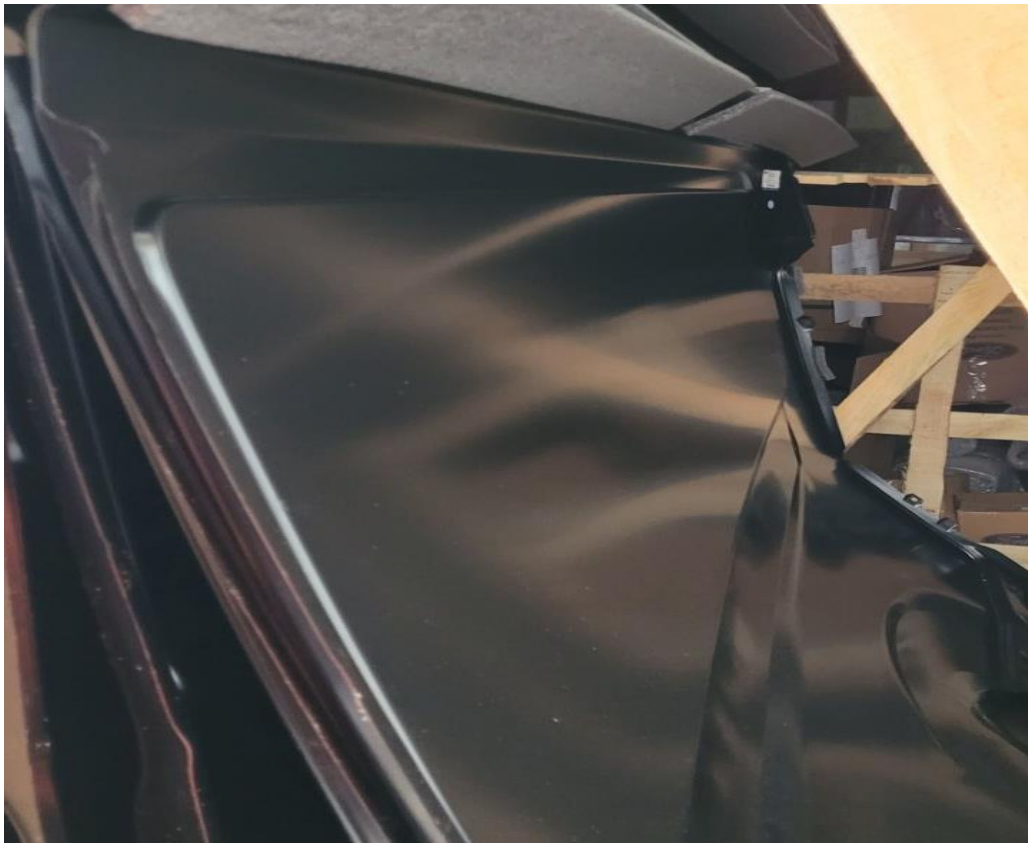
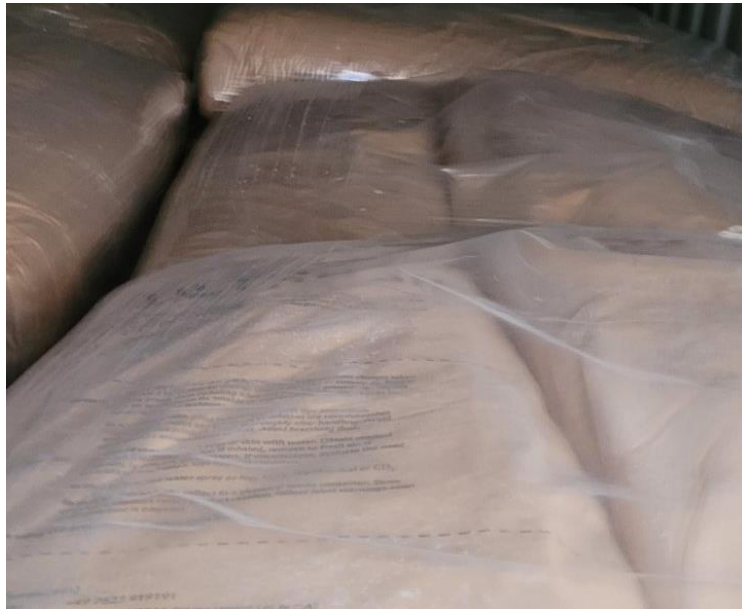
Fig. 4.14.

- When inspecting the cargo in the containers, it was found that the cargo was placed correctly and was not moved during the loading and movement of the wagon (Fig. 4.14 and 4.15);

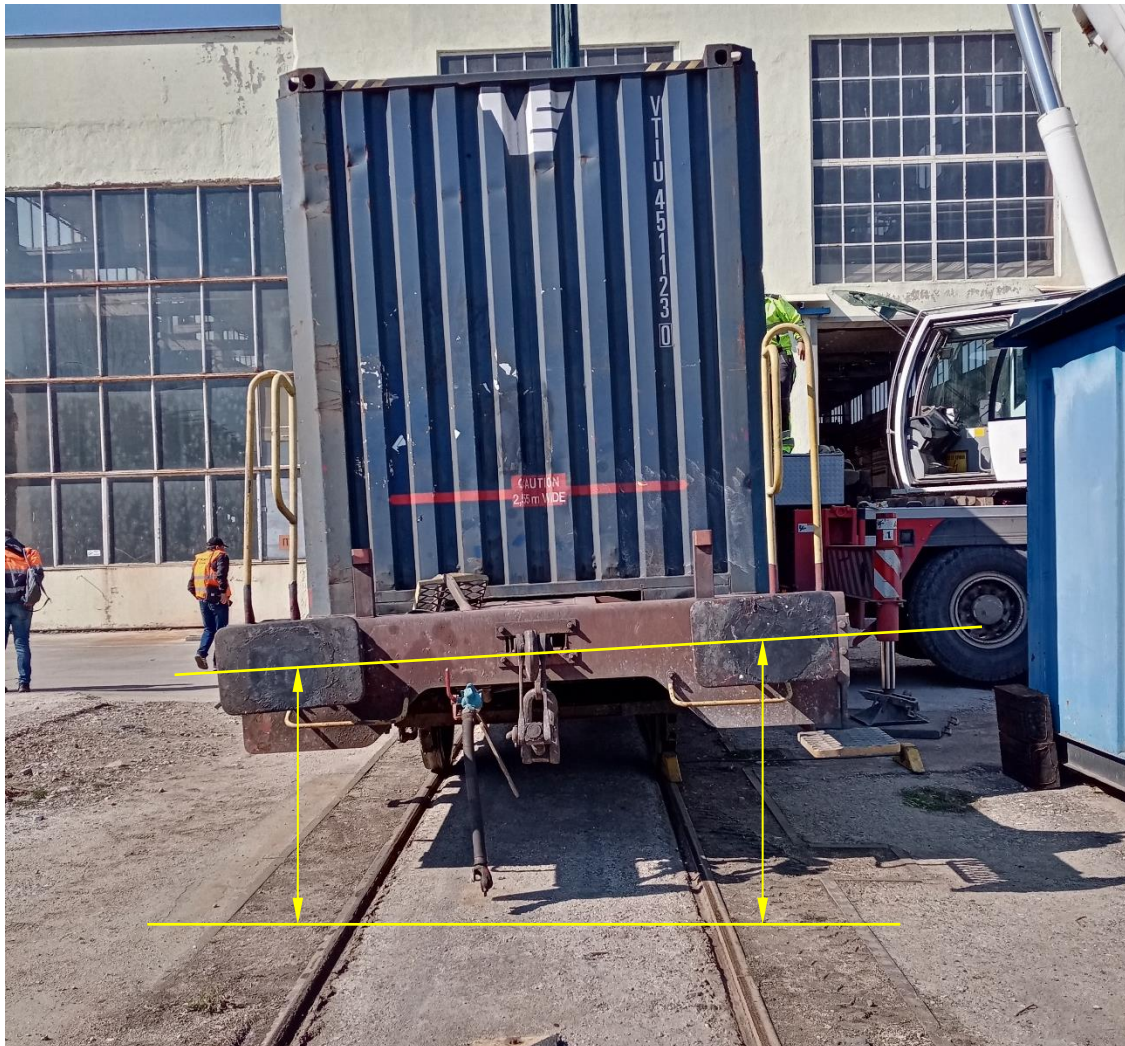
- During the inspection of wagon No. 43714378583-4, it was found that the height of the two buffers from the railhead is different, i.e. the left in the direction of movement (right in the photo) is located higher than the other (Fig. 4.16). This fact prompted the commission to carry out an even more detailed inspection, during which it was found that a leaf spring was installed on the box of wheel No. 1, different in appearance from the others installed on the other wheels (Fig. 4.17 and Fig. 4.18). Subsequently, it was found that the leaf spring in question was indeed different not only in appearance, but also in dimensions and characteristics (Fig. 4.19). Additionally, during the inspection, it was found that the bolts of the box guides were missing, as well as the box guides themselves (fig. 4.17, pos. 1), and the sub-box connection (ferbin) was distorted (fig. 4.17, pos. 2).

Fig. 4.16. On the image is shown the difference in height of the two buffers.

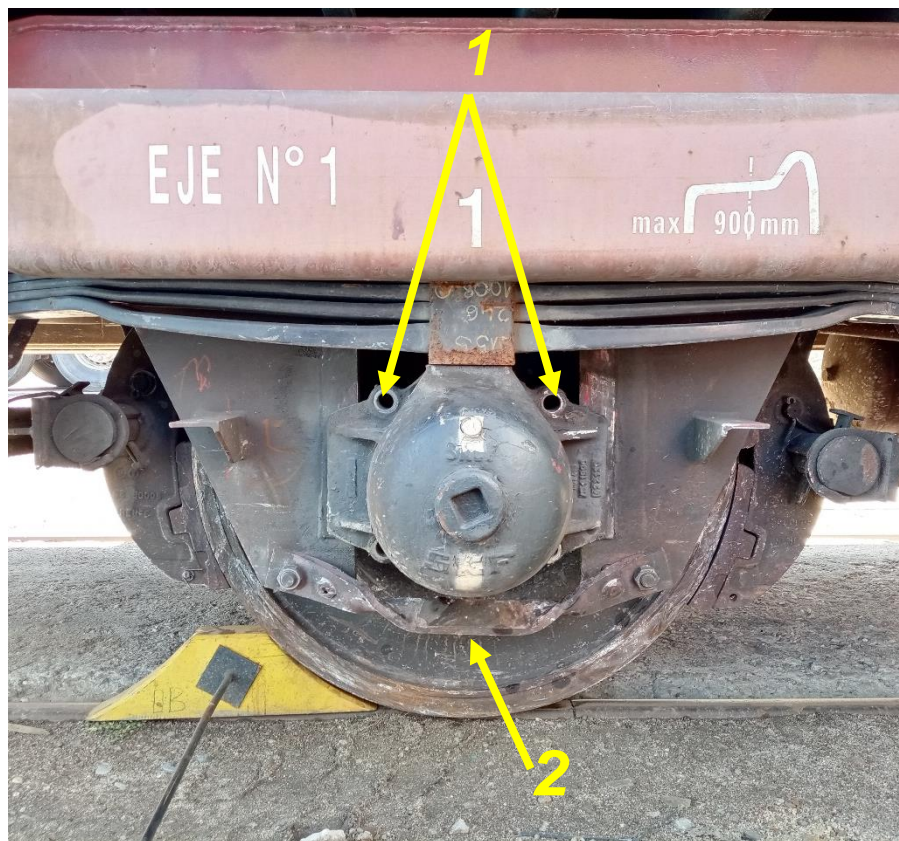
Fig. 4.17. Wheel № 1 (front left in the train movement direction) with installed spring with unsuitable dimensions and characteristics.

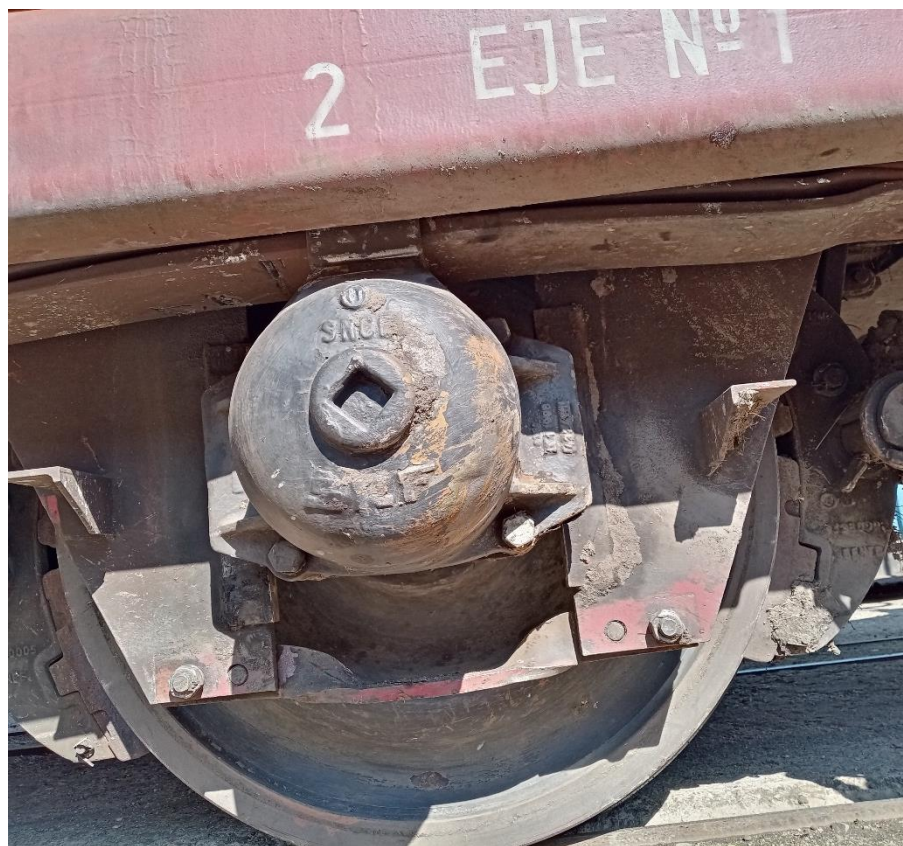
Fig. 4.18. Right wheel with original spring.

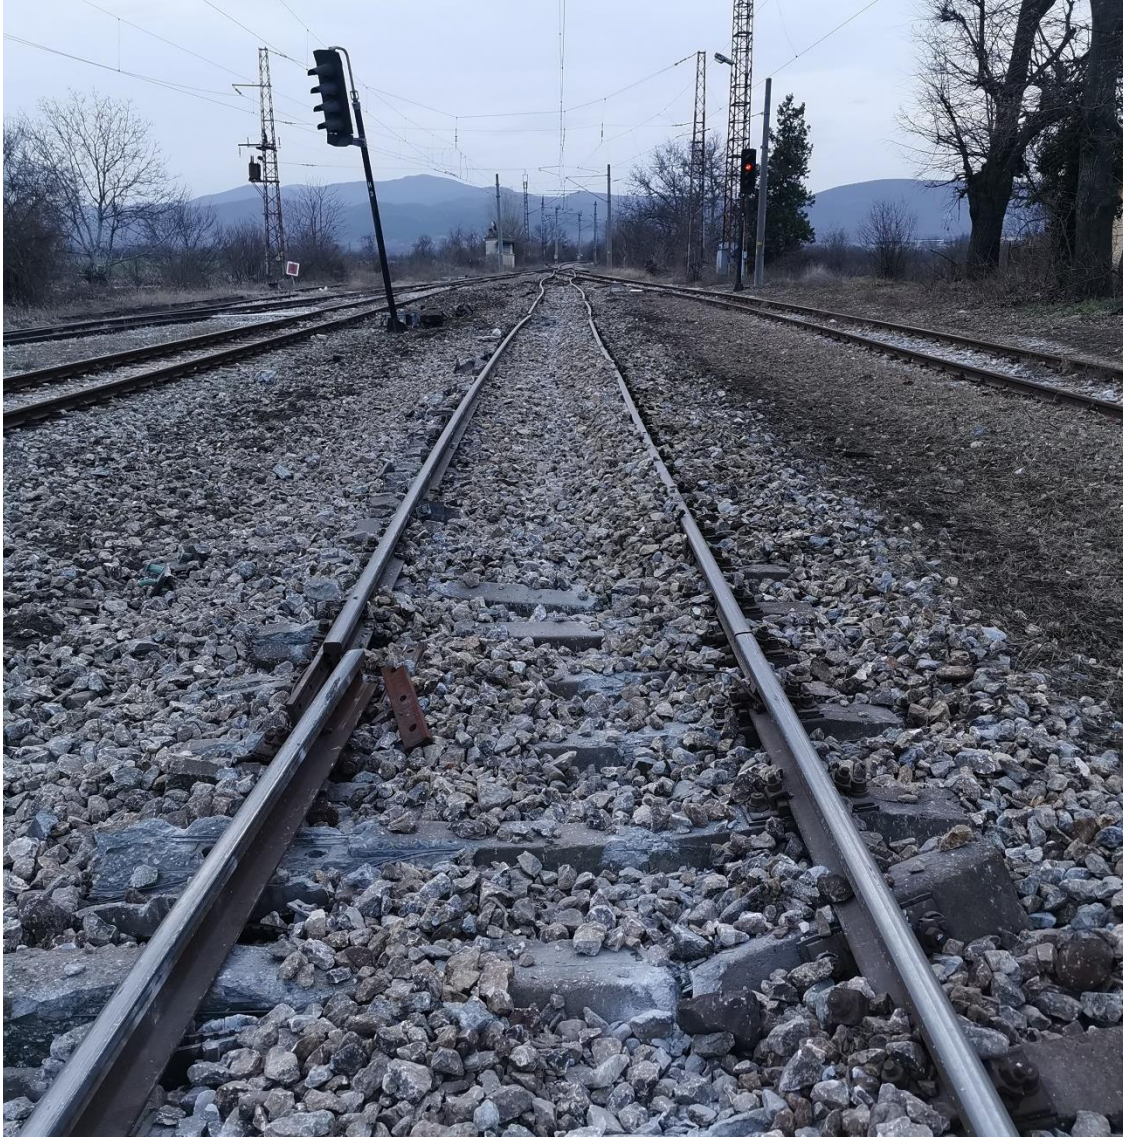
The accident occurred in a left circular curve in the direction of the train, at km 45+561. The rise of the right wheel is 2 m before the end of the transition curve, which is at km 45+563 (Fig. 4.21);

Fig. 4.21. View from second track to switches №№ 2 and 4.
