Rail Accident Report

**Partial failure of a structure inside Balcombe
Tunnel, West Sussex
23 September 2011**

Partial failure of a structure inside Balcombe Tunnel, West Sussex, 23 September 2011

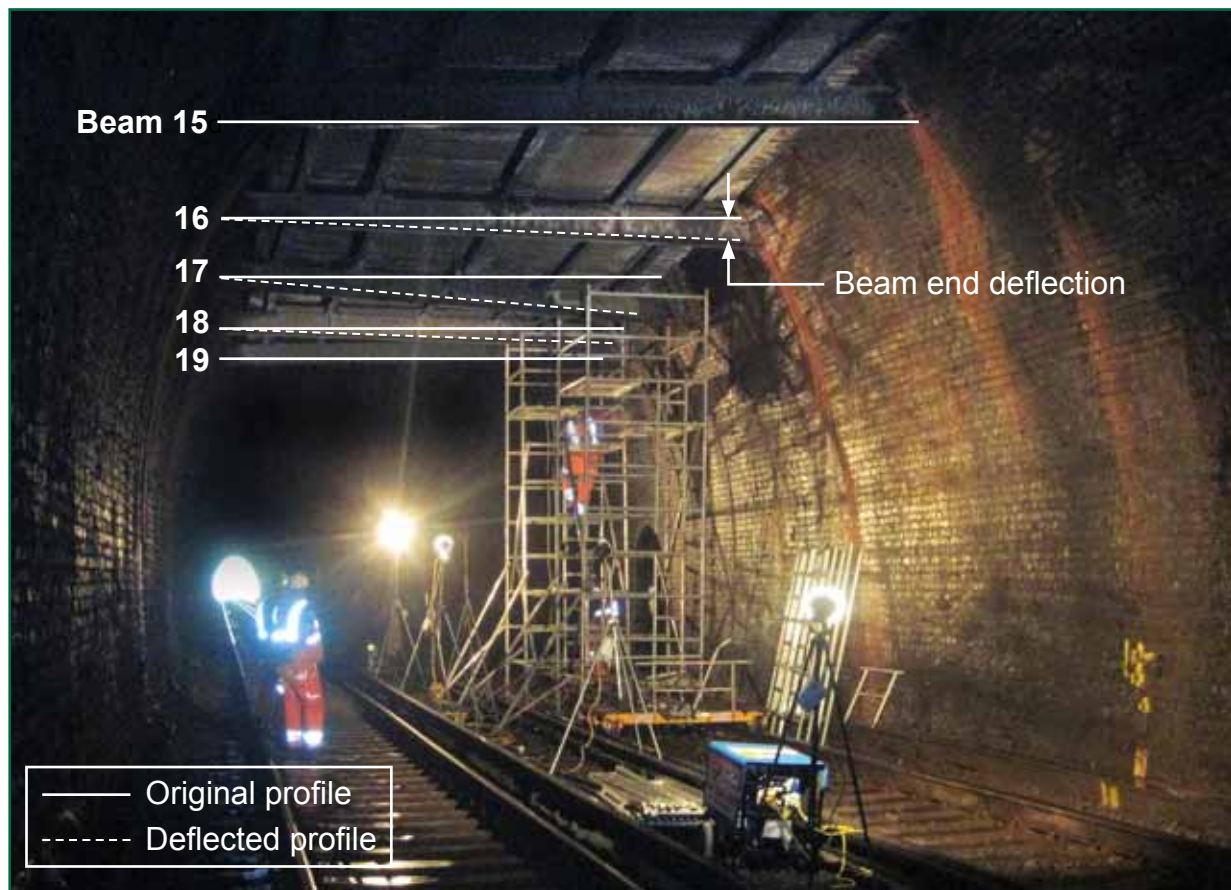
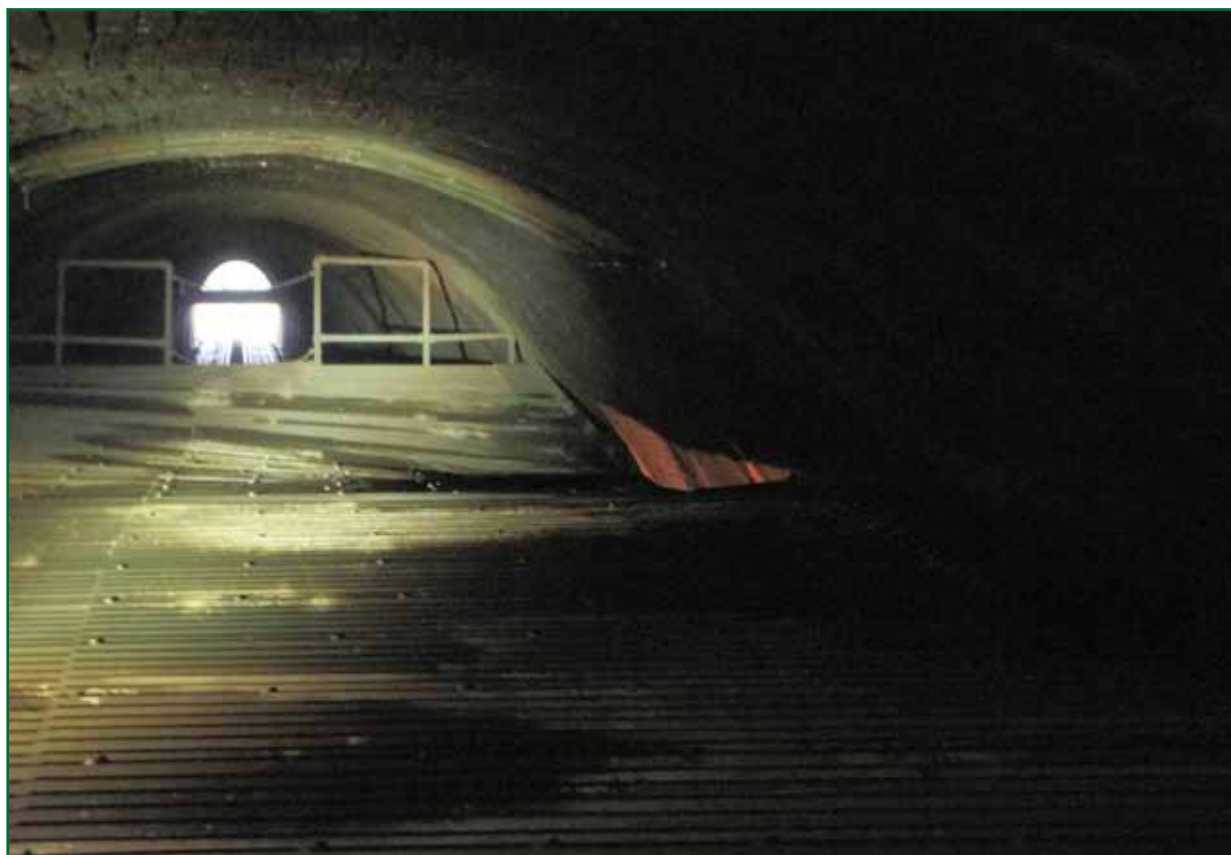
- 33 An initial inspection on 23 September 2011 by on-call staff identified that three transverse beams near the south end of tray 5 (beams 16, 17 and 18 near chainage 36) had become detached from the tunnel lining above the up line.
- 34 Network Rail structures engineers, supported by staff from Amey, undertook a more detailed post-incident inspection later the same day and found that all 12 studs connecting the three beams to the tunnel lining above the up line were missing. The loss of support had caused this part of the structure to sag (figures 9 and 10).

Figure 9: View of deflected structure on 23 September 2011 (photograph courtesy of ORR)

Figure 10: View of deflected structure from above, looking towards the south end of the tunnel, showing the twisted deck on the right-hand side (photograph courtesy of Amey)

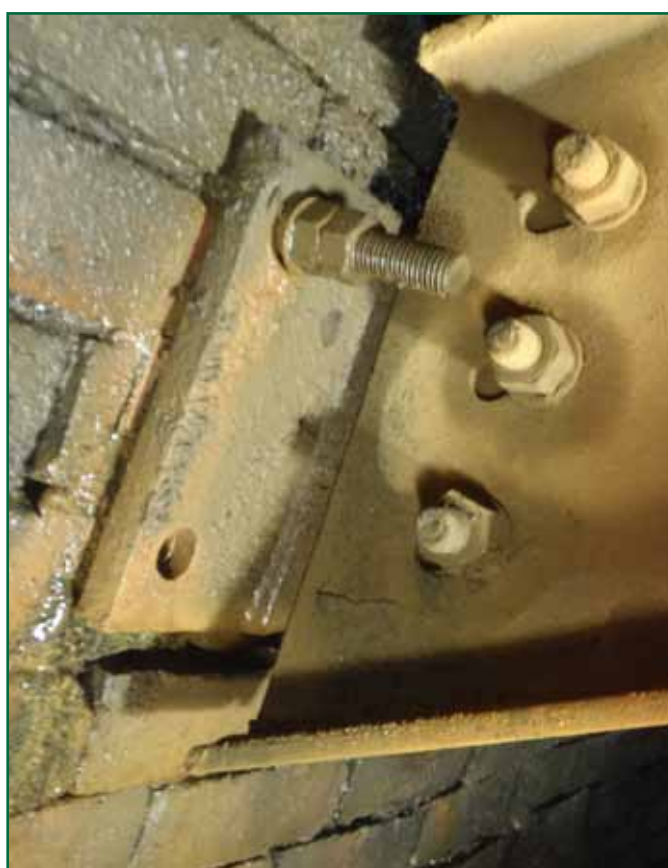
- 36 The post-incident inspection included a physical check of all similar studs within the tunnel with the exception of 13 beam-ends (52 studs). These were located within an exclusion zone, established by Network Rail, to keep staff away from the deflected structure while temporary brackets were installed, or in areas obstructed by equipment. This inspection identified that, in addition to the studs that were missing at the end of the deflected beams, a further six studs were missing (figure 11) and five studs were loose (ie could be removed by hand, figure 12). Within the tunnel, a total of 29 studs had one or more nuts loose (table 1).

*Figure 11: Bracket with lower stud found missing
(photograph courtesy of Amey)*

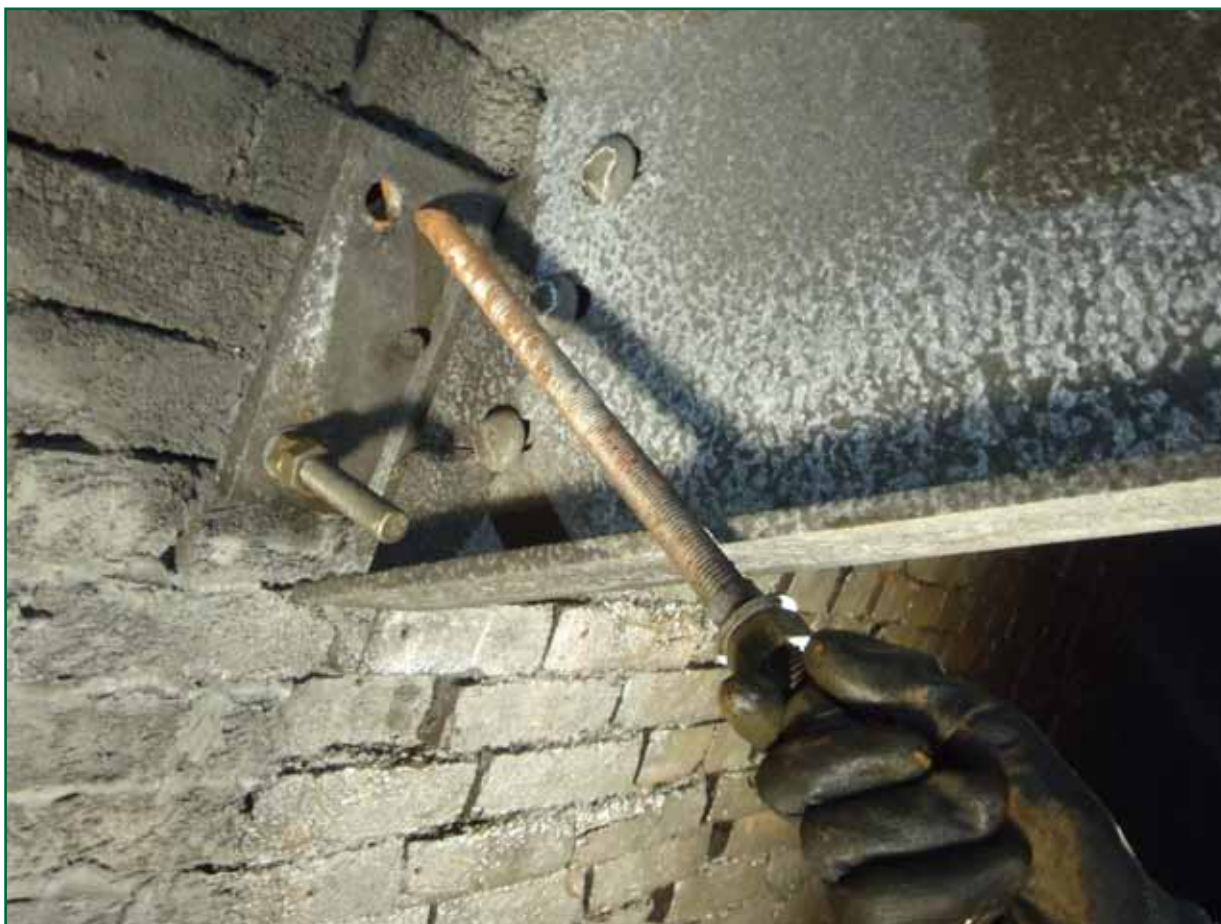
Figure 12: Loose stud outside incident area removed by hand during inspection on 23 September 2011 (photograph courtesy of Amey)

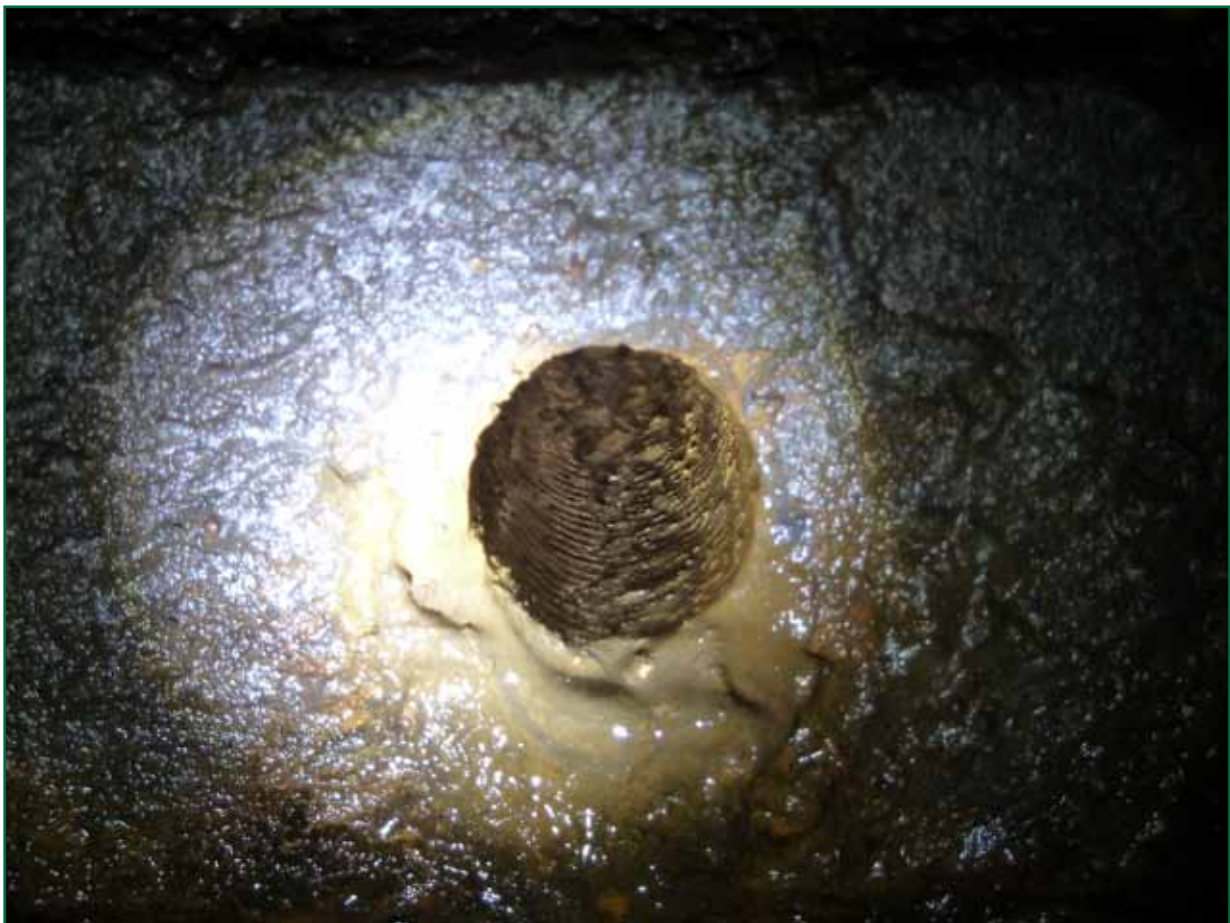
- 43 Examination of the holes in the brickwork from which the studs had fallen showed an imprint of the threaded bar at some locations (figure 13). Some holes exhibited signs of wear and had deformed (figure 14), indicating that the stud had oscillated upwards and downwards, rather than simply rotated (unscrewed) out of the hole.

Figure 13: Hole in brickwork from which studs had fallen, showing thread pattern imprint

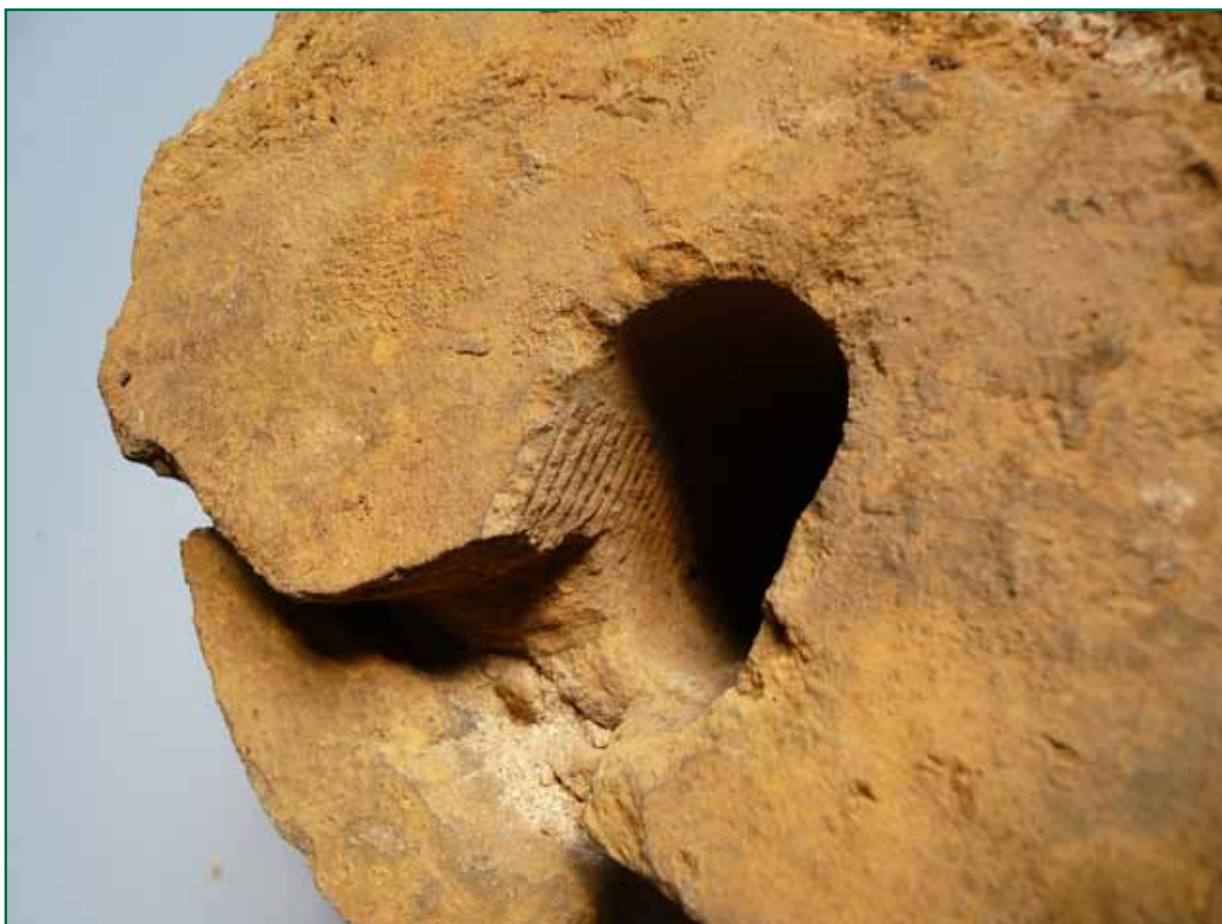
Figure 14: Deformed hole in brickwork core removed from tunnel lining

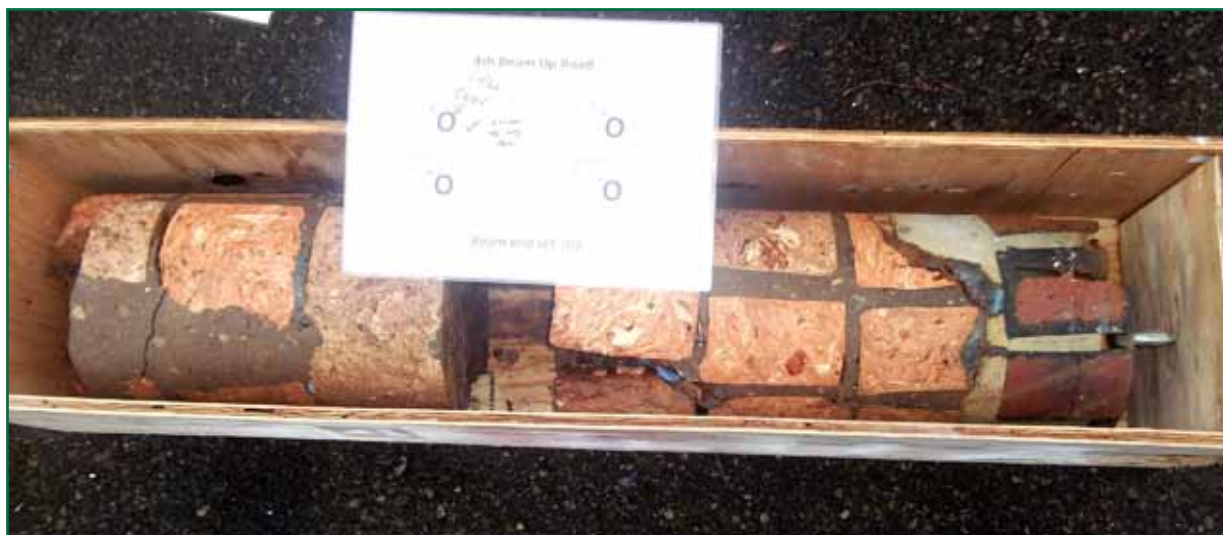
Figure 15: Core taken from tunnel lining during investigation, showing engineering brickwork (right). Core split into two sections during removal (photograph courtesy of Network Rail).

- 47 The cores confirmed that the inner one or two rings of brick (ie those closest to the railway) were constructed of engineering brick, whereas the outer rings were constructed of 'common' brick made of poorly mixed clay. A blue-coloured gel was injected into one hole to keep the sample intact and to highlight cracks in the brickwork (typically gaps between bricks which are normally filled with mortar) through which resin could be lost. Detailed observations for each core are included in appendix D.

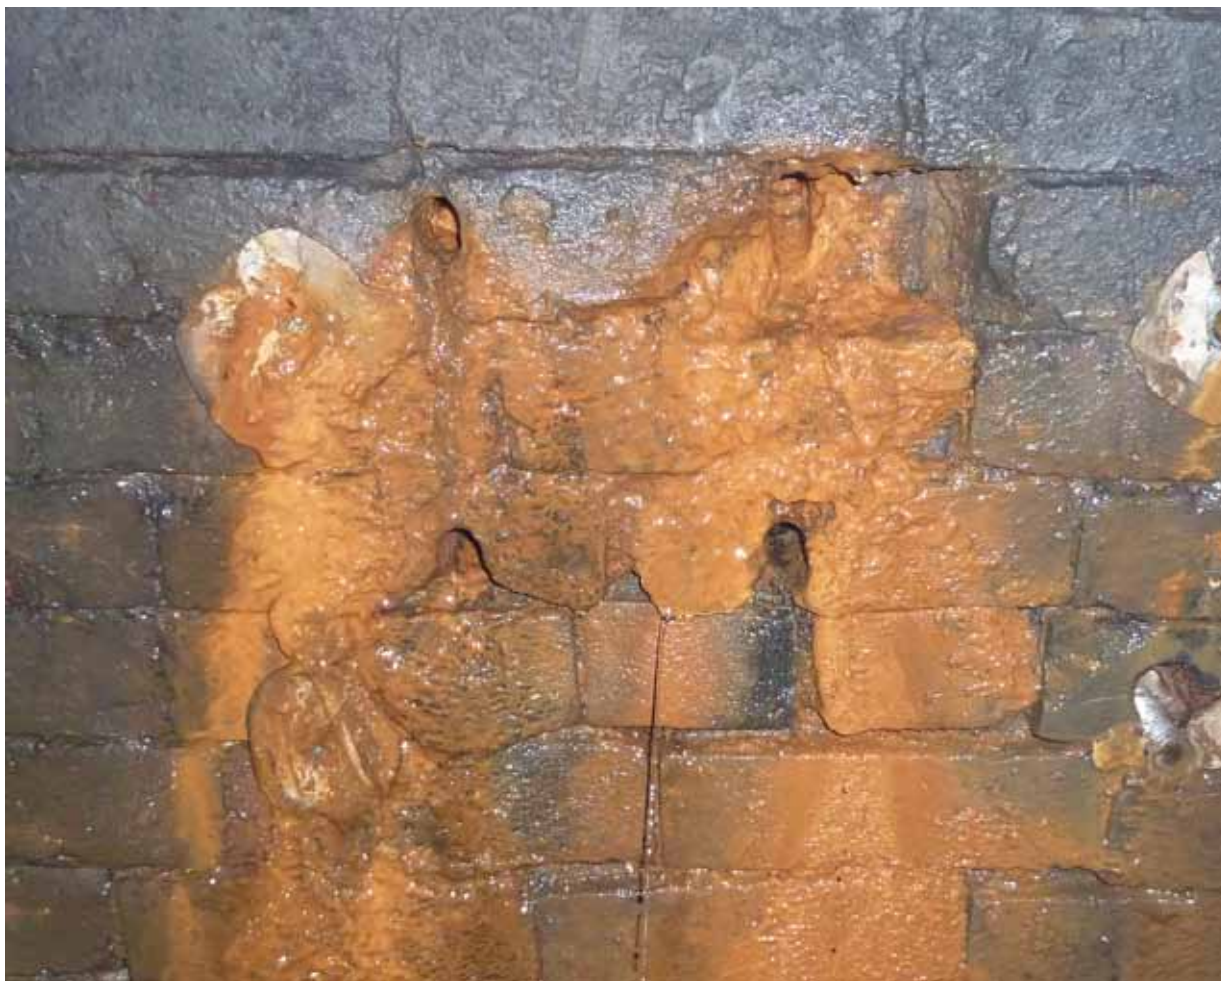
- 50 Some parts of the tunnel are extremely wet. The RAIB observed water running from holes from which studs were missing at chainage 36 (figure 16).

Figure 16: Former position of transverse beam 16 (up side) - note running water

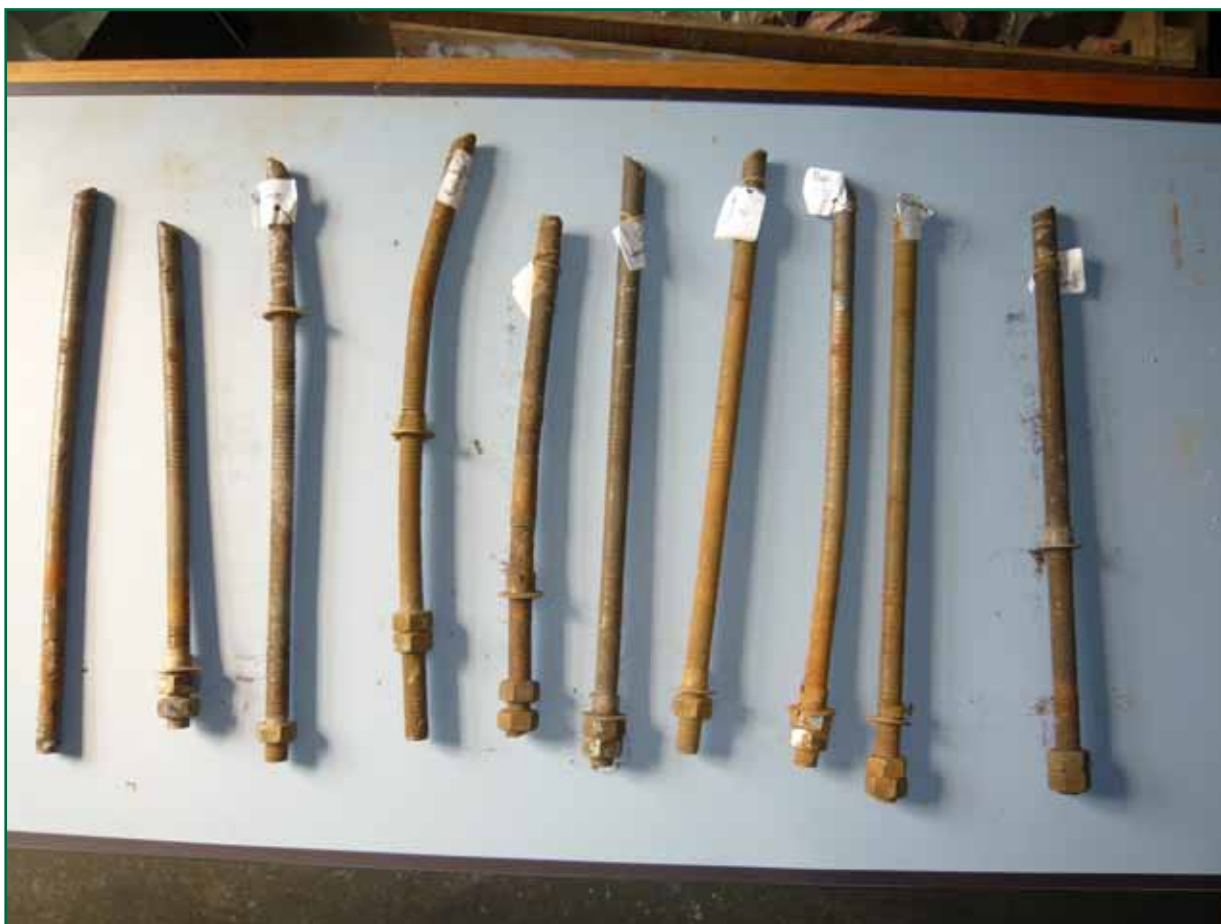
- 60 The length of studs found (figure 17) varied from about 440 mm to about 520 mm, while the depth of the holes, established by a post-incident endoscope survey, ranged from 380 mm to 500 mm. With a fixed quantity of resin, shorter bars or longer holes would encourage the formation of a resin plug at the end of the hole, and gaps in the brickwork would cause loss. Both these features had the potential to reduce the amount of resin at the intended location around the stud. The extent of supervision and quality control of the site work is unclear due to the lack of records. Witness evidence indicates that Railtrack staff were not on site during installation.

Figure 17: Selection of missing studs found in the tunnel - note variation in length

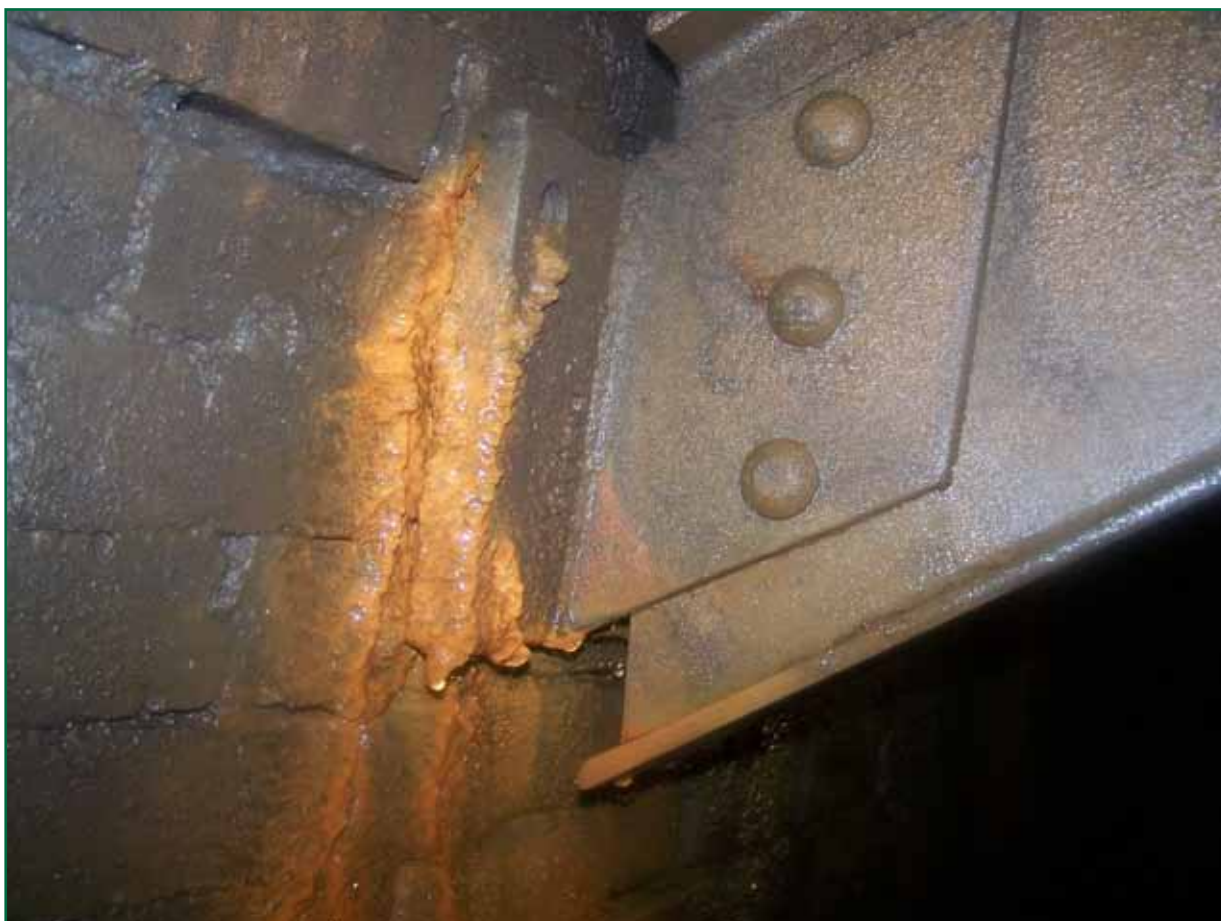
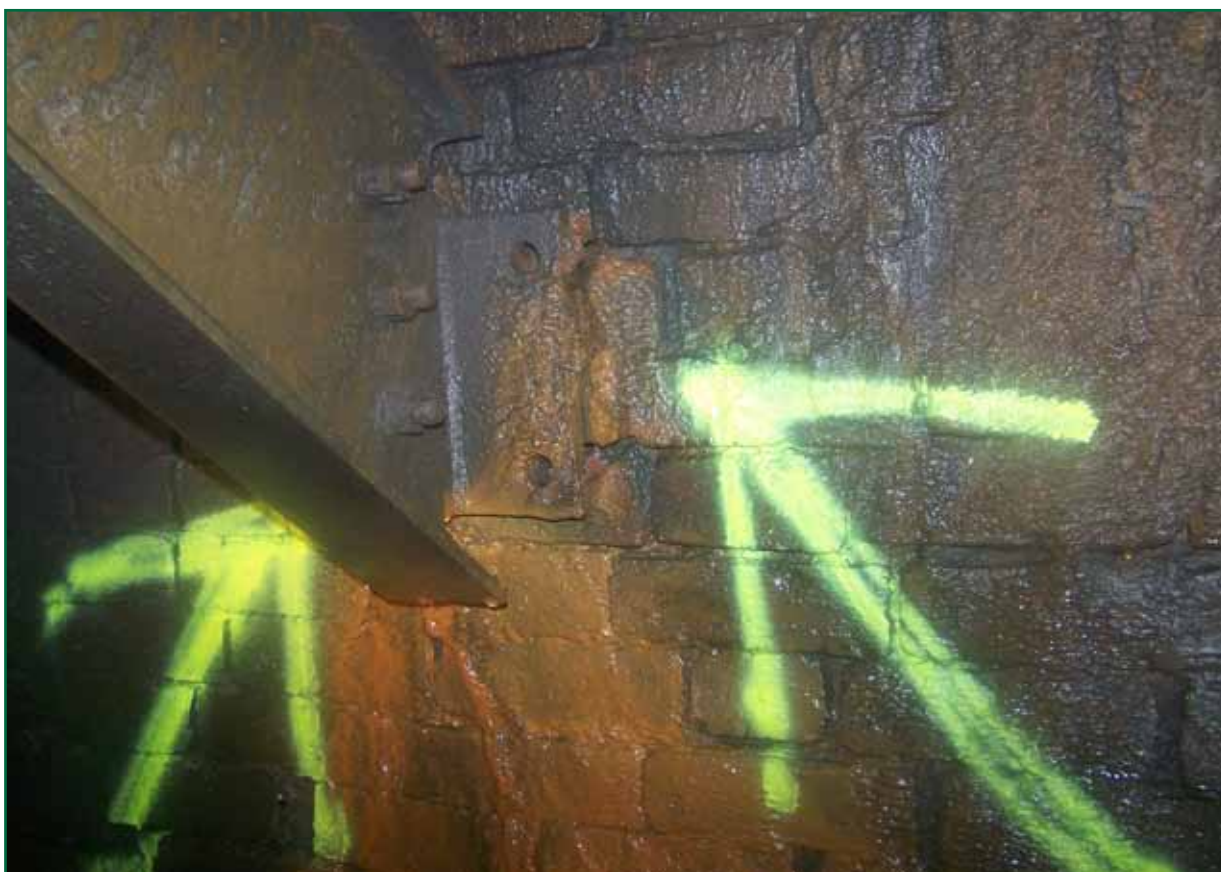
69 The October 2008 examination was part of a *detailed examination* which was not completed on site until January 2009. However, in November 2008, Atkins' tunnel engineer sent an email to Network Rail's South East Territory Structures Management Engineer Tunnels (SME1) providing further information on the missing studs as an interim measure. He attached photographs of the unsupported beam end to the email (figures 18 and 19) and stated:

'This is the specific platform beam bearing where all the bolts are inexplicably missing/sheared at the support that we discussed, discovered following limited access to this area at the latest detailed examination possession.'

'I have sprayed the wall adjacent to highlight the defect... However, early placement of a full set of bolts at the support here must [be] the safest future solution.'

Figures 18 and 19: Missing studs at chainage 34 in November 2008 (photographs courtesy of Network Rail)

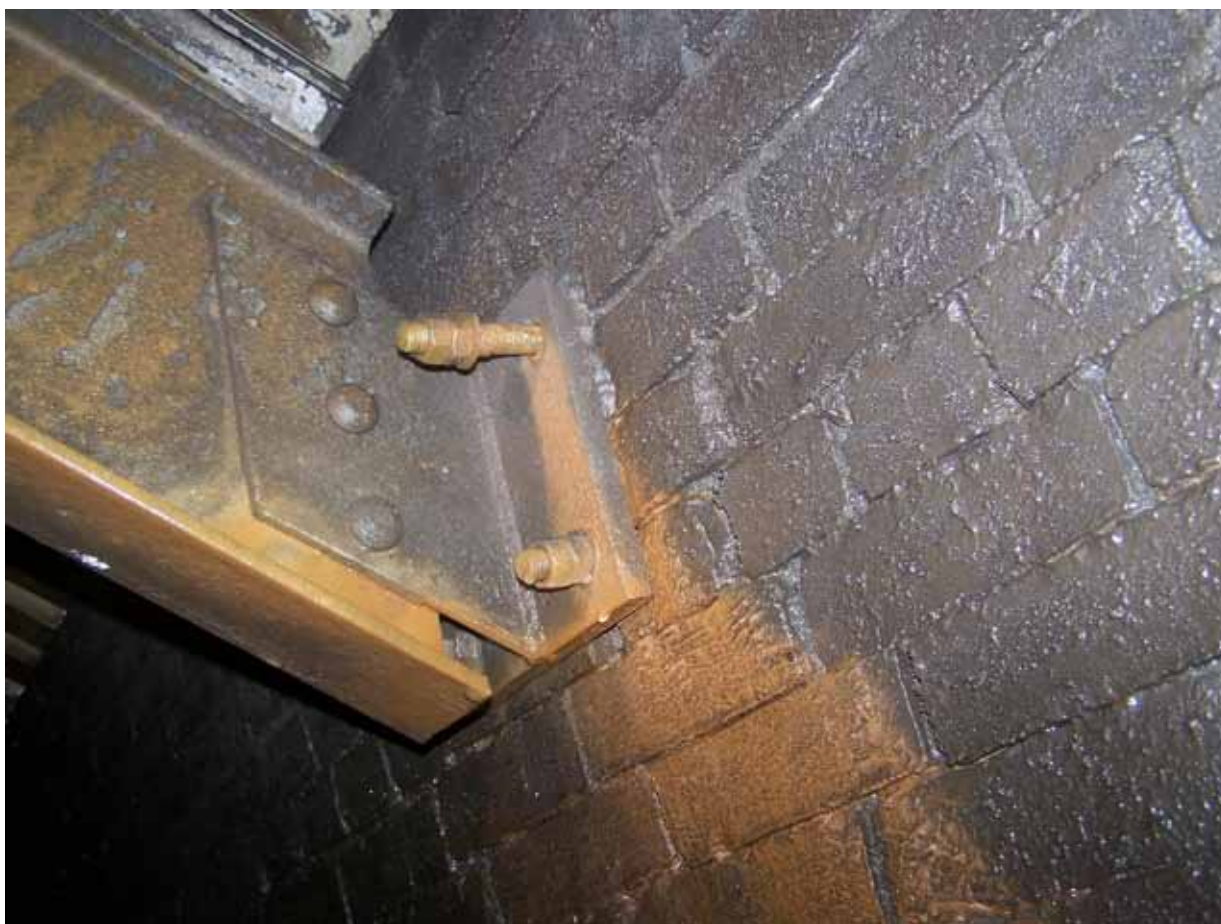
73 In his emails sent in March 2009, Atkins' tunnel engineer also advised SME1 to assume that 50 studs needed replacing or redrilling (25 on each side throughout the tunnel) and enclosed a photograph of a typical loose stud (figure 20).

Figure 20: Loose stud sent to SME1 in March 2009 (photograph courtesy of Network Rail)

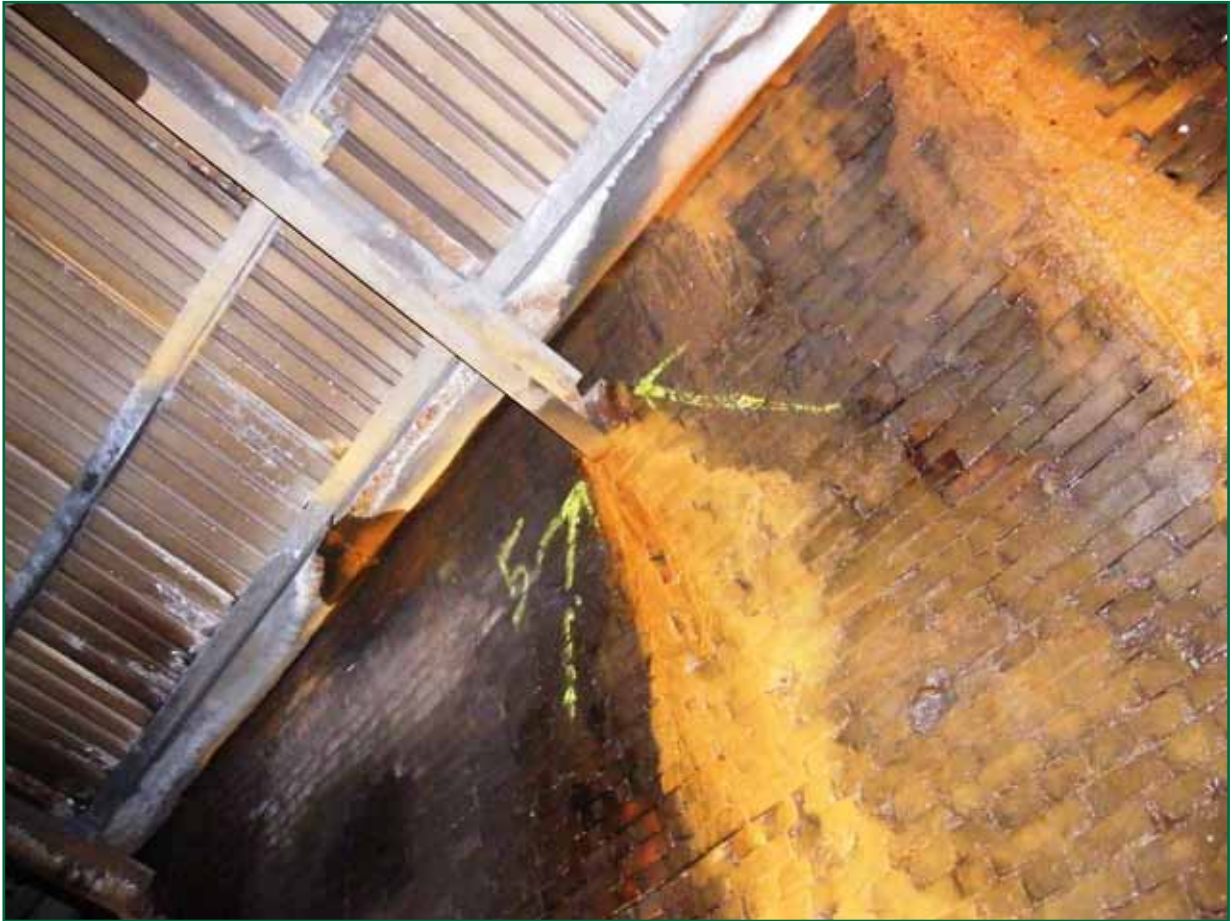
Figure 21: Missing studs at chainage 34 (June 2011) (photograph courtesy of Amey)

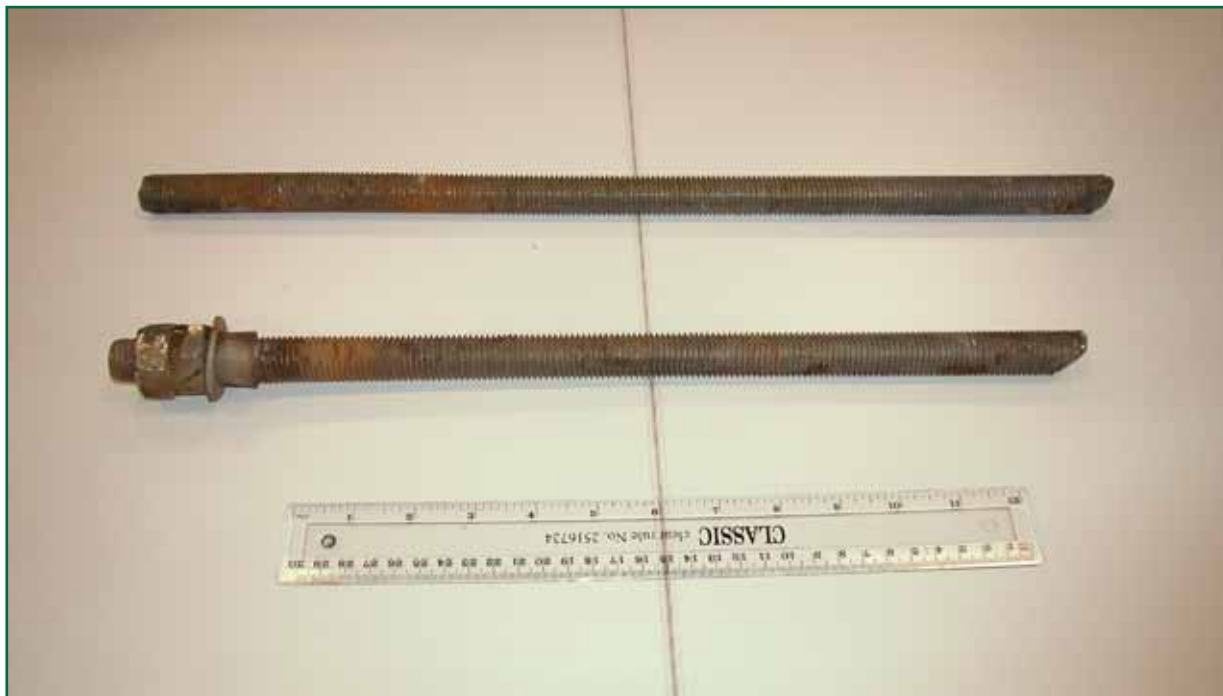
Figure 22: Studs recovered in March 2011 (courtesy of Network Rail)

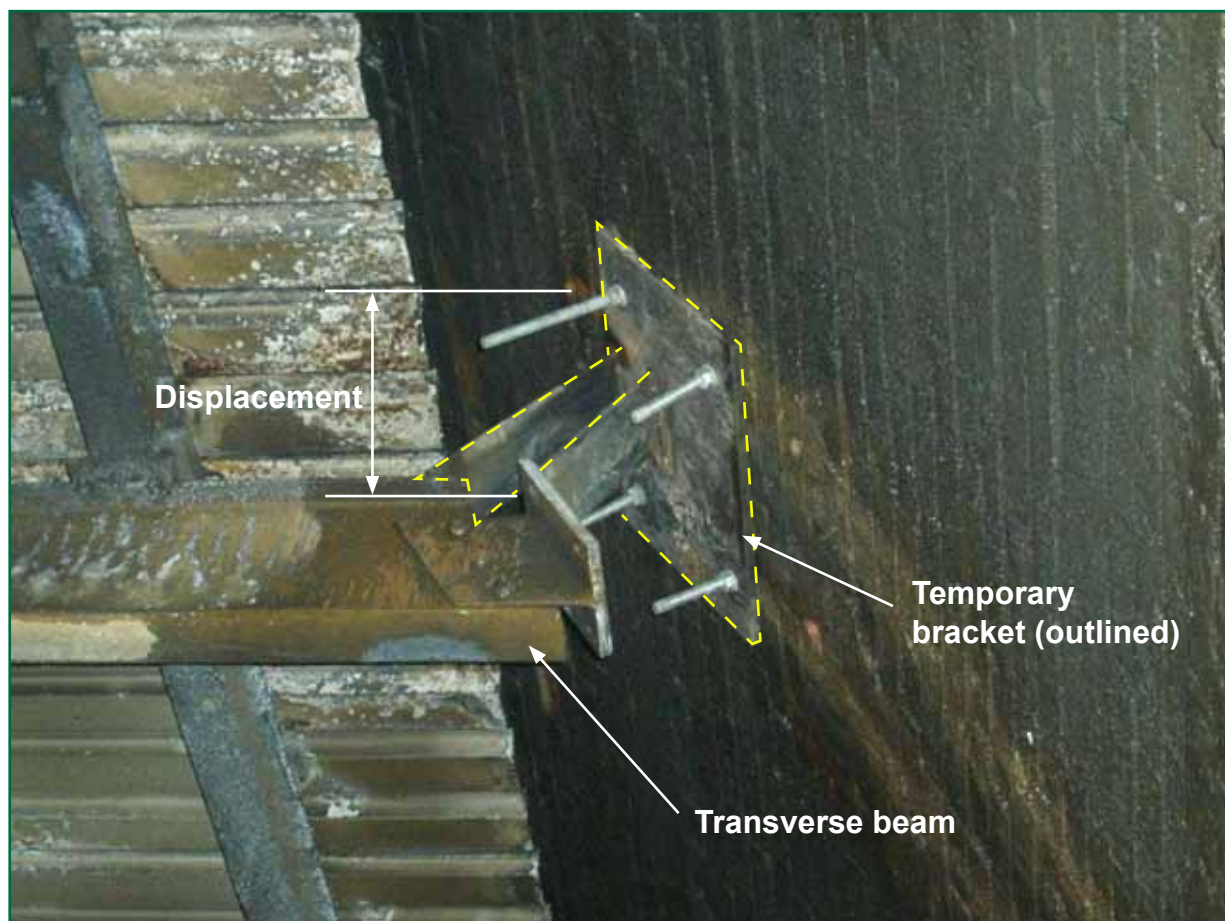
Figure 23: Temporary bracket supporting end of detached transverse beam 16

- 137 Network Rail arranged for temporary brackets to be fabricated and installed to support the three detached beam-ends in their deflected positions (figure 23) before the tunnel was reopened to traffic on 24 September 2011.

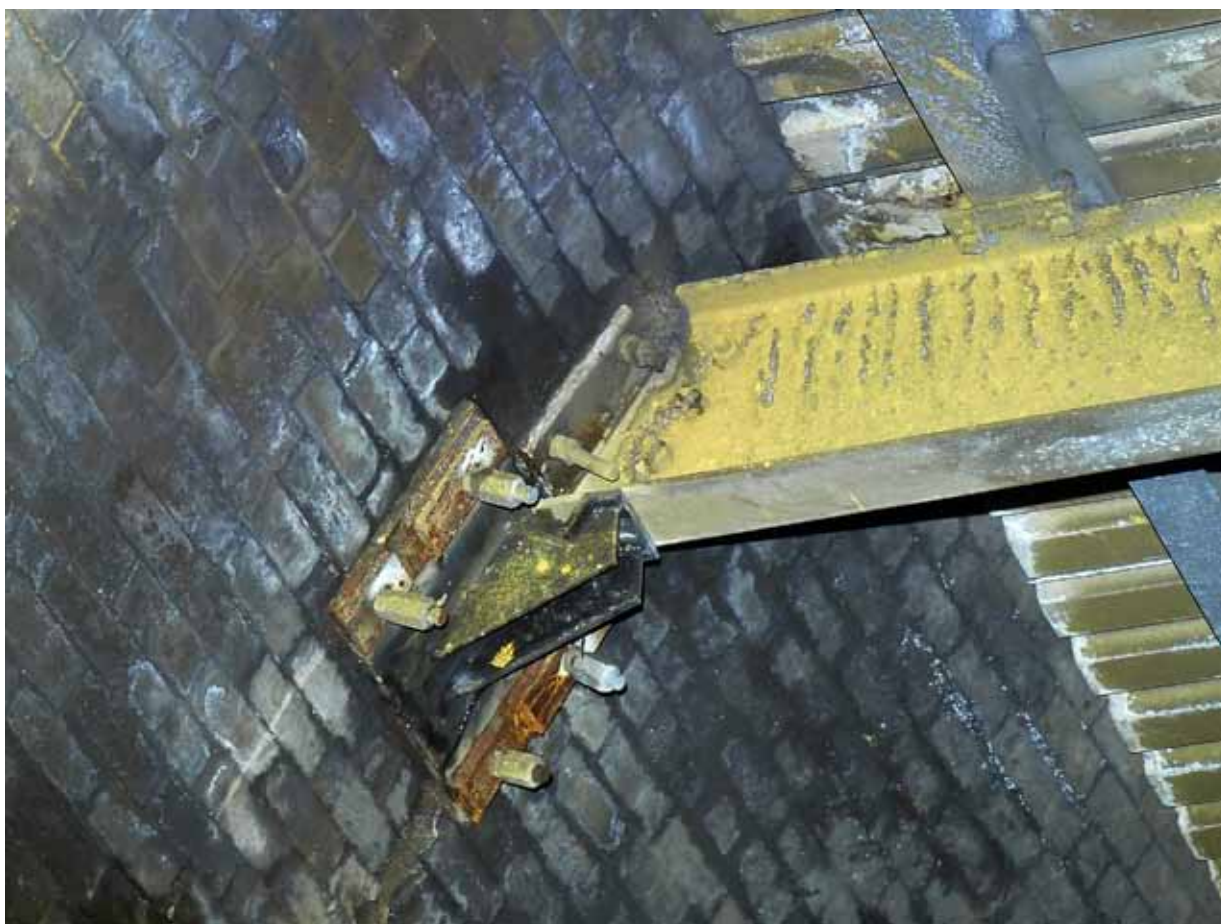
Figure 24: Transverse beam end after fitting of additional support bracket post-incident

- 138 The five southernmost beams of tray 5, including the three deflected beams, were subsequently removed, which resulted in the tray being shortened by 20 metres. Further work undertaken in the tunnel included the provision of brackets to provide additional support to the transverse beams remaining in the tunnel (figure 24).
