Rail Accident Report

Uncontrolled evacuation of a London Underground train at Holland Park station 25 August 2013

This report is published by the Rail Accident Investigation Branch, Department for Transport.

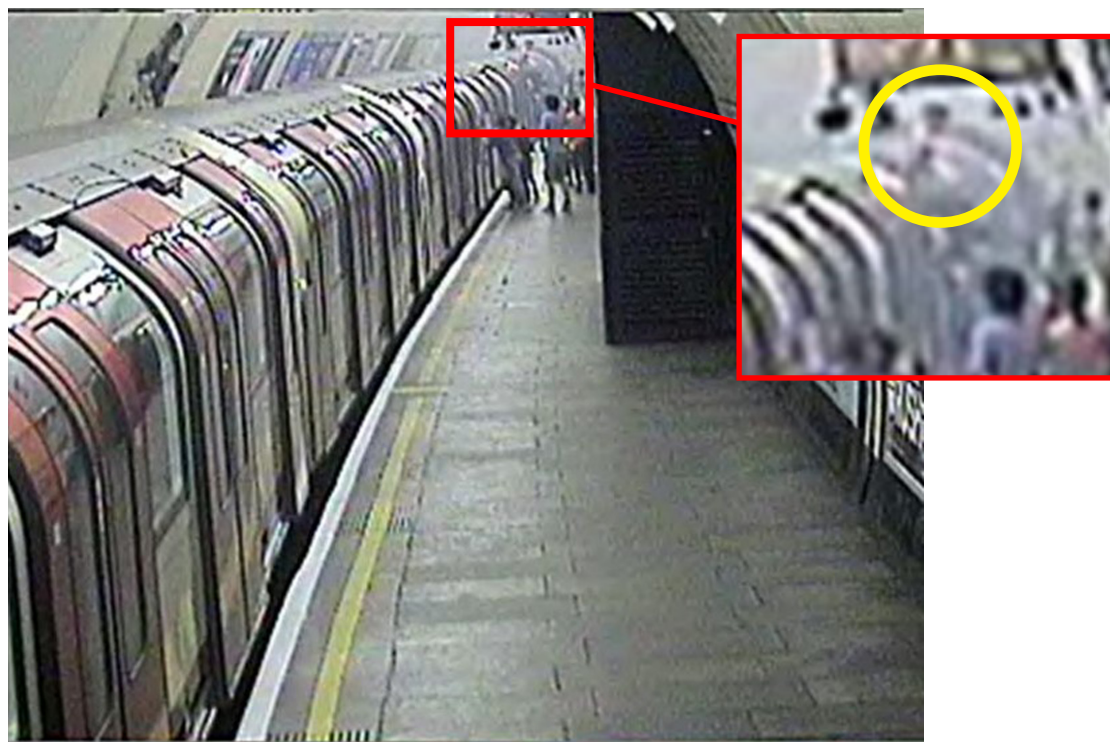
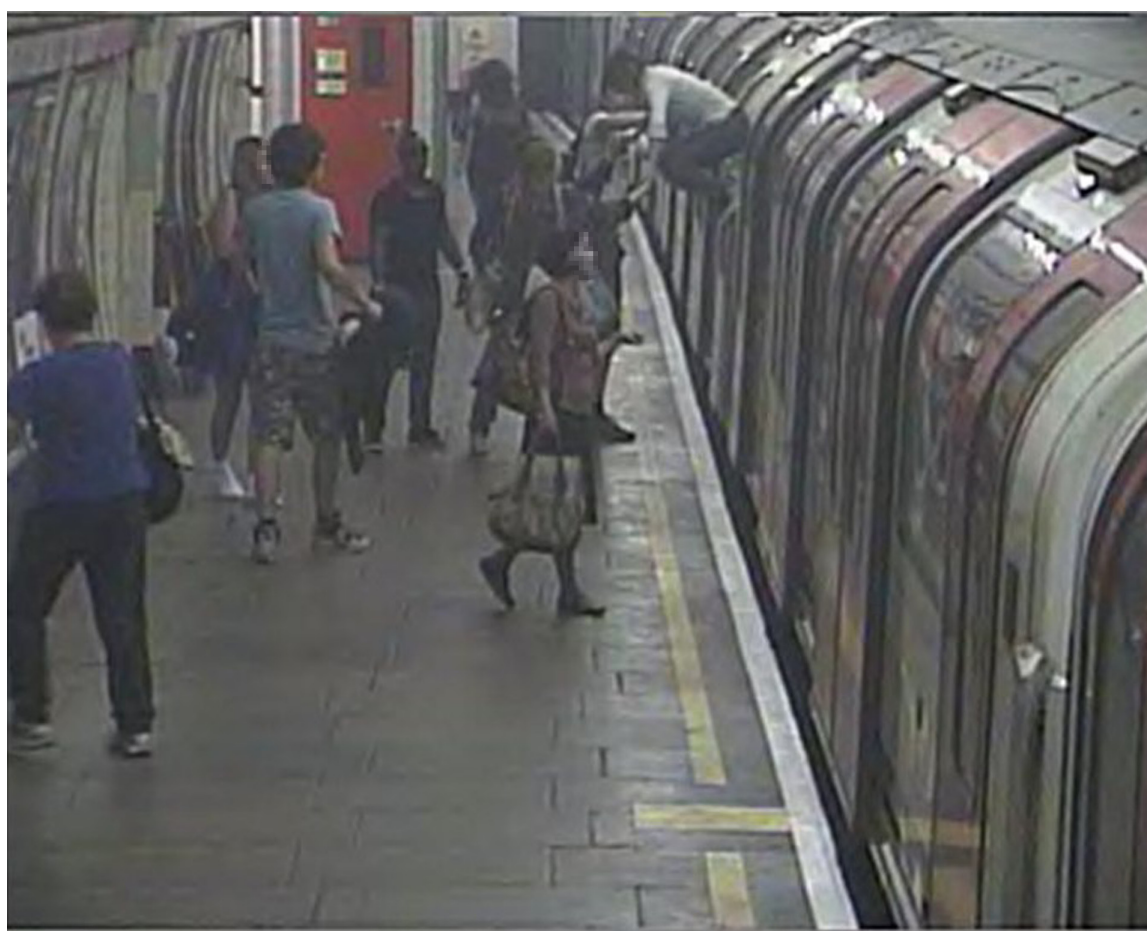
- 6 The train came to a stand with part of the leading car in the running tunnel and with the remainder of the train in the platform. The doors remained locked. Very quickly, fear spread through the train and people, both on the train and on the platform, tried unsuccessfully to force open the doors.
- 7 After less than two minutes passengers began to get out of the train using the interconnecting doors between cars. Over a two minute period approximately 13 people, including some children, climbed over barriers in the gaps between cars to reach the platform (figures 2 and 3).

Figure 2: CCTV images of persons self-evacuating the train

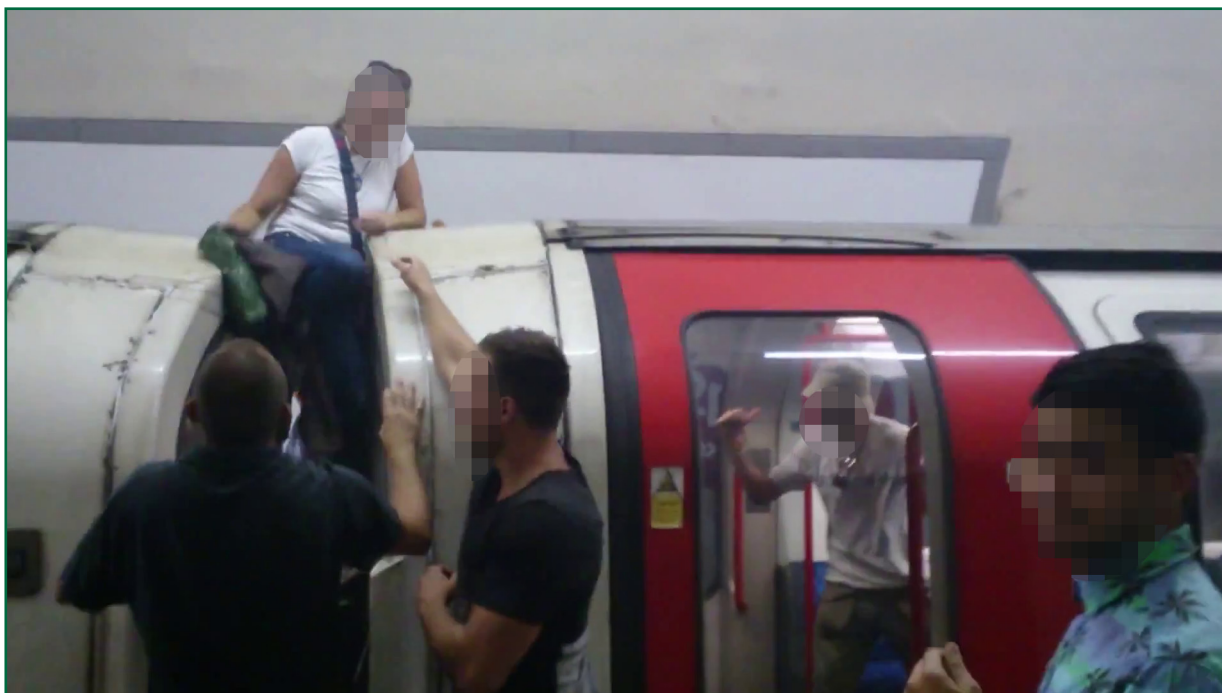
Figure 3: Passenger climbing out between cars 3 and 4 (image courtesy of newsflare.com)

- d. passengers could not see any staff on the platform responding to the situation (**paragraph 90, Recommendation 5 – see paragraph 132**).
- 127 Passengers were able to climb over the inner inter-car barriers to self-evacuate the train (**paragraph 96, no recommendation – see paragraph 133**).

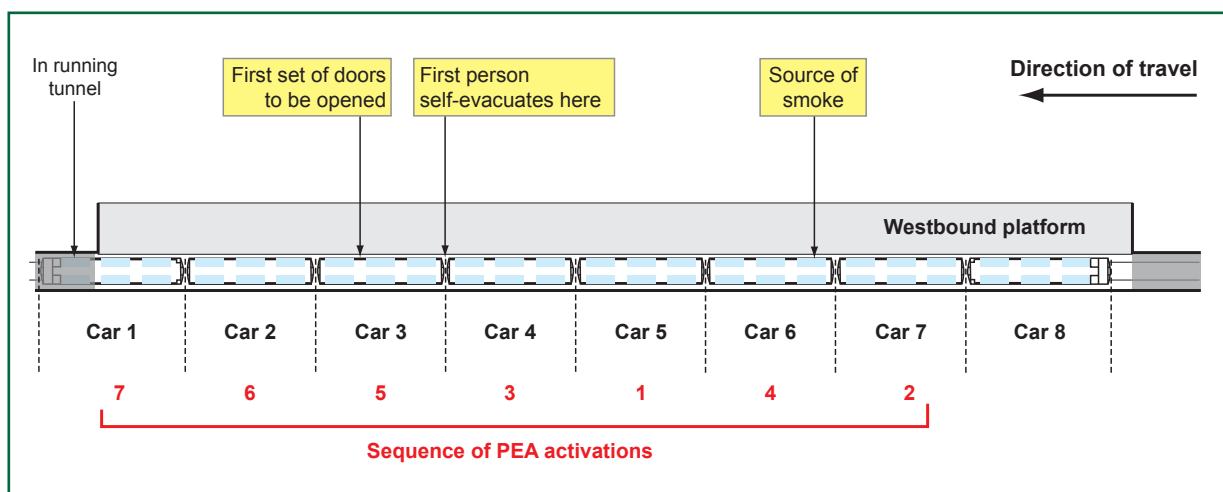
Figure 5: Diagram of train showing incident position in the platform and the sequence of passenger emergency alarm activations

- 44 Around 18:35 hrs, train 003 moved off from the platform at Holland Park station but within seconds was brought to a stand by the activation of a passenger emergency alarm (figure 6) in car 5. The train had travelled about five metres, putting the leading car partly in the running tunnel. Twenty-two seconds later a passenger emergency alarm activation was made in car 7, followed at short intervals by activations from cars 3, 6, and 4. Over a period of almost three minutes there were seven passenger emergency alarm activations in total (figures 5 and 8). The train doors remained locked.

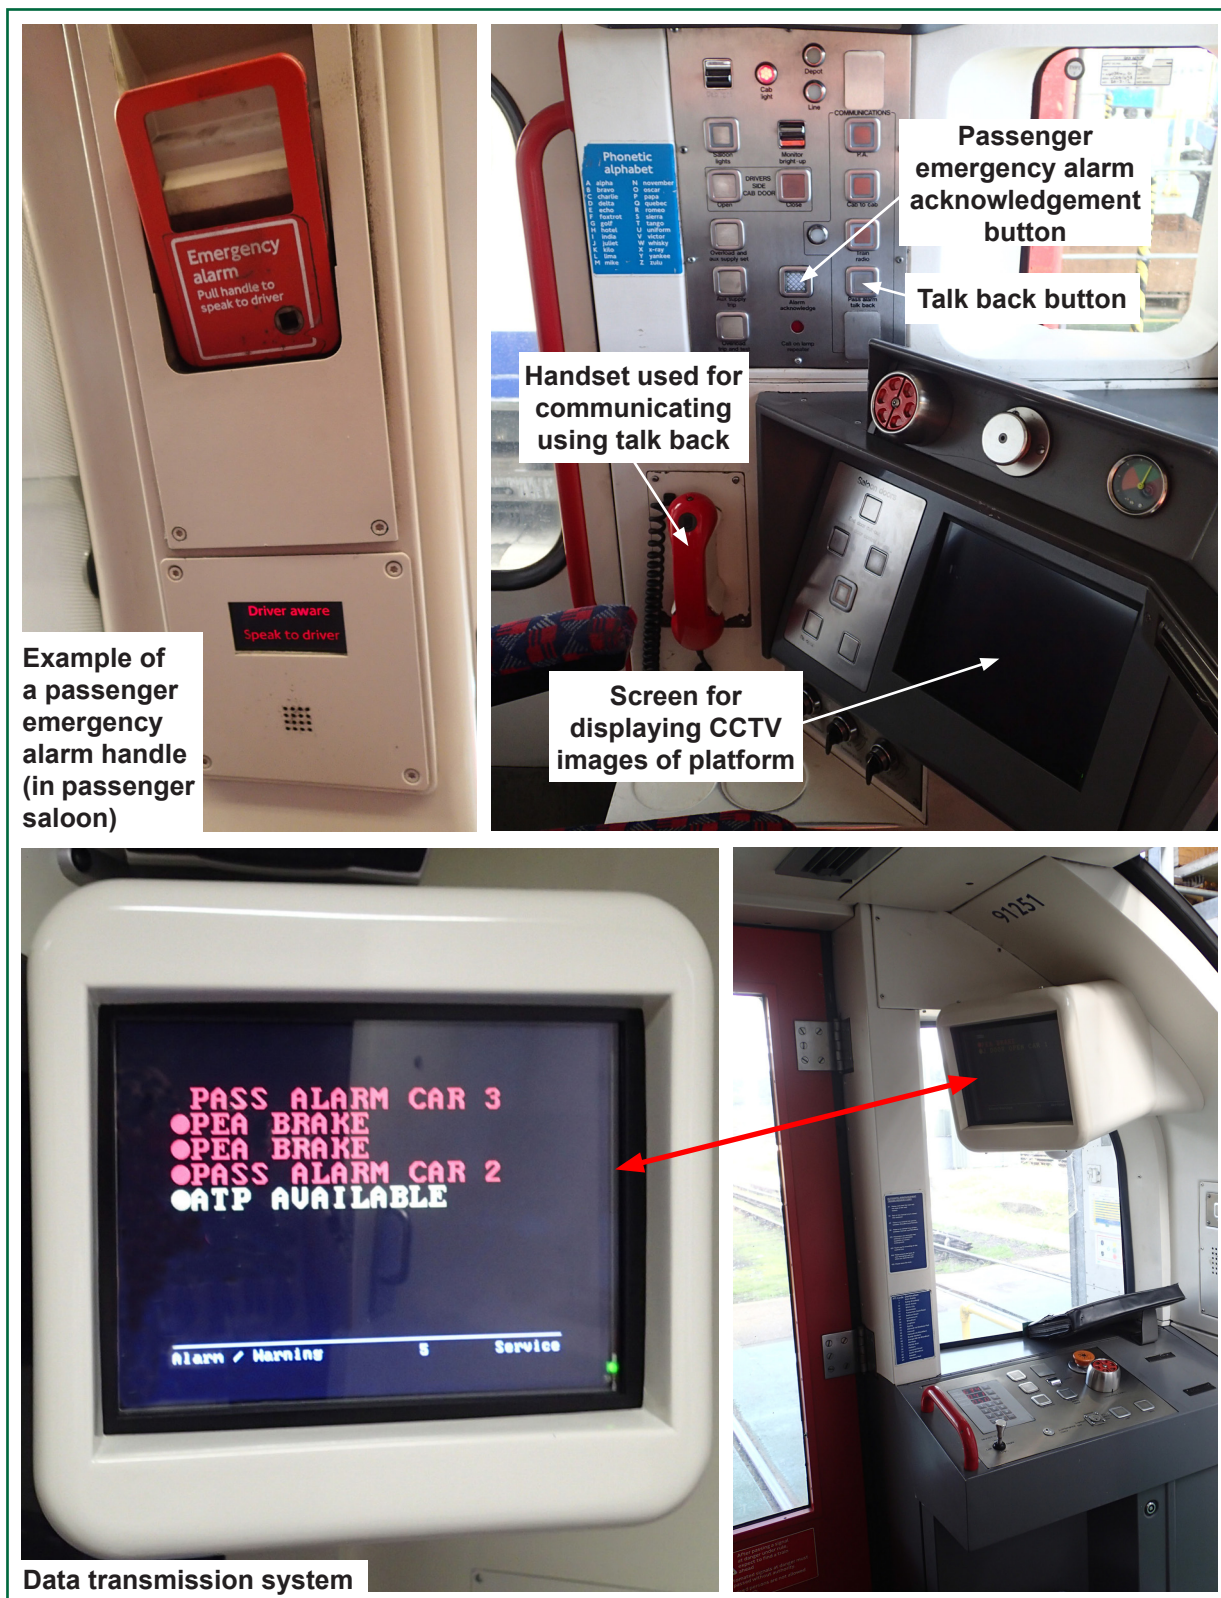
- 20 Trains are equipped with a passenger emergency alarm system (figure 7). The operation of a passenger emergency alarm handle when at least part of the train is within a platform will apply the train's emergency brake, otherwise the train will automatically continue to the next station. This is because the principle underpinning the passenger emergency alarm system is that an emergency on a train is best dealt with in a station. The passenger emergency alarm system has a talkback facility for two-way communications between the train operator and passengers in the car in which the handle has been activated.

Figure 7: Passenger emergency alarm (PEA) equipment

- 1 *The purpose of this recommendation is to promote a design review of the passenger emergency alarm system on 1992 tube stock and the adoption of ergonomics best practice in an improved design.*

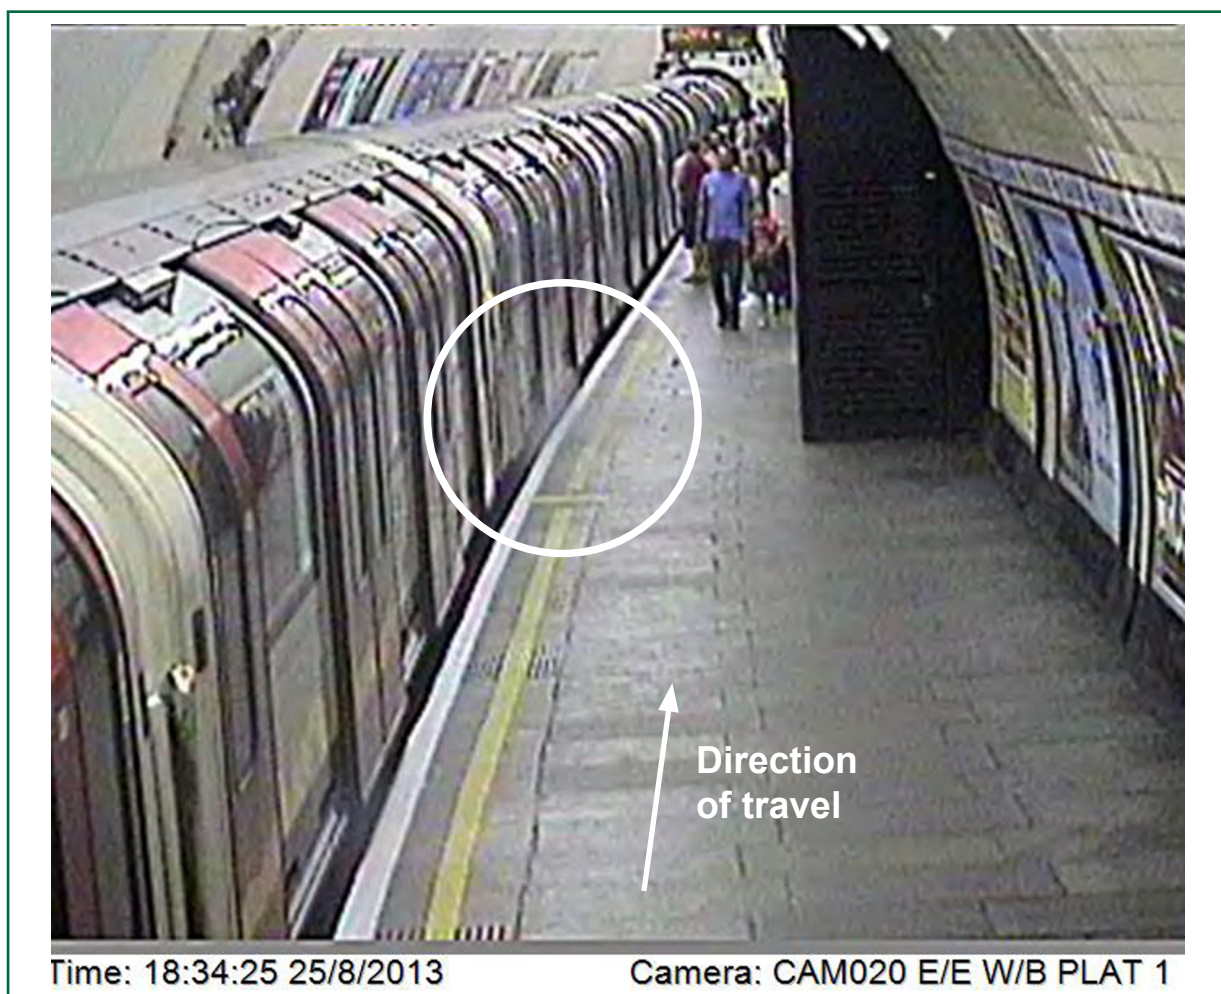
- 42 By the time train 003 arrived at Holland Park station there was smoke coming from the trailing end of car 6 (figure 9). While it was standing in the platform a line information specialist (paragraph 23) telephoned the DSM at Holland Park station to request that a member of station staff be sent urgently to investigate the burning smell that had been reported from Notting Hill Gate station. The content of the call was recorded but the DSM has no recollection of receiving a call at this time and there is no evidence that this request was acted upon.

Figure 9: Smoke emitting from trailing end of car 6 as train 003 was coming to a stand at Holland Park station

- 70 Although there may have been some smell from the brakes, the primary cause of the smoke and burning smell was almost certainly a faulty traction motor. When the train was examined at the depot it was found that one of the traction motors at the trailing end of car 6 had suffered 'flashover' damage. This type of damage occurs when a motor suffers from an insulation breakdown and there is a subsequent electrical short circuit, known as a flashover⁶. It is often accompanied by arcing and smoke from the breakdown and burning of insulation. The train is fitted with safety systems to ensure that the safety of passengers is not at risk from a motor flashover.

- 71 The electrical burning smell reported by a number of witnesses, and the smell from burning glass fibre (a material used in motor insulation), are consistent with a breakdown of insulation, arcing and burning within the motor.

- 131 LUL has reported that, in the short term, the algorithm used to calculate the risk of motor flashover will be changed to increase the weighting given to a motor once it has been in service for 1.6 years after overhaul. This will allow motors to be more accurately targeted for preventative maintenance. Efforts are also ongoing to prevent motors becoming susceptible to flashover; there is an ongoing trial of a modification to the motor which is due to be completed in 2015 and a proposal to develop another modification to reduce wear on motor components associated with flashover (paragraph 72). In the longer term, LUL is seeking to introduce changes to the train and motor control systems to reduce stresses on the motor which appear to be a factor in the process leading to a motor flashing over.

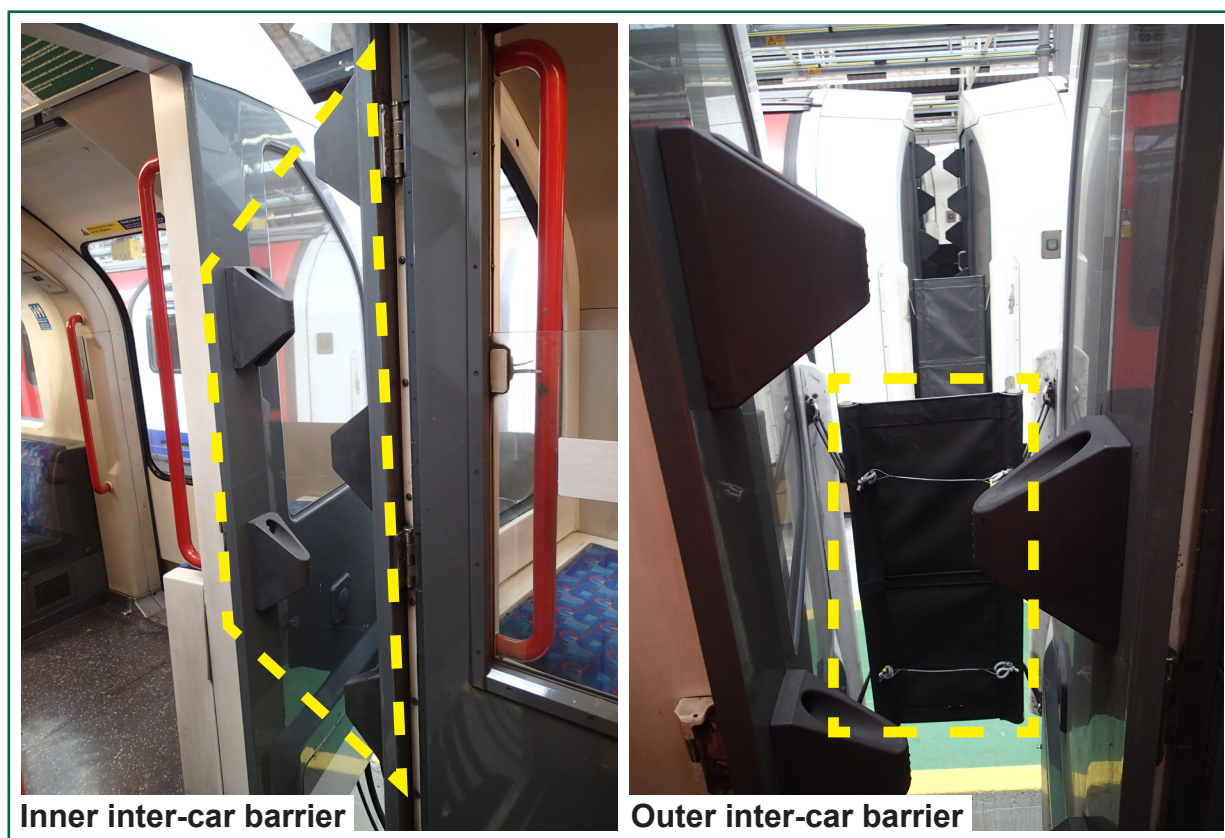
Figure 10: Inner and outer inter-car barriers fitted to Central Line trains

- 98 Inner inter-car barriers were retrofitted to Central Line stock during the early part of 2013. They were fitted to deter a passenger from attempting to get out of a train via the car end-doors after failing to leave the train at the final station stop and being over-carried into sidings where the train operator changes ends. Once the barriers had been fitted, LUL removed the previous requirement for station staff at the final station stop to check that all passengers had got off the train before it moved off to the sidings.

- 104 Canopies would probably have prevented self-evacuation by people climbing over the top of the inner inter-car barriers.
- 105 **The train was not held in the platform at Holland Park station to allow the requested investigation of the burning smell to be carried out.**
