Rail Accident Report

Derailment at Liverpool Street station, London 23 January 2013

Report 27/2014
December 2014

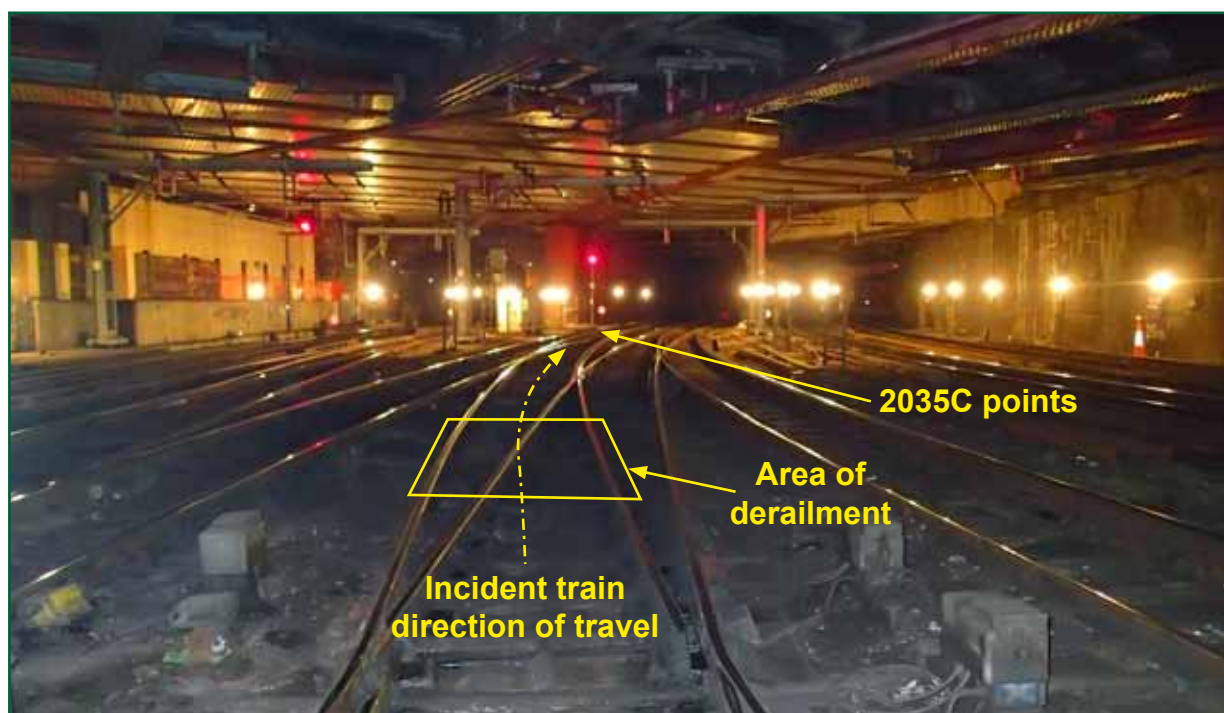
- 8 In addition to minor damage to the train wheels, the *bogie* of one coach, parts of 2035C points and approximately 40 metres of track were damaged. Significant disruption to services using Liverpool Street station continued until 05:45 hrs the following morning.

Figure 2: Derailment site showing path of train 1P18 (2035B points in centre of image)

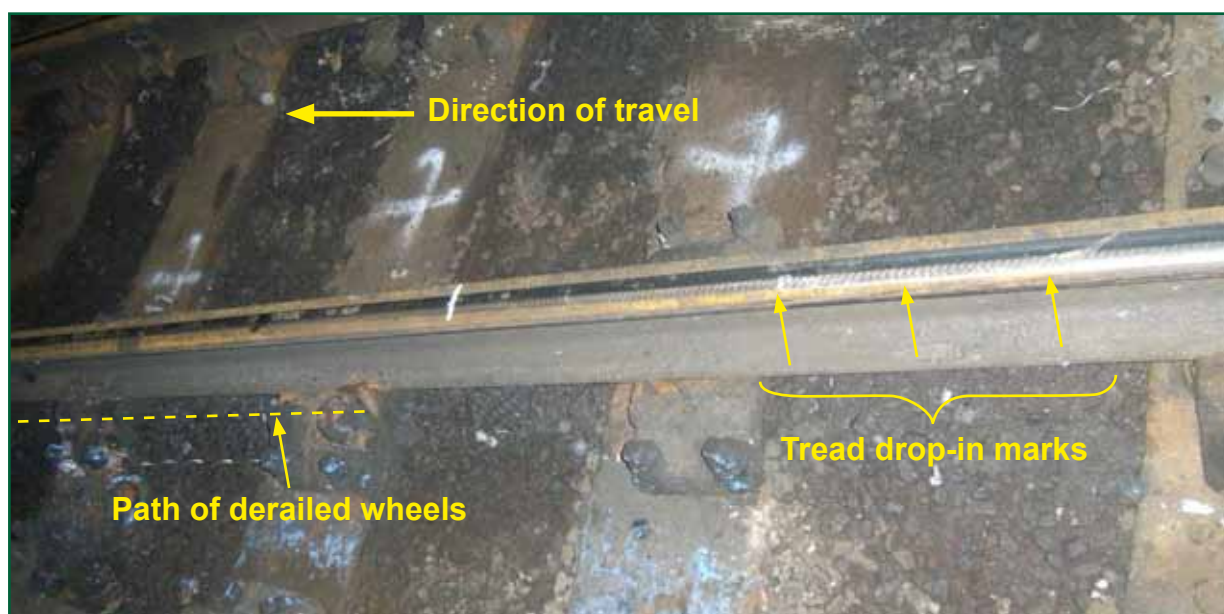
- 63 The derailment evidence comprised closely spaced marks on the right-hand rail indicating that all the derailed right-hand wheels of the train had dropped inside this rail approximately five metres beyond the *tip* of the moveable rail (figures 8 and 9). The RAIB has concluded from the wheel face (the outside face) damage on the train, and a lack of derailment marks elsewhere on the right-hand rail, that the 17 right-hand train wheels derailed in turn as they reached this location. At the point of initial derailment the track is on a right-hand curve and the left-hand wheels were running along a section of rail that should be fixed.

- 64 The first of the wheelsets exhibiting wheel face damage were on the *trailing bogie* of vehicle 3 (figure 5). Damage to the track fixings of the right-hand rail (figure 9) and the absence of damage on the left-hand wheels of this bogie show that these wheelsets continued with the right-hand wheels dropped inside the right-hand *running rail* while the left-hand wheels remained on the rail. Damage to the track fixings indicate that these wheels ran derailed for about 4.5 metres before encountering a *fishplate* forming part of a rail *joint*. As they struck the fishplate, the wheels were raised back up to rail level and guided back on to the running rail (figures 10 and 11).

Figure 9: Wheel tread drop-in marks and damage caused by derailed wheels

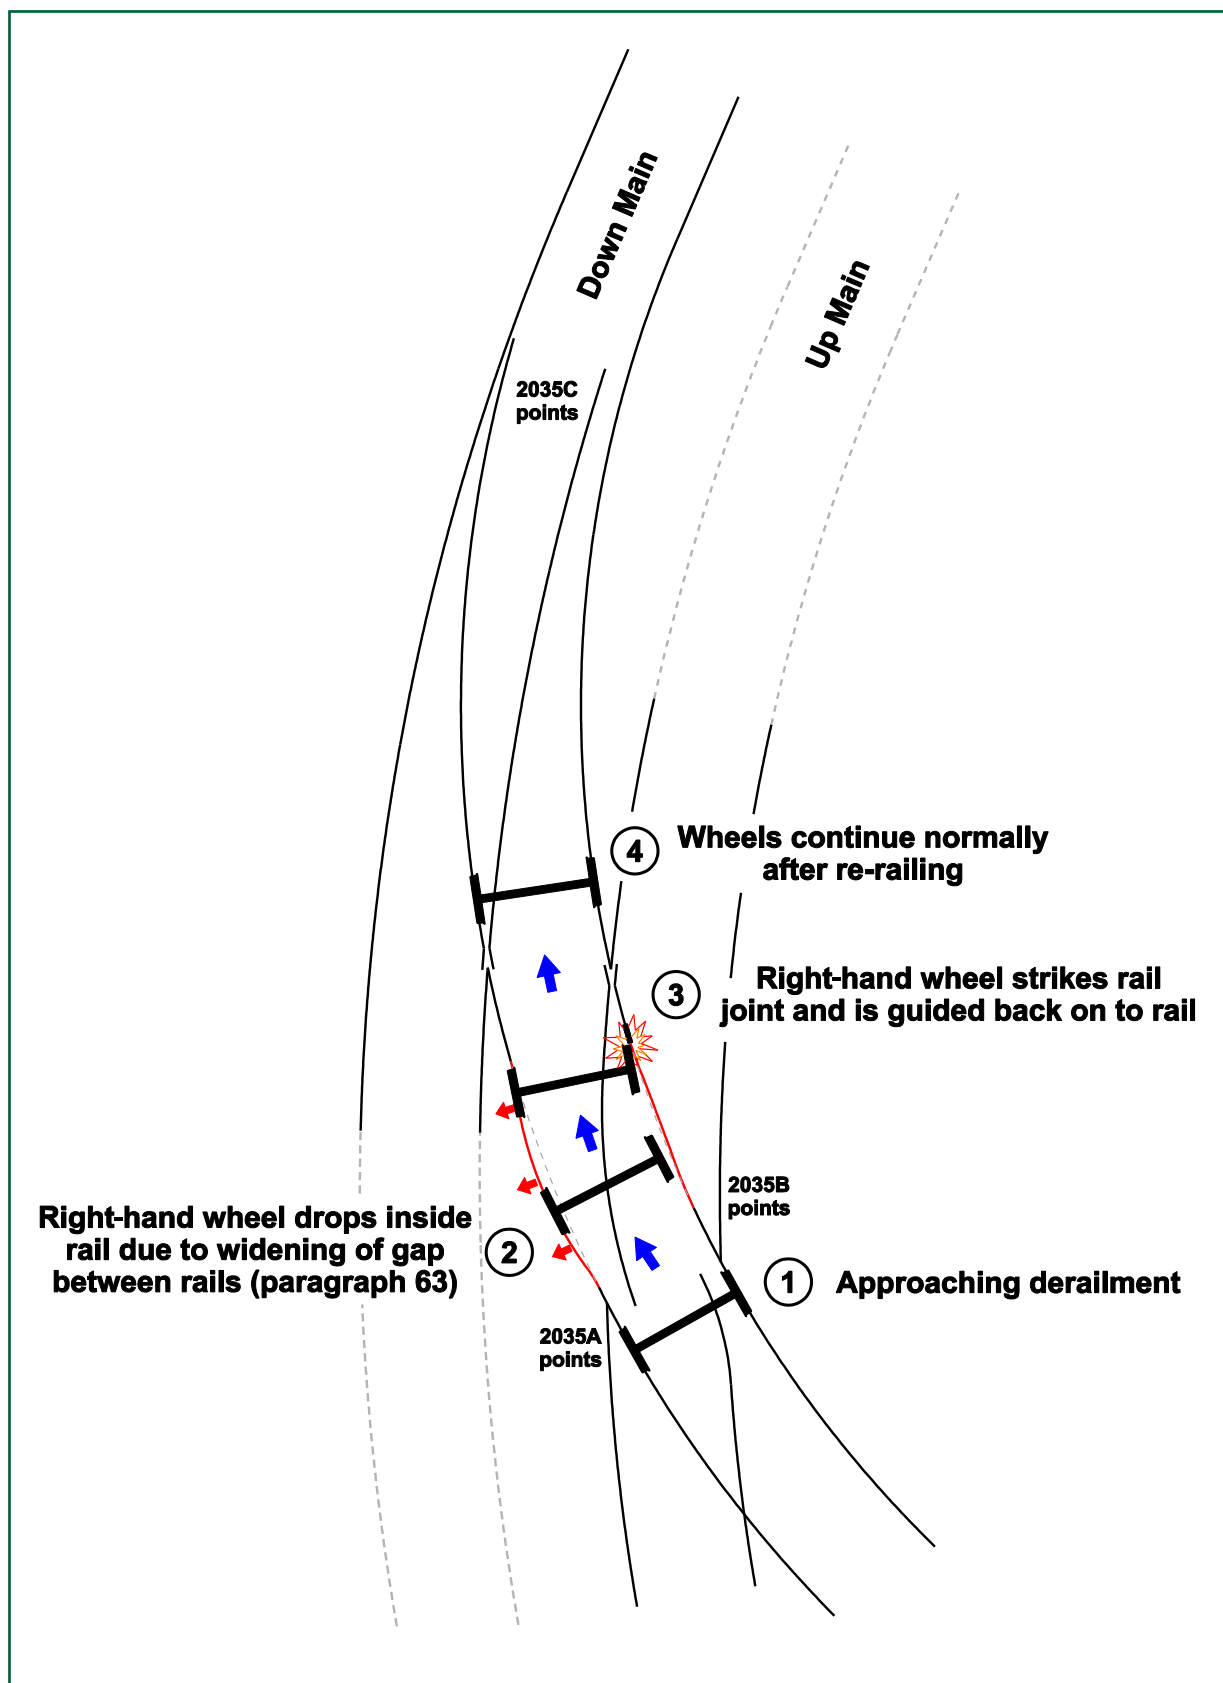
Figure 10: Derailment mechanism (excepting leading bogie of vehicle 4)

- 67 On the remaining 13 wheelsets that derailed, damage was limited to the right-hand wheel face. This indicates that these wheelsets followed a similar derailment path to those of the trailing bogie on vehicle 3 (paragraph 64).

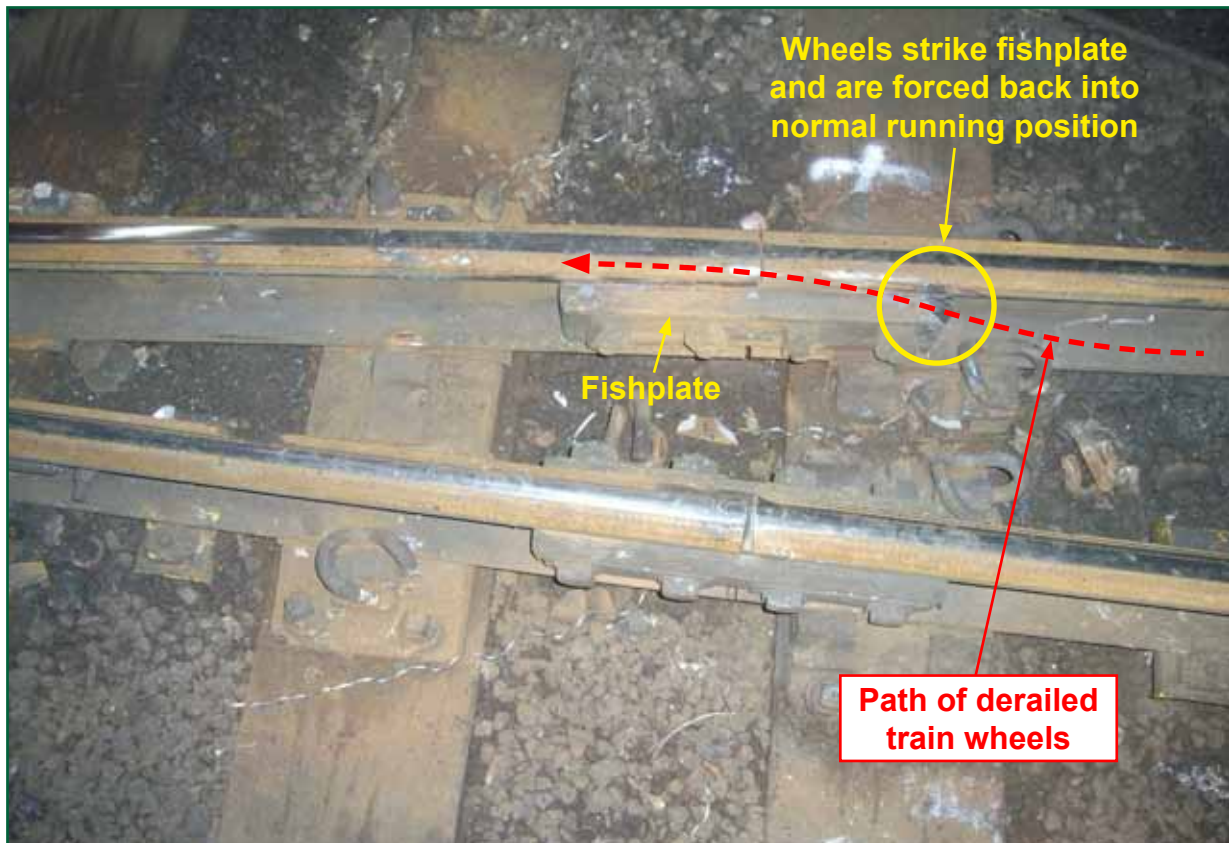
Figure 11: Rail joint which re-railed some wheels

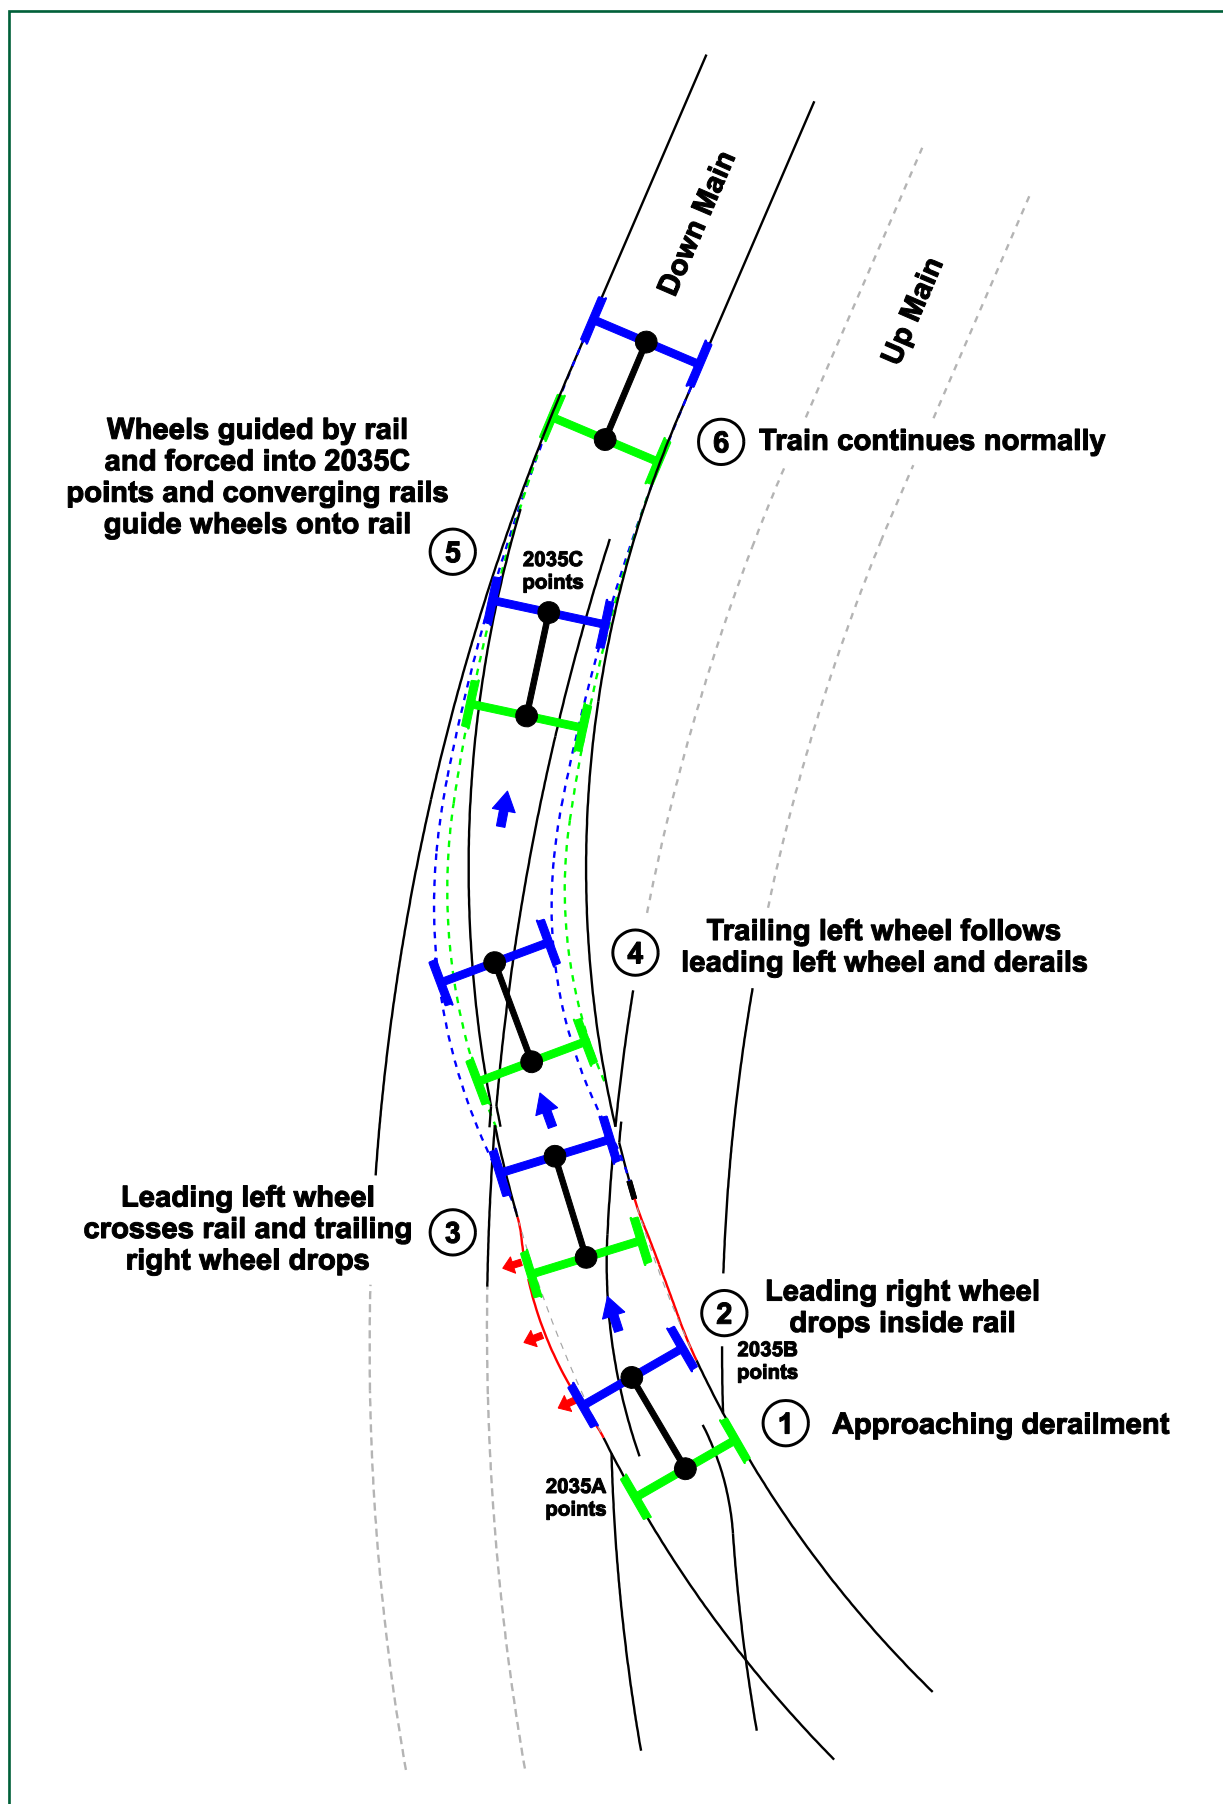
- 65 Damage to all wheels on the *leading bogie* of vehicle 4 indicate that this bogie fully derailed. Rail head marks (paragraph 63) and marks on the right-hand wheel faces show that the right-hand wheels initially followed the same path as vehicle 3. However, instead of the right-hand wheels re-railing at the rail joint, the left-hand wheels climbed over the left-hand rail. This is evidenced by damage to the flanges of the left-hand wheels, marks left across the left-hand rail head and damage to the track fixings on the outside of the left-hand rail.

- 66 The extent of damage to track fixings shows that all wheels on this bogie then continued in a derailed state for approximately 40 metres until converging rails at 2035C points forced the wheels to run through the closed points and guided them back into a normal state on the running rails (figure 12).

Figure 12: Derailment mechanism for vehicle 4 leading bogie

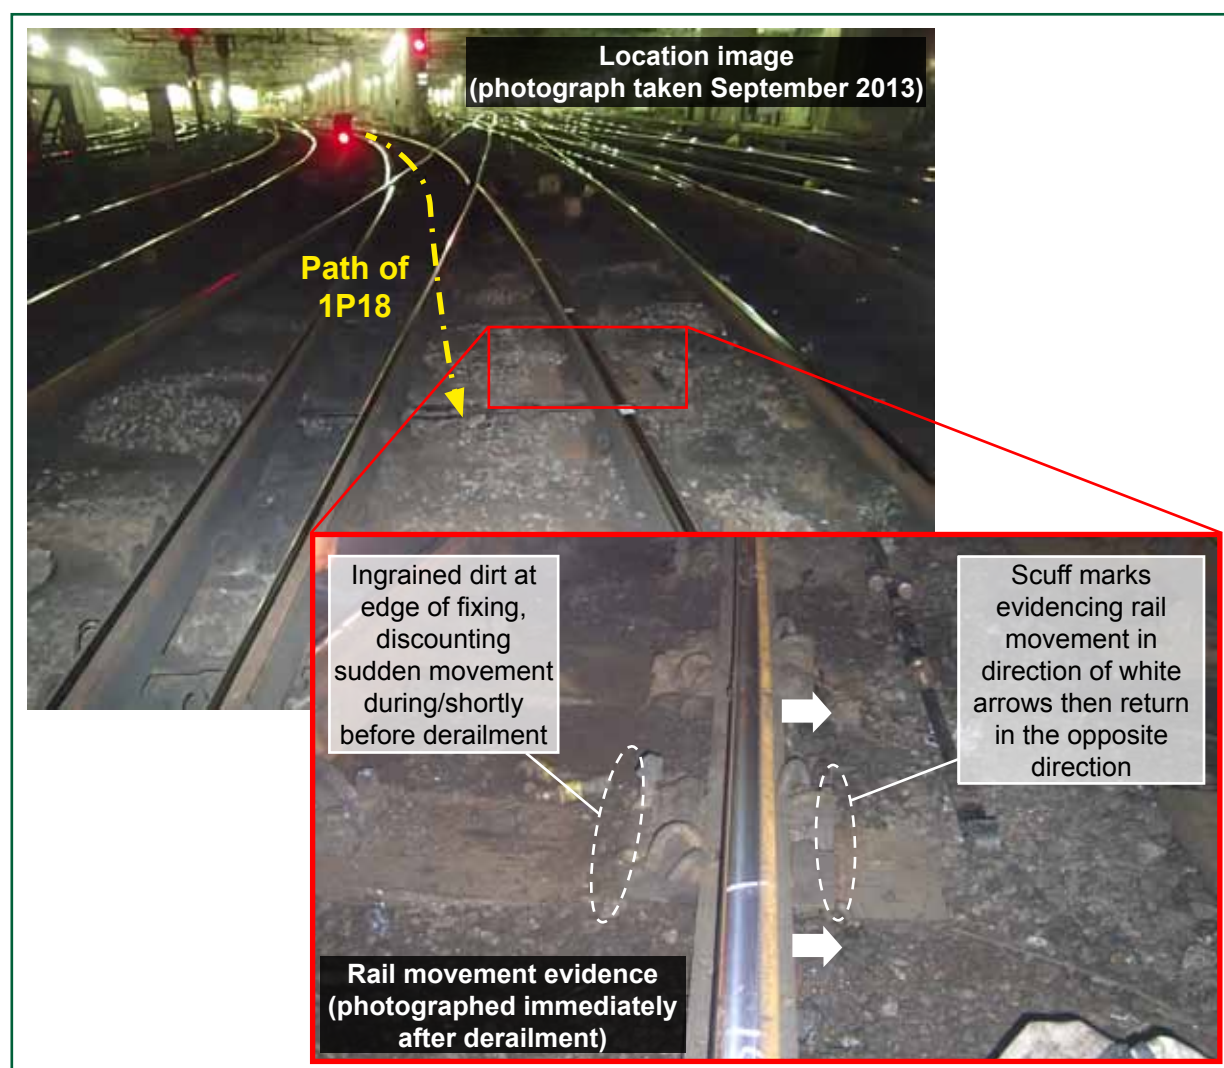
Figure 15: Wide gauge rail fixing with ingrained dirt around baseplate discounting possibility of recent movement

- 79 The static track gauge was measured throughout the derailment site immediately after the derailment and a value of 1474 mm was found at the drop in (derailment) marks. If found during routine inspection, Network Rail standard NR/L2/TRK/001 would require remedial action within 36 hours. Although gauge was not measured immediately before the derailment, the build up of dirt immediately behind the baseplate (figure 15) discounts the possibility that the baseplate first moved during, or shortly before the accident. Network Rail records show that the static gauge was measured on March 2012 and found to be less than 1455 mm (paragraph 122) indicating that significant deterioration had occurred over the following ten months.
- 80 The inspection regime intended to detect, and trigger correction of, excessively wide static gauge at Liverpool Street is described in paragraph 102.

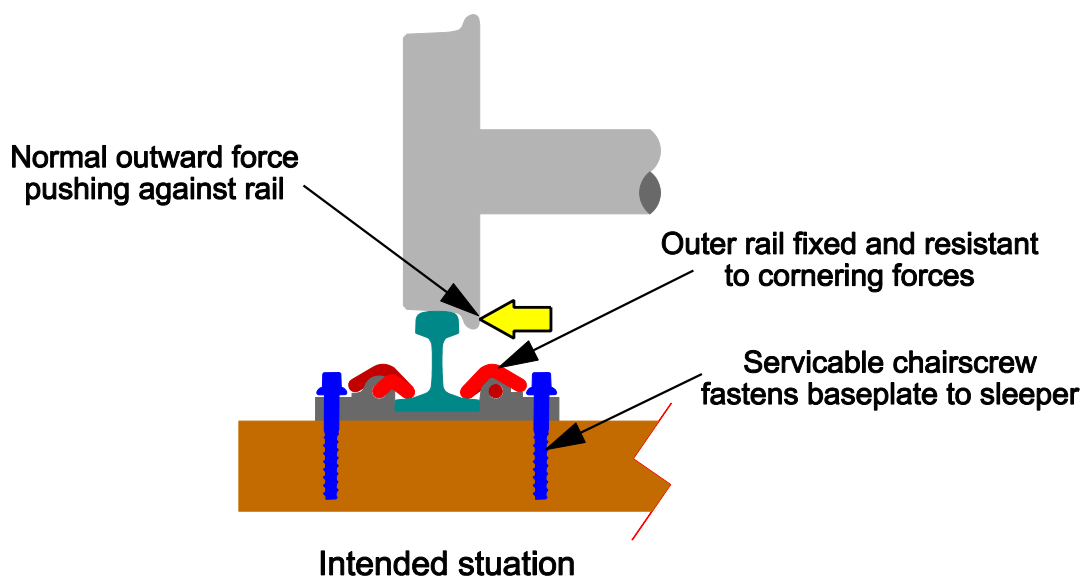
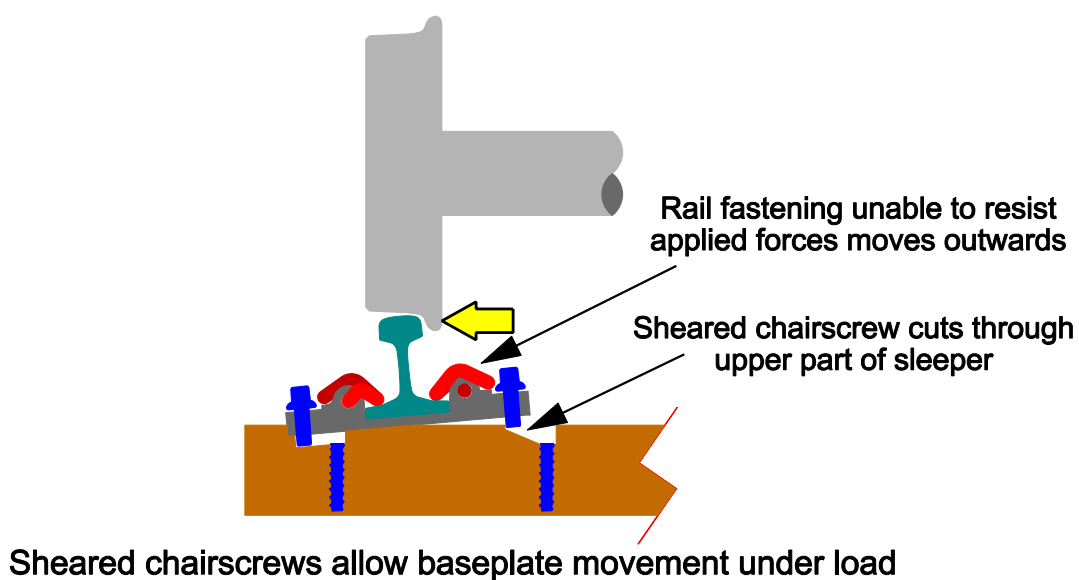
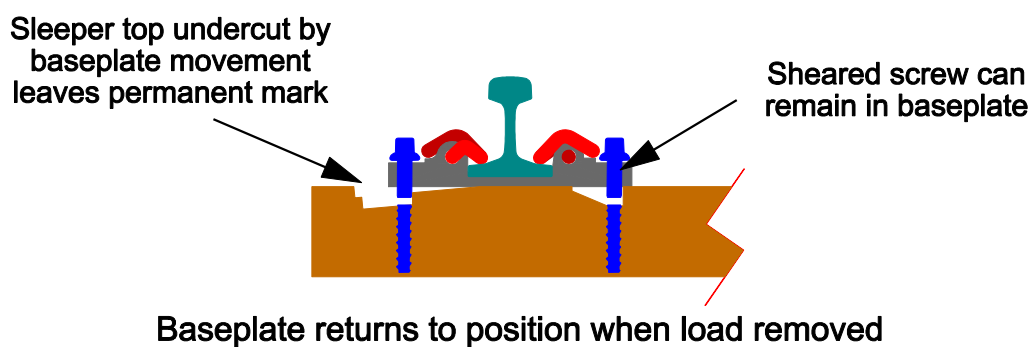
- 68 Scuff marks and depressions indicative of rail fixing movement were evident on the upper surface of sleepers near the point of derailment. The extent of these marks observed by the RAIB showed that the left-hand rail fixings had moved outwards, increasing the distance between the running rails by up to 35 mm. This rail was intended to remain in a fixed position but it was able to move as a consequence of deterioration of the rail fixing (paragraphs 82 to 84).

- 84 The scuff marks and depressions observed after the accident on the upper surface of sleepers near the point of derailment were associated with the greatest displacement of the baseplate which probably occurred during the derailment. These are likely to have obscured any scuffing and depressions associated with previous shuffle. The observed marks and depressions show that, during the derailment, the left-hand rail fixings moved laterally by up to 35 mm beyond the static gauge. The measured static gauge and shuffle marks varied at each sleeper, but when both are added together, the combined maximum measured was 1508 mm at the point of derailment. This maximum included 4 mm of wear on the left-hand rail, an amount within the limits permitted by Network Rail standards.

- 85 As the greatest baseplate displacement had probably occurred during the accident, it was not possible to determine the extent of any shuffle marks that may have been visible before the accident. However, evidence of pre-derailment shuffle is provided by witness marks left by sheared chairscrews found in five sleepers after the accident. These chairscrew marks were beneath the baseplate so would have not been visible before the accident.

Figure 16: Baseplate shuffle and sleeper marks

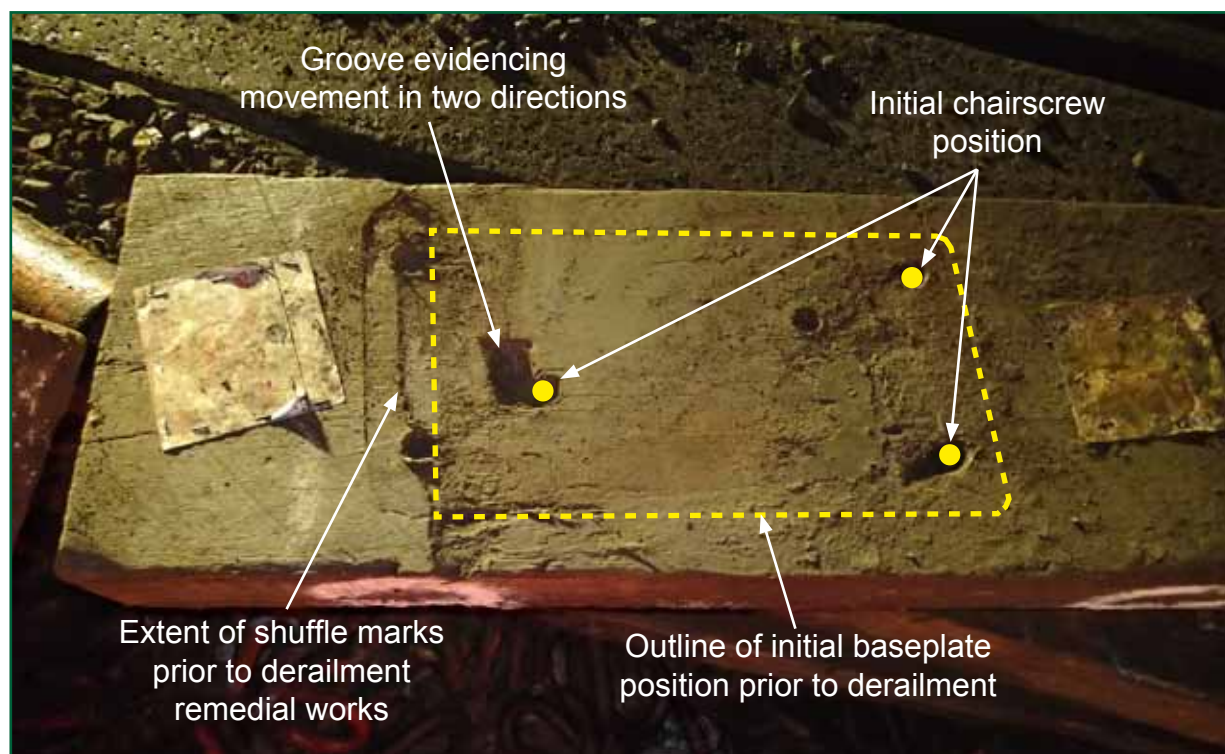
- 86 The chairscrews had broken a short distance below the underside of the baseplate leaving a short length of chairscrew protruding downwards into the sleeper. Subsequent movement of the baseplate was evidenced by grooves cut into the upper part of the sleeper. These grooves remained after repairs were undertaken immediately following the derailment and were seen by the RAIB while permanent repairs were being undertaken in November 2013 (figure 17).

Figure 17: Marks caused by pre-derailment shuffle (post-derailment marks shown on figure 18)

- 87 These pre-accident grooves were much wider than the chairscrews indicating that the sides of the groove had been worn outwards by many cycles of movement. Some of the grooves had developed in more than one direction and this is inconsistent with them being caused only by movements during the derailment.

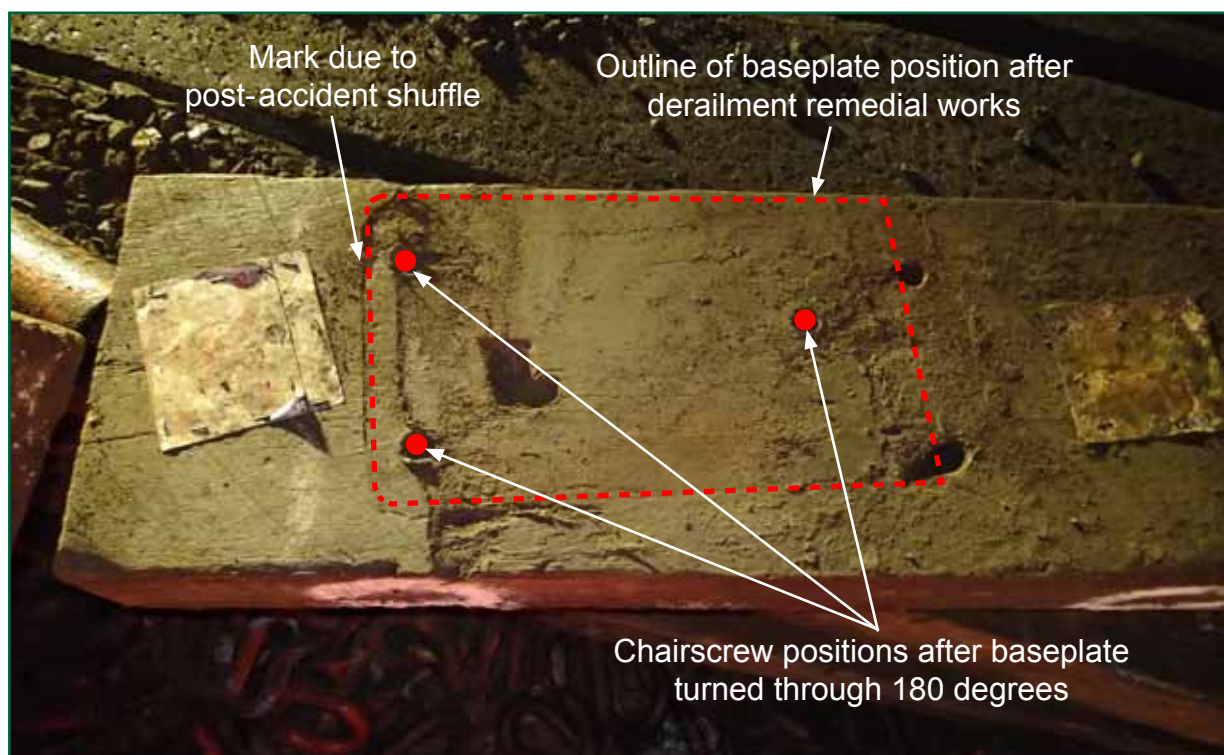
- 93 As part of the repairs undertaken immediately after the derailment, Network Rail turned the existing baseplates through 180 degrees and re-fixed them to the existing sleepers. The asymmetrical chairscrew hole pattern in the baseplate meant the chairscrews were then screwed into a previously unused part of the sleeper. Turning the baseplates also meant that the baseplate edges were in a slightly different position on the sleeper. It was therefore possible for the RAIB to distinguish between the effects of shuffle before and during the derailment and that which occurred later.

- 94 Shuffle continued to occur in the 10 months between re-fixing the baseplates immediately after the derailment and the implementation of permanent repairs in November 2013. The marks made by the lateral movement during post-accident shuffle are shown in figure 18. The post-accident shuffle was associated with sheared chairscrews which were found during the relaying works in November 2013 (figure 19).

Figure 18: Marks caused by post-derailment shuffle (pre-derailment marks shown on figure 17)

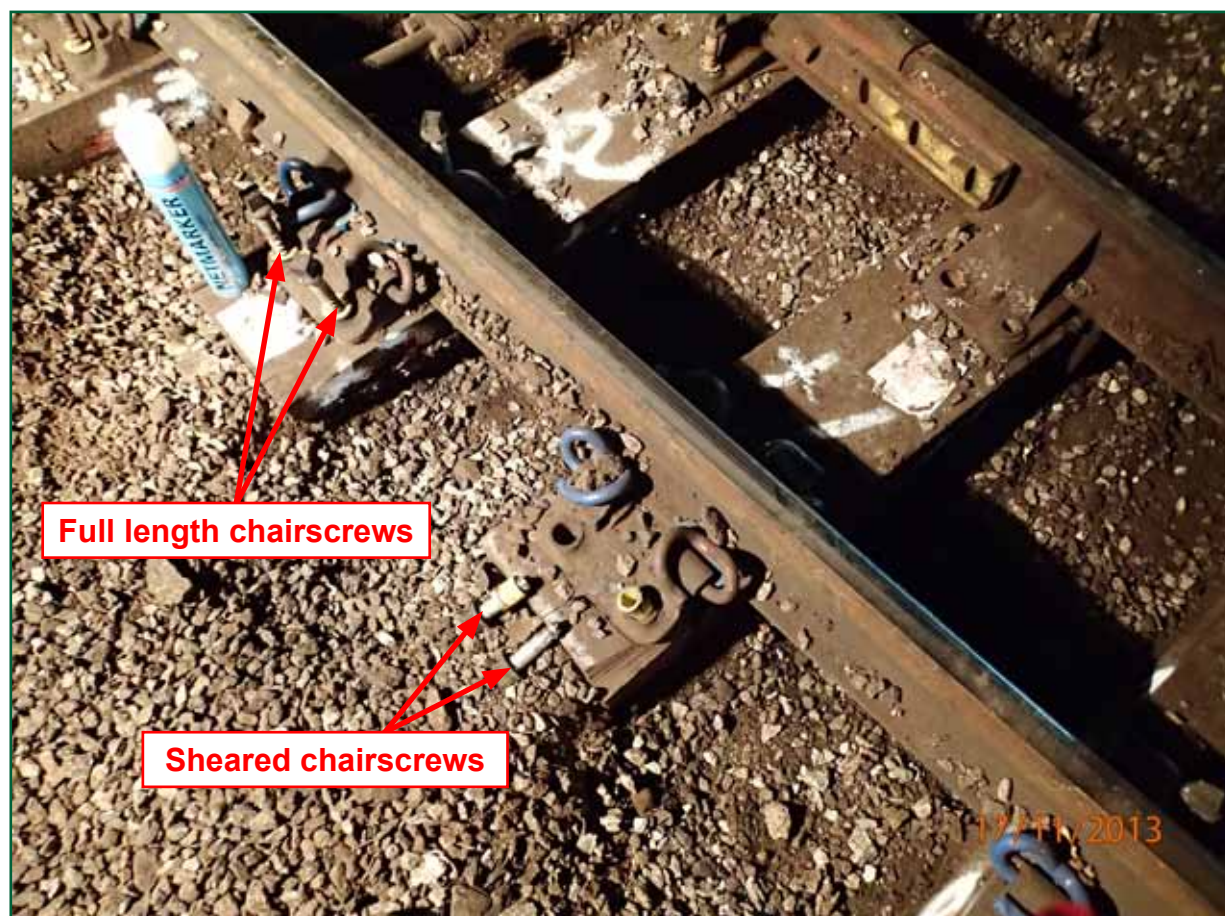
- 88 A sample of the sheared chairscrews were examined after the derailment and the fracture faces examined. The sample included a screw with a fully rust covered fracture surface, a screw with a clean fracture across the full width of the screw and a partially rusted screw with a remainder of the surface still shiny.

- 89 The fully rust covered fracture surface indicates there were screws which had fractured for some time before the derailment and remained in the baseplate as described in paragraph 87. The screws with a clean surface across the full width of the fracture face indicate the bolt had recently failed, possibly as a result of an overload as a consequence of the derailment. The part rusted fracture face indicates a crack which had formed in the screw allowing rust to penetrate, but which finally failed under load during the derailment.

Figure 19: Sheared & intact chairscrews

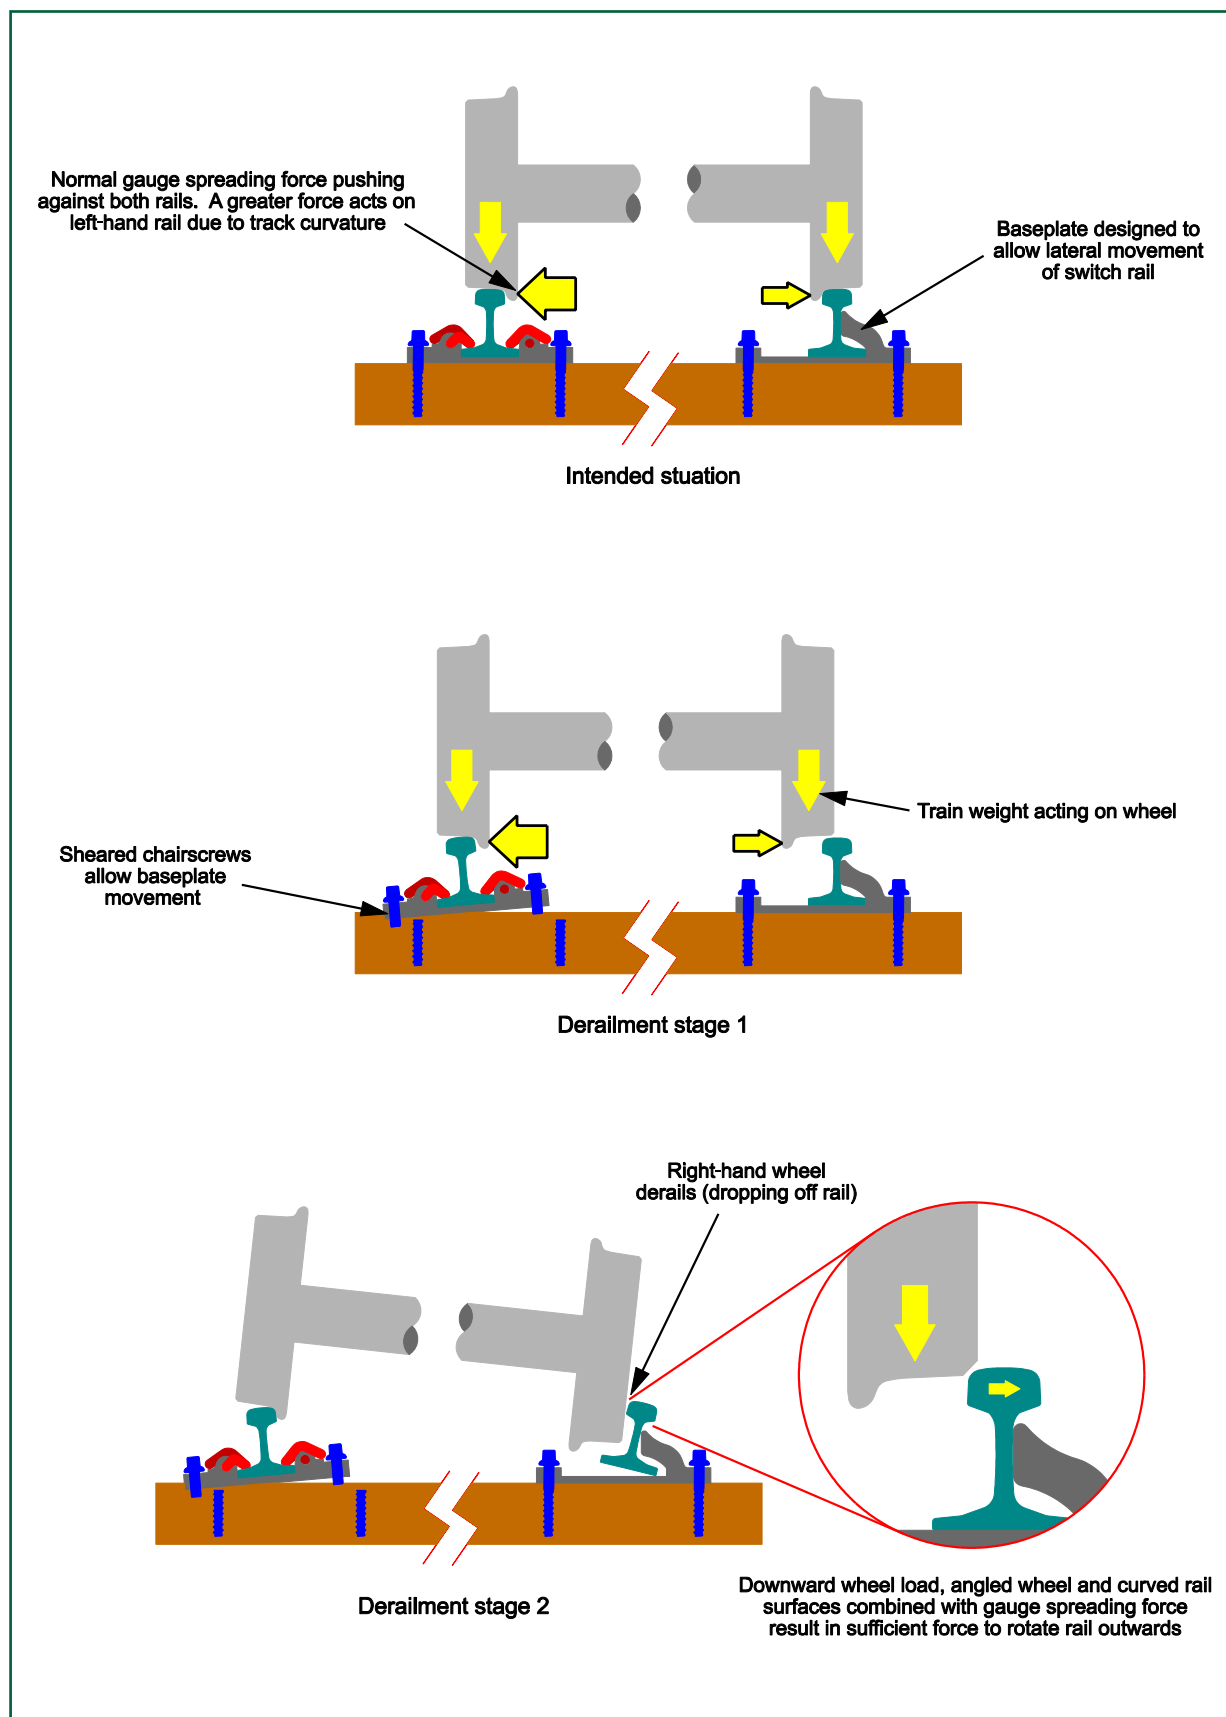
Figure 20: Derailment sequence

- 97 The right-hand switch rail is intended to move laterally according to the direction in which 2035B points are set (figure 7). The rail support system allowing this movement does not prevent the top of the right-hand rail moving outwards due to rotation at the foot of the rail. The right-hand rail is not normally subjected to sufficient gauge spreading force (paragraph 69) to cause movement of this type. However, in this instance, it is likely that the displaced position of the left-hand rail meant that the outer edges of the right-hand wheels were running on the inner edge of the switch rail. In this position, the downward load from the wheels, the angled shape of the wheels and the curved rail head combining with the gauge spreading force would result in the top of the switch rail being pushed outwards (figure 20, inset).

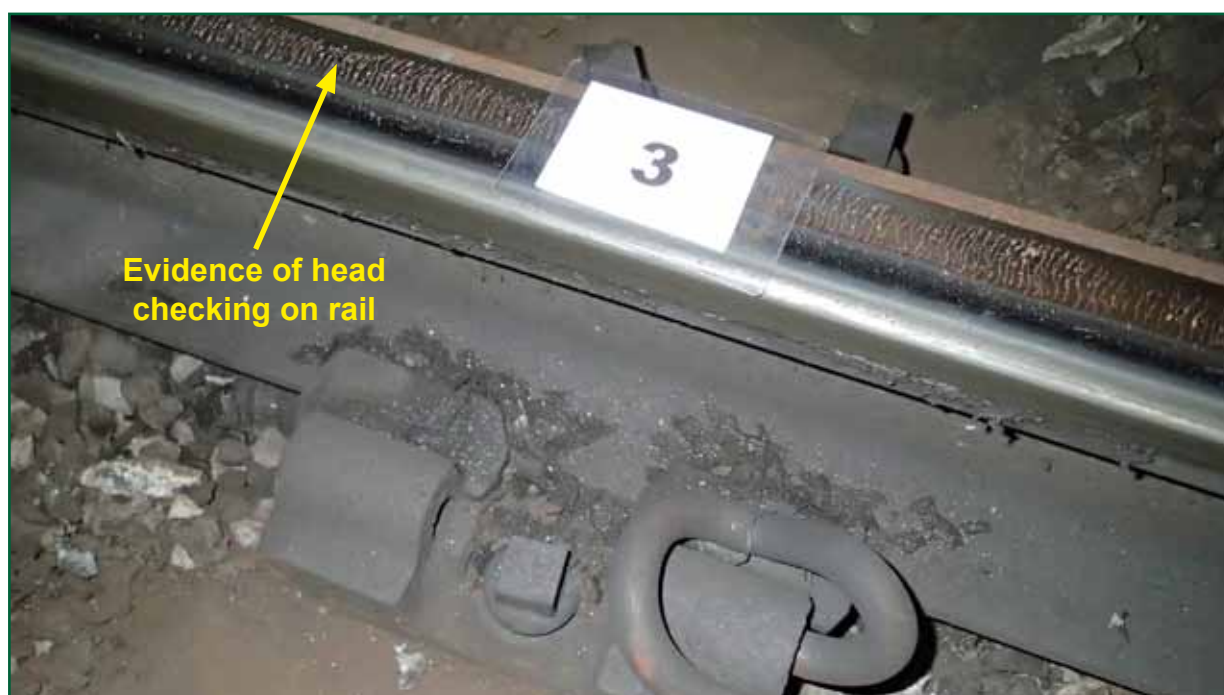
- 131 Irregularities and very small cracks in the surface of the rail head, known as *head checking*, were found during an examination by the RAIB in September 2013 (figure 22). Head checking was not seen immediately after the accident, but the surface had been smoothed by recent *rail head grinding*, a process intended to grind off the metal containing small cracks before these grow large enough to cause a broken rail.

- 132 Head checking is caused by the transfer of forces along the track at the wheel/rail interface and is commonly found in terminal stations as a result of traction and braking forces acting longitudinally along the rail. Head checking can also occur on the rail head of tight radius curves at other locations, due to wheels slipping on the rail head. This slipping happens because wheels on the inner and outer rails rotate together, but the distance travelled along the inner rail is less than that along the outer rail. The RAIB made enquiries with other Network Rail engineers who stated that they would not enhance the inspection regime due to head checking alone, but would consider doing so if there were also other indicators of high lateral forces such as shuffle or broken fastenings.

Figure 22: Head checking found on the running rail ten months after the derailment
