Rail Accident Report

**Fatal accident at Morden Hall Park footpath
crossing
13 September 2008**

Fatal accident at Morden Hall Park footpath crossing, 13 September 2008

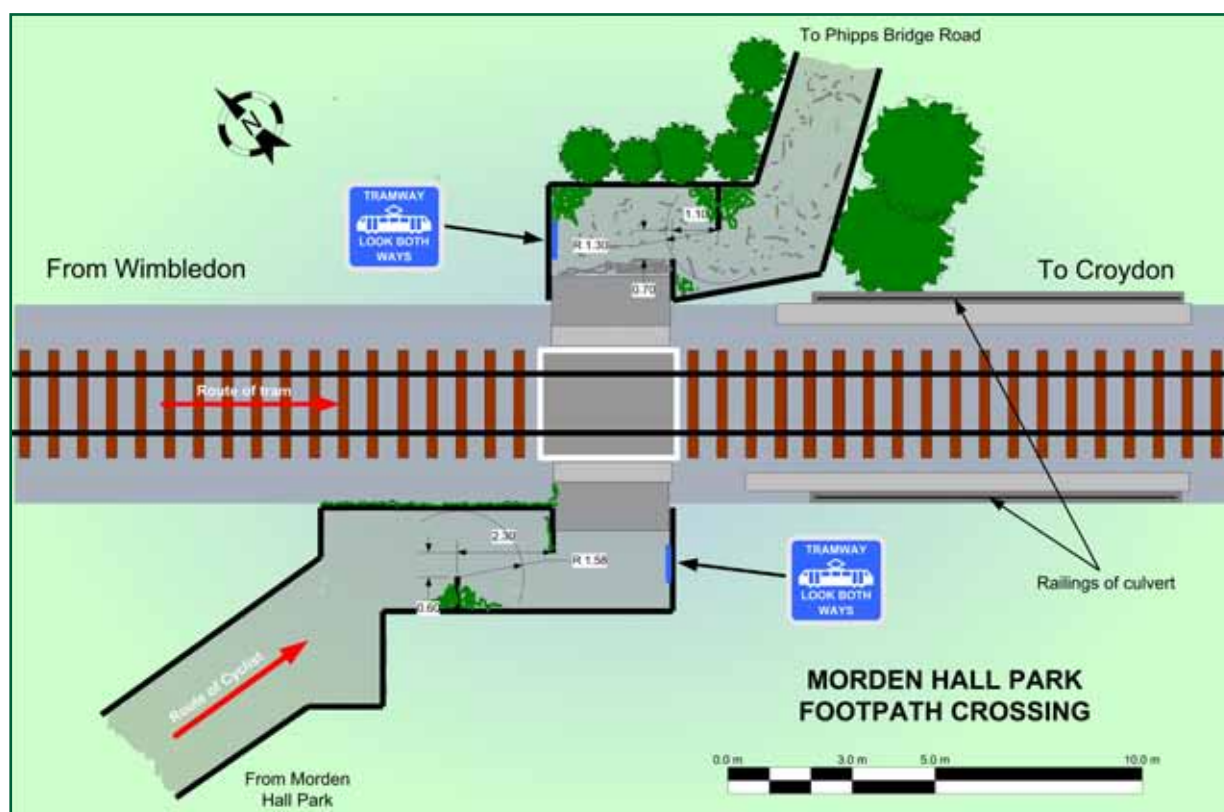
Figure 2: Layout of foot crossing

- 18 The crossing is approached through *chicanes* on both sides, constructed of wooden post and rail fencing about 1.25 m high. The chicanes on each side have quite different dimensions, but a common factor is that the barriers which form the chicanes do not overlap, but have a clear gap 0.6 m - 0.7 m wide between them, which gives a clear path width of at least 1.3 m through the chicane (Figure 2).

- 52 Mr Sivalingam cycled towards the crossing with his back to the tram. The design of the chicane at the crossing made him slow down, but did not cause him to stop or dismount. After passing through the chicane, he turned left to cross over the track, but he did not complete the turn (so that he was at right angles to the track), until he reached the centre of the track. The design of the chicane and crossing permitted him to approach the tramway without turning to be at right angles to the track, and hence he remained with his back to the approaching tram. If he had turned and seen the tram before moving onto the crossing, he would probably have been able to stop clear of the track.
- 53 RSPG Part 2G provides guidance on the design of intersections between the tramway and roads and footpaths.
- 54 In particular, paragraph 56 of RSPG Section 2G said:

‘Fencing or pedestrian guard rails should be provided where necessary to guide pedestrians to face oncoming trams before they cross the track.’
- 55 The chicanes at Morden Hall Park crossing were not effective in this respect because the distance between the chicane barriers and their orientation at right angles to the track, combined with the very short final approach to the crossing, did not force users, both on foot and on bicycles, to turn fully towards the tramway when passing through the chicane and before turning onto the track. This was a causal factor in the accident.

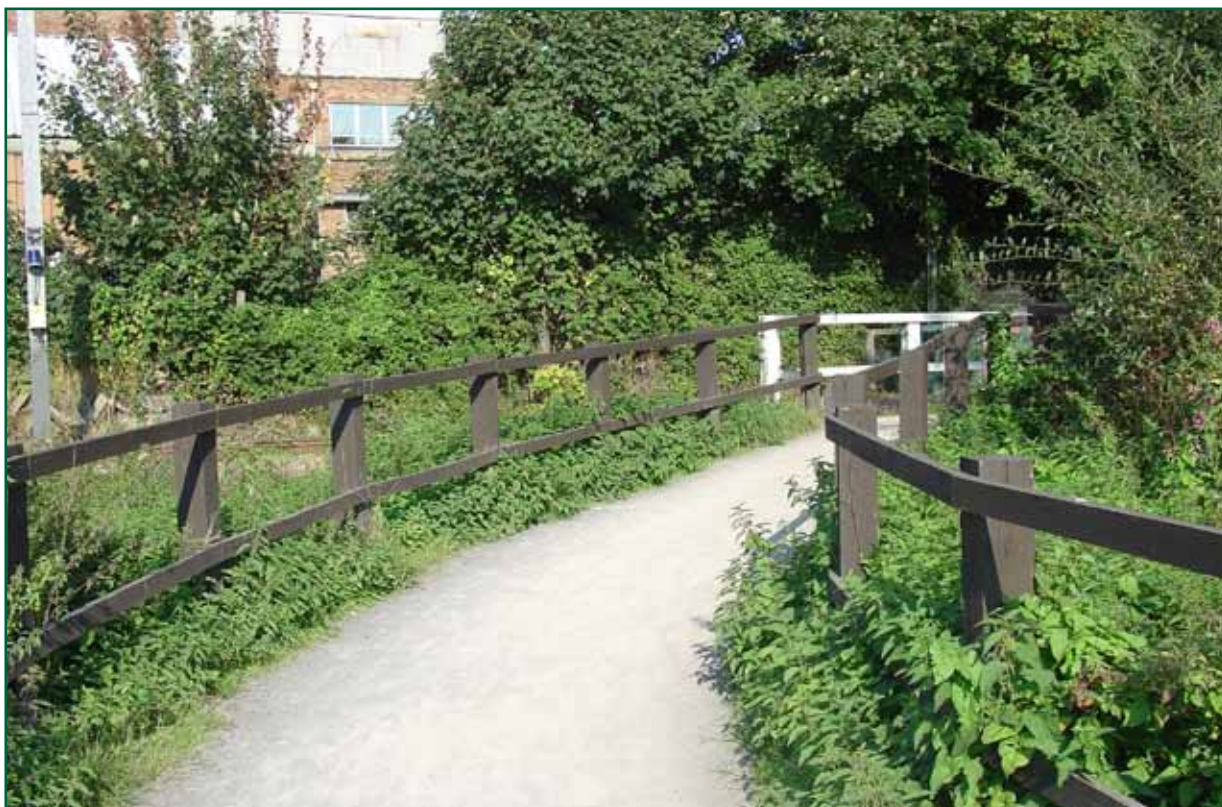
Figure 3: Approach to crossing from south-west

- 19 The approach to the crossing from the south-west is along a fenced, curving path 2.6 m wide (Figure 3). Before 2006, this approach was by a narrower path which ran directly towards the tramway at right angles to the track. In the winter of 2005/06 the layout of the approach paths was altered as part of a project to re-route the Wandle Trail around the edge of the wetlands which are an important feature of the park (Figure 4). The re-routed path curves round to approach the tramway at an angle of about 40°, and then bends sharply to enter the chicane, which is parallel to the tramway. Visibility along the tramway in both directions is unobstructed for several hundred metres in both directions from the point when a potential user reaches the centre of the chicanes (Figures 5 and 6).

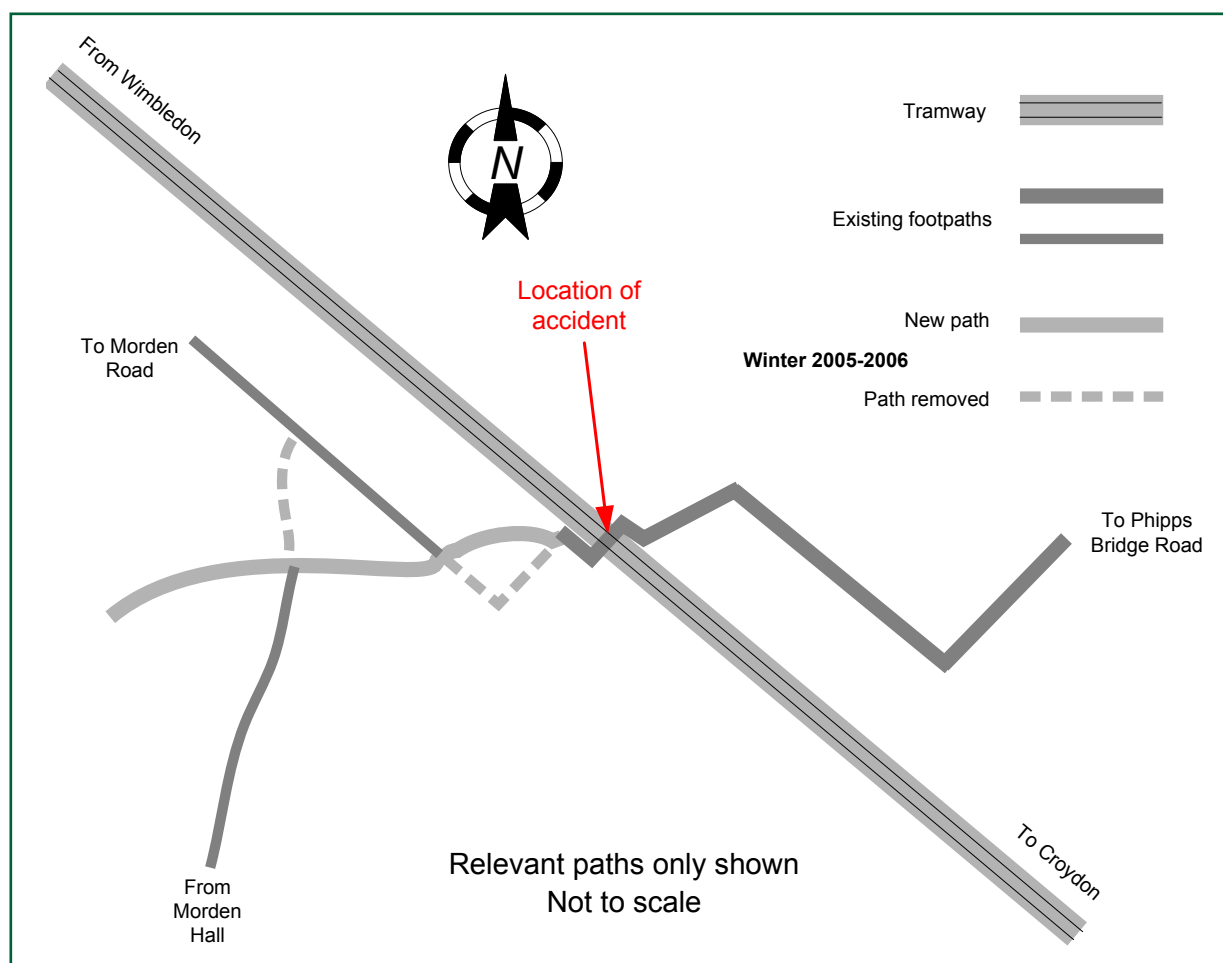
Figure 4: Footpaths near tramway crossing

- 60 The layout of the path on the south-west side of the crossing was altered over the winter of 2005-06 (paragraph 19 and Figure 4). As originally installed, the path approached the crossing at right angles, giving a user the opportunity to look both ways before turning right to pass through the chicane. The revised layout turns the user to the right gradually as they approach the crossing. This means that as they enter the chicane cyclists and pedestrians have their back to trams approaching from the Wimbledon direction, making it less likely that such people will become aware of trams unless they deliberately turn to look.

- 62 There was consultation between SWELTRAC, the National Trust and TCL before the work was done, but there is no evidence that the risk associated with the revised layout was identified by TCL. The change to the layout was a possible contributory factor in the accident.

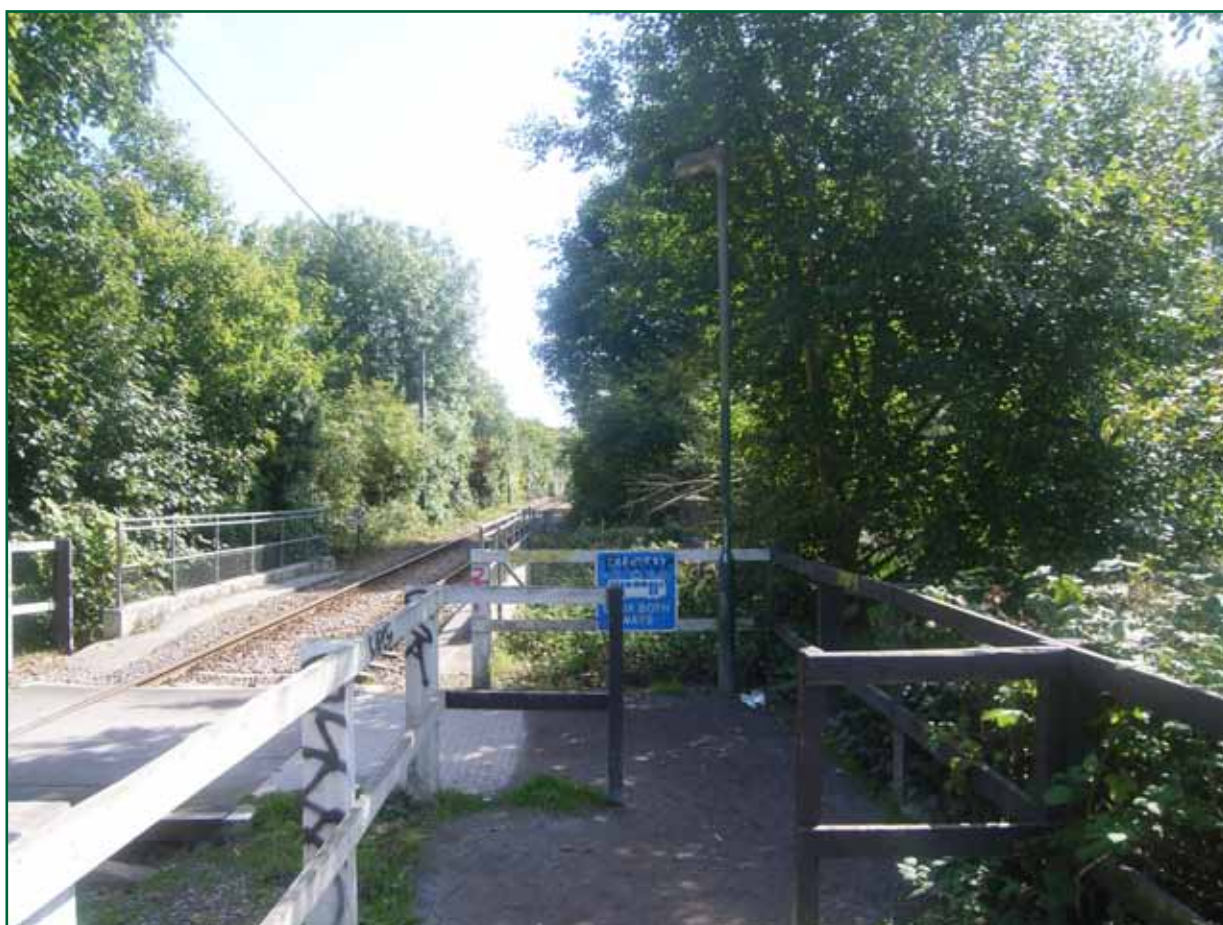
Figure 6: View towards Phipps Bridge, south-east from crossing

- 20 There are blue signs 0.7 m square showing a pictogram of a tram and the wording '**TRAMWAY – LOOK BOTH WAYS**' (diagram 963.3 of the Traffic Signs Regulations and General Directions 2002), fixed to the fencing at waist level, facing users coming through the chicanes, on both sides of the crossing (Figures 2 and 6).

- 58 The sign warning of the tramway was slightly obscured by graffiti (Figure 6). Mr Sivalingam was a local resident who is known to have been familiar with the crossing, and the condition of the sign and its position (paragraph 20) are not considered to have contributed to the accident.

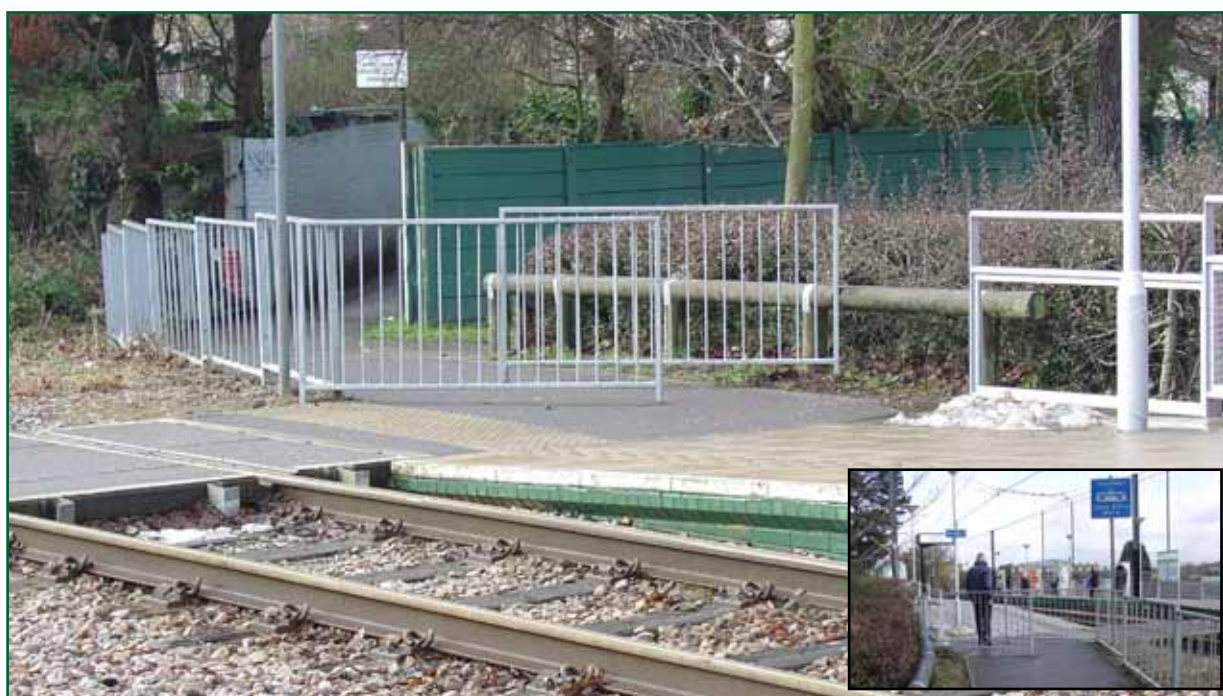
Figure 7: Chicane installed at Arena tram stop

- 70 An accident occurred at Arena tram stop on 23 August 2007 in which a pedestrian was struck by a tram. The pedestrian had run towards the tram stop along a path almost parallel to the tramway, and was concentrating on a westbound tram which he could see approaching and which he wished to catch. He did not notice an eastbound tram which was approaching from behind him, crossed the line just in front of it, and was struck and became trapped under the tram, but suffered only minor injuries.
- 71 Following this accident, additional fences were installed to form a chicane in the approach path at Arena (Figure 7). The design of these forces pedestrians and cyclists approaching along the path, who wish to cross the line, to turn to the right as they move onto the crossing. This makes it more likely that they will notice a tram coming from their right.

- 72 If the risks at other crossings on the network (including Morden Hall Park) had been considered at the time the chicane was introduced at Arena, and appropriate action taken, the risk of an accident might have been reduced. However, given the absence of any previous accidents at this location, it is possible that an assessment of this crossing would not have given a high priority to changes to the design of the chicane. The absence of an adequate risk assessment for the use of footpath crossings was a contributory factor in the accident.

- 74 These considerations mean that chicane barriers with the dimensions of those at Arena are unlikely to be suitable for use on the designated cycle track at Morden Hall Park. However, a design along similar lines, which would have the effect of turning a cyclist to face towards Wimbledon during their approach, might reduce the risk at this crossing.
