DUTCH
SAFETY BOARD

Risk management for the transport of dangerous goods by rail

Train collision Tilburg

6 March 2015

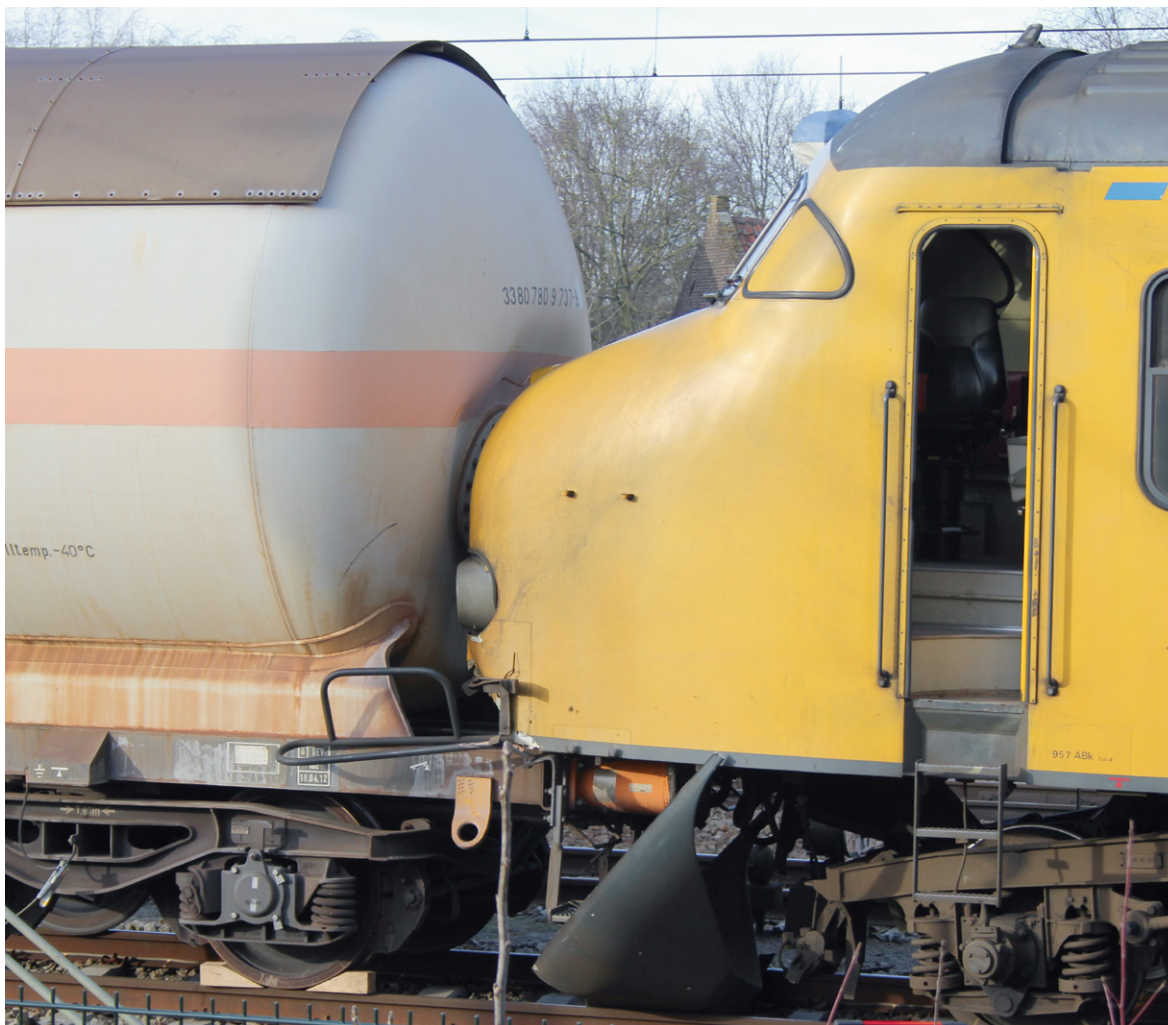
- The first contact occurred between the automatic coupler on the front of the passenger train and the coupling hook on the back of the under frame of the rearmost wagon (a tank wagon) of the freight train.
- After the automatic coupler on the passenger train had been pushed backwards, the front of the passenger train collided with the buffers of the tank wagon. As a result of height differences, only the top section of the buffers was hit. As a consequence, the front of the passenger train rose up and over the buffers.
- The passenger train then continued to slip forwards, and the front of the passenger train collided with the rear wall of the tank (see figure 6).

Figure 6: The front of the passenger train rose up and over the crash buffers on the tank wagon, and ended up against the tank. (Photo: Dutch Safety Board)

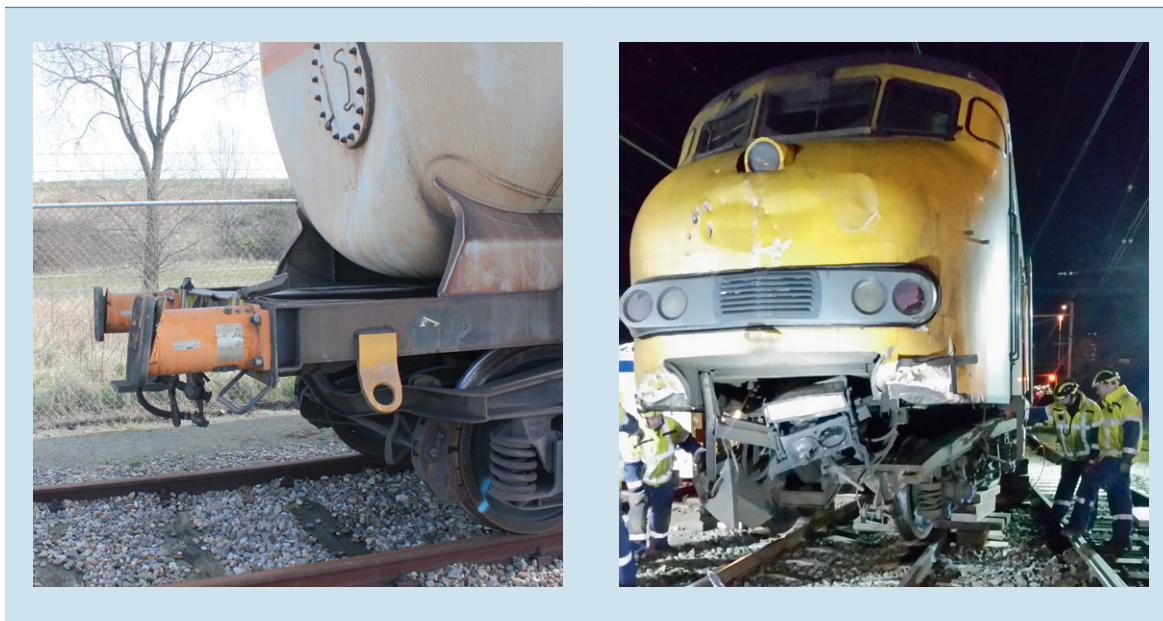
The collision caused damage to both trains (see figure 7). The front of the passenger train and the coupling components between the multiple units suffered damage. On the freight train, only the back end of the rearmost tank wagon suffered damage. This mainly involved the impression and minor deformation of the crash buffers,²² bending of the tow coupling and a dent in the rear wall of the tank.

Figure 7: The damage to the rear of the tank wagon (left) and the front of the passenger train (right). (Photos: left = Dutch Safety Board, right = fire brigade)

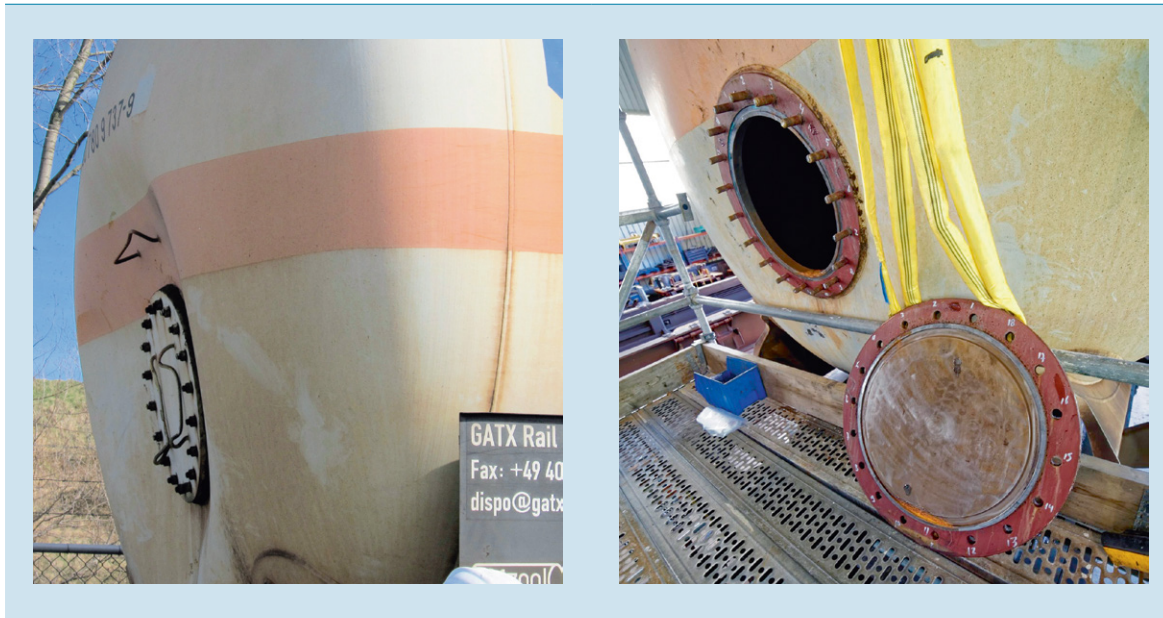
The technical inspection of the tank wagon (see appendix B2) showed that the leak occurred along the seal of the manhole cover.²⁵ The purpose of such manhole covers is

Figure 8: The manhole cover as fitted (left) and removed (right). (Photos: Dutch Safety Board)

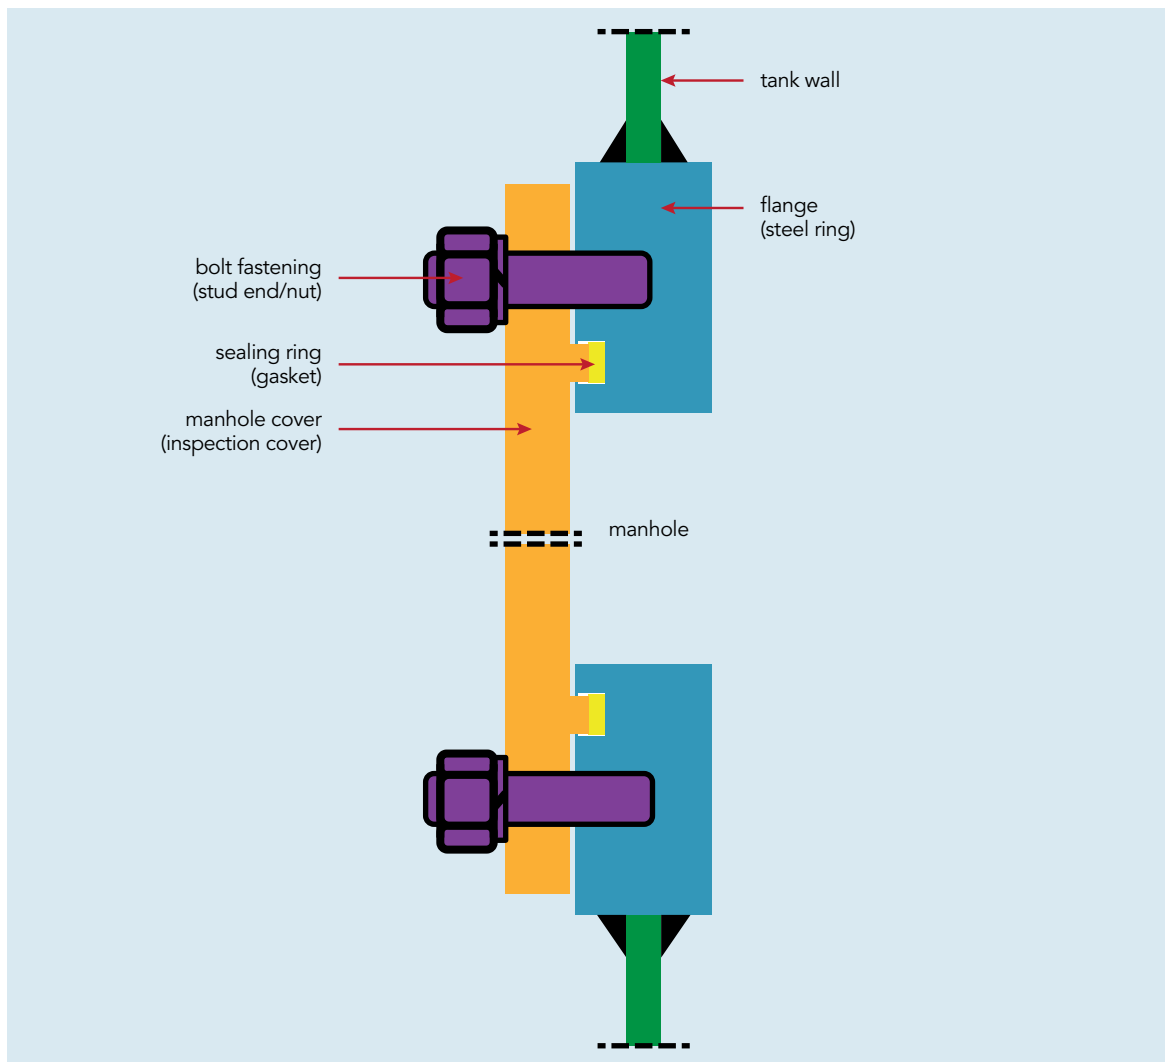
to allow entry to the tank during periodic inspection of the inside.²⁶ On tank wagons of this kind, the manhole cover consists of a thick round steel panel which is screwed against a ring-shaped steel flange, with bolt fastenings, and which is welded slightly below the centre in the end wall (see figure 8). The actual seal is achieved with a plastic sealing ring (gasket), which is clamped between the cover and the steel ring (see figure 9).

Figure 9: Cross-section of the manhole cover, diagrammatic representation.

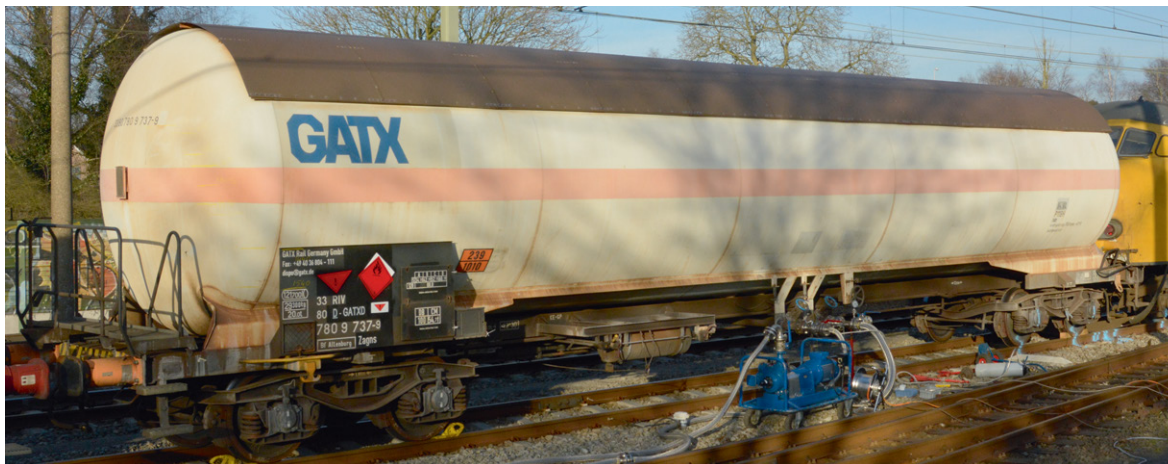
The leak was relatively small (drip level). Before towing away the tank wagon, the content was pumped into another tank wagon, using a mobile pump. It took approximately two days to remove the stock in question and to re-release the accident location for train traffic.

Figure 10: The damaged tank wagon was pumped empty with mobile pumps. (Photo: Dutch Safety Board)

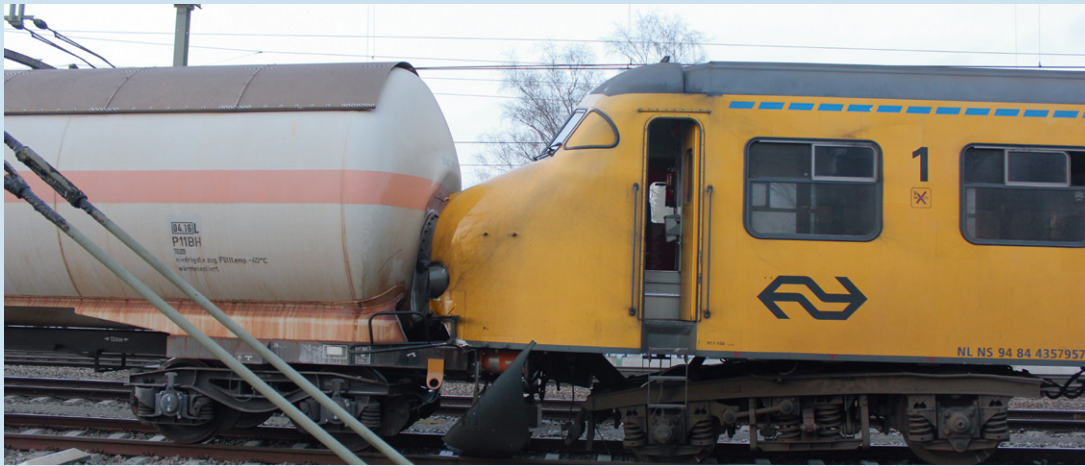
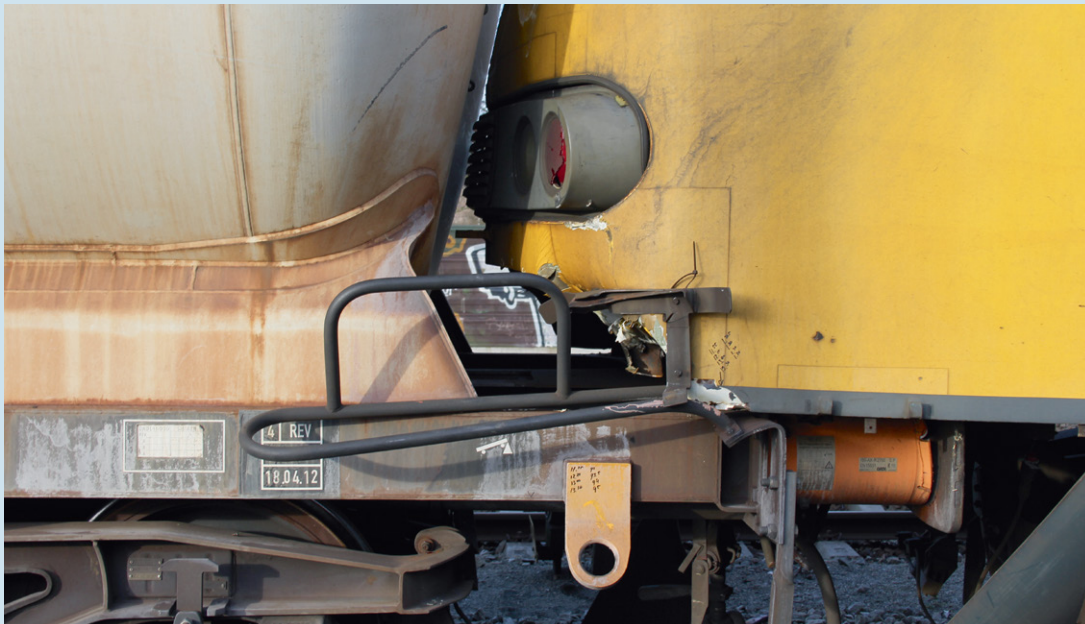
Figure 23: These photographs show that the nose of the passenger train had climbed up and over the buffers of the tank wagon, before colliding with the rear wall of the tank. (Photos: police)

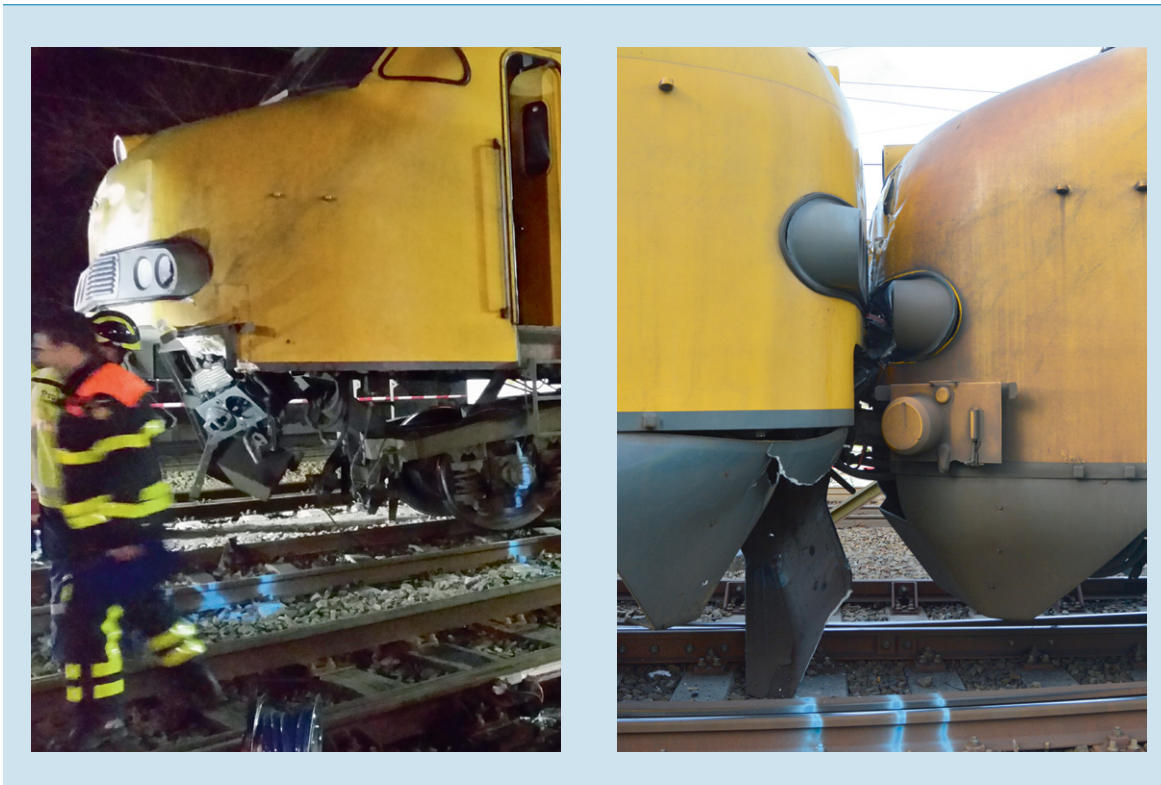
On the passenger train, most damage occurred at the front end of the front multiple unit, and the coupling between the two multiple units. The damage at the front end (see the left-hand photograph in figure 24) mainly affected the automatic coupler, the draw bar and its attachment. The damage to the midsection of the train (see right-hand photograph in figure 24) above all affected the coupling parts that joined the two multiple units together

Figure 24: These photographs show the damage to the passenger train. The left-hand photograph shows the front end of the front multiple unit, the right-hand photograph shows the connection between the two multiple units. (Photos: left = fire brigade, right = police)

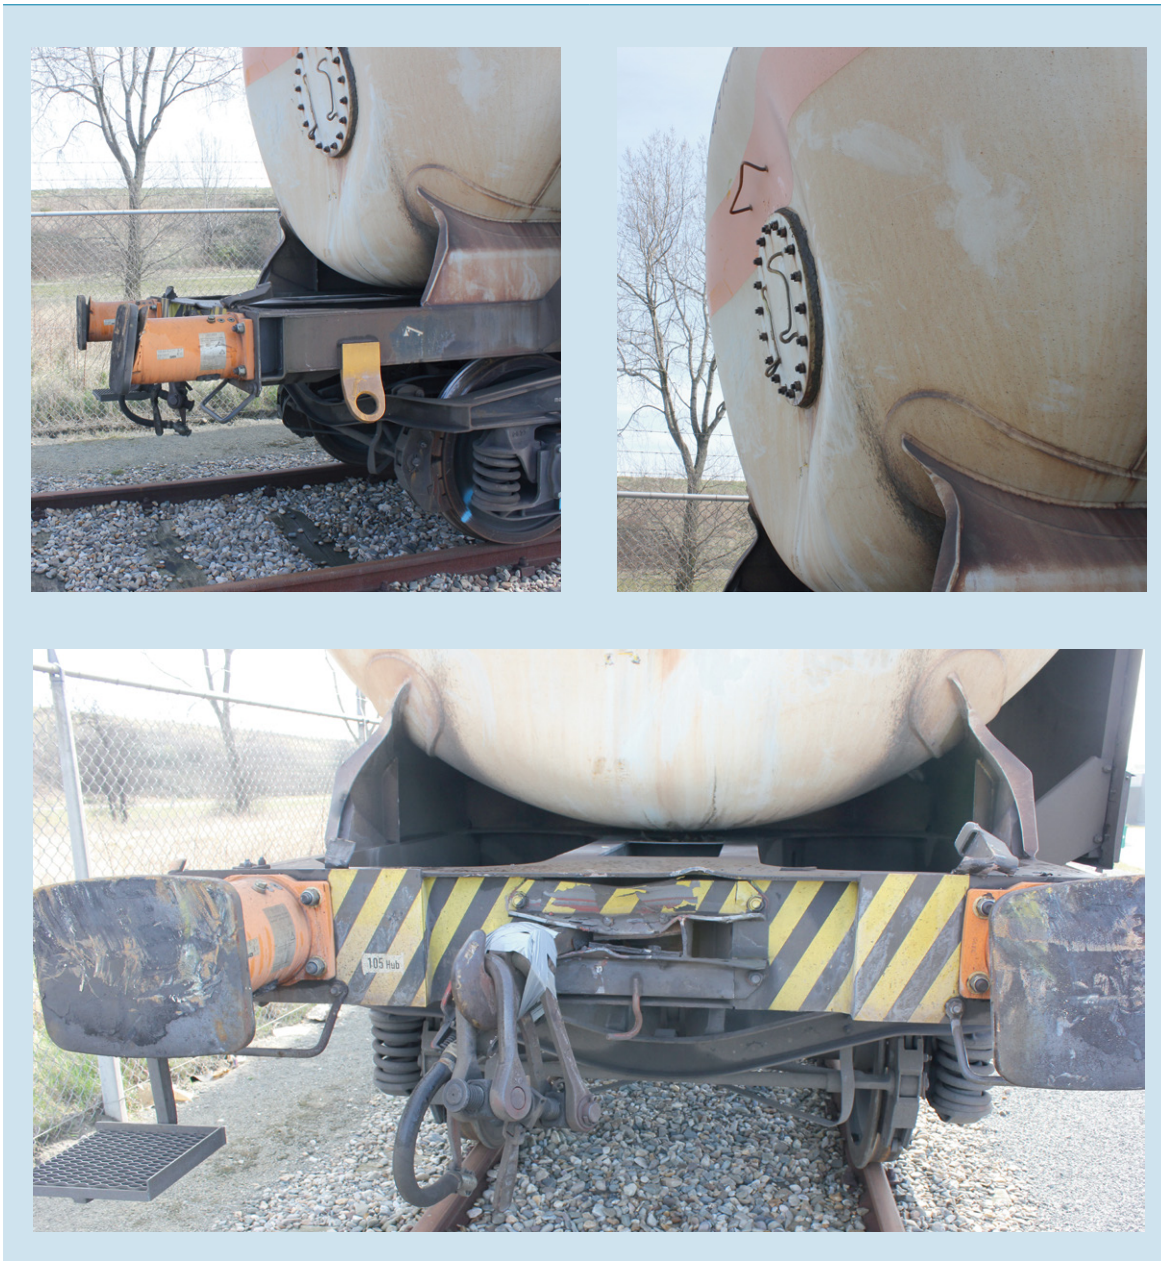
Figure 25: These photographs show the damage caused by the collision to (the back of) the rearmost tank wagon. (Photos: police)

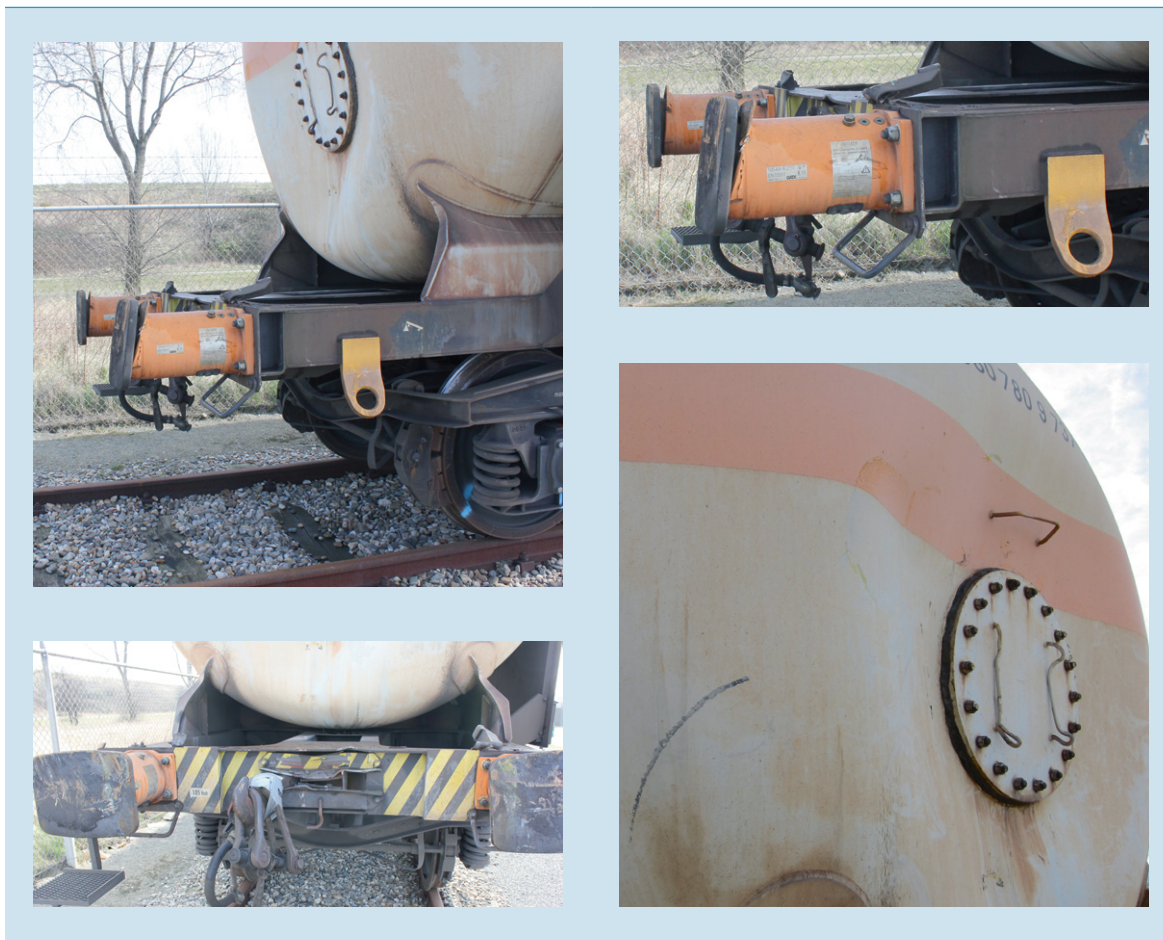
Figure 28: These photographs show the damage to the tank wagon. (Photos: Dutch Safety Board.)

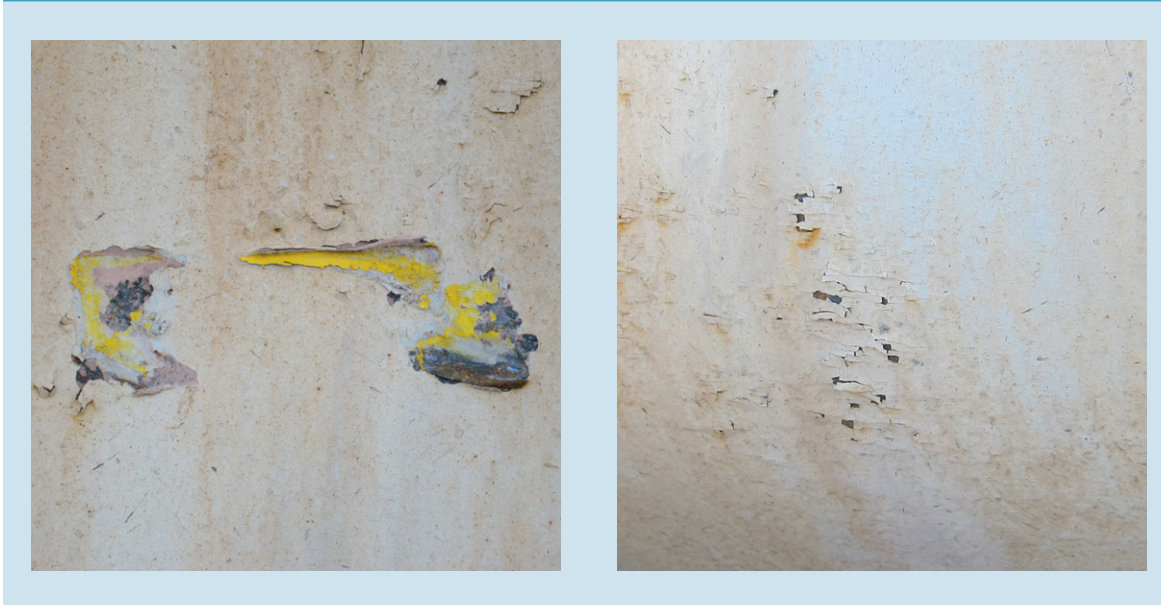
Figure 29: The left-hand photograph shows the mechanical damage observed below the manhole cover on the rear wall of the tank. The damage is the imprint of the draw eye on the front of the passenger train. The right-hand photograph shows local crackling of the paint layer on the tank. (Photos: Dutch Safety Board)

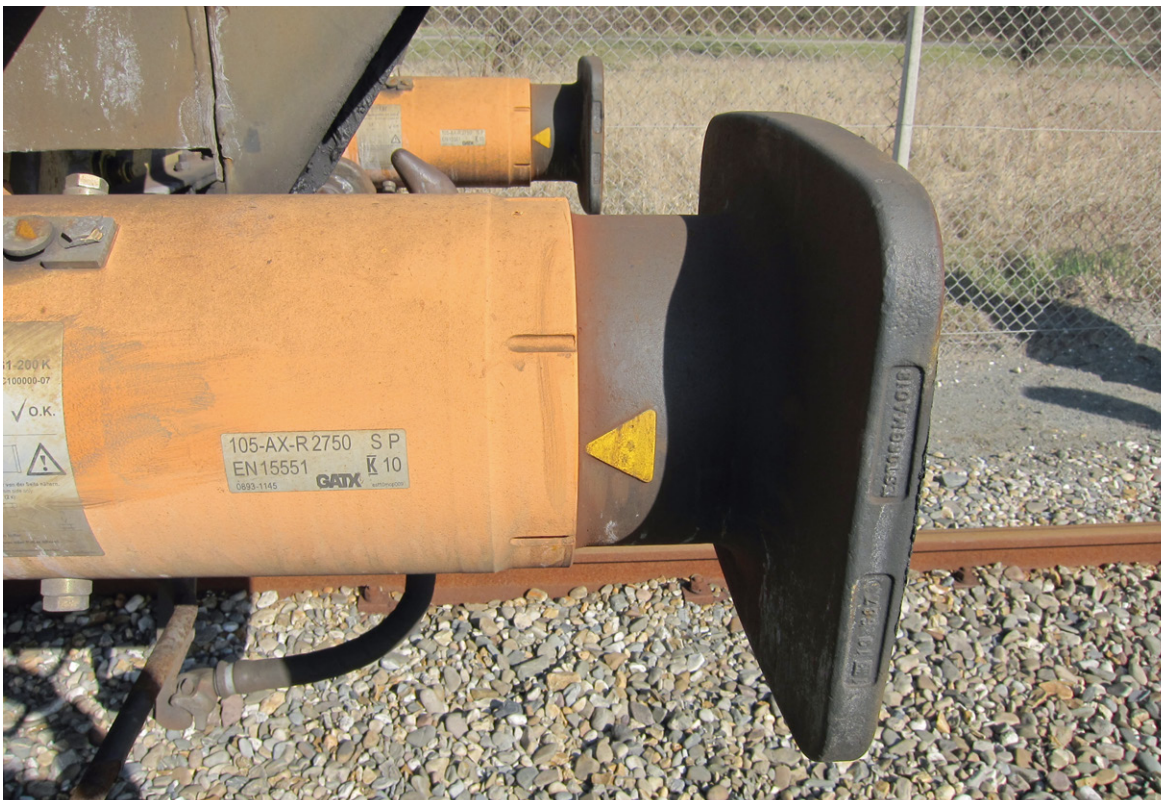
Figure 30: The crash buffers on the side of the tank wagon not run into showed no permanent deformation. (Photo: Dutch Safety Board)

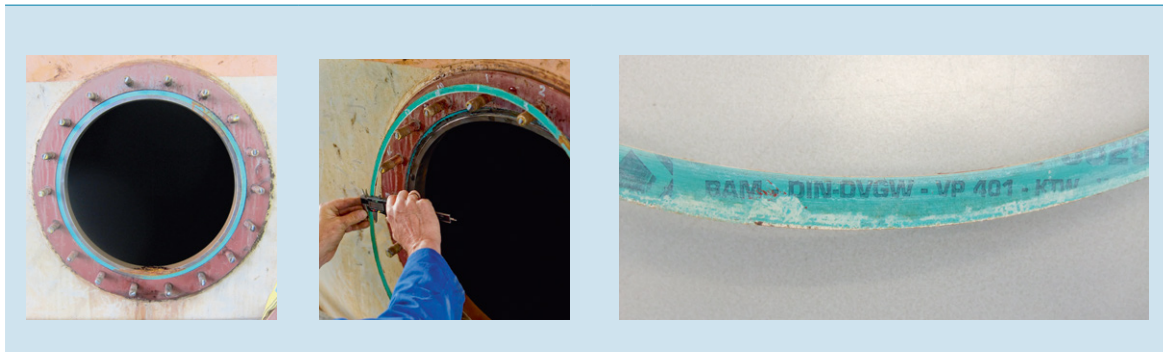
Figure 32: These photographs show the gasket. On the left-hand photograph the (green) gasket is still in the intended flange groove. On the right-hand photograph we see the markings. (Photos: Dutch Safety Board)

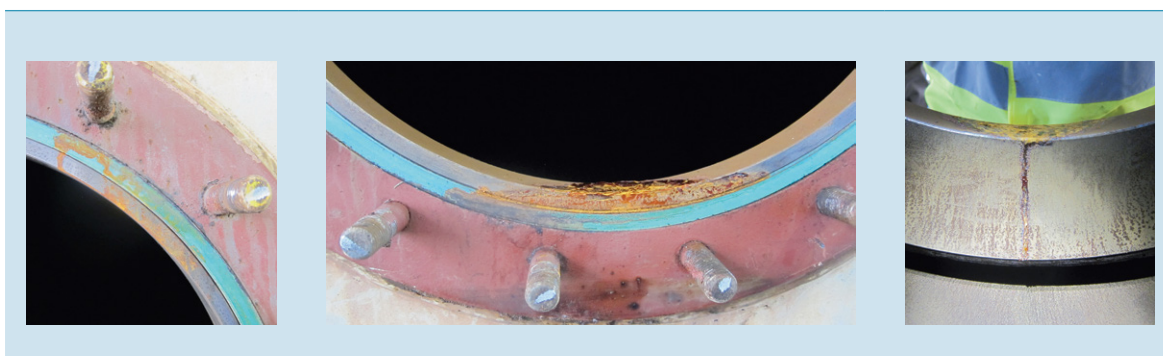
Figure 33: These photographs show the rust-coloured leak tracks, which became visible following removal of the manhole cover. The left-hand photograph and middle photograph show the outside of the flange (including gasket) while the right-hand photograph shows the inside (Photos: Dutch Safety Board)

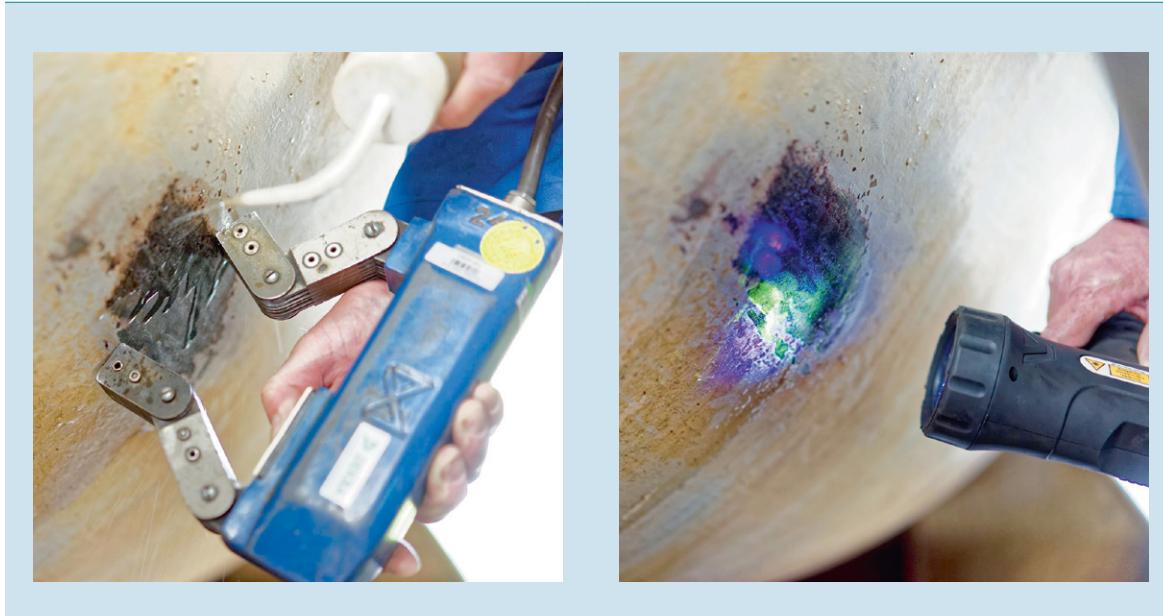
Figure 34: These photographs show the magnetic crack investigation, which was carried out at two locations on the rear wall of the tank. (Photos: Dutch Safety Board)

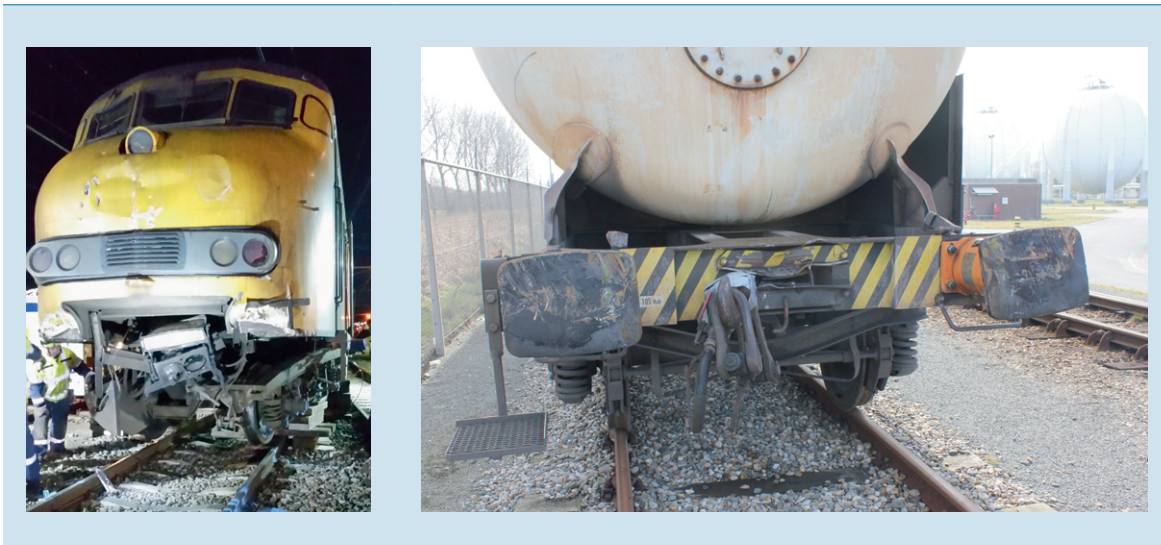
Figure 36: These photographs show the damage caused by the collision on the front of the passenger train (left) and the back of the tank wagon (right). On the front of the passenger train we see the impressions of the buffers and the manhole cover of the tank wagon; on the top section of the buffers of the tank wagon, we see an impression of the passenger train. (Photos: left = fire brigade, right = Dutch Safety Board)

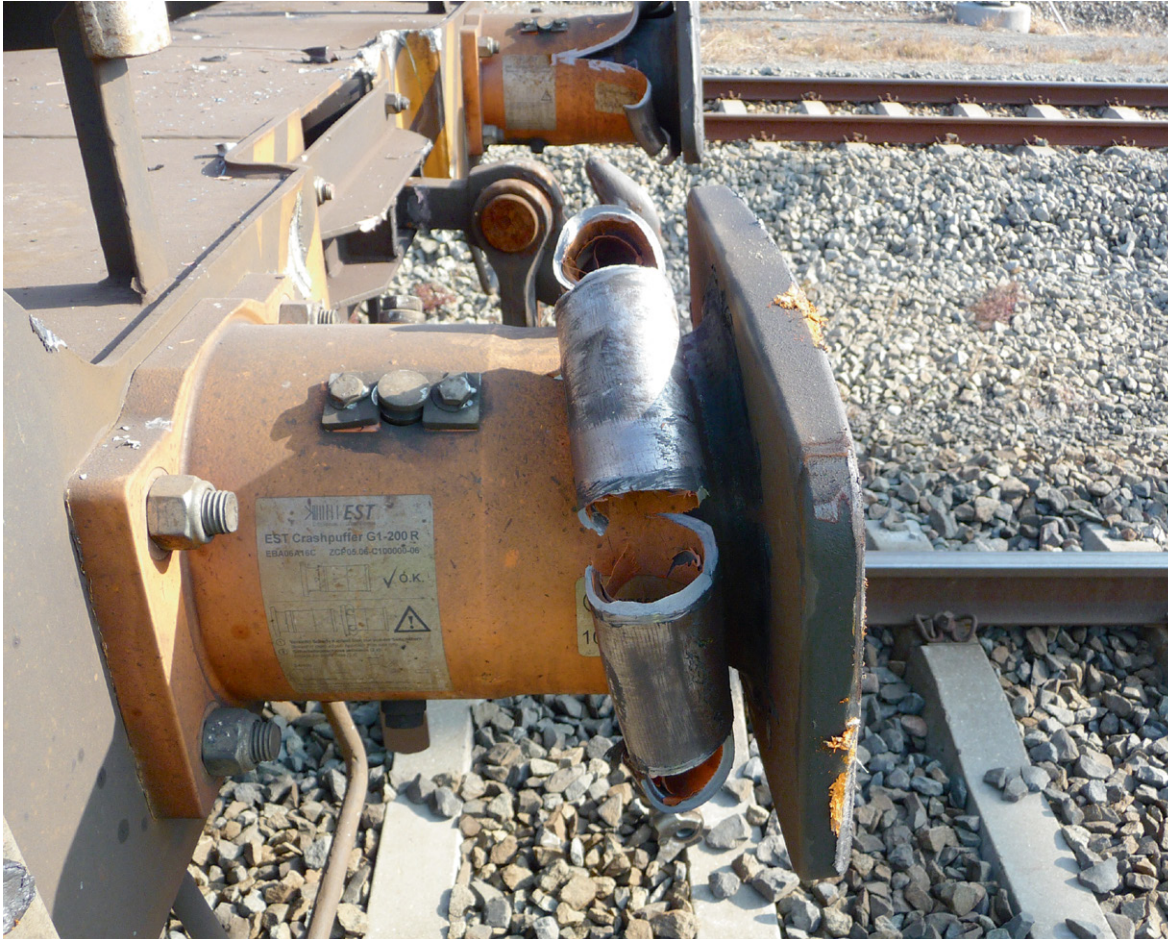
Figure 44: This photograph shows crash buffers with external absorption elements (the orange tubes) which as a result of a collision have torn and curled up, thereby absorbing energy. (Photo: Dutch Safety Board)

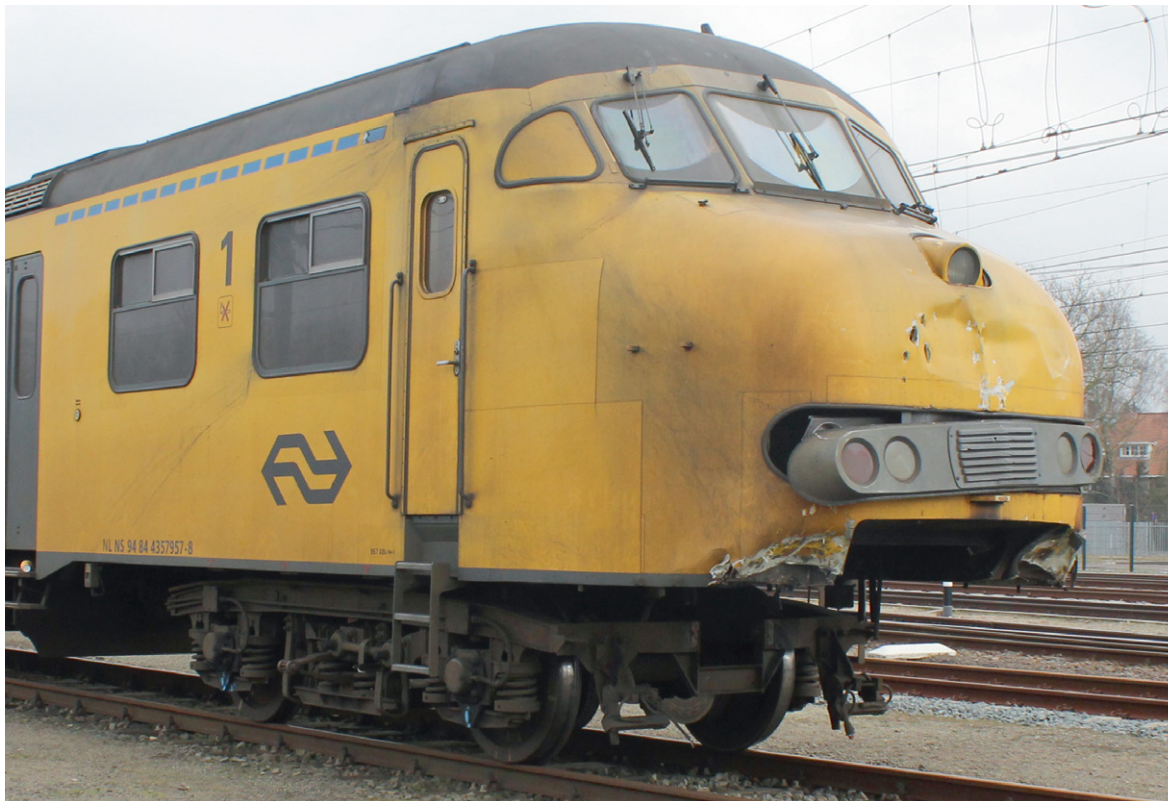
Figure 47: This photograph shows the damage to the front of the passenger train (Mat'64) involved in the accident in Tilburg. When the photograph was taken, the automatic coupler, which was seriously deformed, had already been removed. (Photo: police)
