# REPORT

JB 2019/04

## REPORT ON RUNAWAY WORK MACHINE AT ENSJØ METRO STATION, 7 JUNE 2018

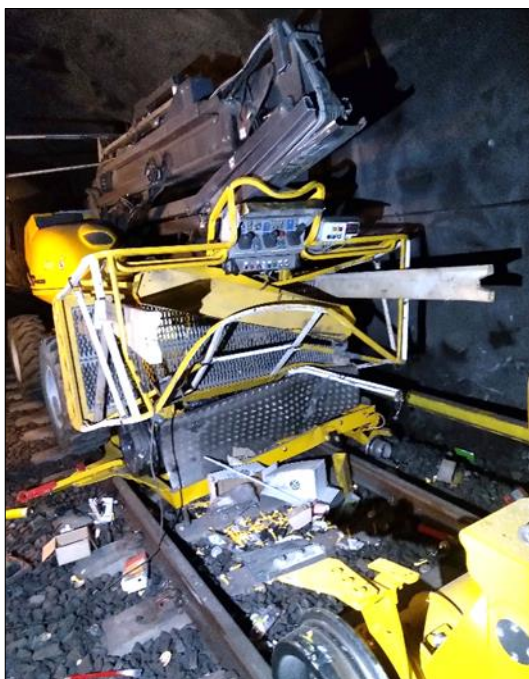
Figure 1: The MEWP after the collision. Photo: BMO Entreprenør AS

The personnel basket and boom were damaged; see figure 1. A trailer attached to another work machine was broken.

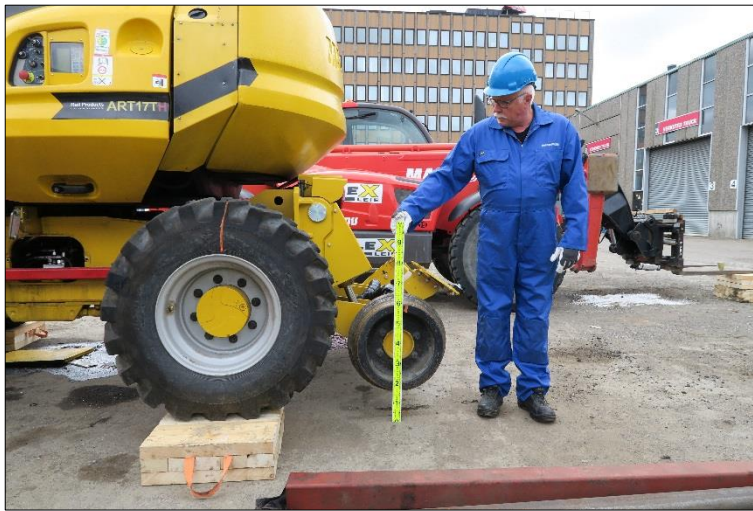
Figure 4: Test of the machine on 21 June 2018. Photo: AIBN

The conclusion from the test was that the parking brakes were released automatically on lowering or raising the rail wheels. The test also showed that if the emergency stop function was activated while lowering the rail wheels, the parking brake was engaged automatically. See Appendix A for more information about the tests.

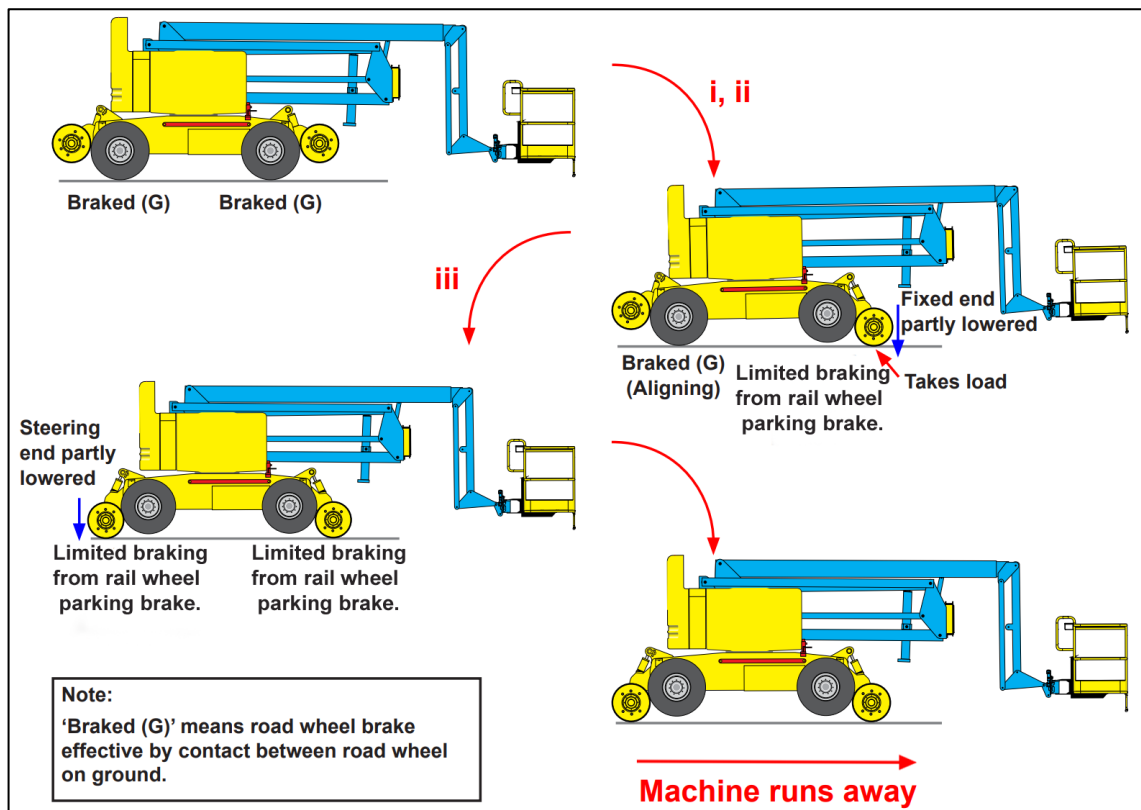
Figure 5: Illustration showing the on-tracking method that was tested. Source: RAIB, © Crown copyright 2019, modified by AIBN

The AIBN's investigation shows that on-tracking of the vehicle in the way it was done when the accident happened leads to deactivation of the parking brakes on both axles. This means that the vehicle can start to run away. For the parking brakes to be effective, one rail axle must be lowered first, before lowering the other in the same way. As the rail axle is lowered, the parking brake will be released so that the wheel can turn freely, to limit rail and wheel wear. The tests also showed that when the emergency stop button is activated with the rail axles in the 'mid' position, the parking brake is activated and braking is effective.

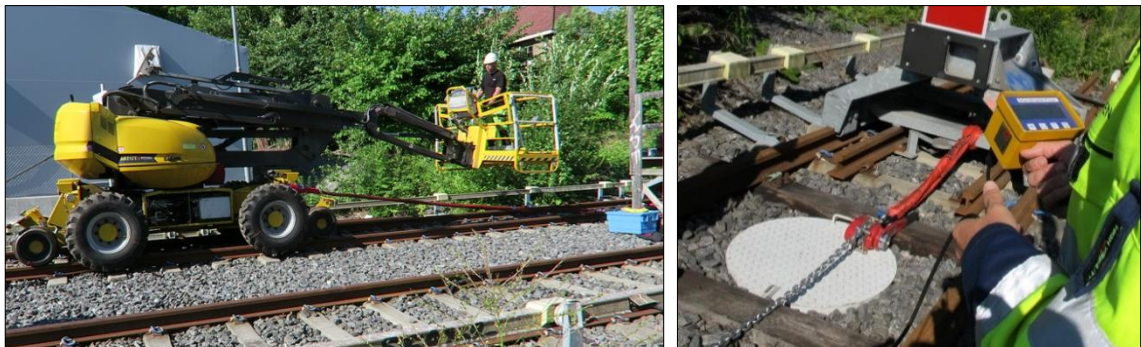
Figure 6: Test of the machine on 6 July 2018. Photo: AIBN

The test was carried out on Oslo Metro's dead-end track at Majorstuen. The MEWP that was involved in the accident was parked on the track for approximately 13 hours before the test was carried out, the same amount of time as the MEWP was parked before the accident. For the test, the machine was chained to an end stopper, a jack was used to tighten the chain and the force needed to move the machine was measured using a dynamometer. In addition, a work machine was used to pull the MEWP over a longer distance in order to test the emergency stop function at speed. See Appendix B for more details about the test.

(Appendix F) show that approximately 500 kg<sup>1</sup> braking power is required at a gradient of 40‰. In the test, the MEWP moved when it was pulled with a force of 300 kg. By adding the safety factor of 1.4 it is required that the machine has a braking force of 750 kg in a gradient of 40‰.
