# REPORT RAIL 2022/08

***Faulty interlocking system at Jar metro station on the Kolsås line, 27 November 2021***

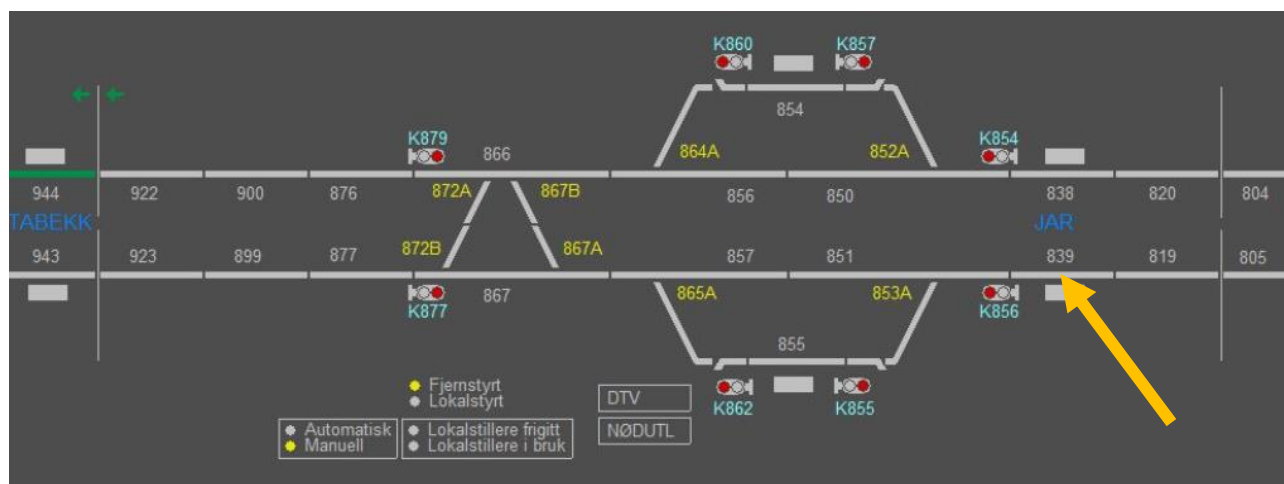
At 07:56 on Saturday 27 November 2021, Sporveien T-banen AS's traffic controller observed that train no 1316, an SL95 type tram, was presented in the traffic control system as being 'Lost at track'. The traffic controller completed the established troubleshooting procedures, and received confirmation that the subsequent train no 303, an MX metro train, was also presented as not occupying the track section. Track circuit 839 covers the track section along the platform for incoming metro trains at Jar station (Figure 1).

Figure 1: Schematic track diagram showing track sections at Jar station (the relevant track section is marked). Source: Sporveien T-banen AS

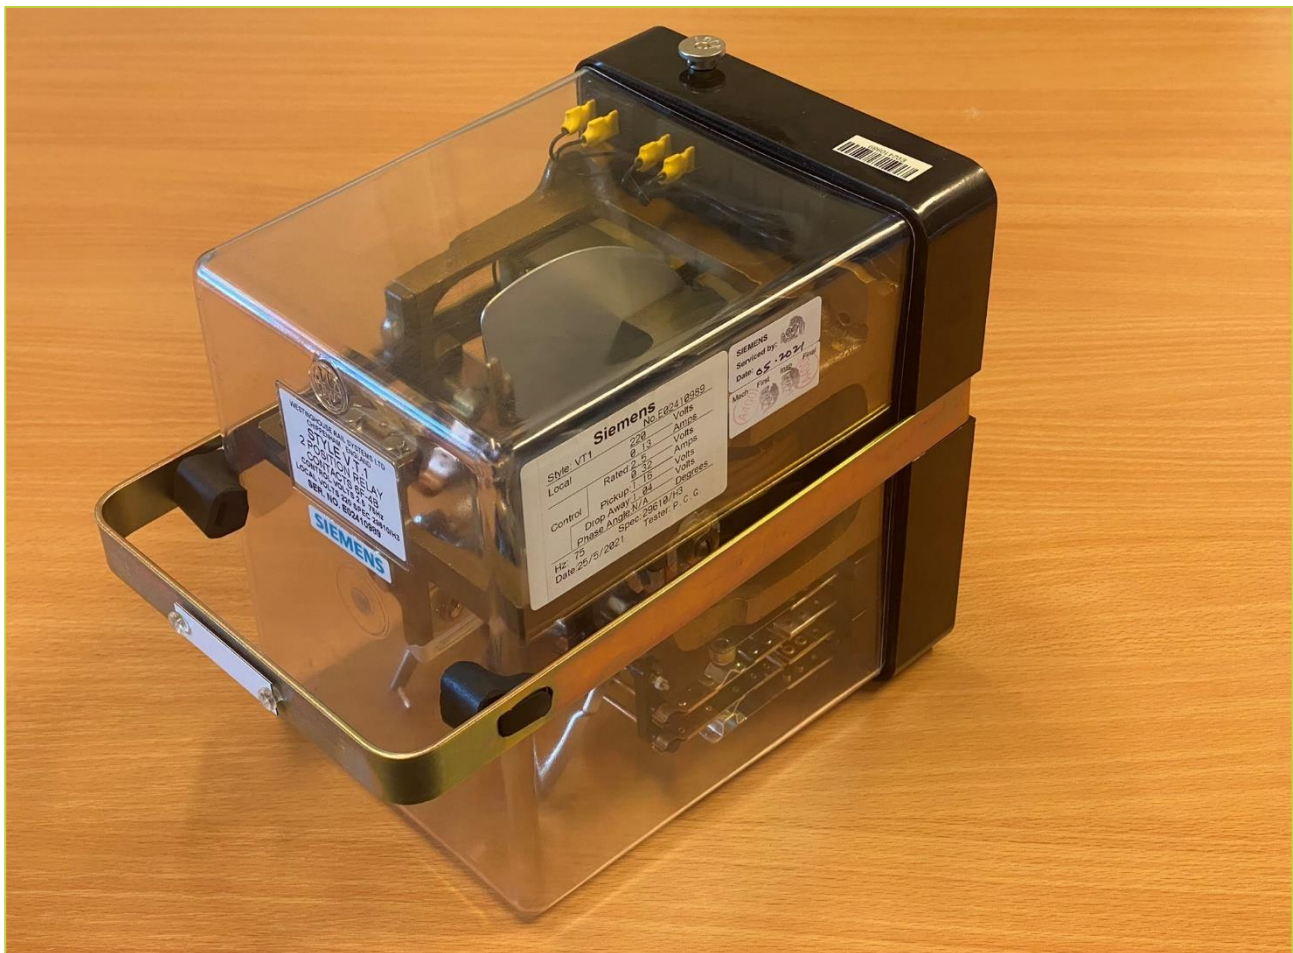
The relay involved in the incident at Jar was of the type Westinghouse Rail Systems Ltd Style VT1-6F-4B with serial number E02410989, manufactured by Siemens Mobility Ltd (Figure 2).

Figure 2: VT1-6F-4B relay. Photo: NSIA

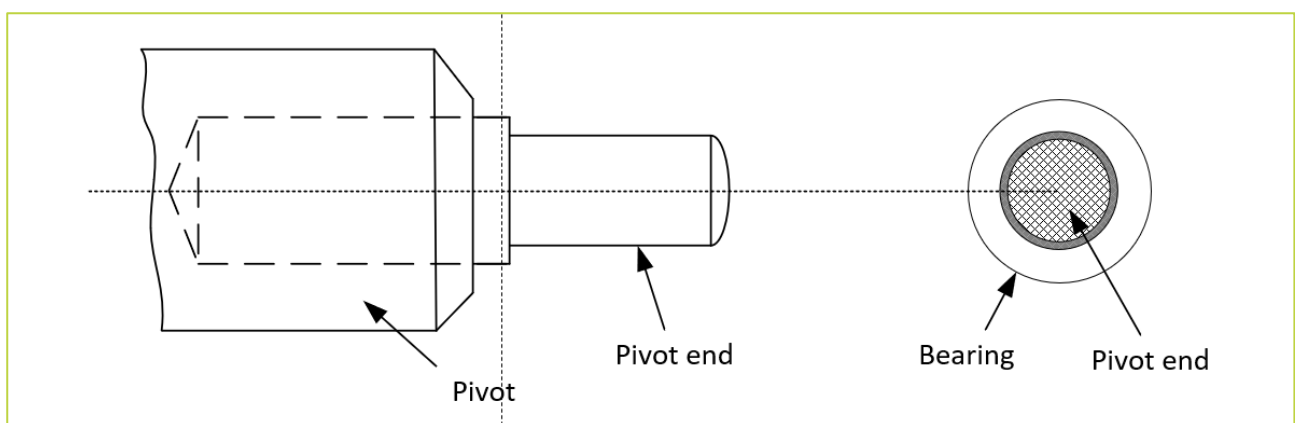
Figure 3: Schematic drawing of pivot and bearing. Illustration: NSIA

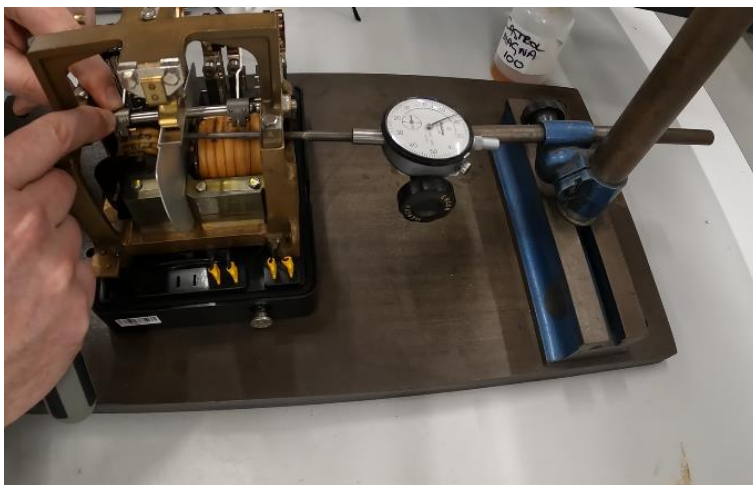
1. When the relay was checked in relation to the specifications for final testing and inspection, the vane was found to have been displaced laterally by 1/1,000 inch.
2. When the relay was disassembled, particles were found inside the vane bearings (Figure 6, Figure 8).

Figure 5: Measuring lateral vane clearance. Photo: NSIA

The NSIA found that the lateral vane displacement at the pivot was greater than the limit set for final testing and inspection. Nonetheless, the lateral displacement was not great enough to cause the aluminium plate to come into contact with the coils that drive the relay, and it can therefore not explain why the relay did not open.

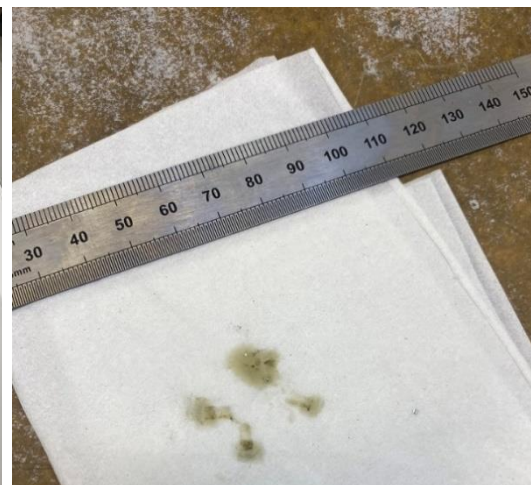
Figure 6: Wiped-off material from the vane. Photo: NSIA

Furthermore, metal fragments were found in the lube oil when the pivot ends were wiped clean. The fragments were of a brass alloy, the source of which was neither the pivot ends nor the bearing housing. During normal operation, the relay is not expected to produce shavings or fragments, and the horizontal position of the vane makes it highly unlikely that anything could fall, by force of gravity, into the clearance gap between the bearings and pivot ends. The NSIA therefore considers it probable that the fragments entered the bearings when the relay unit was

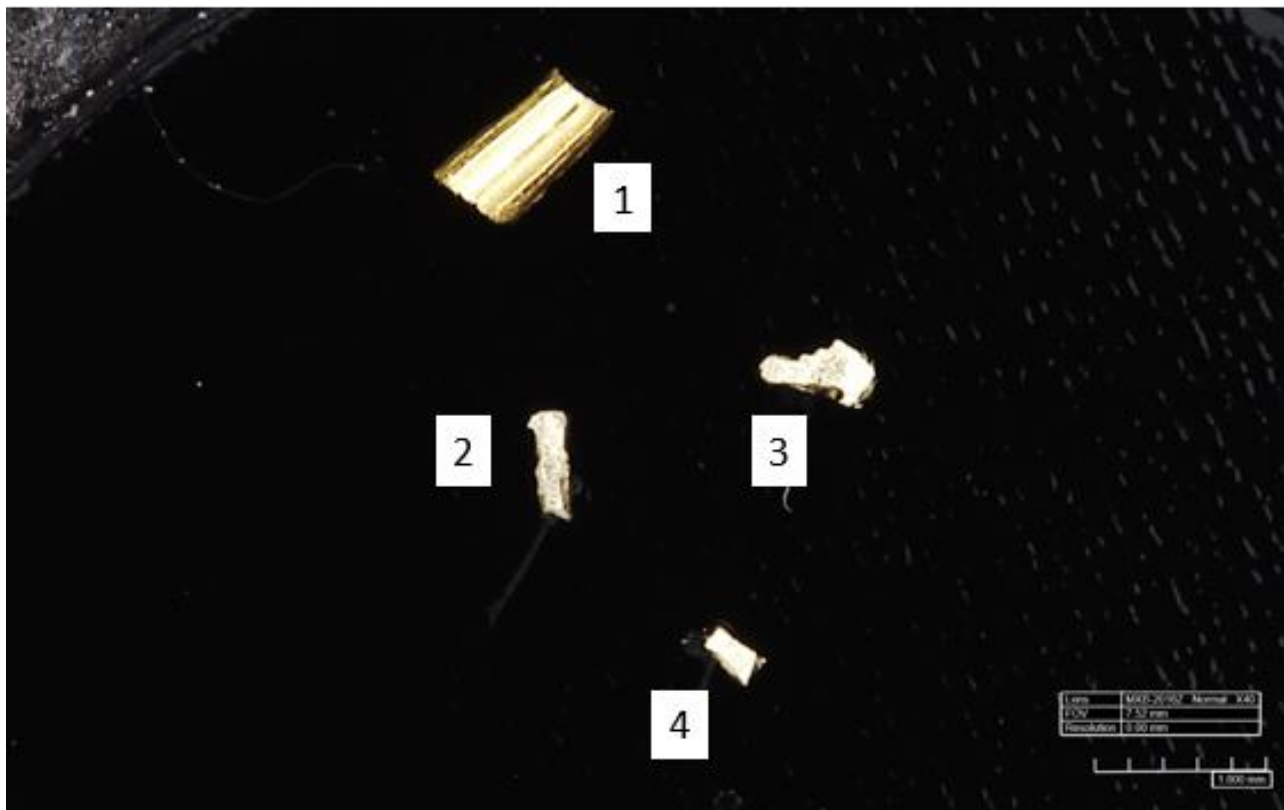
Given that the bearings were found to contain fragments, the NSIA requested further examinations of the fragments by the Norwegian Armed Forces Laboratory Services. These examinations enabled documentation of fragment sizes and alloys. The particles were described as consisting of a brass alloy, using energy-dispersive X-ray spectroscopy (EDS). The NSIA did not observe any wear on the pivot ends or bearings that could explain the fragments.

Figure 9: Overview of the fragments found on the pivot ends. Fragment sizes are stated in Table 4.  
Photo: FOLAT

| Fragments found in the bearings, ref. Figure 9 | Width (imp) | Length (imp) |

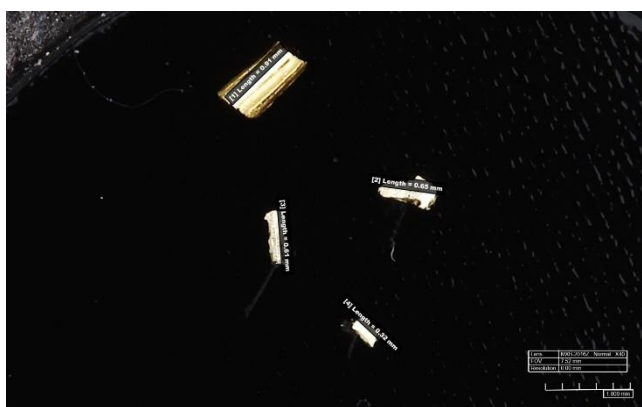
Figure 10: Fragments marked with length.  
Photo: FOLAT

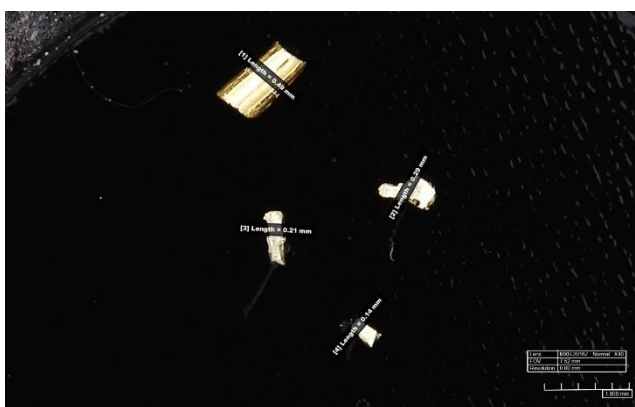
Figure 11: Fragments marked with width.  
Photo: FOLAT

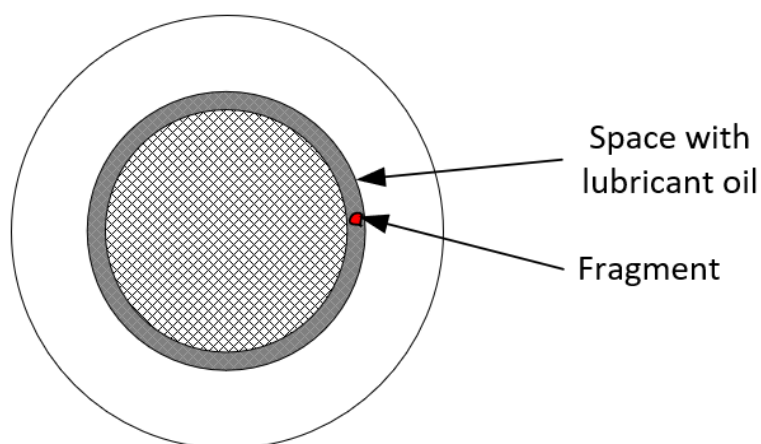
When compared to the measurements in section 1.10.3, the measurements highlighted in red in Table 4 indicate cases in which the maximum fragment size exceeds the available clearance gap between the bearings and pivot ends (illustrated in Figure 12).

Several fragments may also have been co-located and thereby jointly exceeded the size of the separate fragments.

Figure 12: Sketch of bearing, pivot end, bore and fragment. Sketch: NSIA

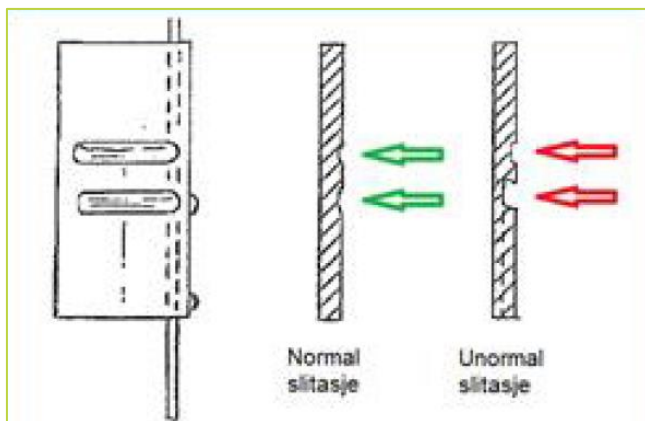
- In one case, the relay had remained closed as a consequence of extraordinary wear on the vane's stop plate/contact plate and where the relay contacts got stuck / mechanical conditions prevented the vane from returning to the open position (Figure 15). This fault is common knowledge, and is followed up by Sporveien T-banen in periodic inspections described in the standard job procedure 'Standardjobb 20'. The inspection is carried out visually and is easily done by the signal engineer. The fault is known to have occurred in several similar systems and, as far as the NSIA is aware, it is dealt with by infrastructure managers who use this type of relays.

Figure 15: Description of fault where the VT1 relay's stop plate/contact plate has suffered extraordinary wear. Source: Sporveien T-banen 'Standardjobb 20' version 10.20.

- To be replaced with a new relay or a relay overhauled by the supplier, the old relay is to be delivered to the supplier for overhaul.
- All contact pins must be controlled after a relay replacement. Notification of replacement is to be sent in the IFS system.
