**Goods train derailment
Amsterdam-Muiderpoort,
22 November 2008**

The Hague, March 2010 (project number M2008RV1122-01)

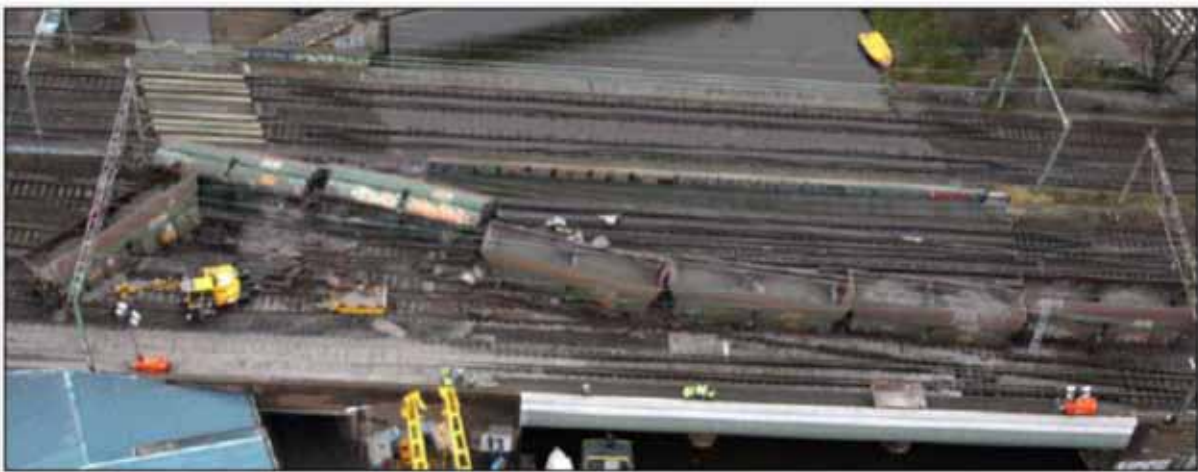
Figure 2: This photo shows the final position of some of the derailed wagons.

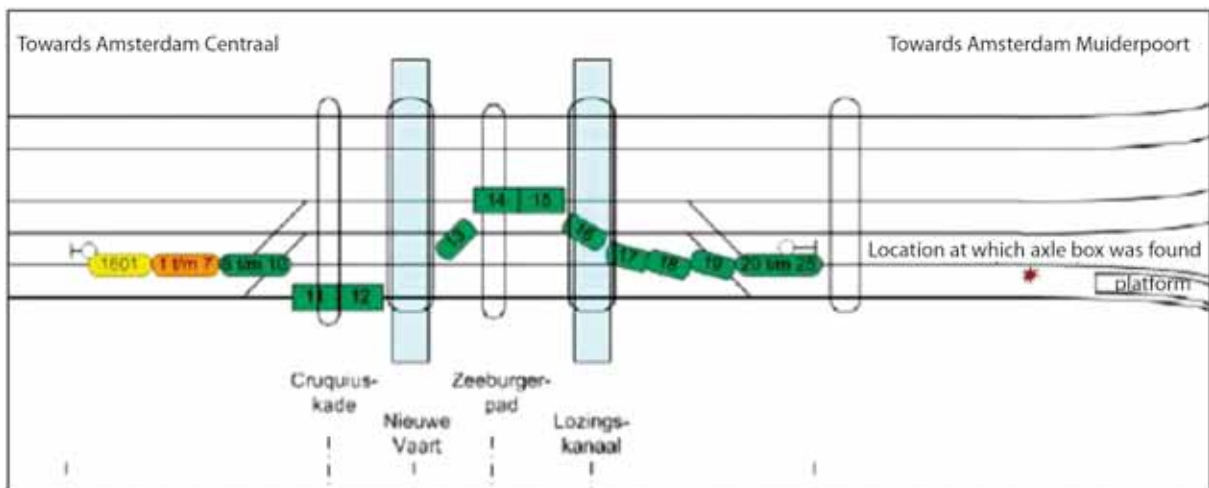
Nine wagons derailed, four of which toppled over and shed their load of chalk. The track was damaged over a distance of 500 metres. A set of points was also destroyed. Wagon 14 came to rest against a concrete section of the bridge over the Zeeburgerpad. The derailed wagons 16 to 18 inclusive sank into the bridge. A cyclist on the Zeeburgerpad escaped with a fright when concrete rubble from the bridge fell onto the cycle track behind him.

Figure 3: Diagram of the end position of the wagons.

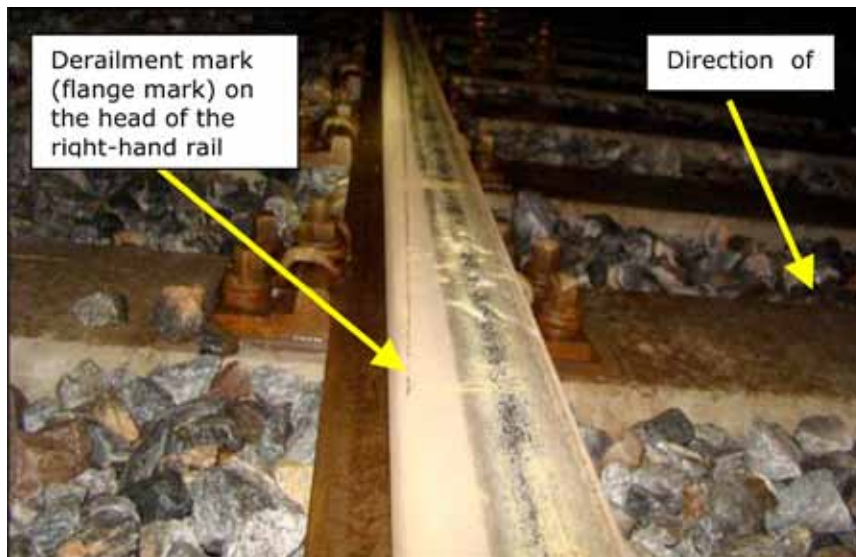
- a) Damage was seen on the right-hand rail of the relevant track (UP) 51 metres past the end of the platform that was indicative of a wheel flange climbing over the head of the rail. The length of these 'derailment marks' were about 15 metres.

Figure 12: This photo shows the derailment marks on the head of the right-hand rail.

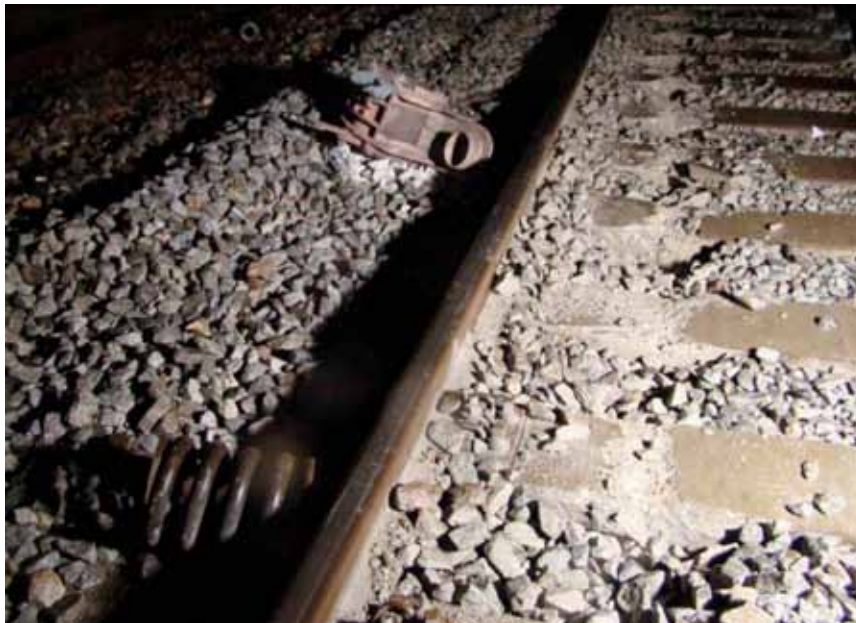
- b) The sleepers immediately following the end of the derailment marks exhibited damage indicating that a wheel set had run alongside the rails.

Figure 13: This photo shows the damage the left-hand wheel of the derailed wheel set caused to the concrete sleepers. The overheated axle box and one of the four springs accompanying the axle box lie next to the rail.

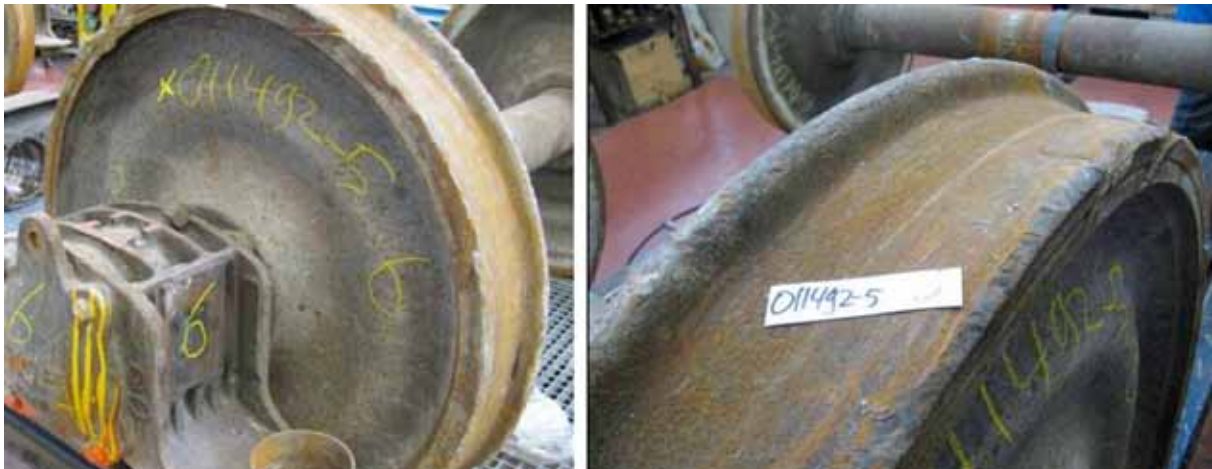
The two wheels of the front wheel set were the only derailed wheels that exhibited severe damage of the flanges and running face of the form that can be expected when wheels run a considerable distance over concrete sleepers (see Figure 14).

Figure 14: These photos show the damage to the wheels of the front wheel set (of the front bogie of the eleventh wagon) caused by the wheel set running over the concrete sleepers.

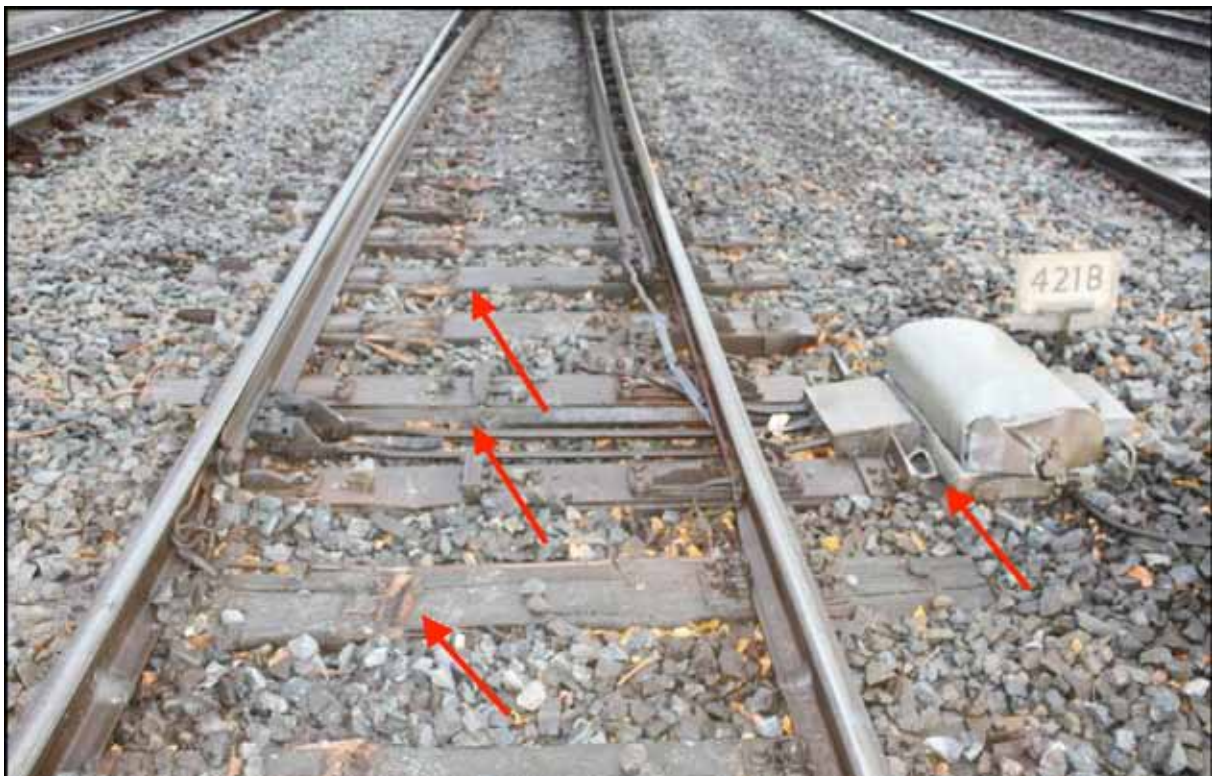
Figure 15: This photo shows the damage the derailed wheel set caused to the sleepers and the operating mechanism of the set of points

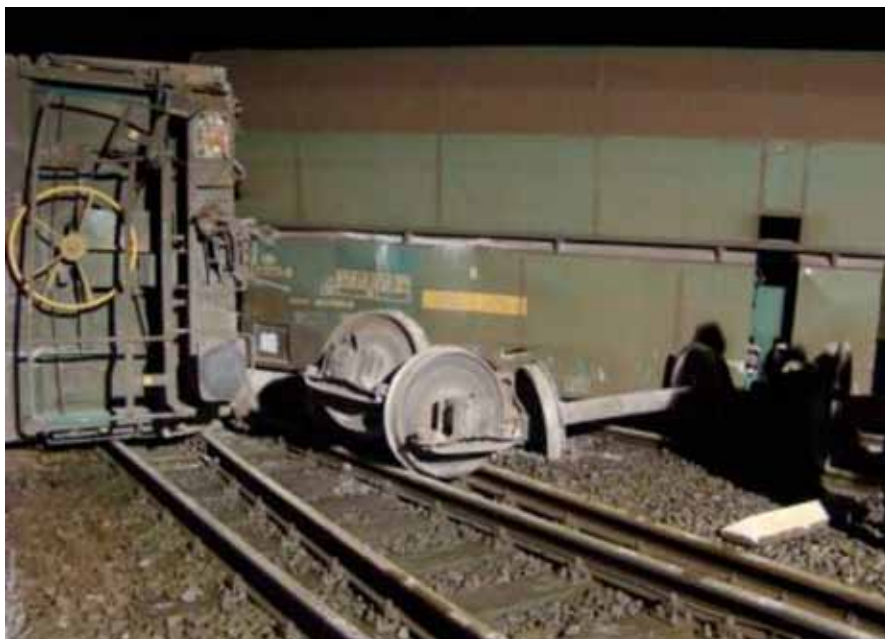
Figure 16: This photo shows some of the derailed wagons and a number of wheel sets that had broken off.

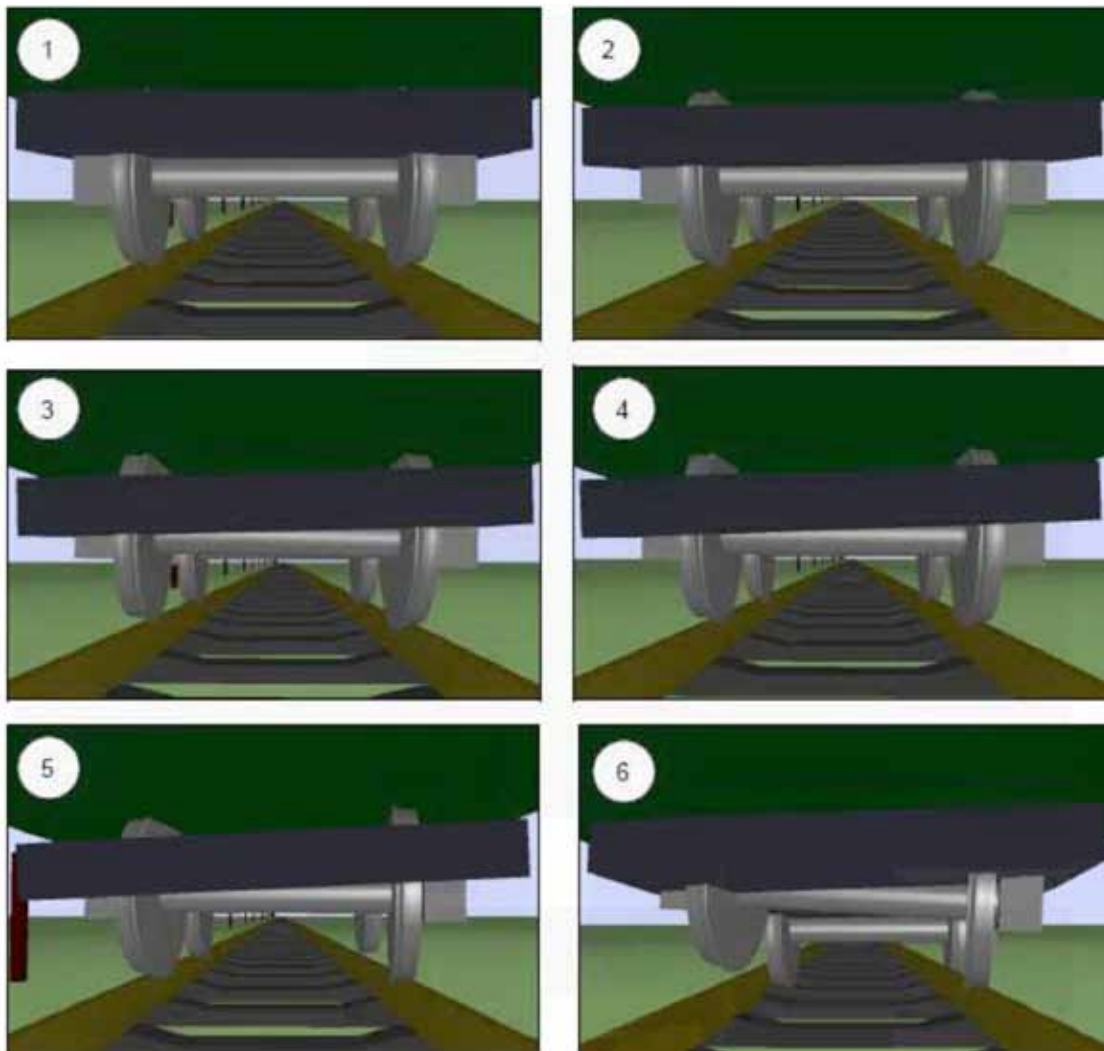
- Without the defective wheel mounting the wheels exhibit no tendency to derail at the section of the track where the derailment occurred, since the unloading of the wheel is restricted to less than 20% and the value of Y/Q remains below 0.4.

Figure 17: Simulated derailment process (seen in the direction of travel): 1 = initial situation, 2+3 = rear wheel set climbs left rail , 4+5 = front wheel set climbs right rail and 6 = derailment of front wheel set.

The simulations explained above reveal that both the derailment of the wheel set and the location at which the derailment occurred are determined by the time at which the axle journal melted completely off. The simulations also reveal that the rail alignment (both the radius of the curve and the canting) did not play a material role.

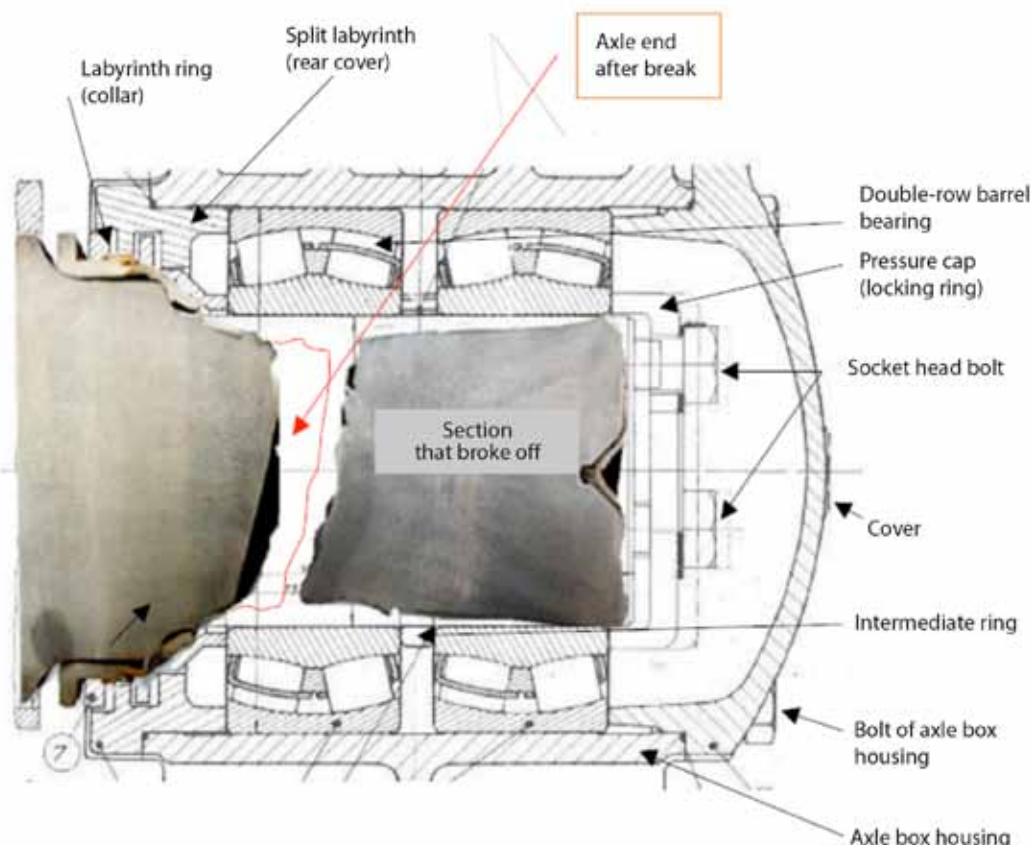
Figure 18: Cross-section of the axle journal and axle box housing. Two double-row barrel bearings are mounted in the axle box housing. The axle journal has broken at the point where it passes through the inner bearing.

The axle journal broke at the point where it passed through the inner bearing. The boring of the inner ring of the outer bearing exhibited clearly-visible erosion: this indicated that the axle journal had rotated in and eroded this bearing. Sections of the inner ring were completely worn away.

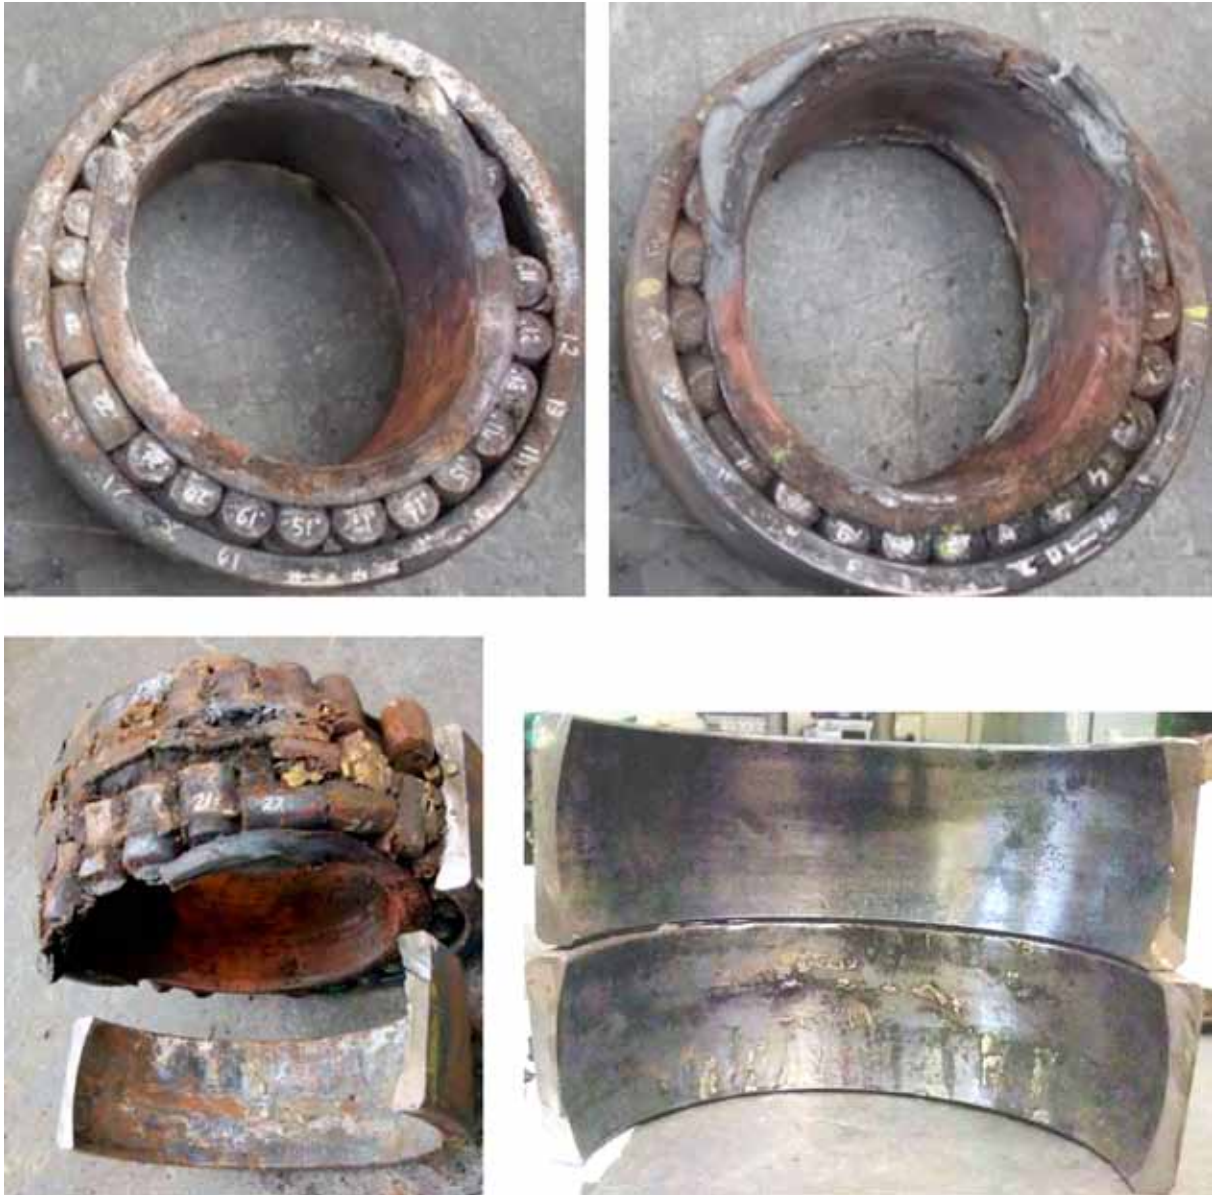
The outer bearing was extremely severely damaged (see photos below).

Figure 19: The outer layer from the overheated axle box. the top left photo shows the outer side, the top right photo the inner side. The bottom left photo was taken once the outer ring had been cut through and partly removed. The bottom right photo shows the raceway of the outer ring after the ring had been cleaned.

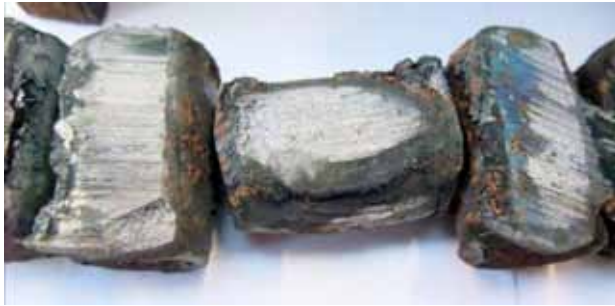
An inspection of the raceways of the inner ring and the outer ring after the bearing had been opened did not reveal a degree of chipping that could have explained the seizure (see Figure 20, bottom right photo). It was also observed that flats had been worn on some of the rollers in the bearing before the rollers had become 'welded' to the inner ring (see Figure 20).

Figure 20: Three rollers from the outer layer: one roller had turned through 90 degrees and flats had worn on all three rollers.

This situation can be explained only by the relevant rollers becoming jammed relative to the outer ring while the inner ring was still rotating. Since one of the rollers had turned through 90 degrees (see Figure 20) at least one cage lip of the bearing cage must already have been broken off at the time the bearing began to seize.

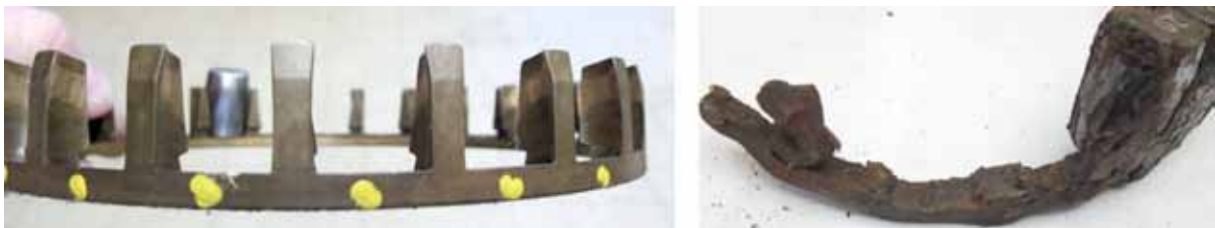
The bearing cage, which was made of brass and was comb-shaped (see left photo in Figure 21), had largely melted. The cage lips had broken off from the remains of the bearing cage (see right photo in Figure 21).

Figure 21: Left: a comb-shaped brass bearing cage of the type used in the relevant bearings. Right: the remains of one of the two bearing cages from the outer bearing mounted in the overheated axle box (with the cage lips broken off).

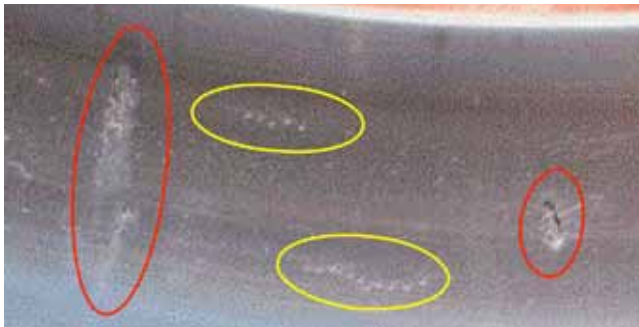
In addition, one of the twenty bearings that were inspected exhibited chipping of the raceway of the outer ring at two locations. The distance between the two locations was equal to the centre-to-centre distance between the rollers. In the opinion of the bearing experts the Board consulted the form and the distance between the chipping indicated that this chipping was probably not caused by current-flow damage but by brinelling⁶⁶ or corrosion.

Figure 22: The adjacent photo shows the current-flow damage (circled in yellow) and chipping (circled in red) in the raceway of the outer ring of a bearing from one of the ten other axle boxes that were inspected.

The bearing experts that the Board consulted stated they expected that chipping of this magnitude would have resulted in the failure of the bearing within the remaining period of the overhaul interval (eight years).

3. To Xpedys:
Evaluate the periodic maintenance of the axle boxes of the series of wagons involved in the Muiderpoort derailment, with due regard for the chipping damage encountered in one of the bearings of the derailed wagons.
4. To Railion and ProRail:
Carry out an investigation of the current-flow damage to the axle box bearings observed with the wagons involved in the Muiderpoort derailment and make sure that the necessary measures are implemented to prevent this form of damage.

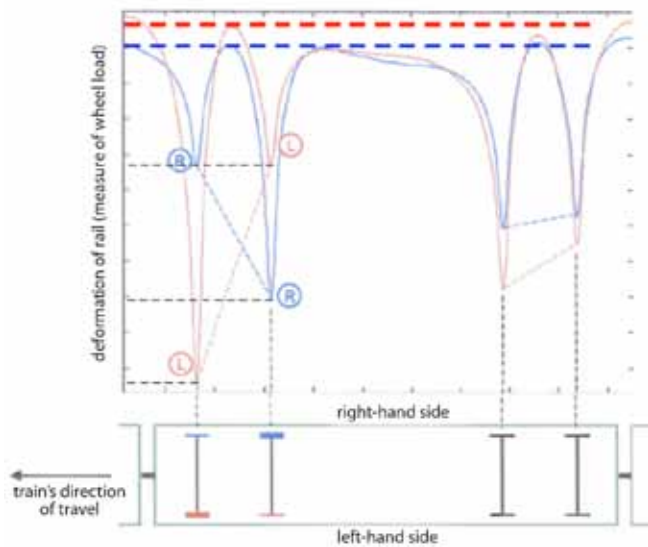
Figure 23: This figure shows the wheel loads of the eleventh wagon as recorded by the QuoVadis-Gotcha station at Tricht. The front bogie exhibits a diagonal difference in the wheel loads.

The anomalous distribution of the wheel loads at Tricht should be viewed in combination with the fact that by the time the train reached Amsterdam-Muiderpoort the left-hand axle box of the rear wheel set of the relevant bogie had overheated to an extent such that the axle journal had eroded its way through the axle box. For this reason the Board concludes that the difference in wheel loads measured at Tricht was due to the fact that at that location and at that time the axle box had eroded through the axle box to an extent such that the axle box had already 'sagged' by an appreciable distance. On the basis of the available information about the dimensions of the relevant parts and the spring stiffness of the primary suspension the wheel unloading measured at Tricht (approximately. 40%) is equivalent to the axle box sagging - and the axle journal eroding into the axle box - by a distance of approximately 95 mm. This distance (95 mm) is about half of the total distance (approximately 200 mm) required for the axle journal to erode completely through the axle housing (before the axle journal broke free shortly before reaching the derailment point at Amsterdam-Muiderpoort).

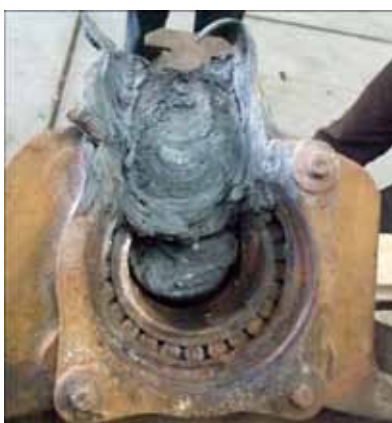
Figure 24: This photo of (the inner side of) the overheated axle box shows that the axle journal erodes its way upwards through the axle box.

In the Board's opinion it is also possible to state that this degree of erosion (approximately 95 mm) of the axle journal through the axle box would have been accompanied by the generation of sufficient heat to raise the temperature of the axle box to a level that could also have been detected by a HotBox detection system at that location and at that time.

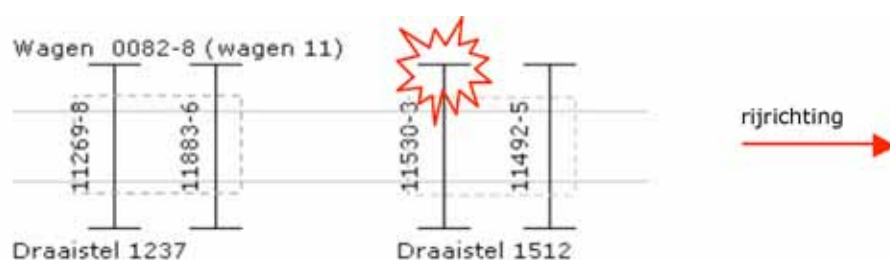
Diagram of wagon number 11 with bogie and wheel set numbers; the overheated axle box was on the left-hand side of wheel set 11530-3.
