STATE COMMISSION ON RAILWAY ACCIDENTS INVESTIGATION
Ministry of Interior and Administration

REPORT No PKBWK 05/ 2021

on the investigation of a serious train accident that occurred on
26 January 2021 at 07:39
on route between Zbąszynek and Lutol Suchy, track no 1,
level crossing category D
at km 10.196 of railway line no 367 Zbąszynek - Gorzów Wielkopolski

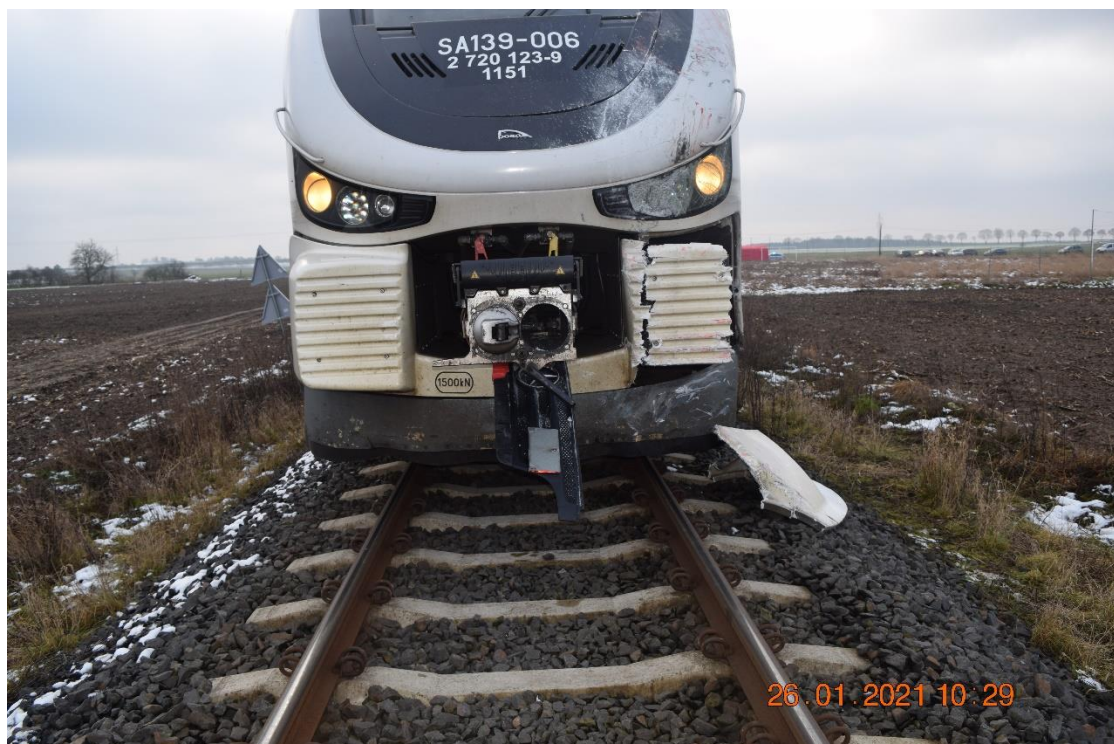
Photo 5- View of damage to the front of a railway vehicle after an accident

Extent of damage to railway vehicle SA139-006:

- broken wiper mechanism cover and siren,
- damaged left headlight,
- damaged track scraper with cover,
- damaged painting of the cab on the left side and the handrail to the driver's cab,
- defective air hose in the brake indicators,
- damaged absorber cover on the left side,
- curved structure of the obstacle deflector,
- Torn out inner fitting of the coupling cover,
- bent handle over the left headlight,
- a crack in the driver's cab laminate on the outside and inside in the area of the cab's attachment to the wheelhouse and the vehicle body,
- faulty coupling valve,
- Defective coupling cylinder connector,
- a crack in the driver's cab windscreen.

The estimated cost of damage to the vehicle amounted to PLN 92 thous.

Damage to the vehicle allowed it to drive to a maintenance facility. There was no damage to the railway infrastructure and no damage to the environment.

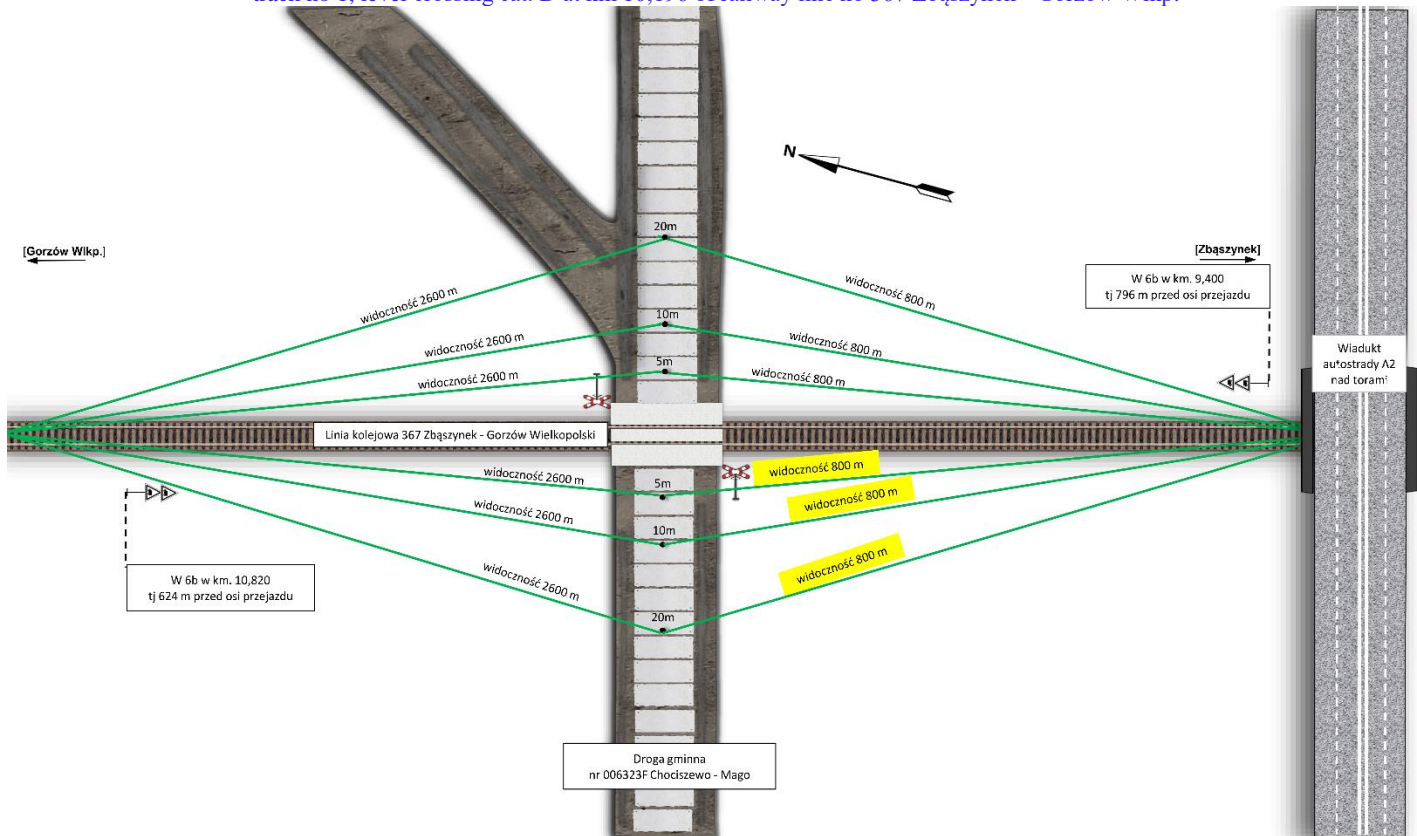
Figure 2- Visibility triangles at level crossing (based on PKBWK)

The yellow marking indicates visibility of train head for the direction from which the road and rail vehicle were running

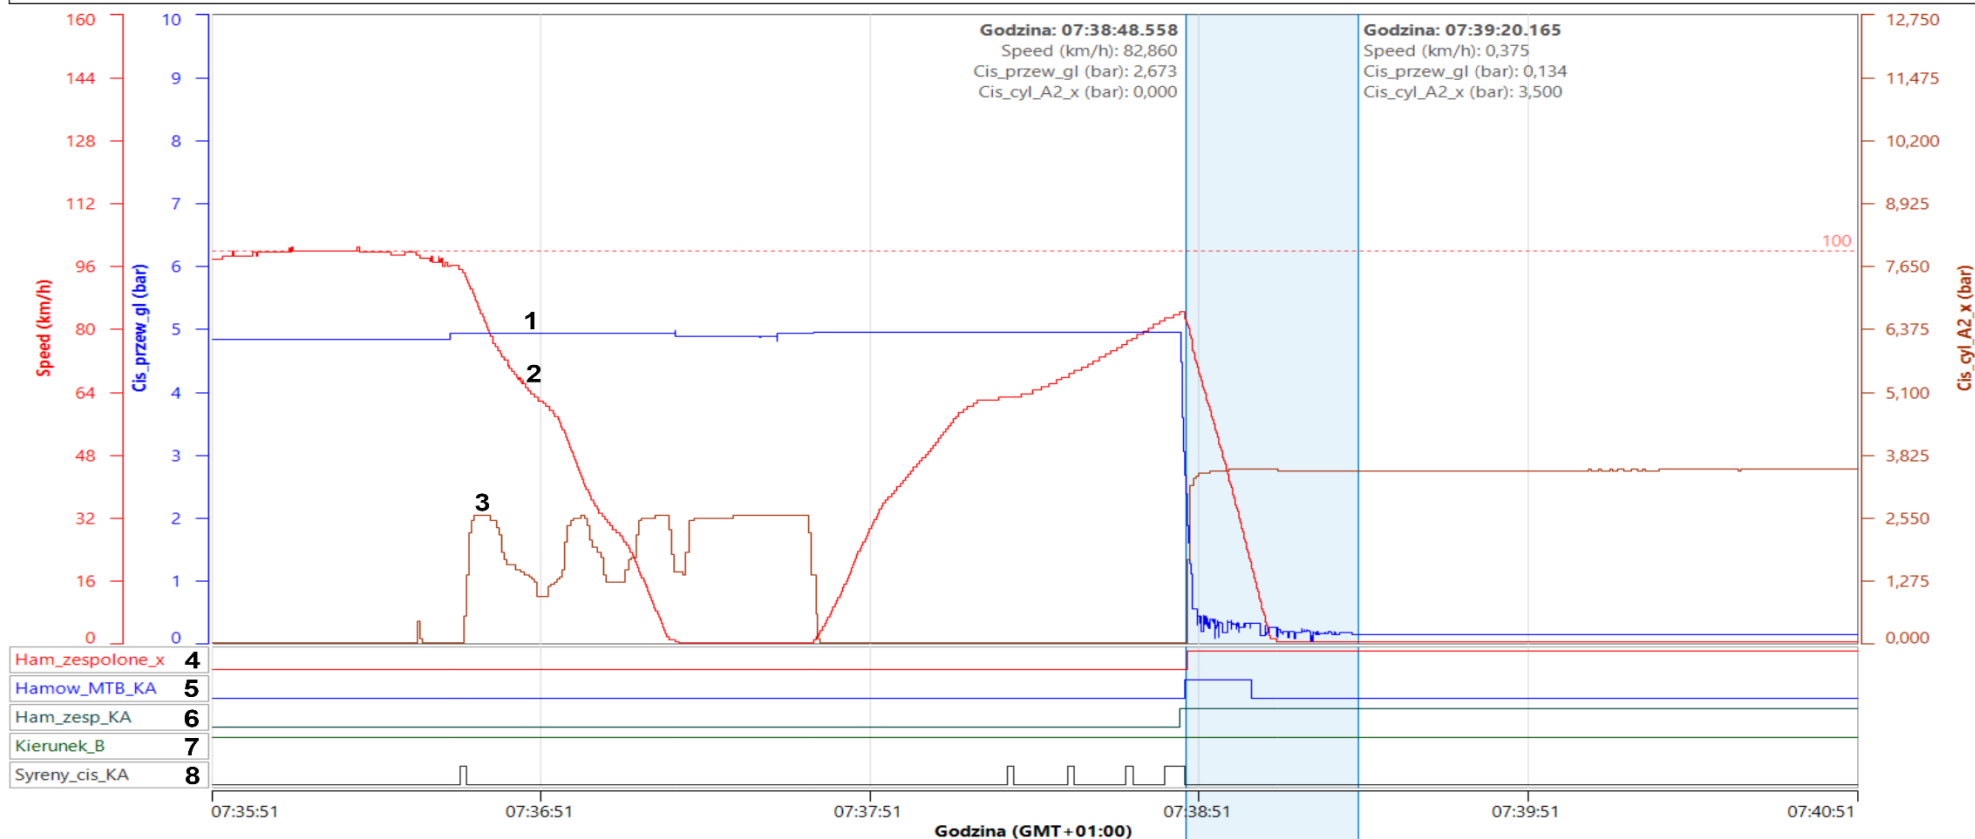
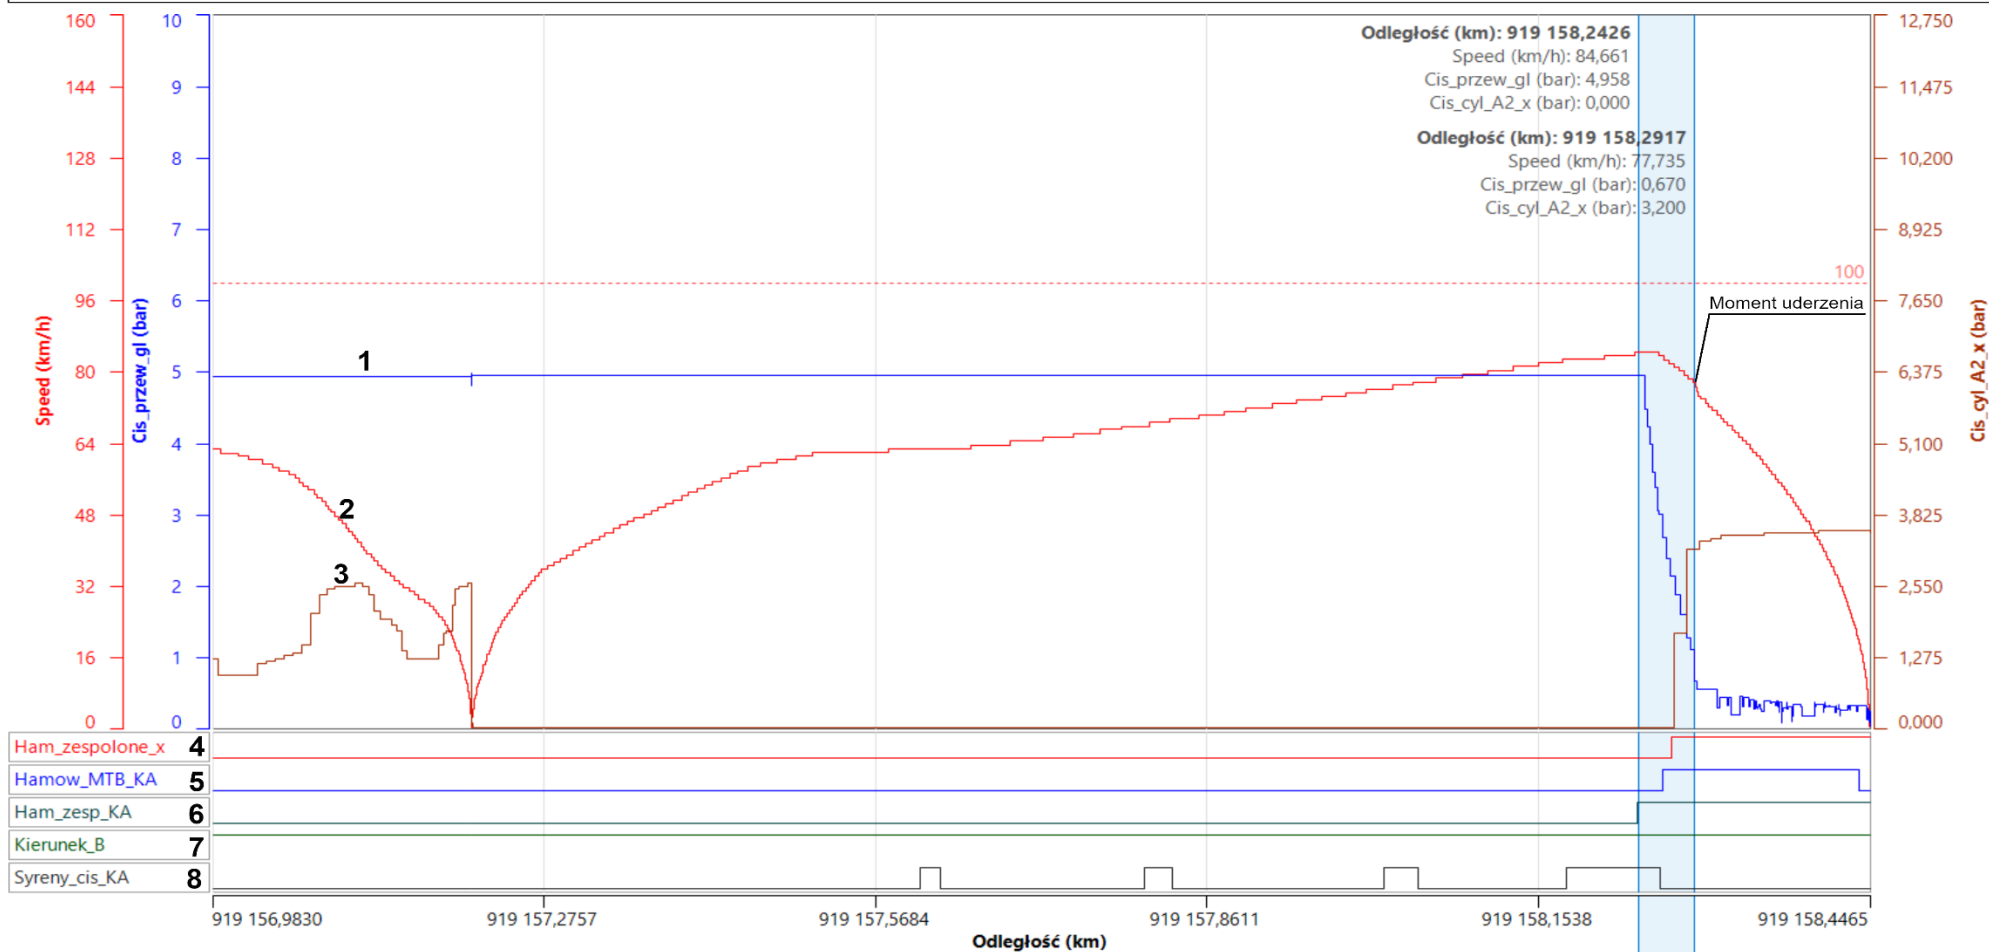
Figure 4- Diagram of the driving parameters of the rail bus SA139-006 as function of distance (elaborated by PKBWK)

The above diagrams show the following parameters of the ROM 78561 train run:

1. Main line pressure
- 2 Speed
3. Brake cylinder pressures
4. Operation of the combined brake
5. Brake operation (MTB KA braking)
- 6 Emergency braking application
- 7 Cabin identification - control from cabin B
8. Use of a beep signal.

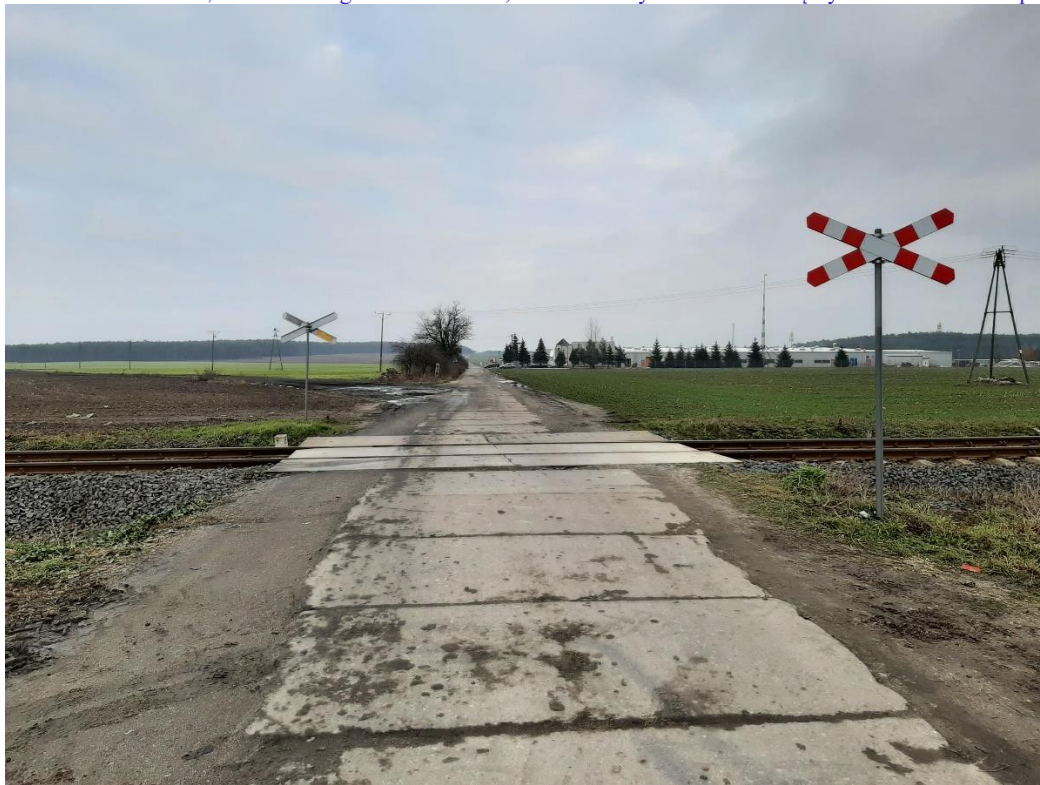
Photo 7- View of the crossing from the direction of the truck

The Investigation Team concludes that the weather conditions and the topographical and technical conditions of the level crossing were not causally related to the incident. A view of the crossing from the direction of the truck is shown in photo 7.
