STATE COMMISSION ON RAILWAY ACCIDENT INVESTIGATION
Ministry of the Interior and Administration.

REPORT No. PKBWK 06/2022

**on the procedure on a railway incident that occurred on 05 February 2021 at 09:37
in Gogolin station track no. 6, 22.400 km of railway line no. 136 Kędzierzyn Koźle – Opole
Groszowice**

WARSAW, 21 July 2022

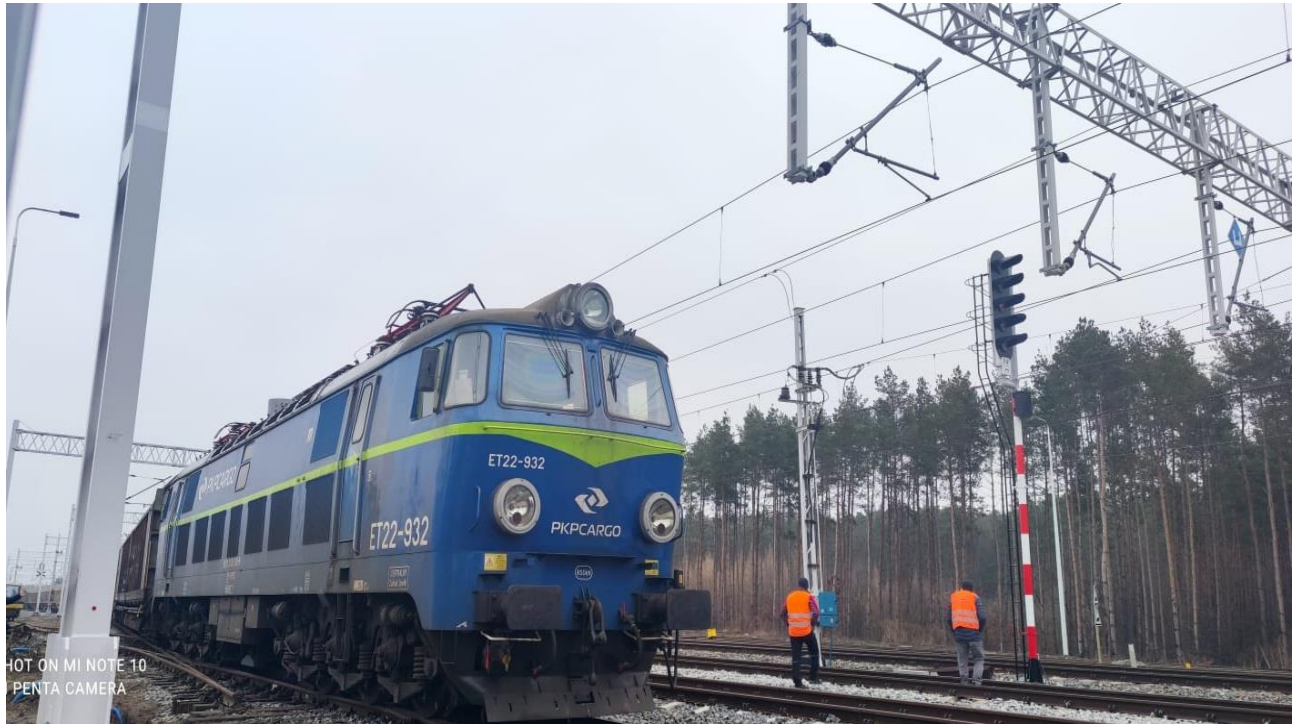
Photograph 1 – View of the site (source: PKBWK)

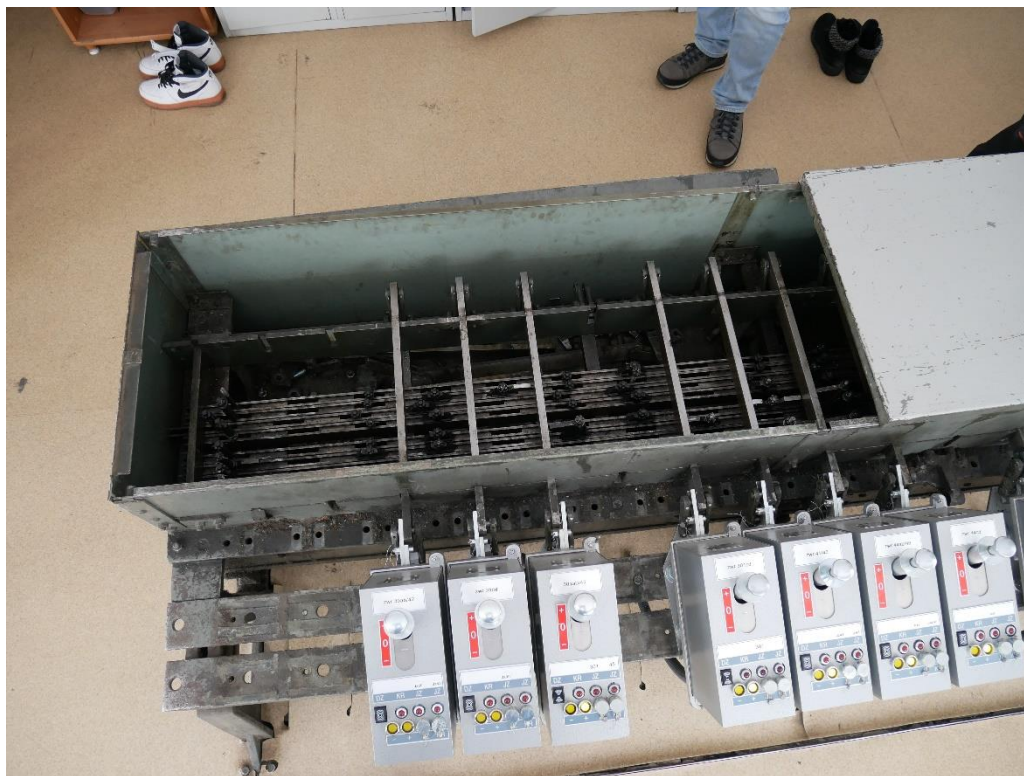
Photograph 2 – View of the combiner with UZE-02 electromagnetic locks on the dependent box Gg2

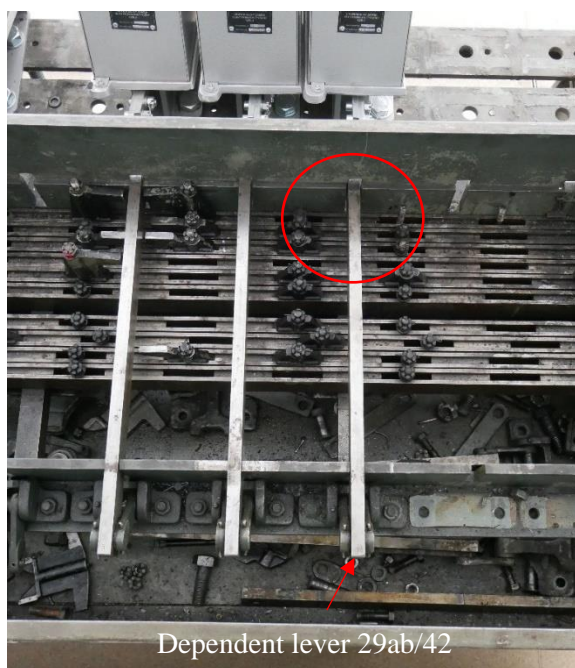
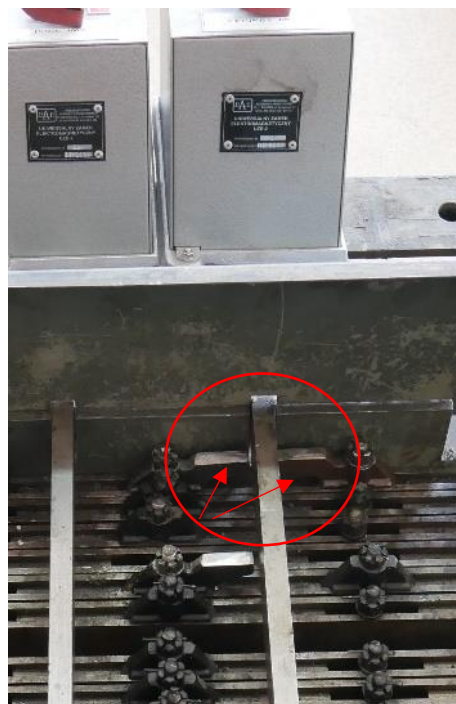
Photograph 3 – View of the combiner without locking dogs (left side – condition after the incident) and with the caps installed after the incident – condition as at 21.04.2021.

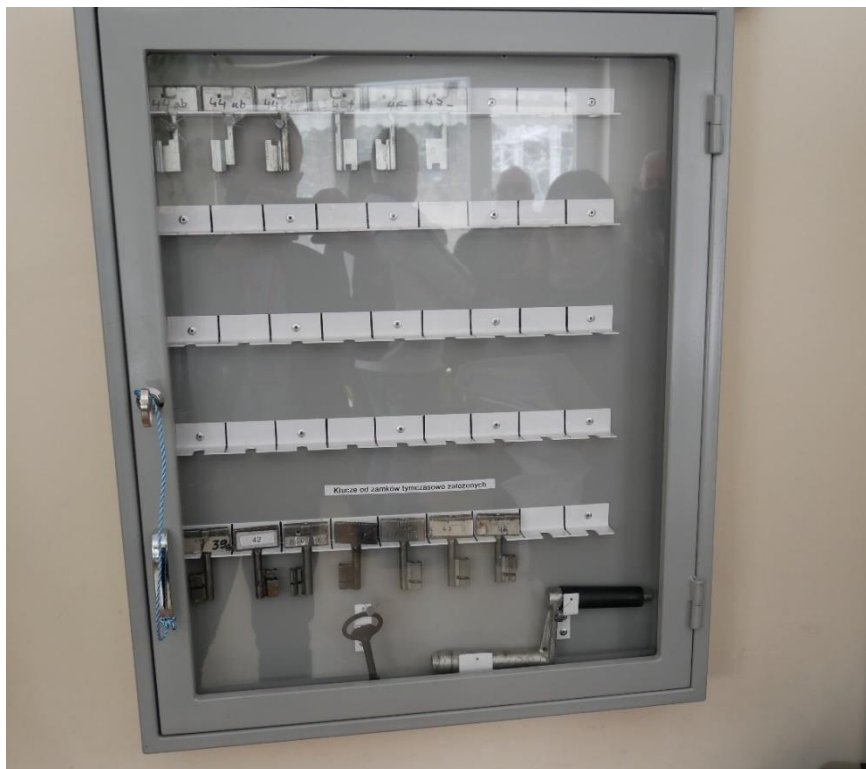
Photograph 4 – Board of spare keys and keys for the locks temporarily installed on the Gg2 signal box

- Placing the active keys for the switch locks built into switches 39ab and 42 in the “spare key cabinet,” which was positioned in an area not visible to the operating personnel, resulting in improper ergonomics of the point operator’s workstation.

- The installation of the pin locks put in place for the duration of the works allowed them to be operated freely, as specified by the designer of the signalling equipment (unsealed keys, accessible to the contractor of the works, placed on the key board in an unsealed manner with a recommendation of accessibility to the contractor, without designing the active key board as a component of the train path).

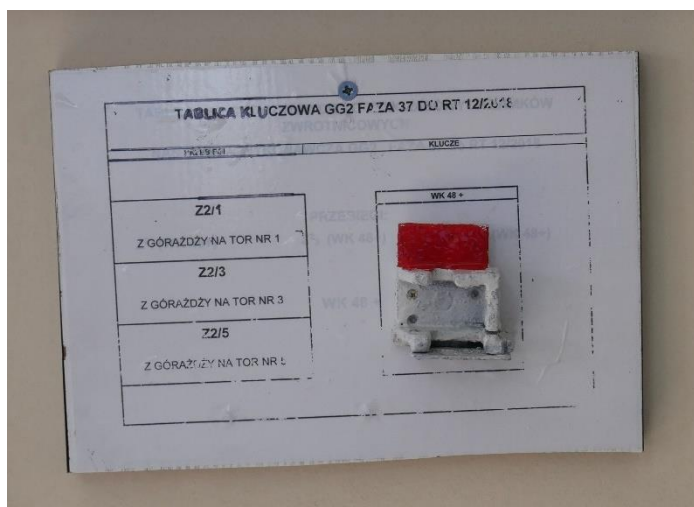
Photograph 5 – Key board of active Gg2 control station made after the incident (during the subsequent stage of works)

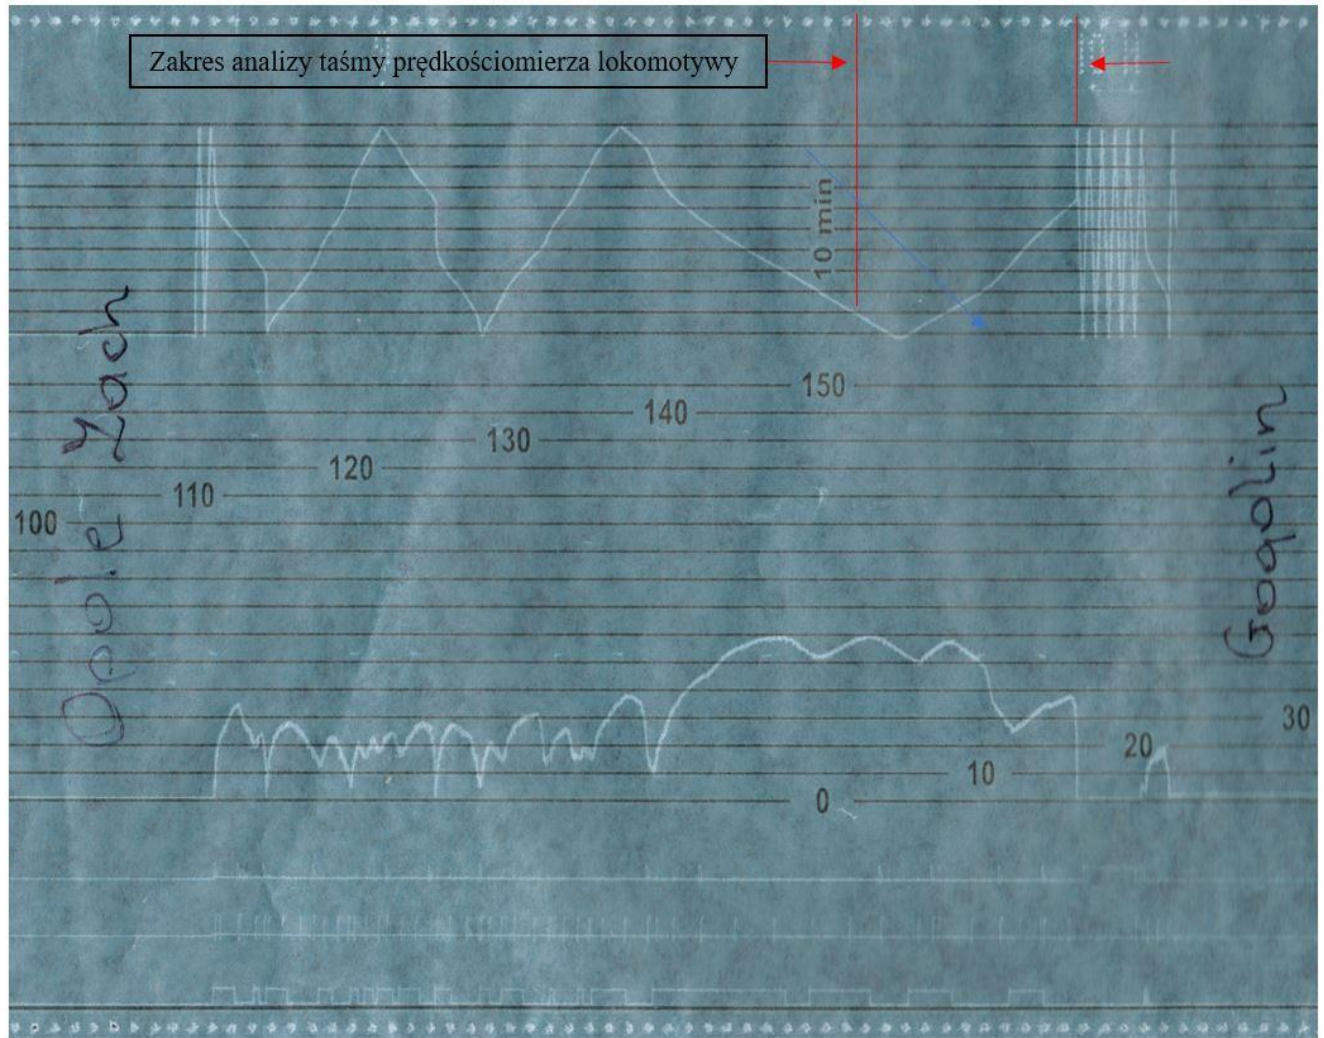
Figure 4 – Diagram of the ET22-932 locomotive running parameters

- 09:30 – 09:31 increase in speed to approximately 57 km/h, recording of running with the drive engaged, no recording of increase in pressure in locomotive brake cylinders, recording of use of SHP and CA vigilance button, recording of passing over track SHP solenoid from "B" cab;

- 09:31 – 09:32 speed reduction to approximately 26 km/h, recording of travel with the drive off, no recording of increase in pressure in locomotive brake cylinders, recording of the use of SHP and CA vigilance button, recording of passing over track SHP solenoid from "B" cab;
