**STATE COMMISSION ON RAILWAY ACCIDENTS INVESTIGATION**  
**Ministry of the Interior and Administration**

**REPORT No. PKBWK 02/2022 from investigation of railway accident that occurred on 26 February 2021 0532 hrs at Grodzisko Dolne station, on second railway track, at km 163.654 of railway line No. 68 Lublin - Przeworsk, railway management infrastructure of PKP PLK S.A., Rzeszów Railway Department.**

**WARSAW, 9<sup>th</sup> of March 2022**

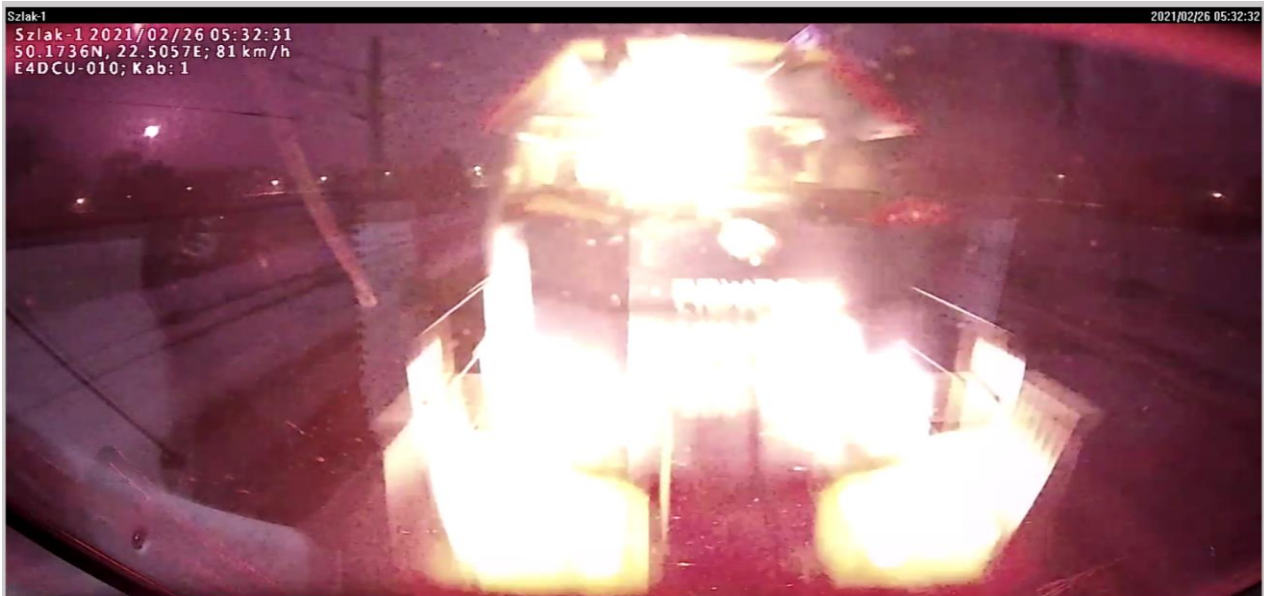
**Photo 1 - shows the situation 1 second before the collision (recorded by the PKP Intercity S.A. locomotive camera).**

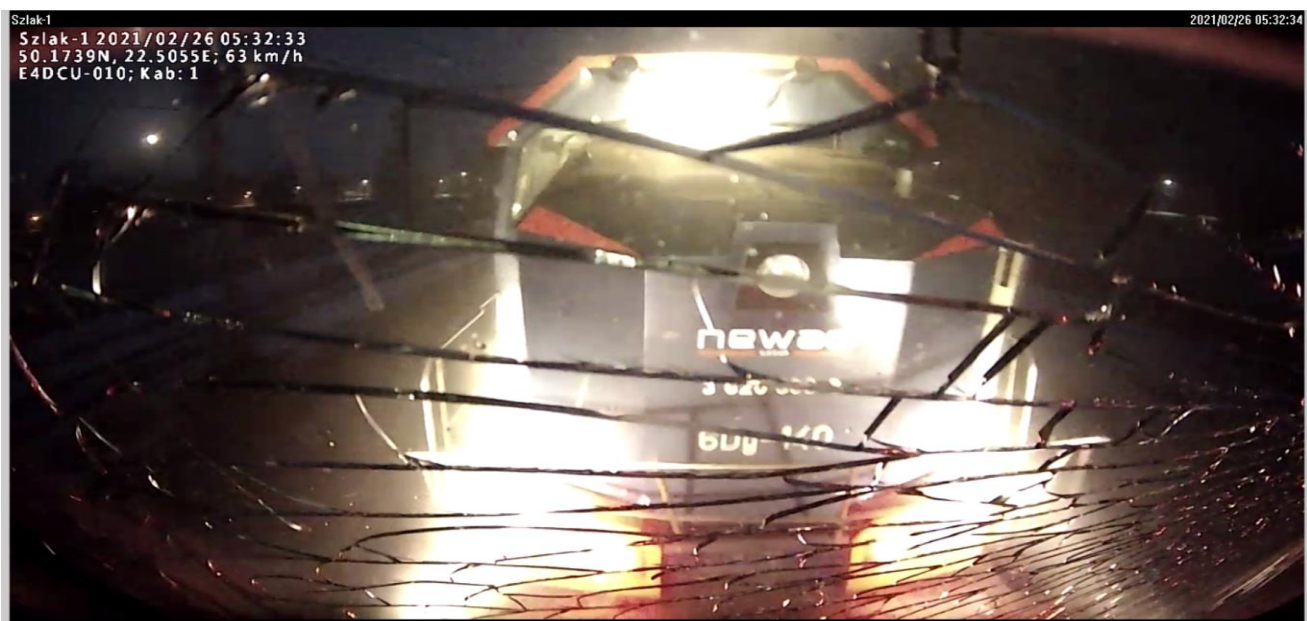
**Consequences of the event:** As a result of the accident, 4 people were injured, i.e. the driver of the loose locomotive and 3 passengers of the passenger train. There were also material losses, i.e. serious damages to locomotives EU160-010 and 6Dg-140, as well as passenger wagons.

**Photo 2 - view of the site and consequences of the accident (own material of the PKBWK)**

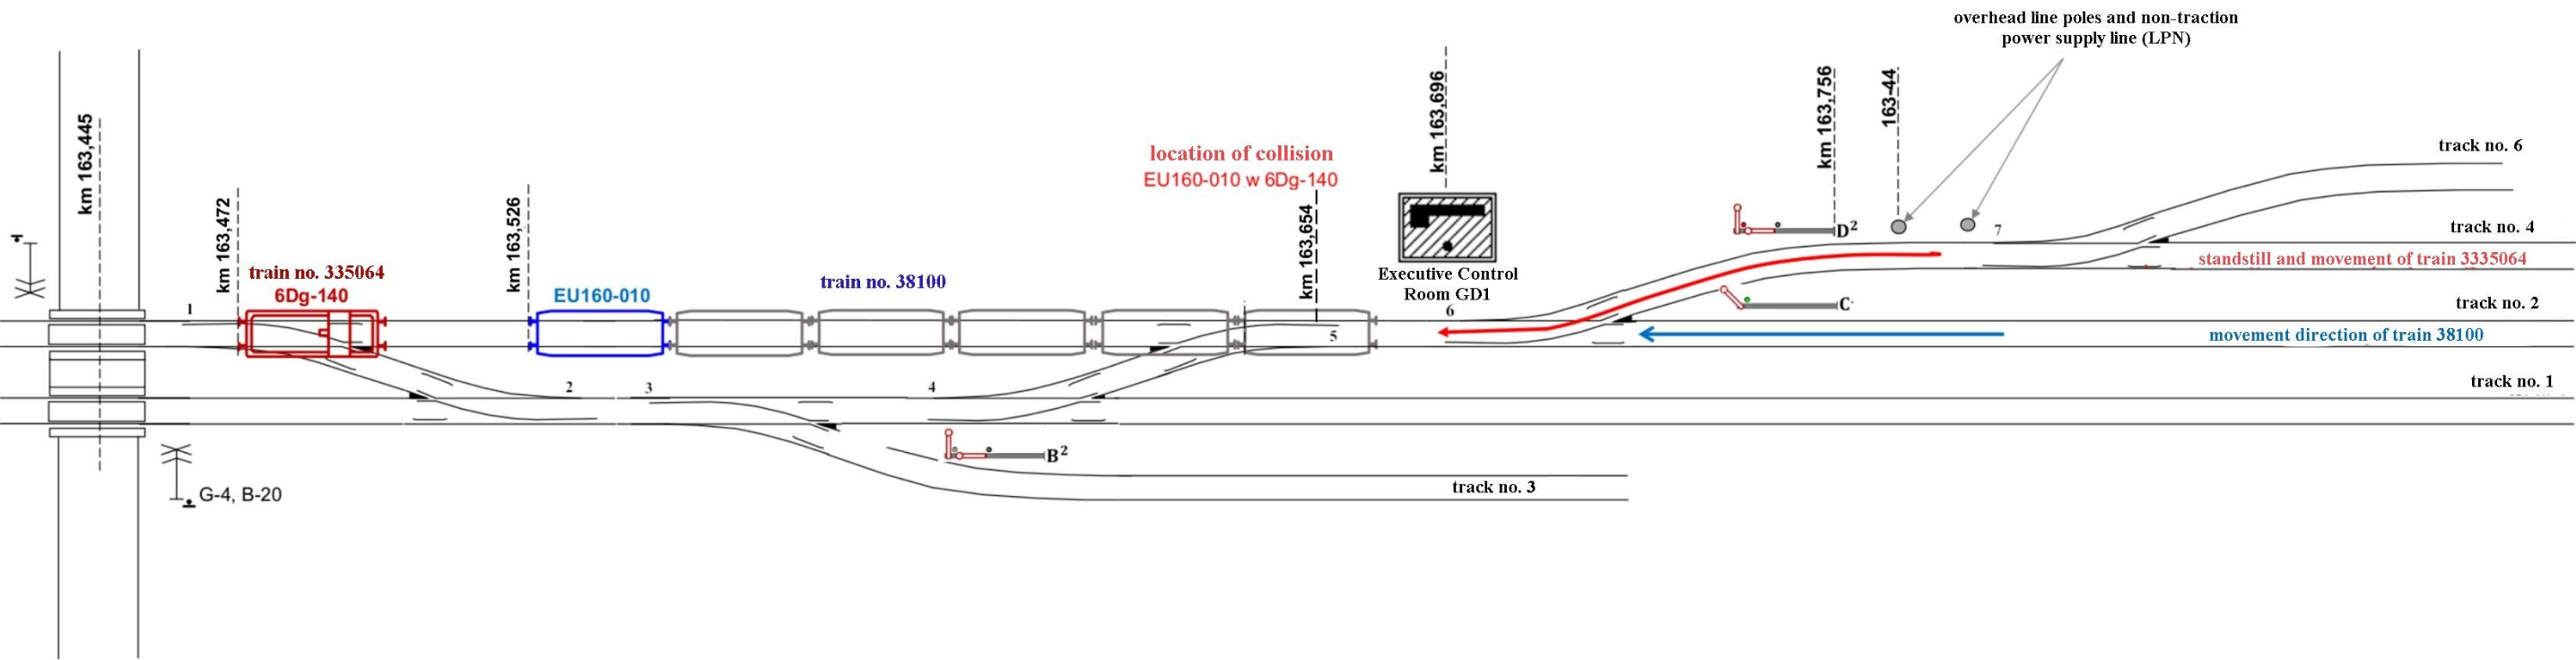
Figure 2 - Sketch of the accident (by PKBWK)

From additional main track no. 4, using not prepared way, without required permission, with D<sup>2</sup> semaphore showing "stop", the train LSS335064 (loose locomotive 6Dg-140) entered the main track no. 2. The entering locomotive 6Dg-140 ripped the turnout no. 6 and entered onto main track no. 2 directly in front of the passenger train MPE38100, without automatically changing signal on semaphore C from "free way" to "stop", due to the type of equipment. The driver of this locomotive (series 6Dg-140) after realising that train MPE38100 is approaching from behind on the same track, started increasing the speed of the locomotive. On the other hand, the driver of passenger train MPE38100, seeing the locomotive in front of his/her train, implemented sudden braking. Despite the actions taken by both drivers, a collision occurred, that is the train of the carrier PKP INTERCITY S.A. MPE38100 collided with the rear of locomotive 6Dg-140 of the carrier LOTOS Kolej Sp. z o. o. The collision occurred on turnout no. 5, at km 163.654. After the collision, the front end of the locomotive EU160-010 stopped at km 163.526, that is after travelling 128 metres. The front end of locomotive 6Dg-140 stopped at km 163.472, that is, after travelling 182 metres after the collision.

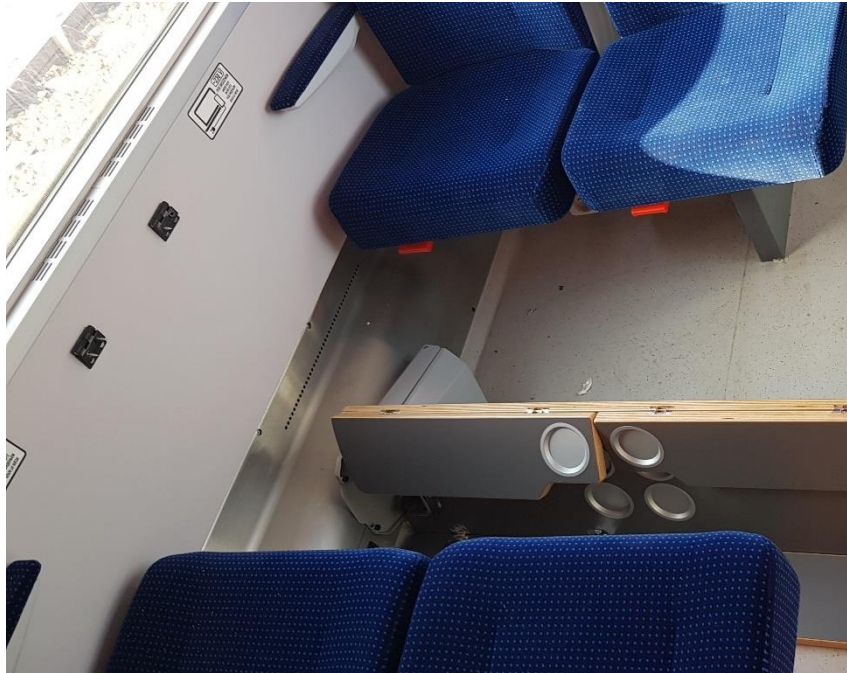
During the inspection of passenger coaches after the accident the investigating team has found the following damages: broken door windows, broken tables, damages of the carriage bodies. The photos below show broken tables in the non-compartment passenger coaches and the way of their fixing.

**Photo 3 – broken table in the passenger coach (photo by PKBWK)**

The fixing of the tables did not fulfil the task of preventing them from breaking off without the involvement of third persons and injuring passengers on the train, which poses a safety risk to travellers. The above photos show the tearing off of tables in the first and second coach behind the locomotive due to dynamic forces caused by the collision of trains, without the presence of passengers.

- 4) Railway undertakings will take measures to improve passenger safety on trains through the appropriate fitting of tables in the non-compartment passenger coaches, guaranteeing travellers' safety.

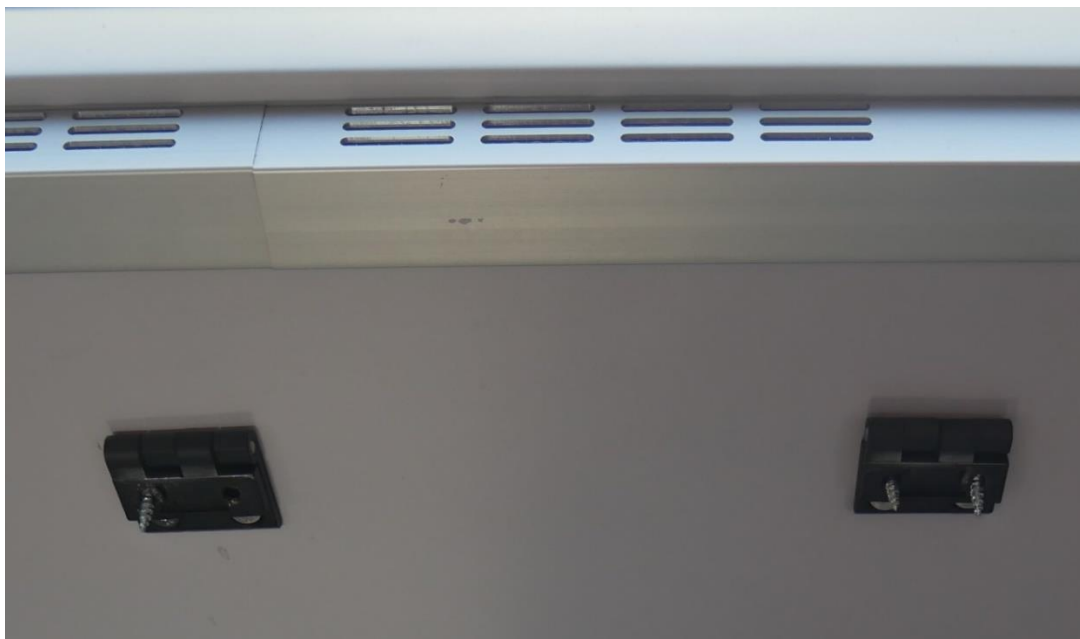
**Photo 4 – fixing system of the table (photo by PKBWK)**

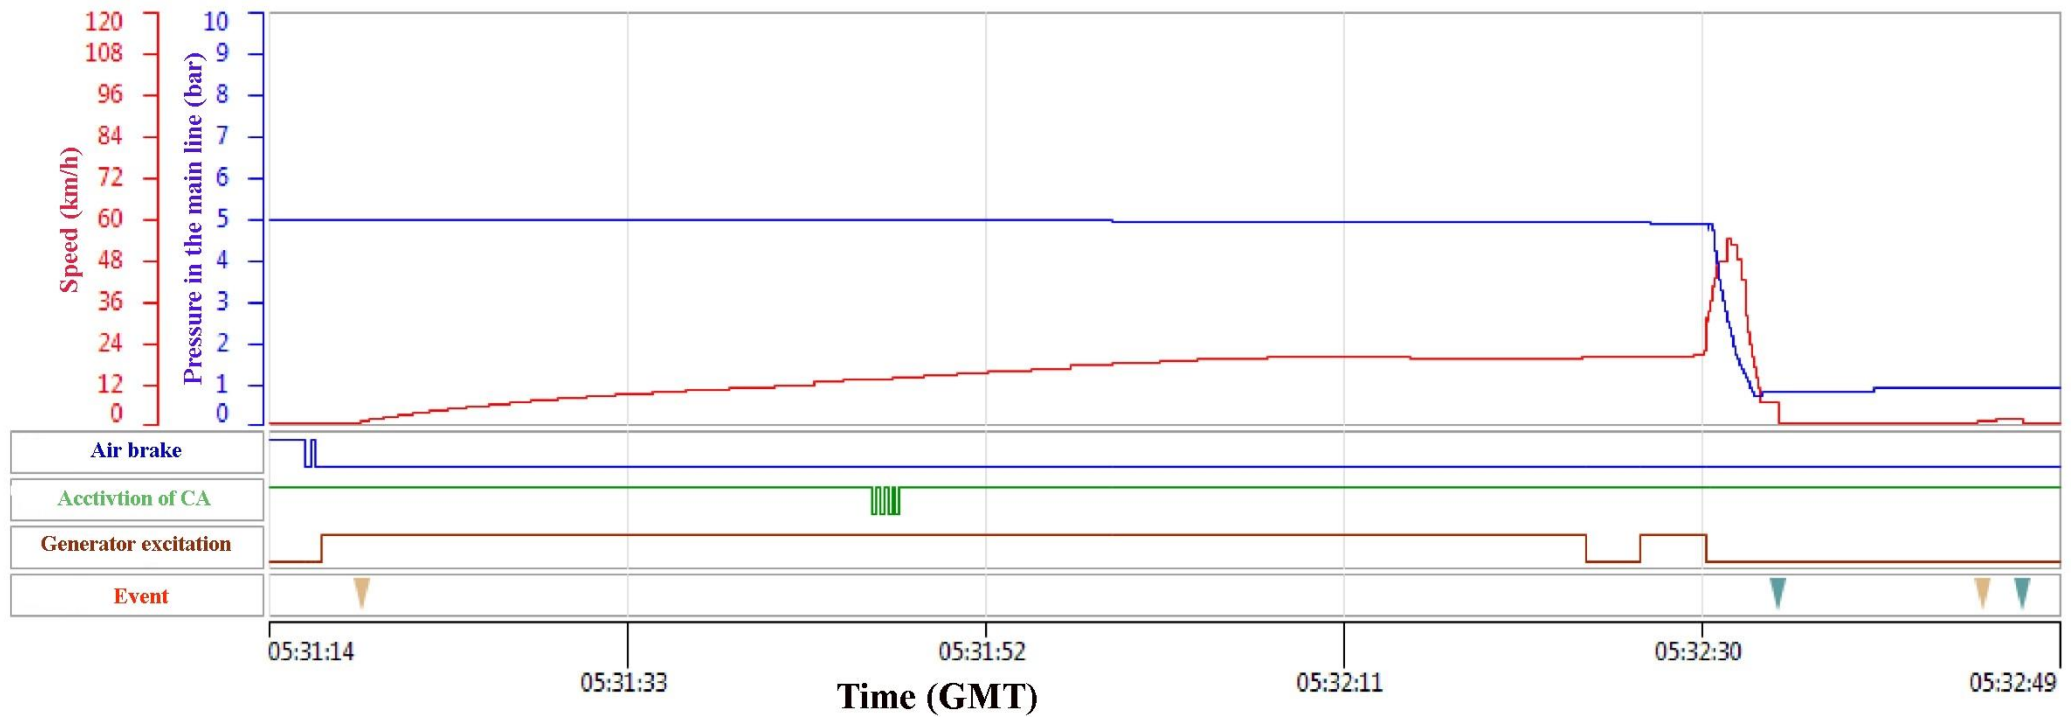
**Figure 3 - Diagram of locomotive 6Dg-140 s running parameters as a function of time (prepared by the PKBWK)**

The investigation team was not able to analyse the course of the accident on the basis of the monitoring system installed in the railway vehicle. The locomotive was not equipped with such a device.

- 8) Railway undertaking LOTOS Kolej Sp. z o. o. will implement order of the President of Office of Rail Transport (UTK) No. DBK-550/R03/KB/12 dated 30.05.2012, addressed to railway operators, about obligation to install pre-field recording devices - digital cameras or video recorders in newly built and operating railway vehicles, according to recommendation PKBWK-076-305/RL/R/11 dated 22.11.2011.

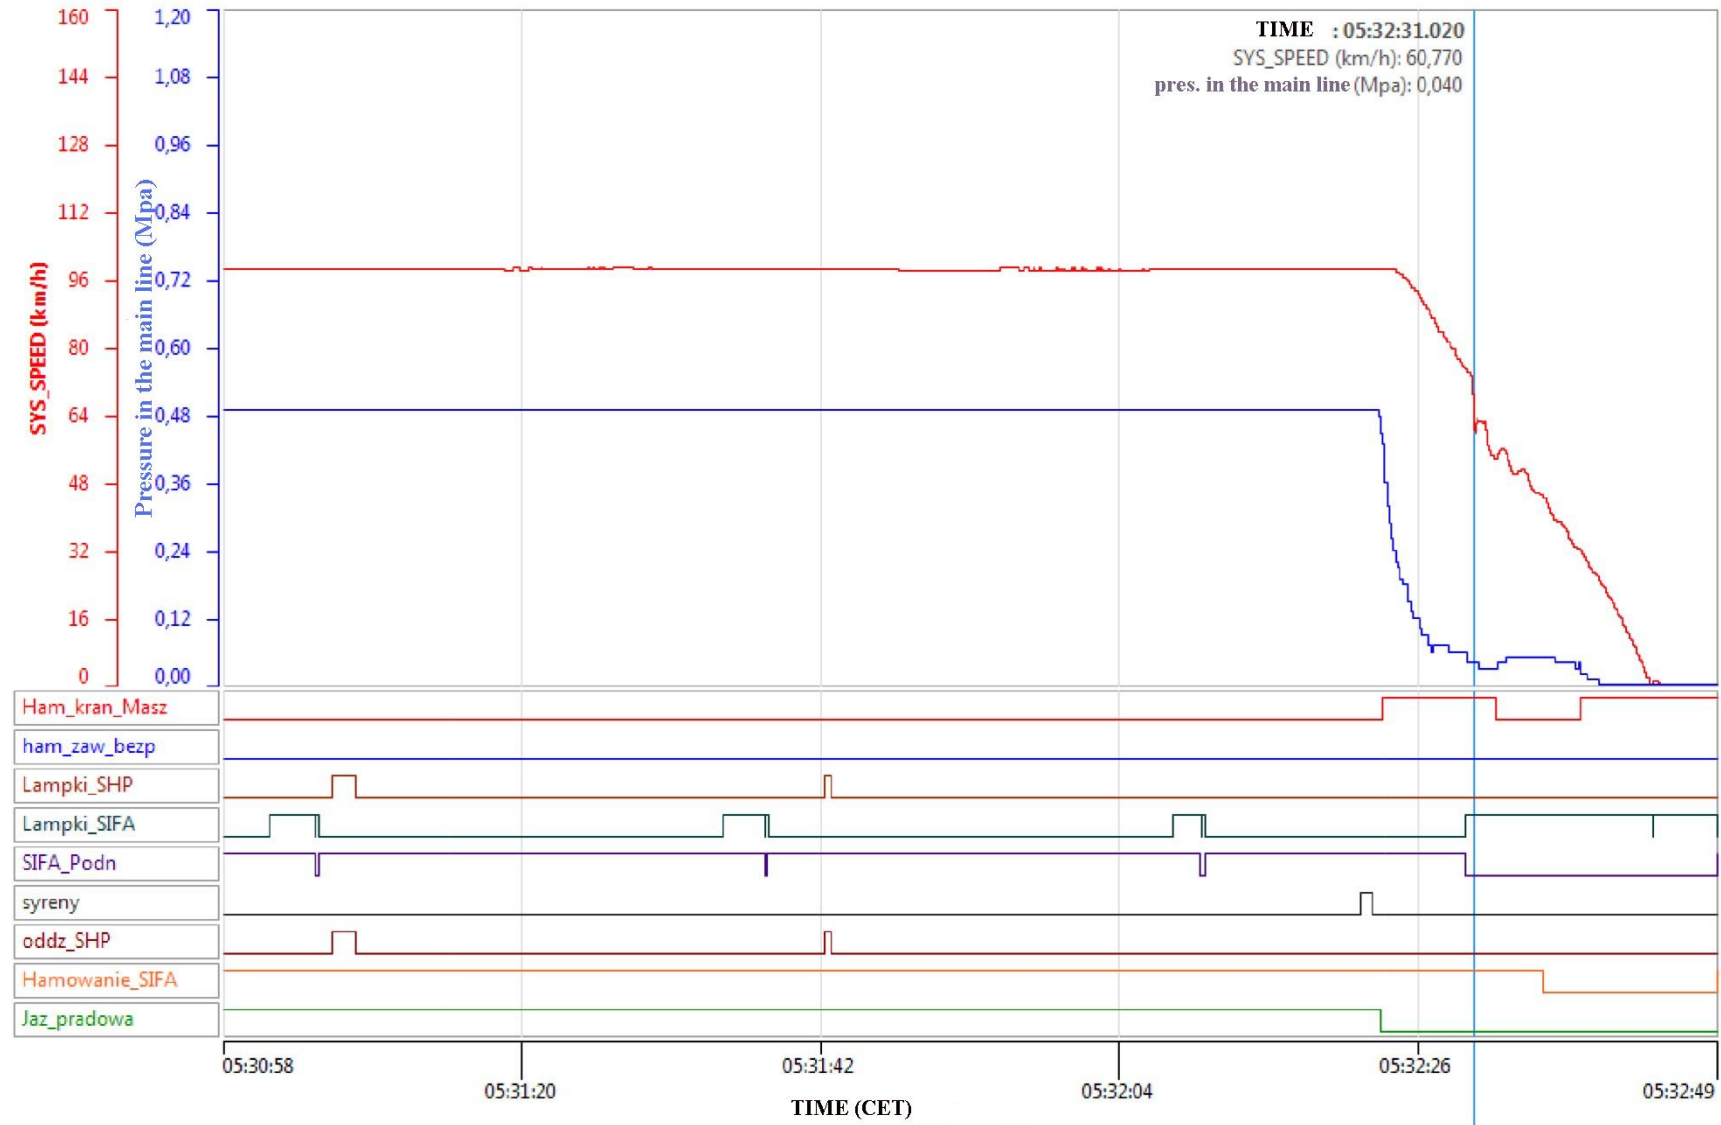
**Figure 4 - Diagram of locomotive EU160-010 running parameters as a function of time (prepared by the PKBWK)**

- at 05:32:36 the braking applied by SIFA was recorded,
- stopping the train at 05:32:44 after travelling 295 metres from the start of braking,
- the distance covered from the moment the attention signal was given to the start of braking was 45 metres, from the moment the brakes were applied to the impact was 163 metres.

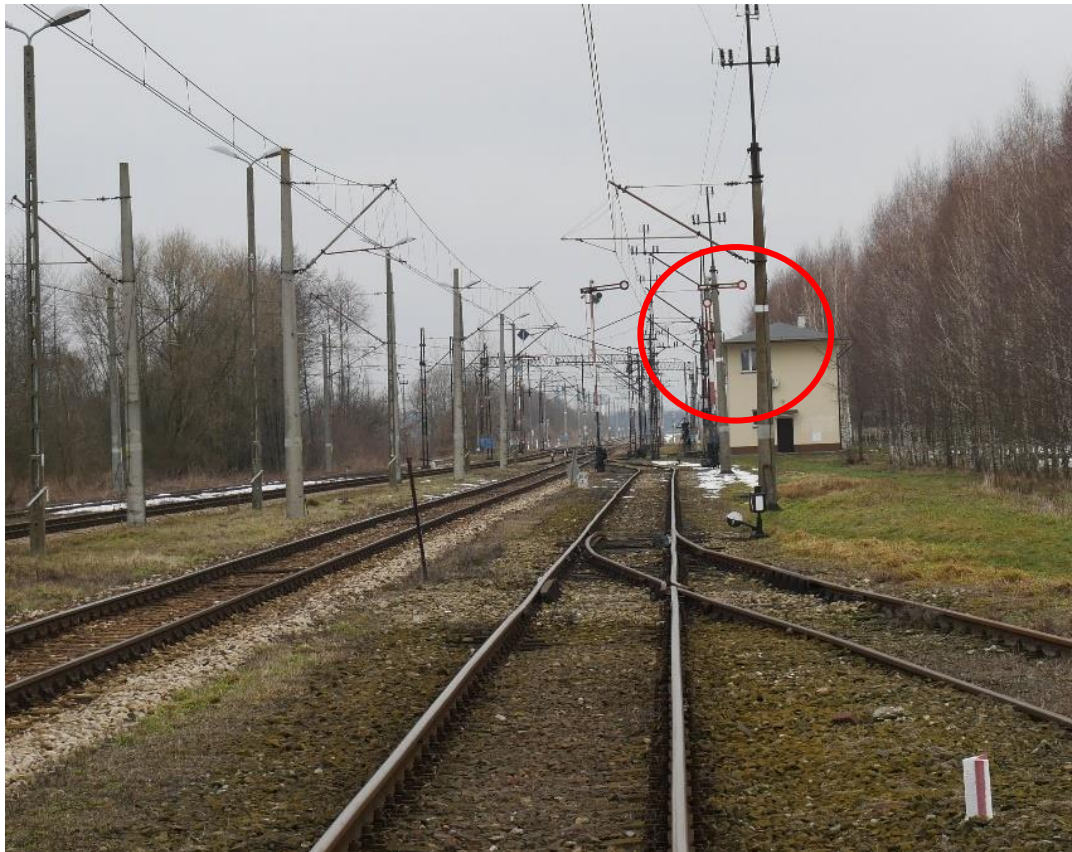
- Lack of uninterrupted visibility (at a distance of 100 metres) of the night signal Sr1 (Stop) given on semaphore D2 (exit from track 4) due to build up overhead line poles and non-traction power supply line (LPN).

Photo 5 – view of pole hiding the night signal of semaphore D (photo by PKBWK)

- 2) To ensure visibility of semaphore D at Grodzisko Dolne station of PKP PLK S.A., the Rzeszów Railway Department shall move the overhead traction line pole 163-44 located in the area of GD1 setting area.

- 3) Infrastructure managers shall perform exceptional checks on the visibility of shape semaphores, during day and night, in stations with overhead traction lines, both over the main and auxiliary tracks.

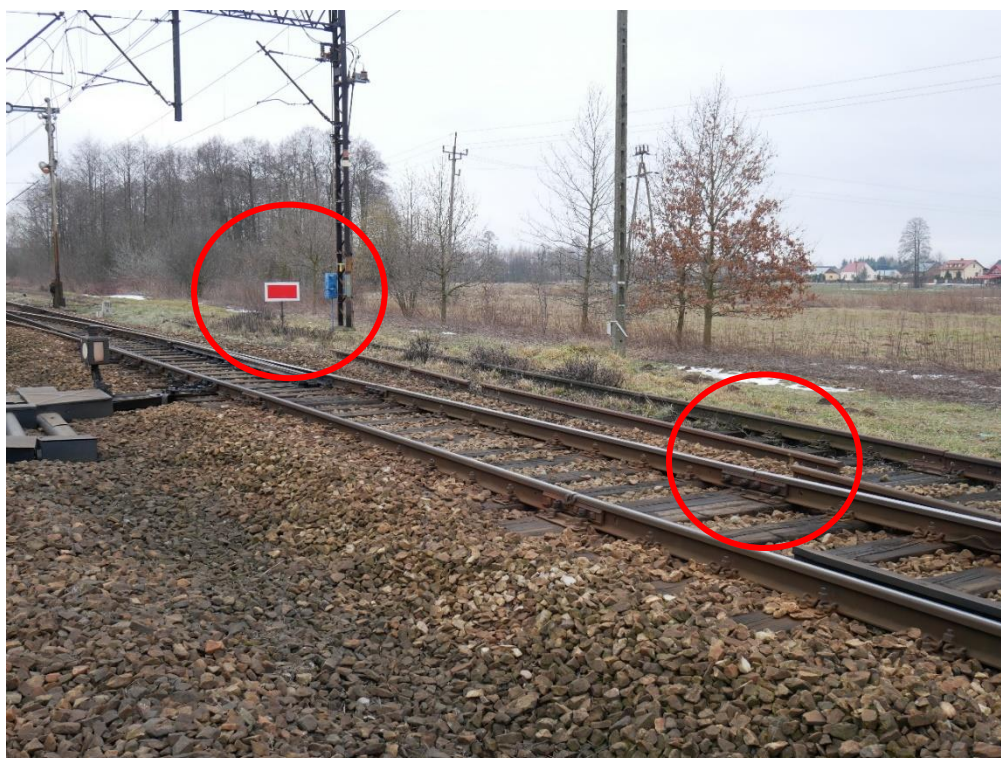
- Unfinished decommissioning of track three, partial decommissioning of turnout no. 3, devastated semaphore B, not removed lever of inoperative semaphore B.
- D1 disc set contrary to regulations.

**Photo 6 – closed track 3 and discontinuity of track 3 beyond the crossroad of turnout no. 3**

- 6) To ensure safety of train traffic on routes a<sup>1</sup><sub>1</sub> b<sub>2</sub> and a<sup>2</sup><sub>3</sub> PKP PLK S.A., Rzeszów Railway Department, shall restore the technical condition of infrastructure in Grodzisko Dolne station to the currently existing technical documentation.

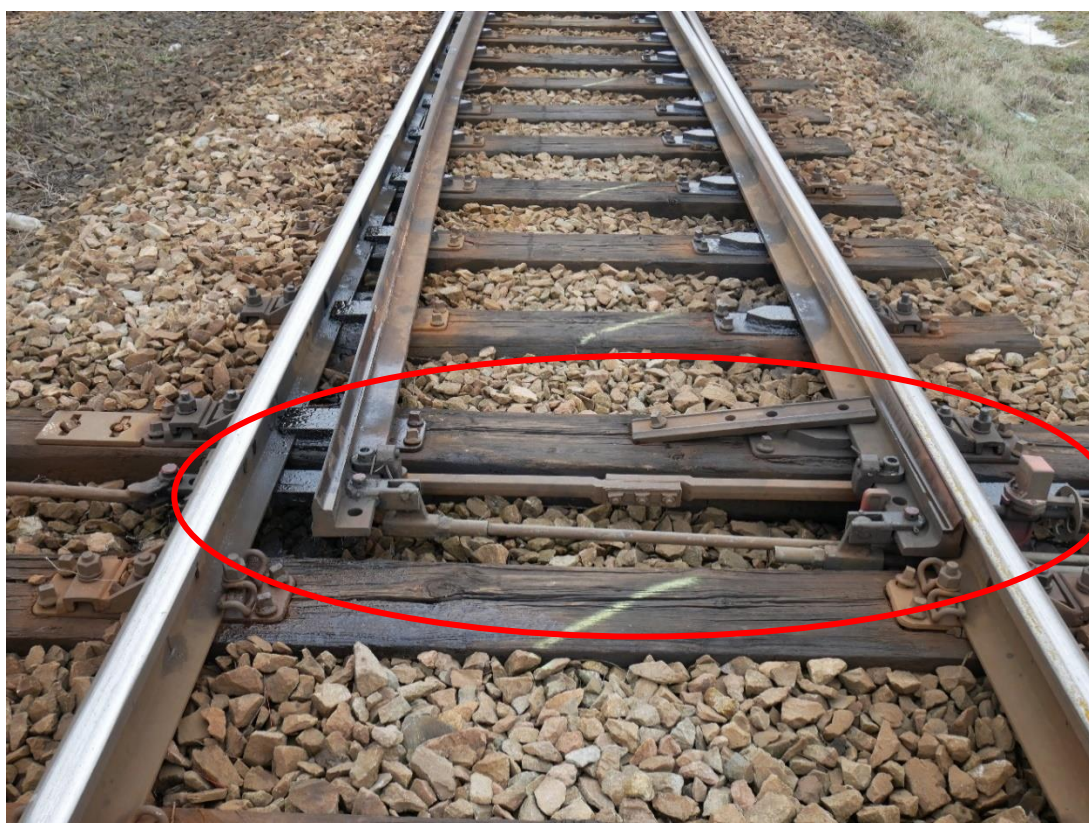
**Photo 7- Method of securing the crossover of turnout no. 3 (photo by GDPWK)**

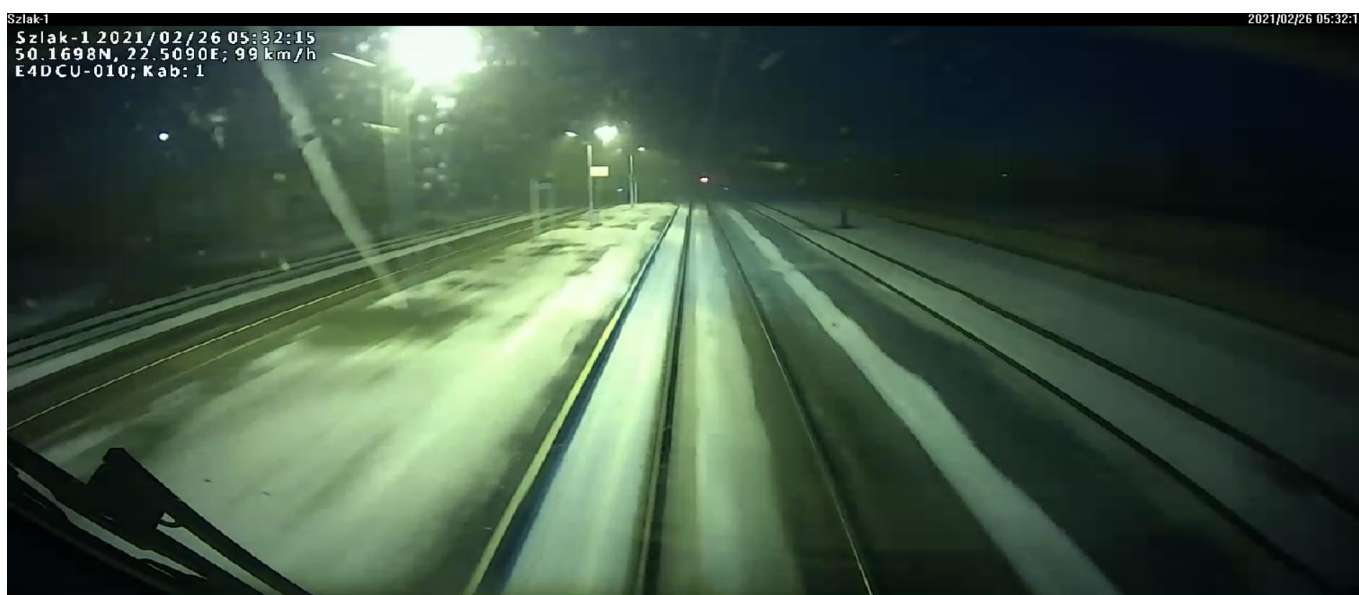
Photo 8 – view from the driver's cab of train MPE38100 travelling on track 2 when train LSS335064 was travelling on track 4 and was 20 metres in front of exit semaphore D.

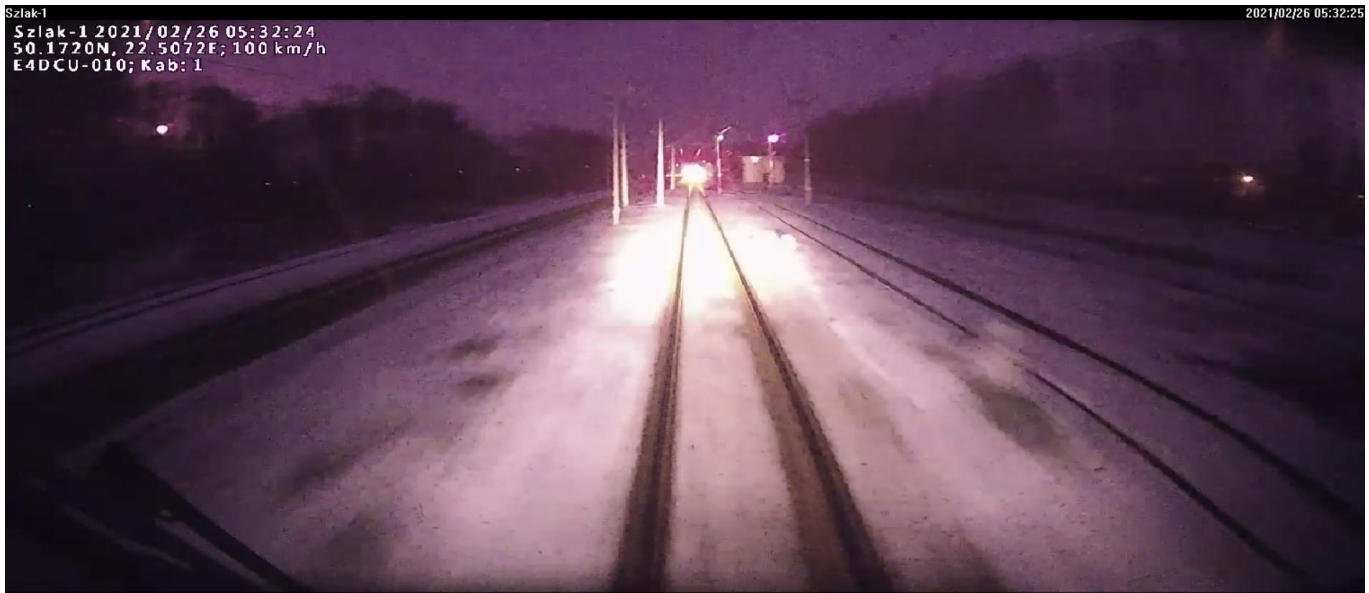
Photo 9 - view from the cab of a train travelling on track 2 at the time it implemented emergency braking as train LSS335064 entered its path, i.e. 99 metres ahead.
