STATE COMMISSION ON RAILWAY ACCIDENT
Ministry of the Interior and Administration

REPORT No. PKBWK 01/2022

**from the procedure in case of serious train accident on 04 April 2021 at 09:10 on route from
Oborniki Wielkopolskie - Rogoźno Wielkopolskie, on track no. 1, railway-road crossing
category D at km 30.453 of railway line no. 354 Poznań Główny POD – Piła Główna**

WARSAW, 23.02.2022 r.

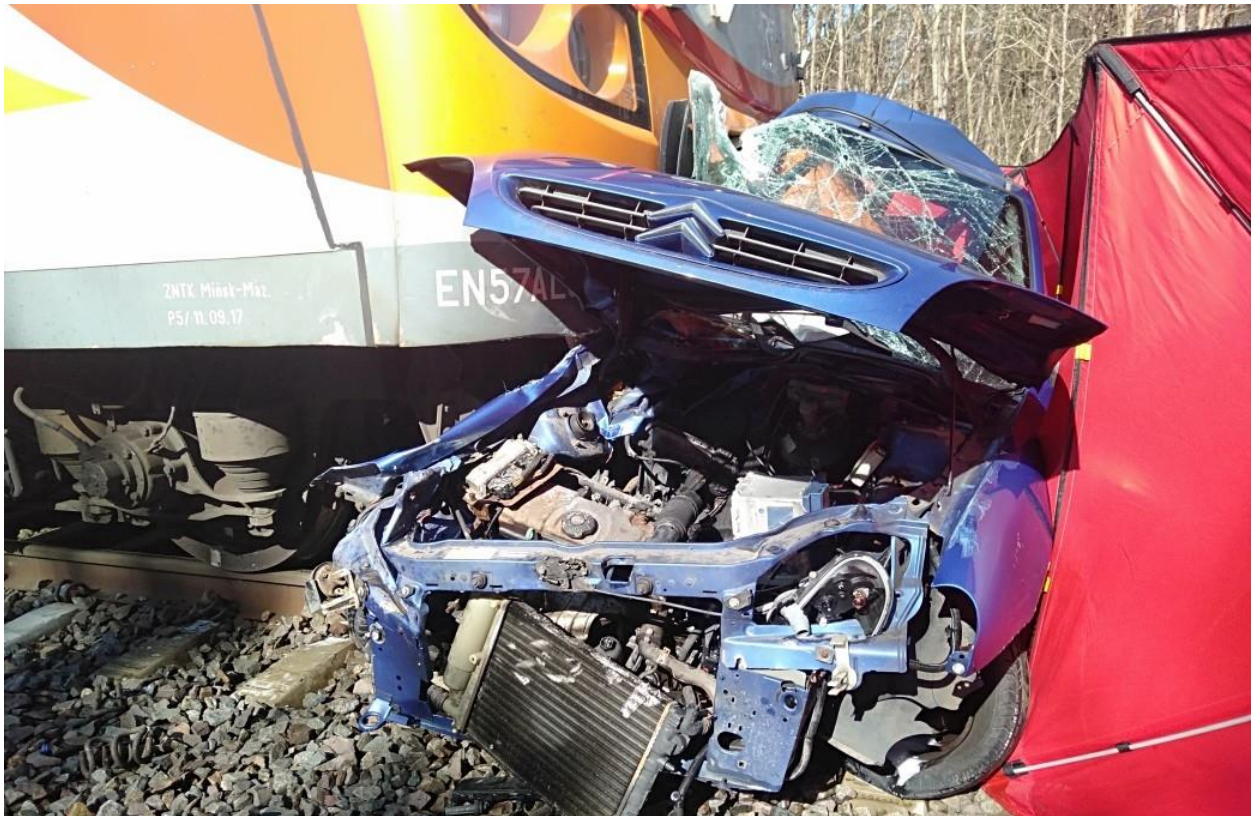
Consequences of the event: As a result of the incident, the driver of the road vehicle died on the spot, a passenger car was destroyed and a railway vehicle was damaged.

Photo 1. Image of the effects of the incident (source: GDPWK)

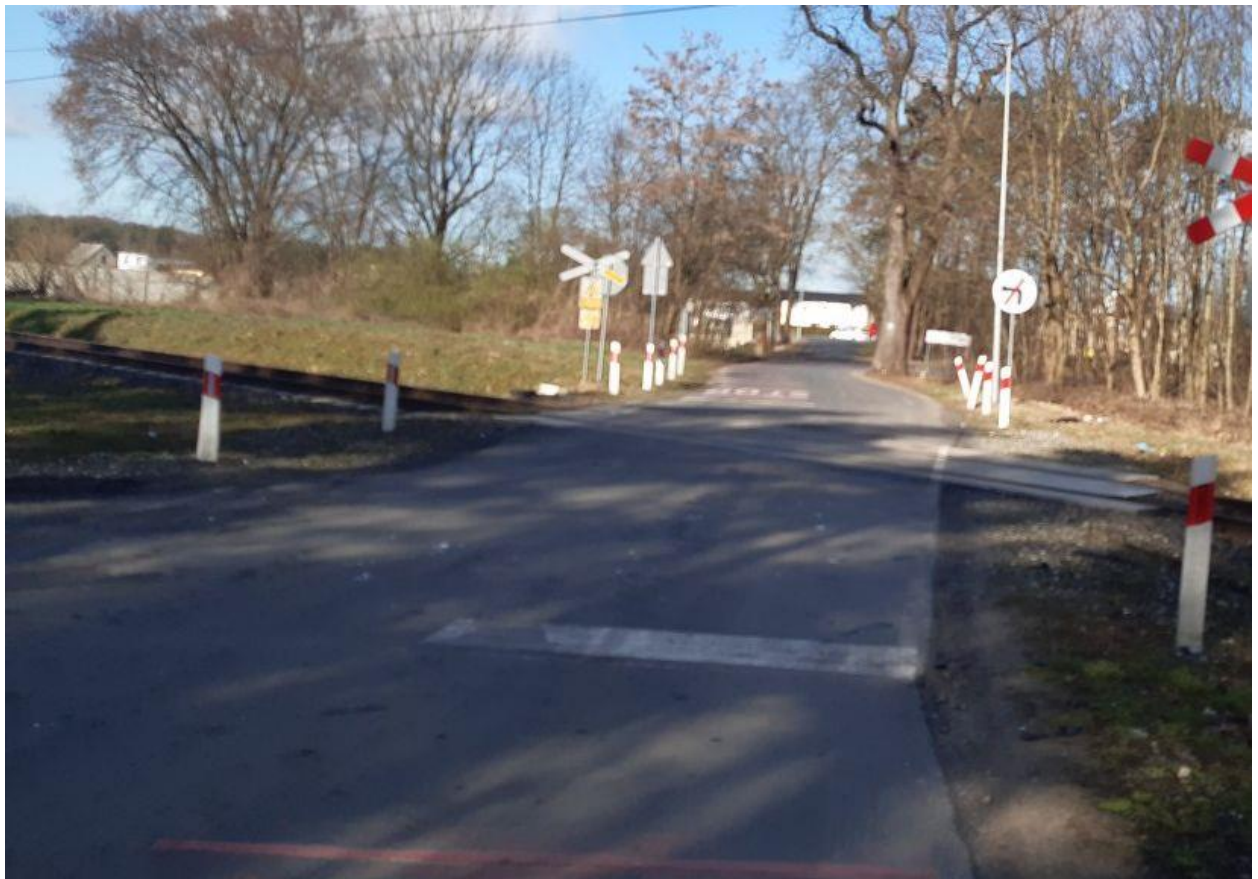
Photo 2. View of the scene(source: GDPWK)

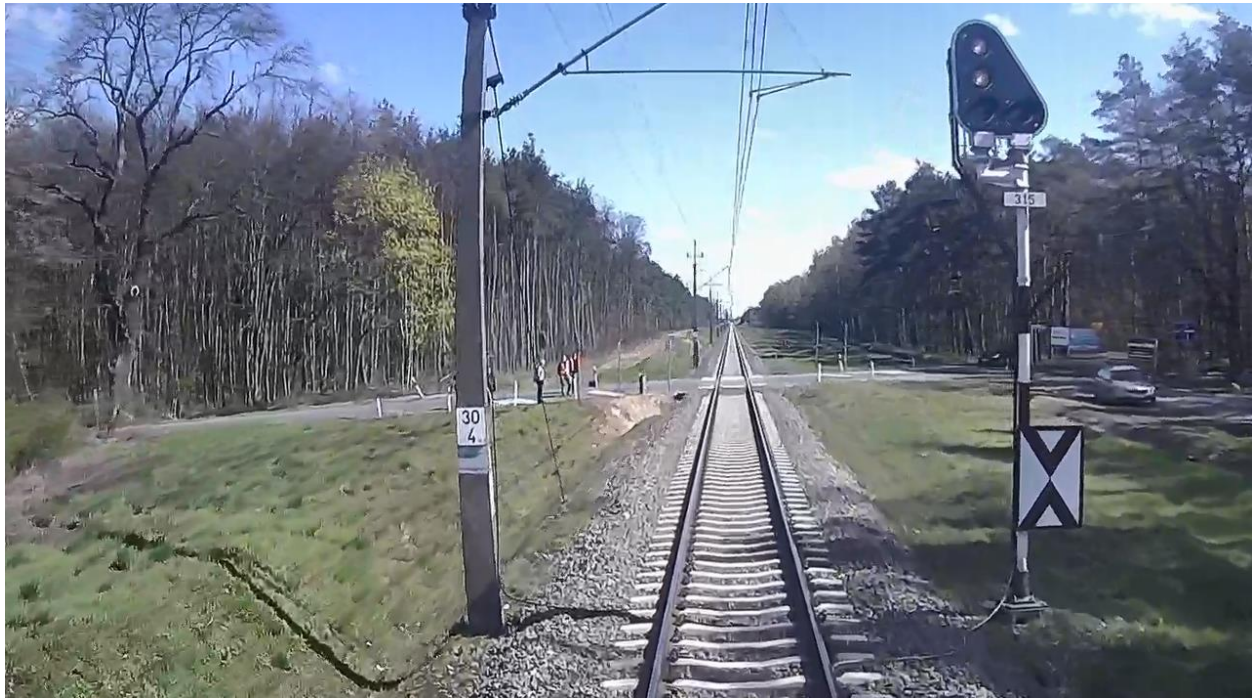
Photo 3. View of a level crossing from the cab of a railway vehicle from the direction of train travel (source: GDPWK)

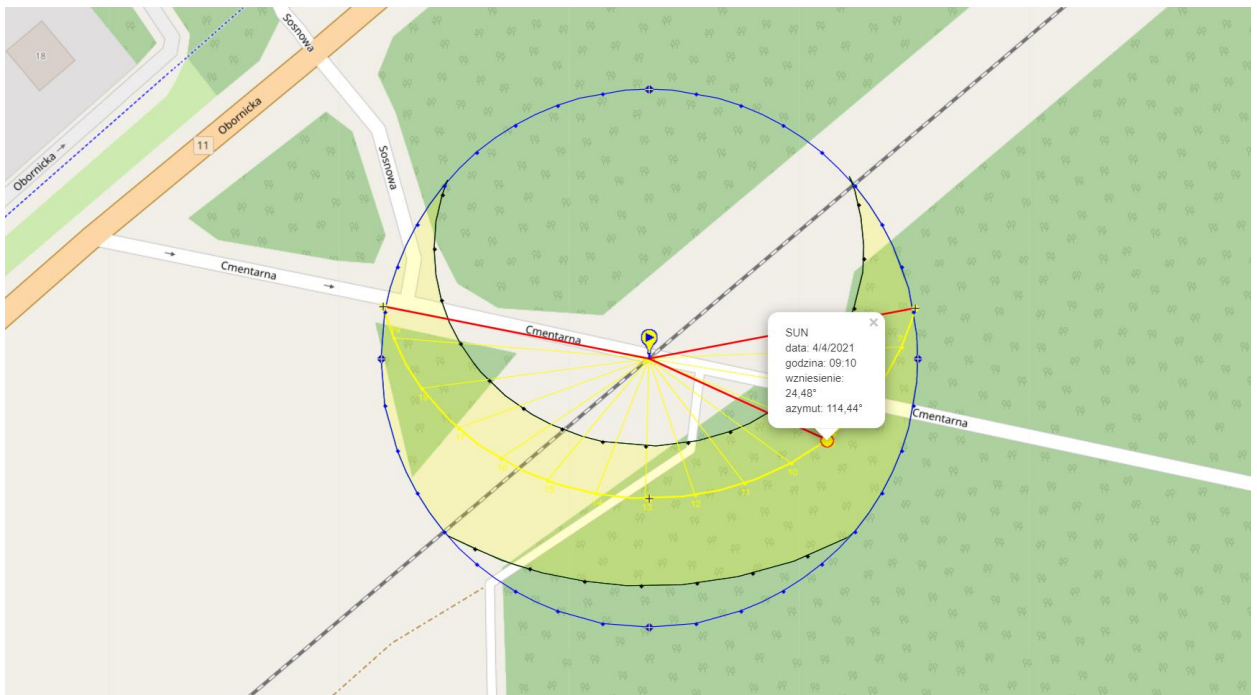
Photo 5. The position of the sun at the time of the event (source: Sunearthtools.com)

The incident took place in good weather conditions, without rain or fog. It was early morning, the sky was cloudless, sunny, the sun was low above the horizon, the direction of the sun's rays was along the road towards the oncoming car, the temperature was about 5° C. Within the railway-road crossing at the time of the incident there were no other road users likely to absorb the attention of the driver of the road vehicle. No work was carried out in the area of the rail-road crossing.

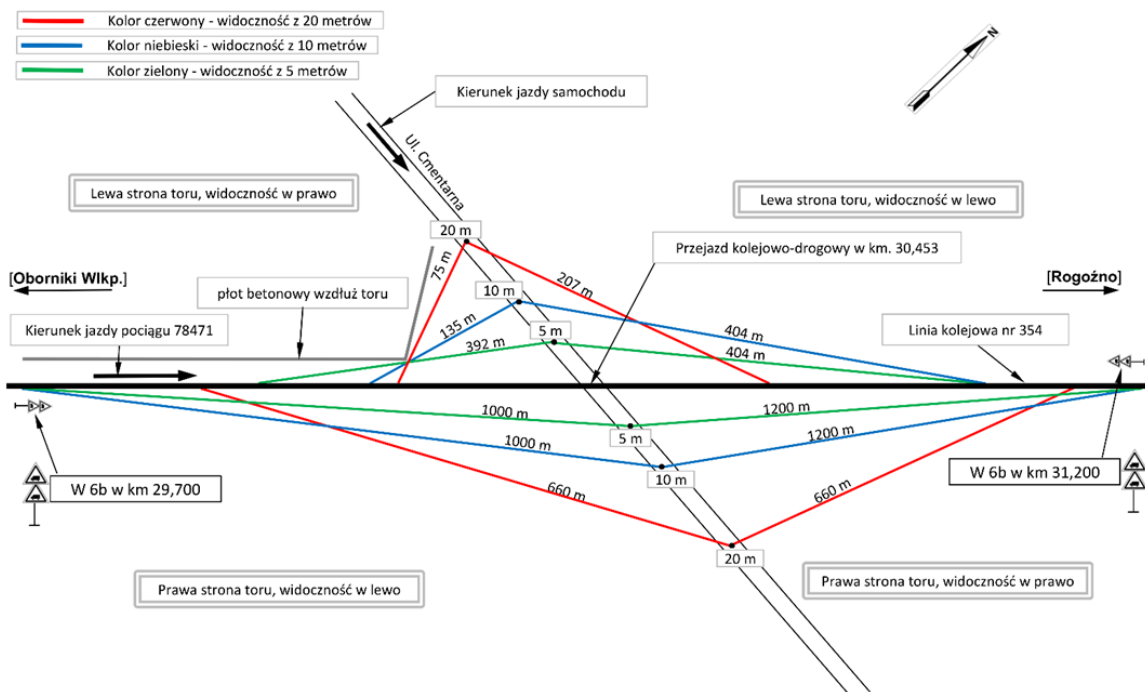
Figure 2 - Triangles of visibility of the train front from the road measured by the Study Team (developed by GDPWK)

The yellow colour in Table 2 indicates the distances measured by the Study Team for visibility of the train front from the direction of travel of the road vehicle.

The investigation team found that the visibility parameters for the train front from the access road as stated in the level crossing metric were not consistent with the facts. On the day of the accident, a train speed of up to 120 km/h was in force at the level crossing. The visibility values given in the rail-road crossing metric allowed train speeds of up to 100 km/h. Taking into account the non-conformities found, the Chairman of the GDPRC issued a recommendation to measure the visibility of the train front from the approach road using a railway vehicle of the same type as in the incident. The results of the measurements are entered in Table 2 and plotted in Figure 2.

Analysing the collected material, the Investigation Team found that the visibility conditions had not changed since the date of the entry of the visibility measurements in the metric of the level crossing, i.e. 20.08.2020. The visibility of the train front was mainly limited by a concrete fence and concrete traction poles (Photo 6). From the measurements made by the Research Team, it is clear that with a train head visibility of 392 metres from 5 metres, the speed of trains within the railway-road crossing should not exceed 70 km/h. In the opinion of the Investigation Team, the data contained in the rail-road crossing metric regarding the visibility of the train front did not reflect the actual situation. The actual conditions of visibility of the train front from the road indicated that the speed of the trains had to be reduced.

- 3) Infrastructure managers shall take measures to improve the quality and depth of inspections, diagnostic tests and the way the visibility triangle of level crossings is measured. When measuring visibility triangles account must be taken of the fact that the visibility of the train head from 5 metres from the outermost rail must be continuous (not obscured by any objects as the train approaches the level crossing) and must include the front end signal lanterns. If this condition is not complied with, the speed of trains in the area of level crossings shall be reduced in accordance with the legislation in force.

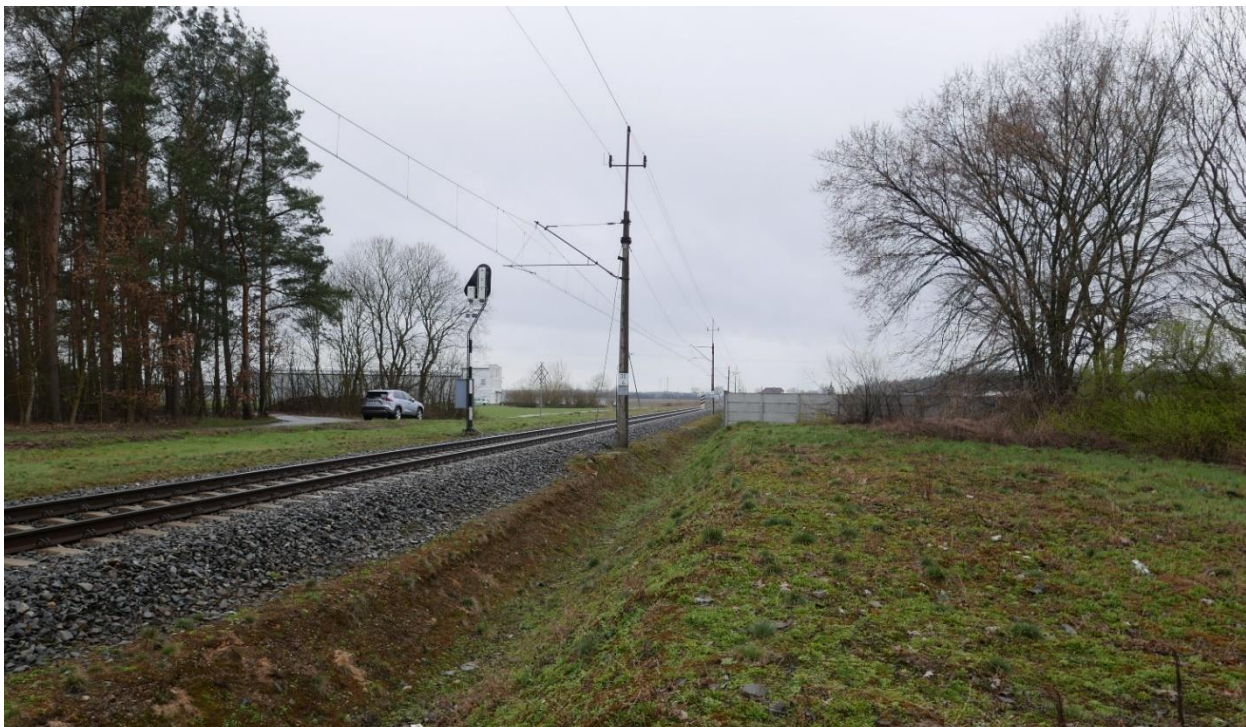
Photo 6. Visibility from 5 m (source: GDPWK)

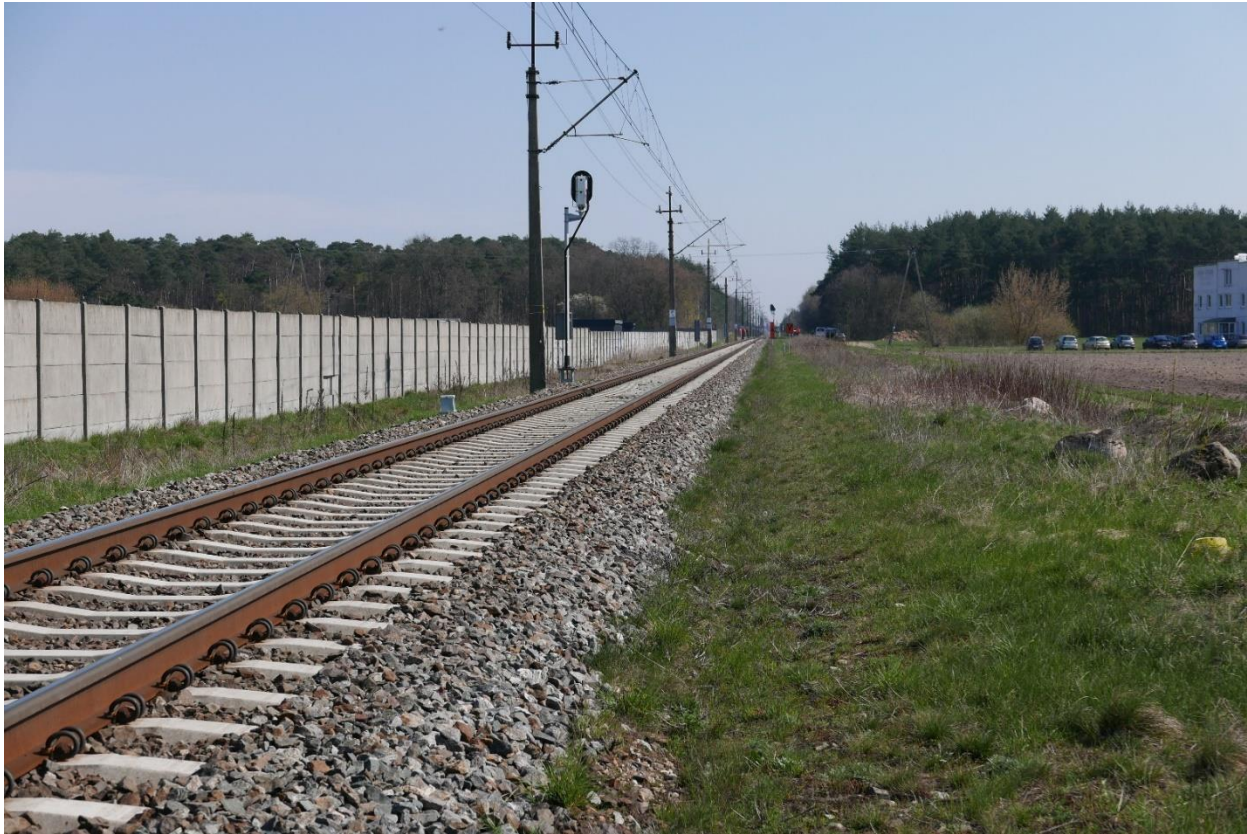
There was a 375 m long fence made of prefabricated concrete elements on the left side of the track before the level crossing from the Oborniki Wlkp station. The height of the fence was 2.0 - 2.5 m, the distance from the rail from 5.0 m to 7.5 m. The fence ends approximately 50m before the level crossing and restricts visibility for drivers of railway and road vehicles.

On the same side of the track as the fence there are concrete catenary poles also limiting the field of vision.

Photo 7. Fence and traction poles restricting visibility (source: GDPWK)

The committee requested that the built-up concrete fence near the rail-road crossing be surveyed and replaced with an openwork fence by the property owners.

During the course of the investigation, the concrete fence was altered and part of it replaced with an openwork fence in order to improve the visibility of the front of the train and the approaching road vehicle.

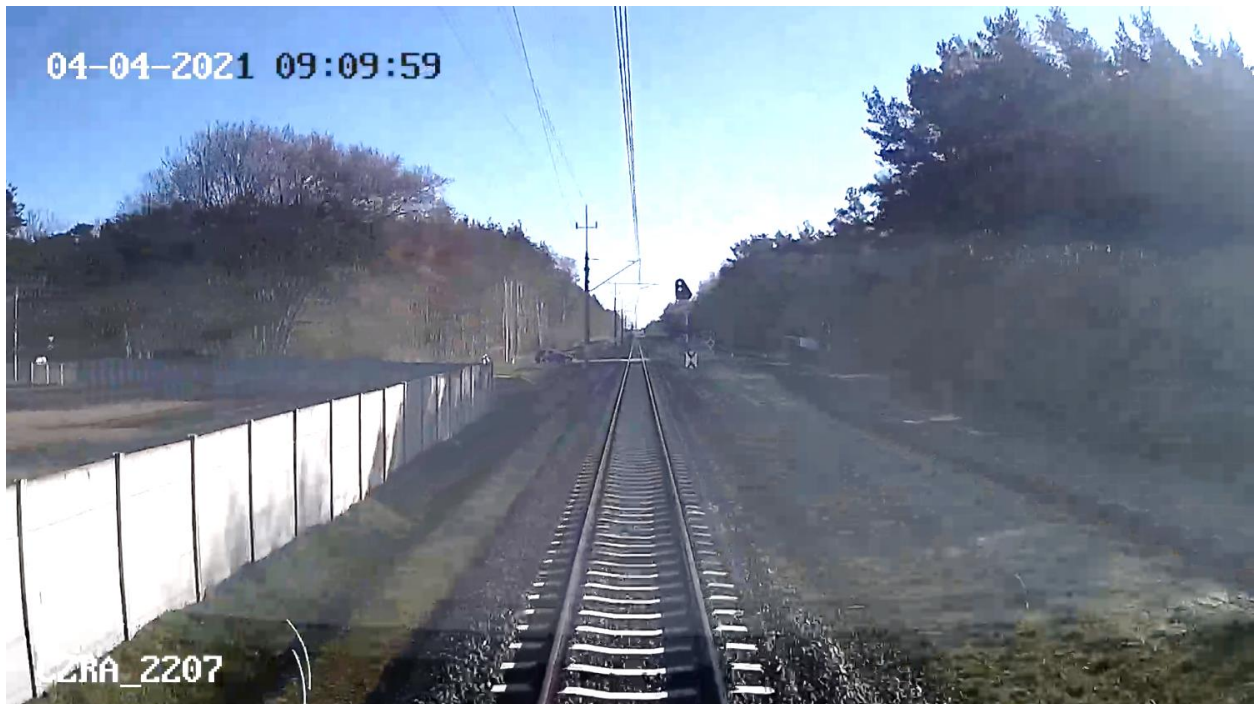
Photo 8. View from the driver's cab just before the collision - about 100m to the level crossing, 09:09:59 (source: GDPWK)

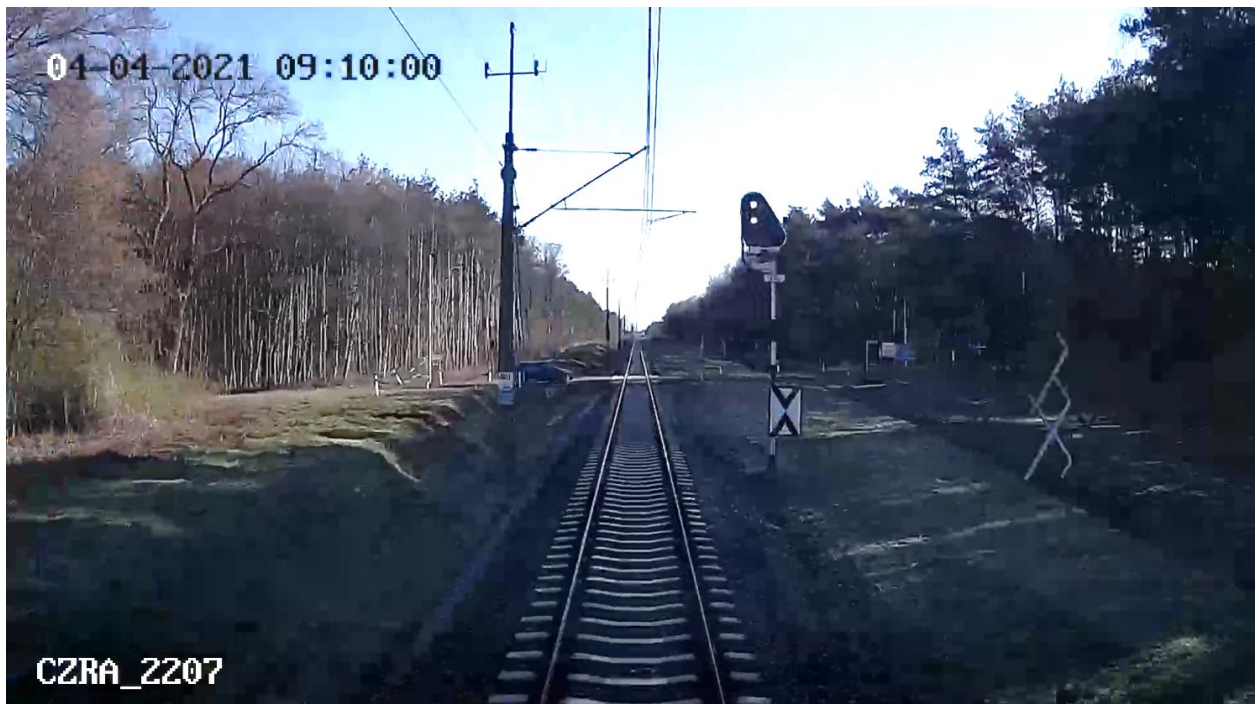
Photo 9. View from the driver's cab just before the crash - about 64m to the rail-road crossing, 09:10:00 (source: GDPWK)

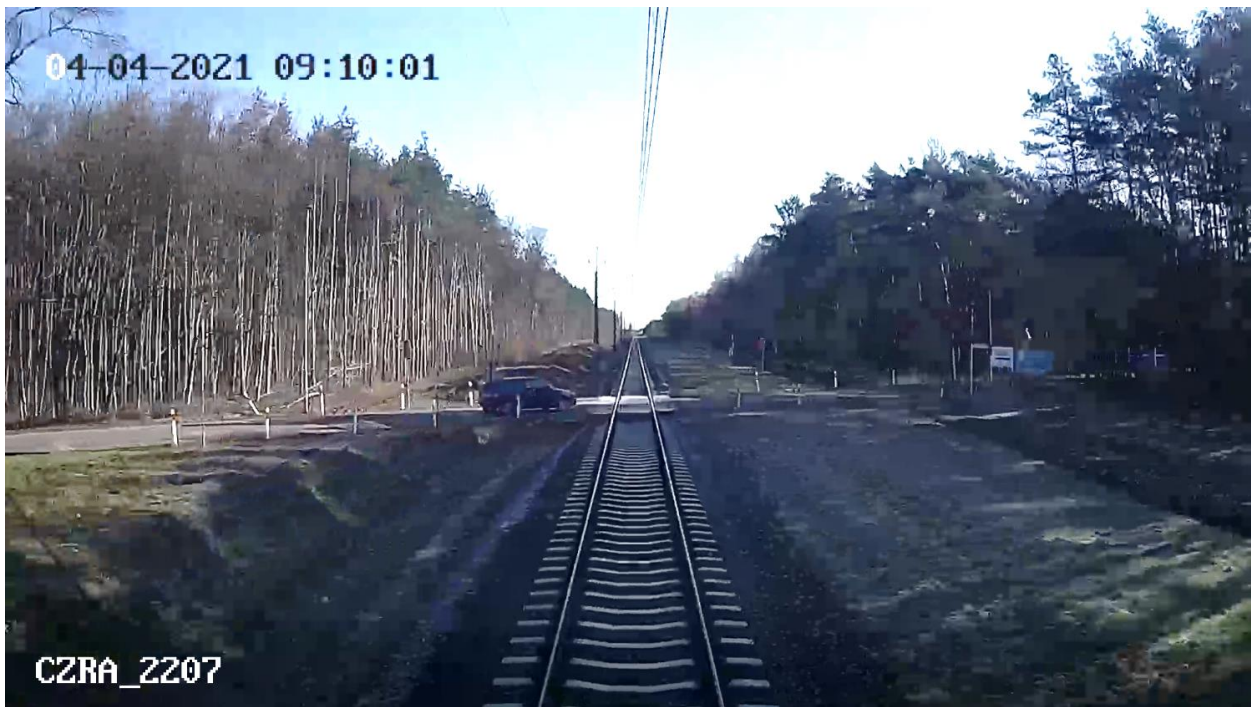
Photo 10. View from the driver's cab just before the crash - approximately 39m to the level crossing, 09:10:01 (source: GDPWK)

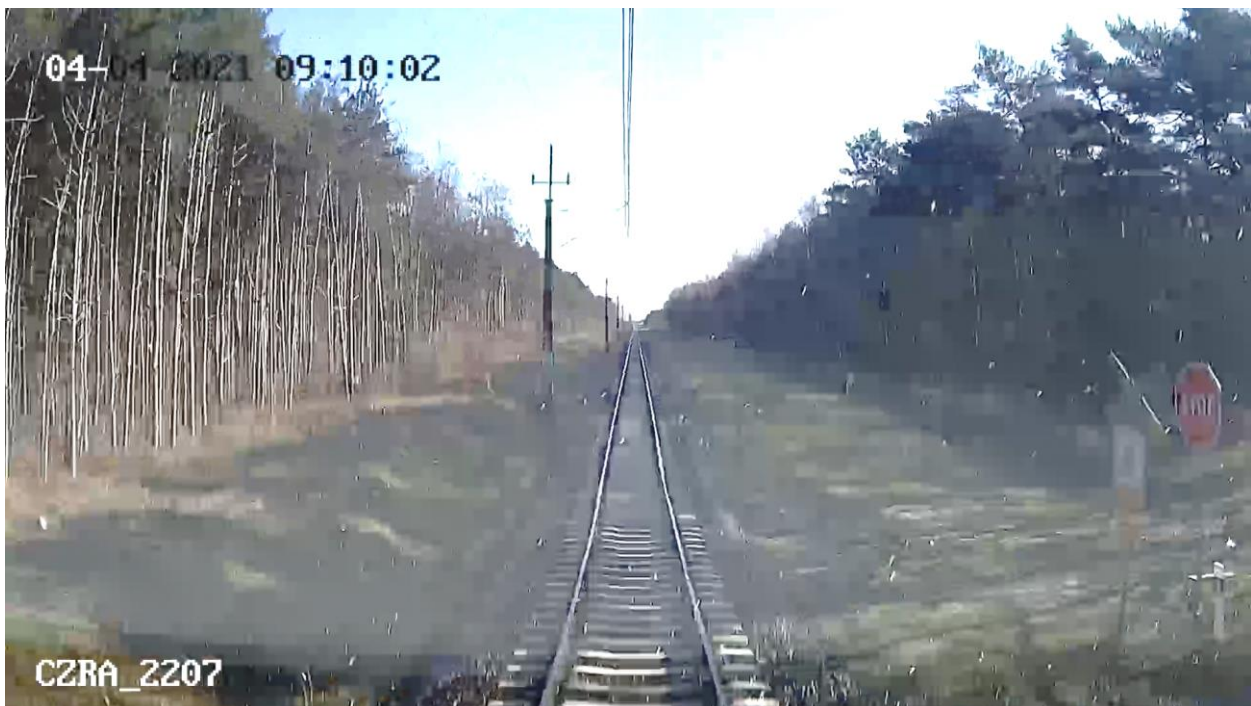
Photo 11. View from the driver's cab at the time of the crash - 09:10:02 (source: GDPWK)

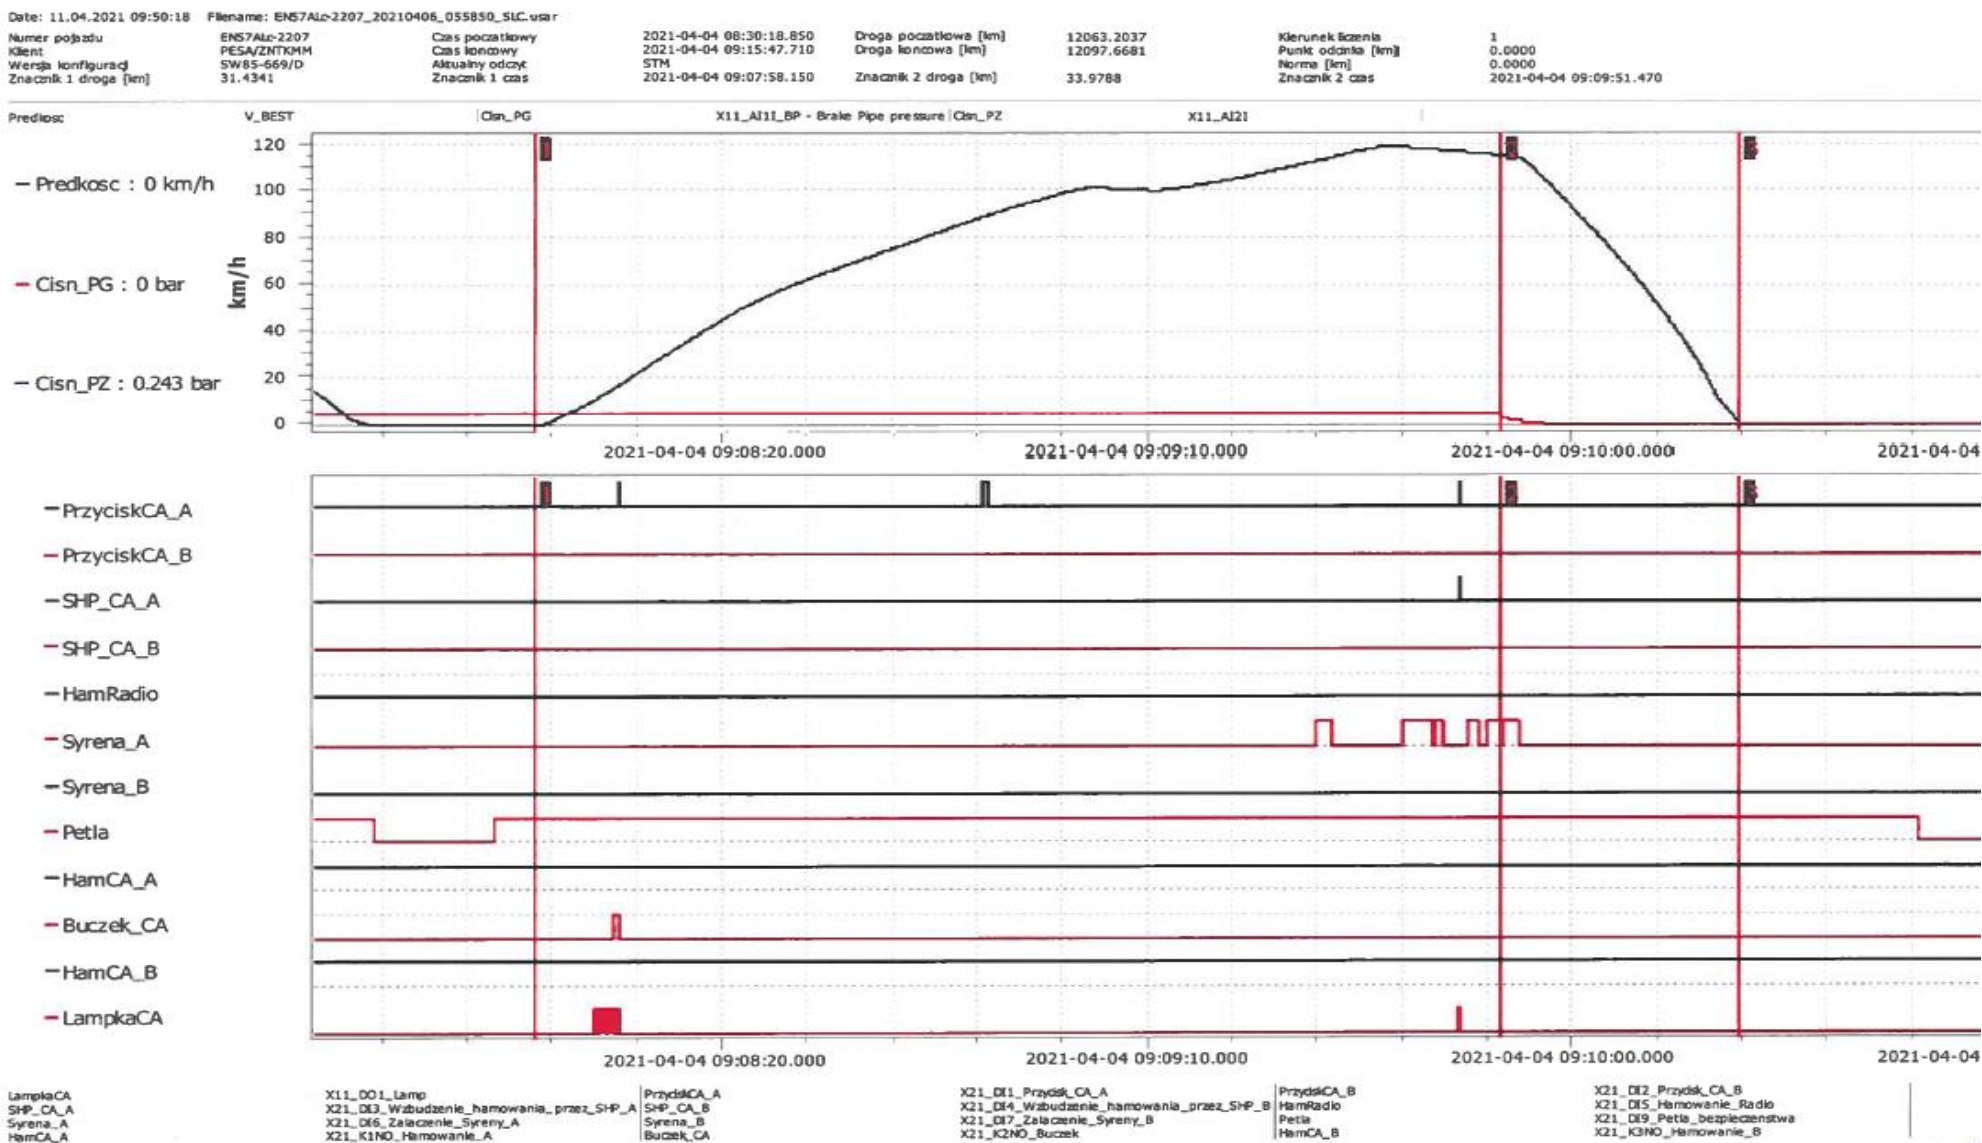
Figure 3 - Graph of EN57ALc-2207 driving parameters as a function of time (developed by GDPWK)

The above diagram shows, inter alia, the following running parameters of train ROJ 78471:

1. speed,
2. pressure in the main line,
3. pressure in the air reservoir,
4. use of the active standby button,
5. use of the SHP button,
6. use of an audible signal,
7. cab identification - control from cab B.
