STATE COMMISSION ON RAILWAY ACCIDENT INVESTIGATION
Ministry of the Interior and Administration.

REPORT No. PKBWK 05/2022

**from the investigation regarding a serious train accident that occurred on 15 June 2021
at 10:05 at Kochanówka Pustków station
on track no 1, level crossing category C at km 313.328 of railway line no. 25 Łódź
Kaliska – Dębica
PKP PLK S.A. infrastructure manager area Zakład Linii Kolejowych [Railway Facility]
in Rzeszów**

WARSAW, 31 May 2022

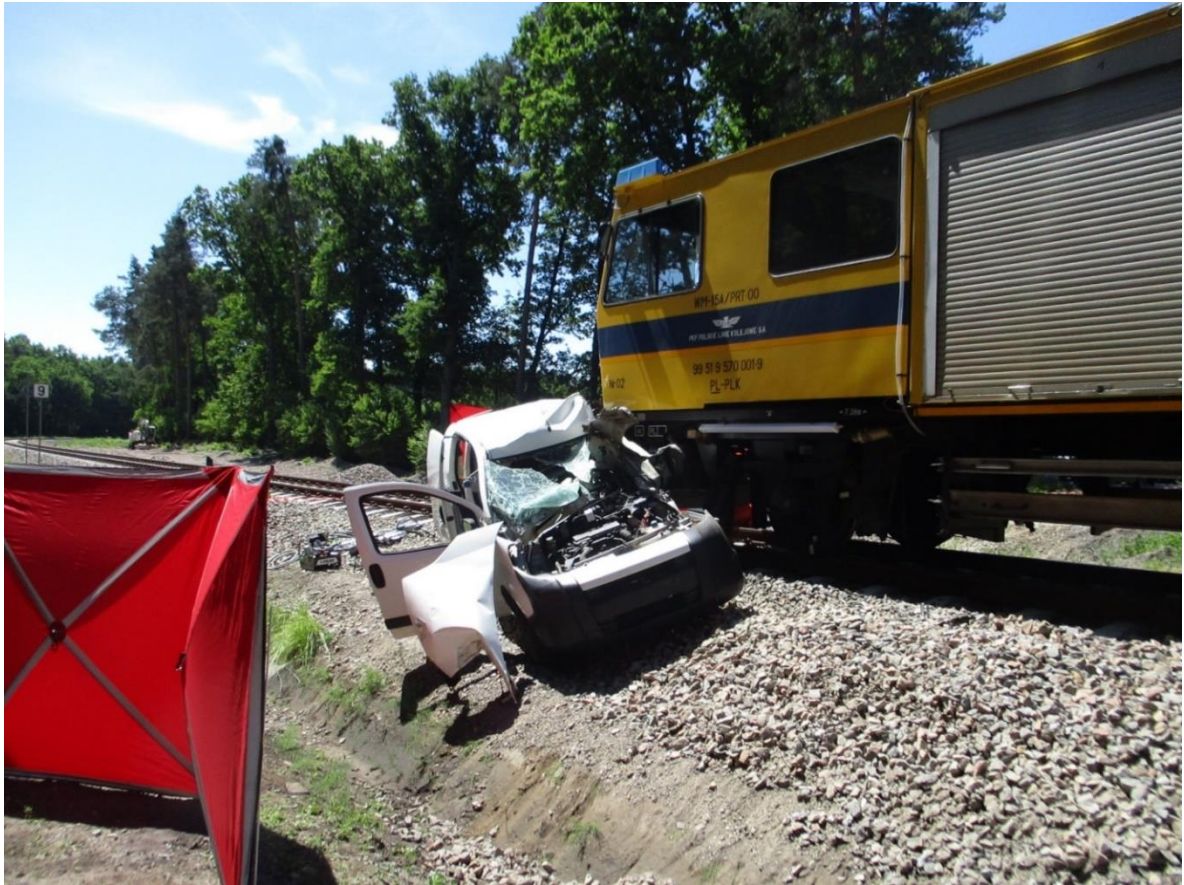
Photograph 1 – Consequences of the Incident (PKBWK own material)

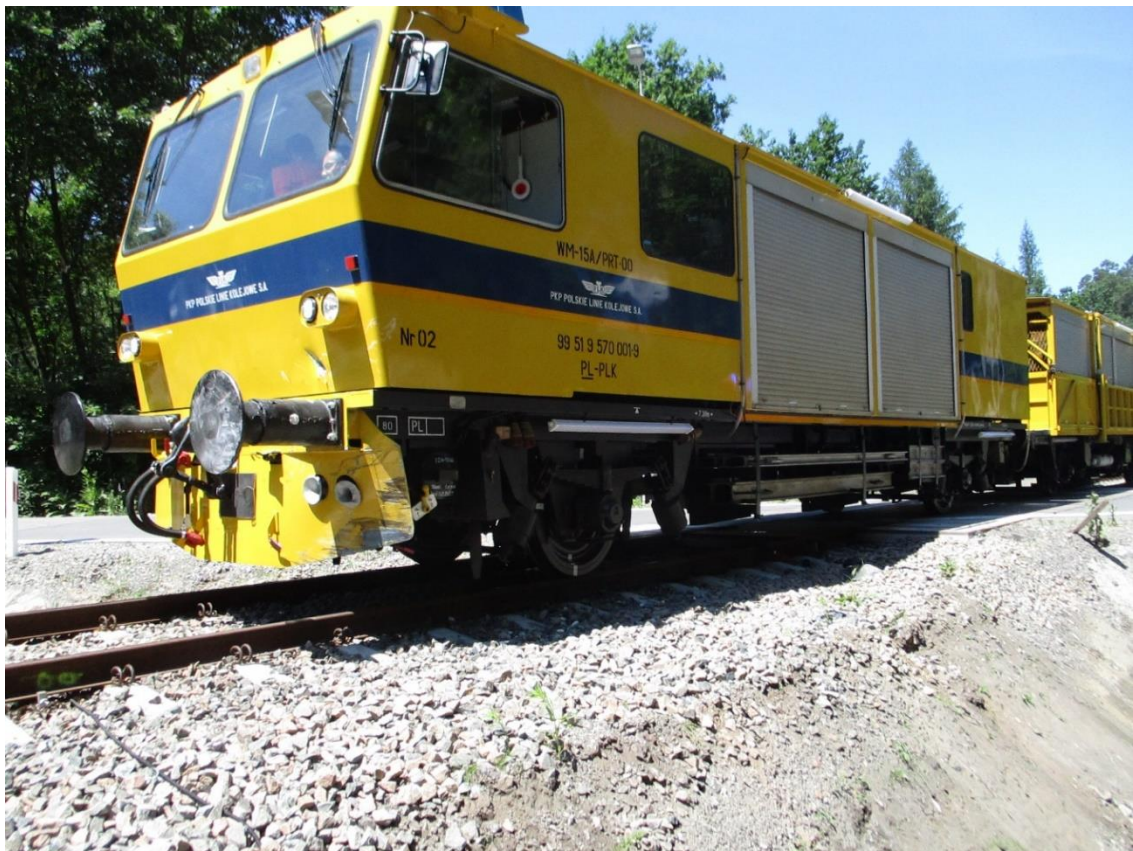
Photograph 2 – Damage to the motor carriage (PKBWK own material)

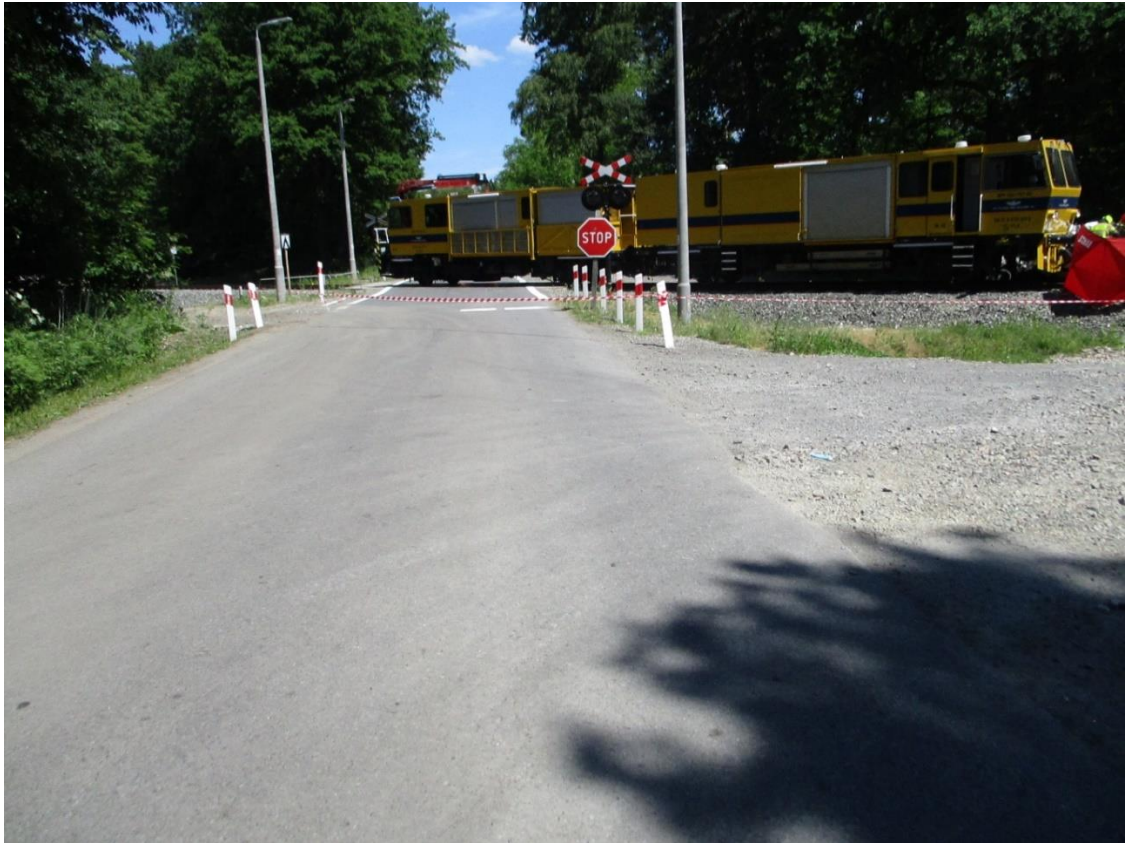
Photograph 3 – Positioning of the motor carriage after the incident (PKP PLK S.A. material)

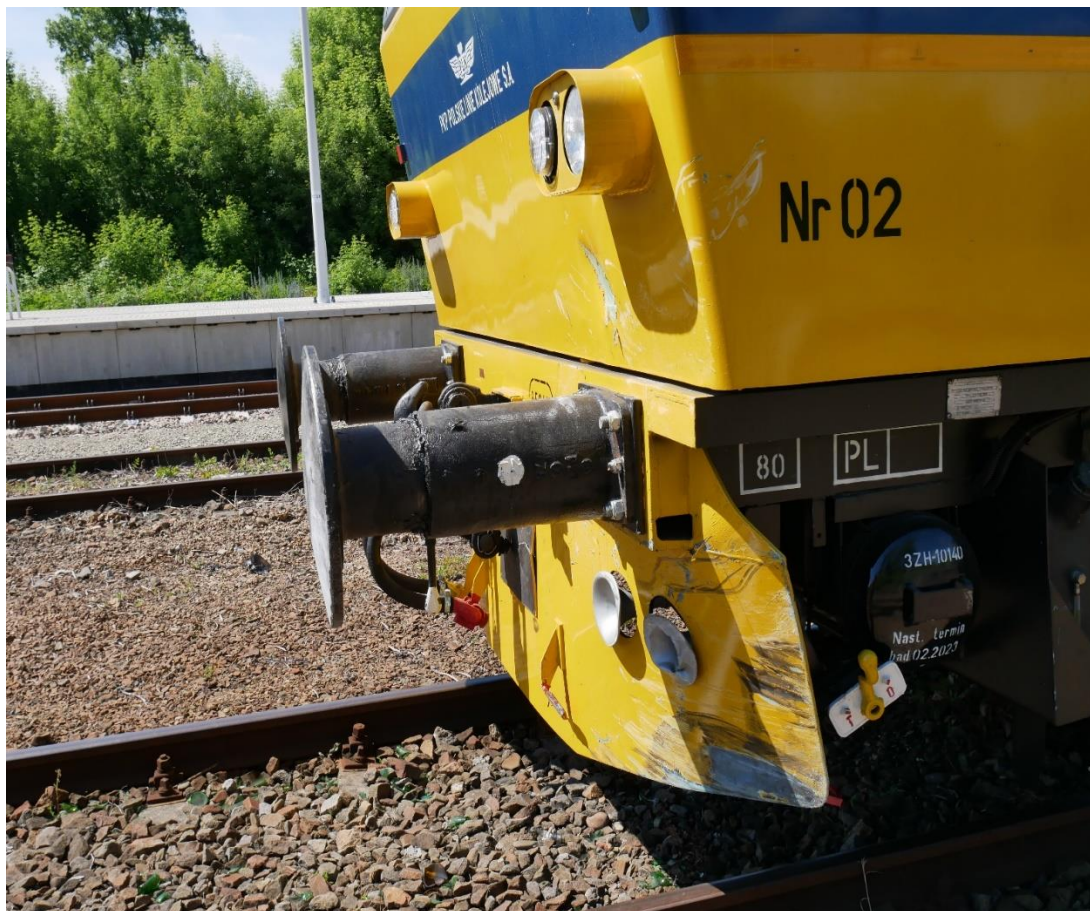
As a result of the incident, the WM-15A/PRT-00 No 02 motive power unit was damaged on the side of cabin A (according to PKP PLK S.A.):

- damaged rail scraper (deflected),
- damaged brake coupling no end cock (broken),
- damaged handle on the end cock,
- damaged brake coupler hanger,
- damaged sound signals, high and low frequency siren and installation,
- deflected T/O rocker arm with the shifting mechanism,
- damaged 521 air reservoir, bent bottom plate – to be replaced,

- WEBASTO fuel tank mounting deflected,
- left bumper to be repaired, right bumper to be checked at the repair station.

Photograph 6 – Damage of the railway vehicle after the accident (by PKBWK)

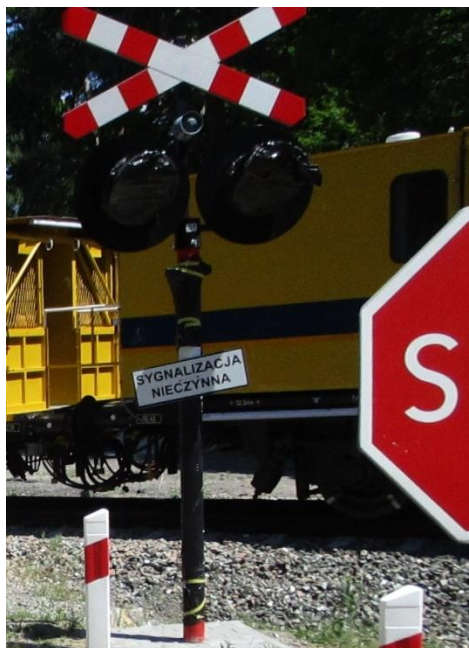
Photograph 7 – “signalling out of order” sign placed on the traffic signal

- the lenses of the traffic signal lights were covered with black film and the signals were not turned in a manner allowing the users of the crossing to see the signalling chambers, which could have caused the passenger car driver to misinterpret that the ssp equipment was operational and the signal was not active because a train was not approaching,

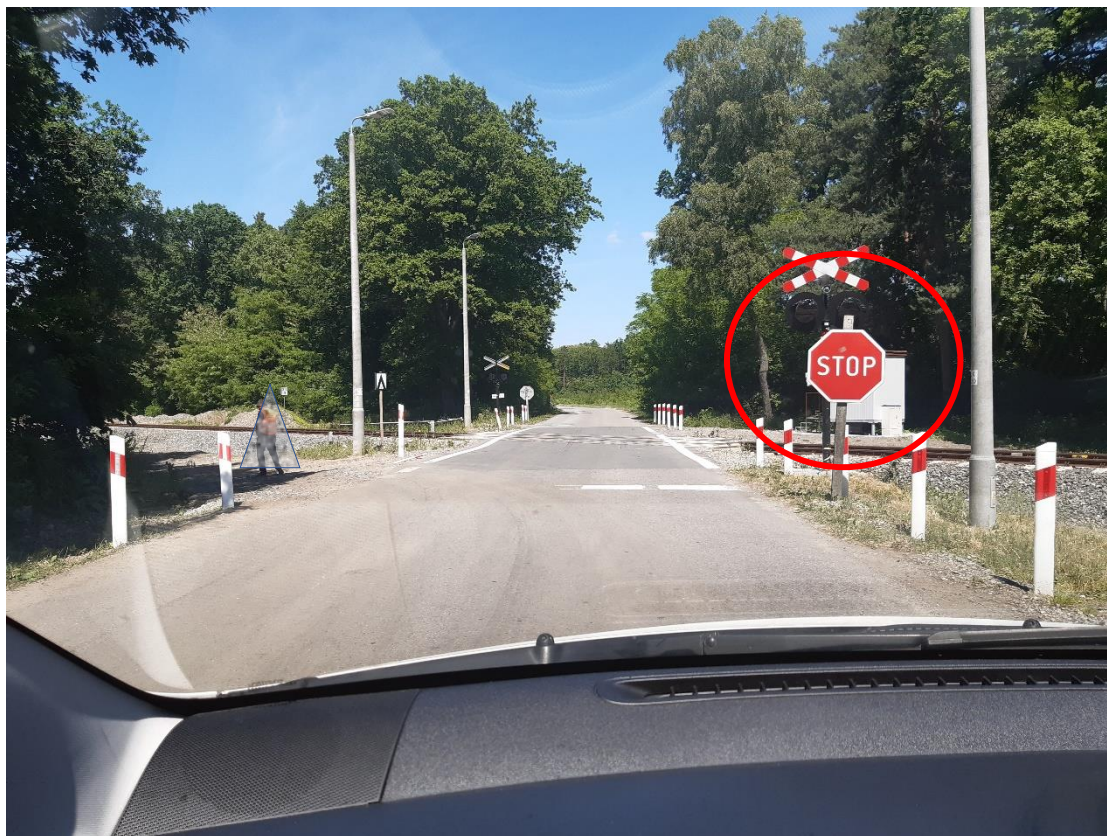
Photograph 8 – Sign B-20 obscuring the “signalling out of order” sign

1. improperly placed B-20 "stop" sign obscuring the plate indicating that the signalling system is out of order – at the side of the passenger car,
2. The lenses of the traffic signal lights were covered with black film and the signals were not turned in a manner allowing the users of the crossing to see the signalling chambers, which could have caused the passenger car driver to misinterpret that the ssp equipment was operational and the signal was not active because a train was not approaching.

- 1) Labelling the level crossing at 313.328 km of railway line no. 25 at the access roads of district road no. 1283R Brzeźnica – Krownice to the crossing with P-12 and B-20 signs pursuant to the applicable laws.
- 2) Introducing a 50 km/h speed limit on road no. 1283R on the accesses to the crossing due to the occurrence of an increased risk of accidents related to excessive speed.
- 3) Setting up temporary A-7 signs on the accesses to the crossing with "Stop" signs stating the distance from the location of the B-20 sign until the formal introduction of a speed limit.

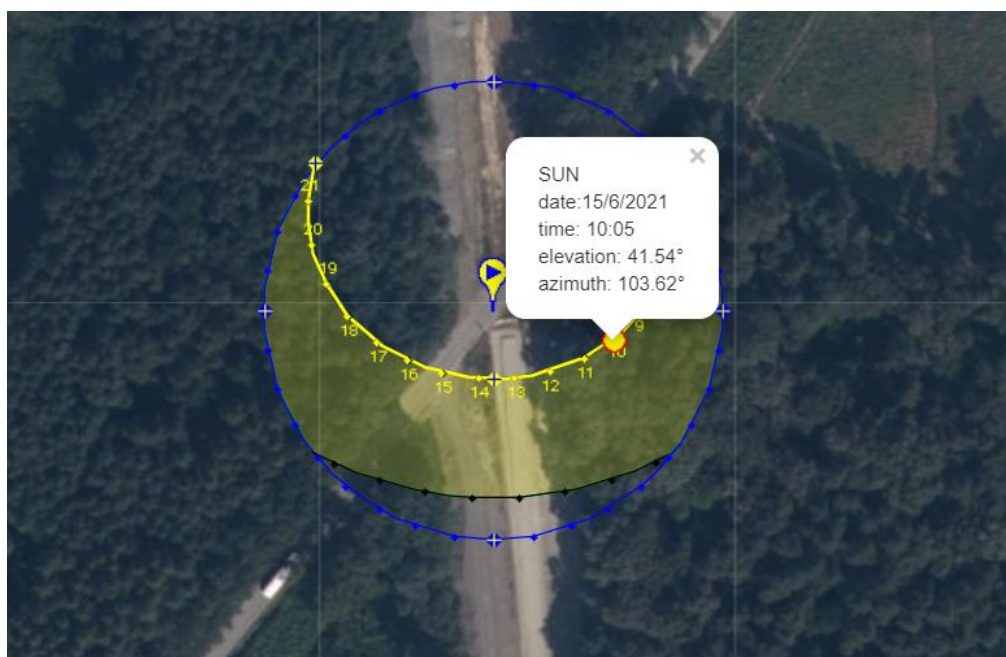
The incident took place in the morning with good air clarity, the sun was not obscured by clouds. The position of the sun had no effect on the glare of the car driver. The incident occurred in an undeveloped but wooded area.

The Investigation Team concluded that weather conditions had no influence on the incident.

Photograph 9 – Sun position at the time of the accident (source: <https://www.sunearthtools.com>)

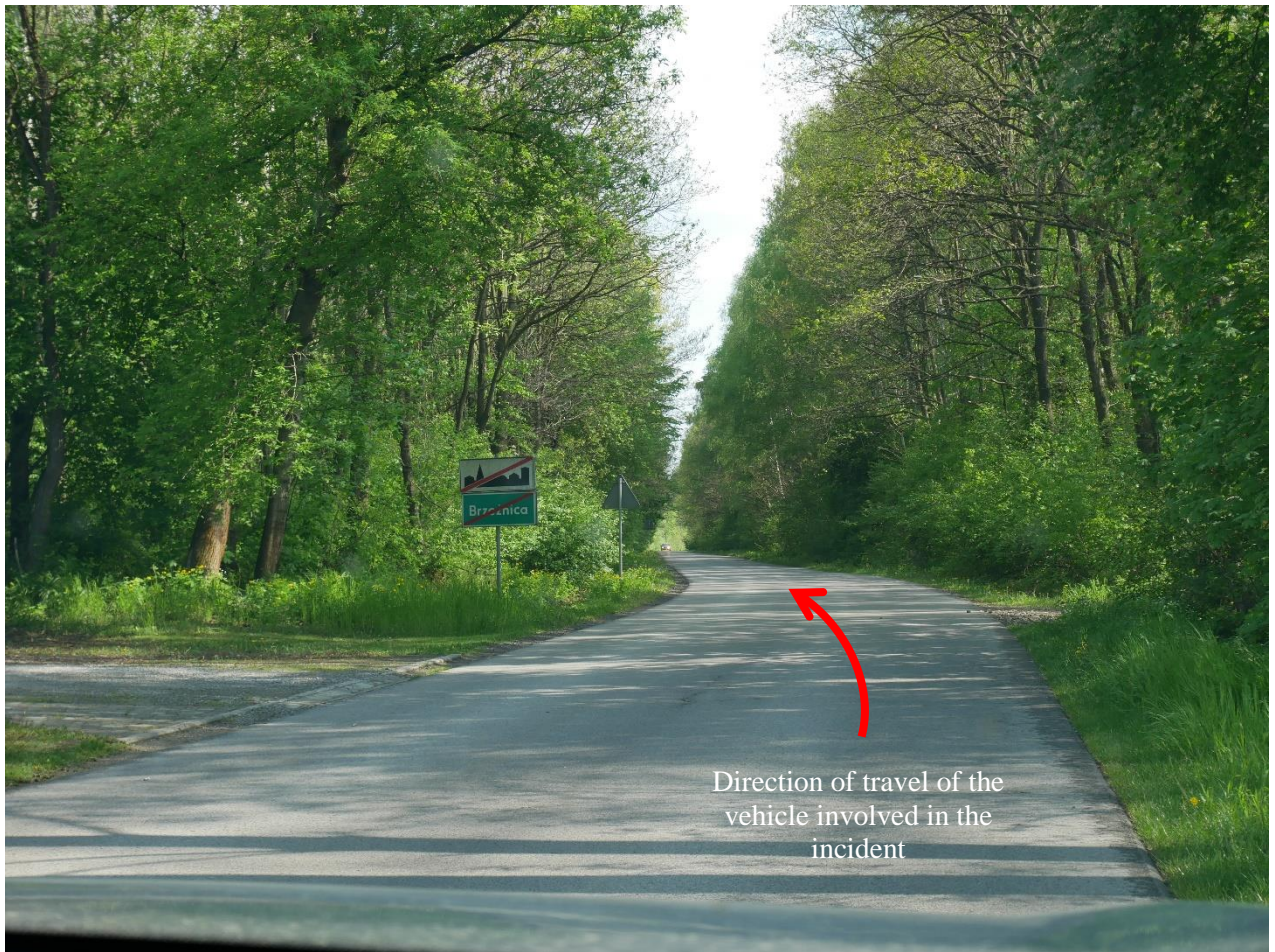
Photo 11 - Road markings in the direction of travel of a car involved in an incident at a level crossing (photo. PKBWK of 09.05.2022)

End of built-up area (50 km/h), start of road in undeveloped area towards the railway/road crossing in question (90 km/h).

- 4) The Road Manager is going to introduce the speed limit up to 50 km/h on the road no. 1283R by the accesses to the level crossing due to the occurrence of an increased risk of accidents related to excessive speed (in accordance with the issued recommendation ref. no. PKBWK.4631.5.2.2021 dated 14 July 2021).
