STATE COMMISSION ON RAILWAY ACCIDENT INVESTIGATION
Ministry of the Interior and Administration.

REPORT No. PKBWK 05/2022

**from the investigation regarding a serious train accident that occurred on 15 June 2021
at 10:05 at Kochanówka Pustków station
on track no 1, level crossing category C at km 313.328 of railway line no. 25 Łódź
Kaliska – Dębica
PKP PLK S.A. infrastructure manager area Zakład Linii Kolejowych [Railway Facility]
in Rzeszów**

WARSAW, 31 May 2022

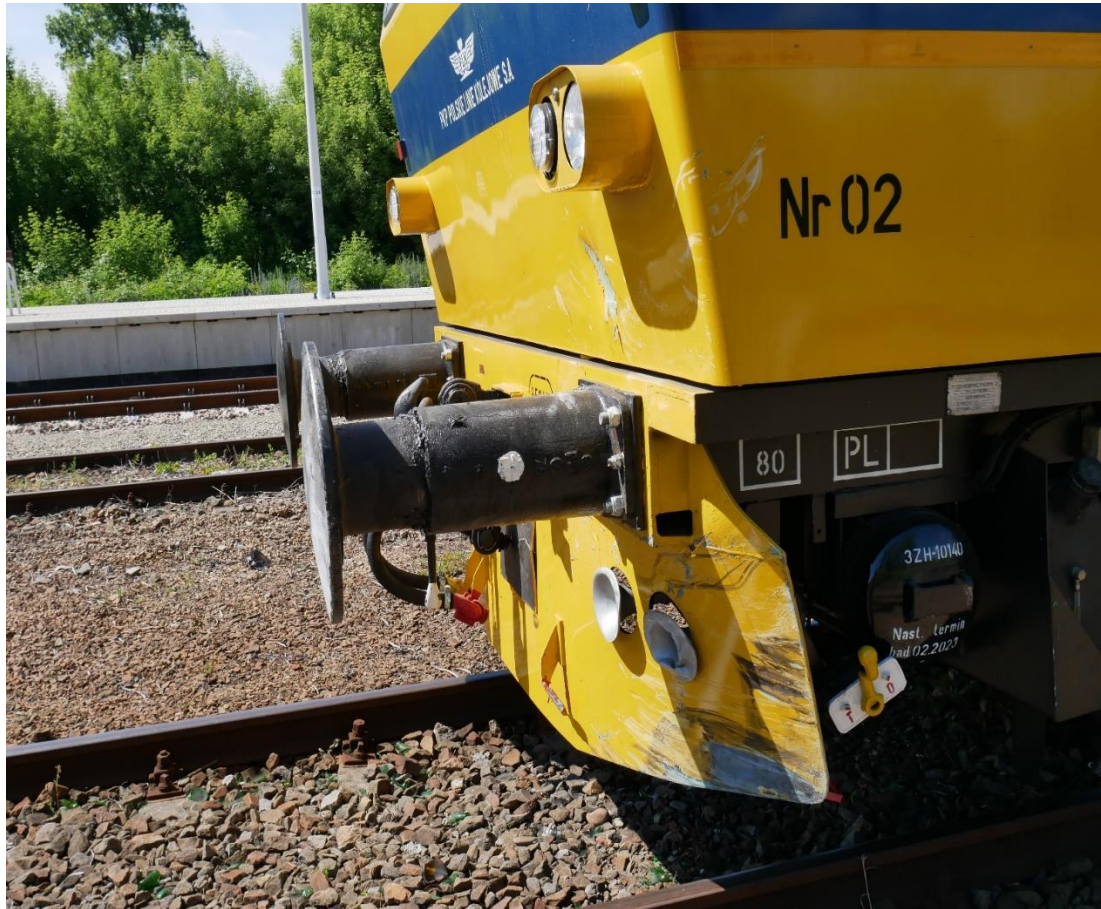
As a result of the incident, the WM-15A/PRT-00 No 02 motive power unit was damaged on the side of cabin A (according to PKP PLK S.A.):

- damaged rail scraper (deflected),
- damaged brake coupling no end cock (broken),
- damaged handle on the end cock,
- damaged brake coupler hanger,
- damaged sound signals, high and low frequency siren and installation,
- deflected T/O rocker arm with the shifting mechanism,
- damaged 521 air reservoir, bent bottom plate – to be replaced,

- WEBASTO fuel tank mounting deflected,
- left bumper to be repaired, right bumper to be checked at the repair station.

Photograph 6 – Damage of the railway vehicle after the accident (by PKBWK)

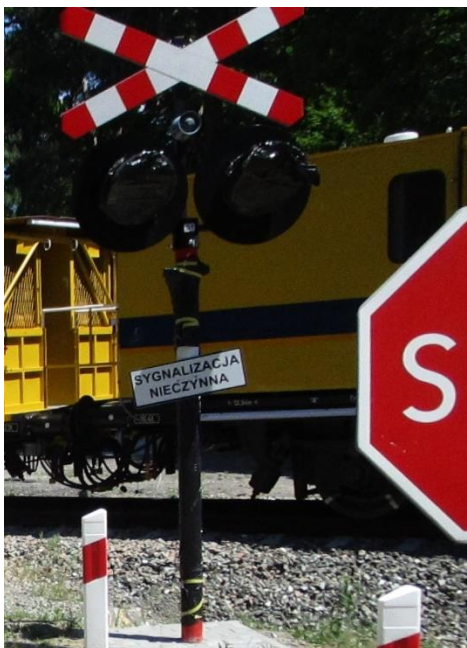
Photograph 7 – “signalling out of order” sign placed on the traffic signal

- the lenses of the traffic signal lights were covered with black film and the signals were not turned in a manner allowing the users of the crossing to see the signalling chambers, which could have caused the passenger car driver to misinterpret that the ssp equipment was operational and the signal was not active because a train was not approaching,
