**STATE COMMISSION ON RAILWAY ACCIDENT INVESTIGATION**  
**Ministry of the Interior and Administration.**

**REPORT No. PKBWK 04/2022**

**from the investigation of a railway accident that occurred on 29 July 2021 at 06:15 on the track Szczecin Gumieńce – Tantow, on track no. 1, at the railway crossing category C at 7.585 km of the railway line no. 409 Szczecin Gumieńce – State Border (Tantow) PKP PLK S.A. infrastructure manager area Zakład Linii Kolejowych [Railway Facility] in Szczecin**

**Warsaw, 11 May 2022**

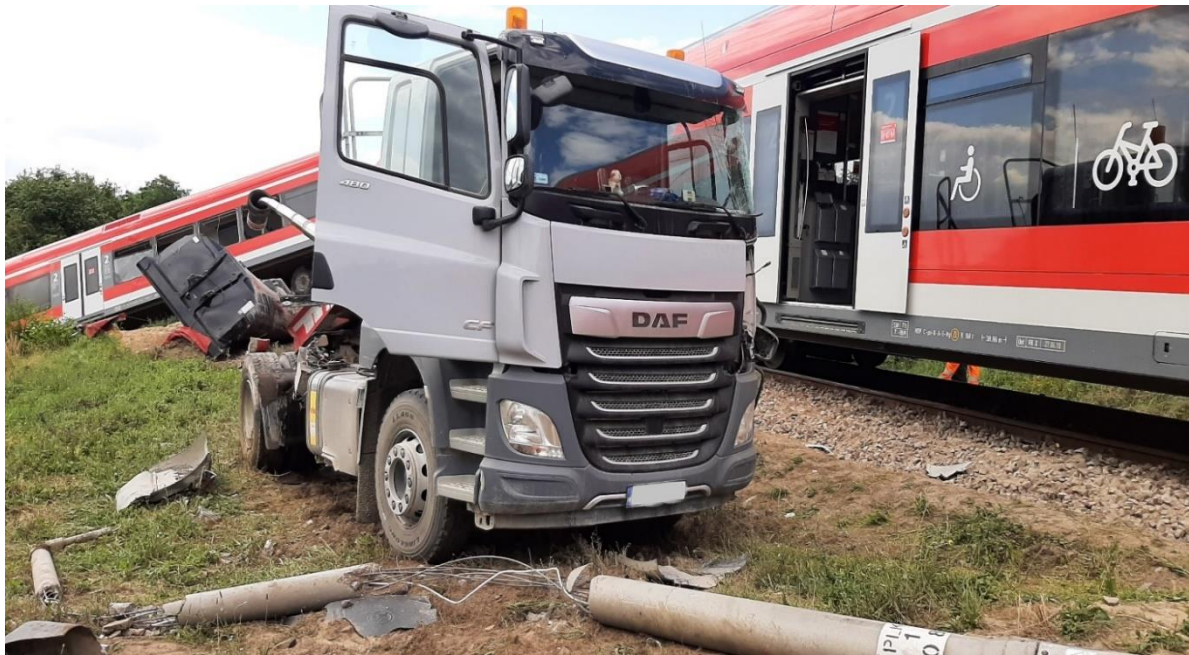
**Photograph 1 – Consequences of the Incident (SCRAI own material)**

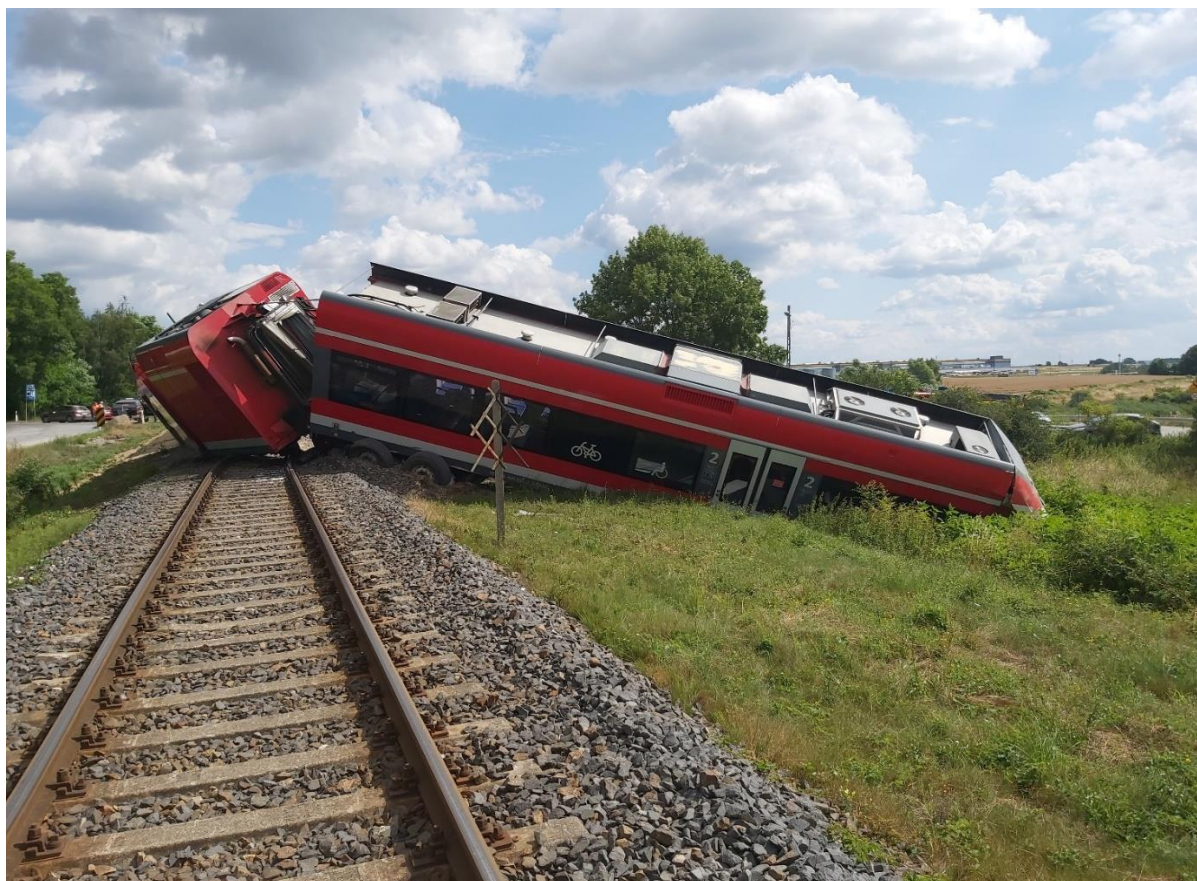
**Photograph 2 – Consequences of the Incident (SCRAI own material)**

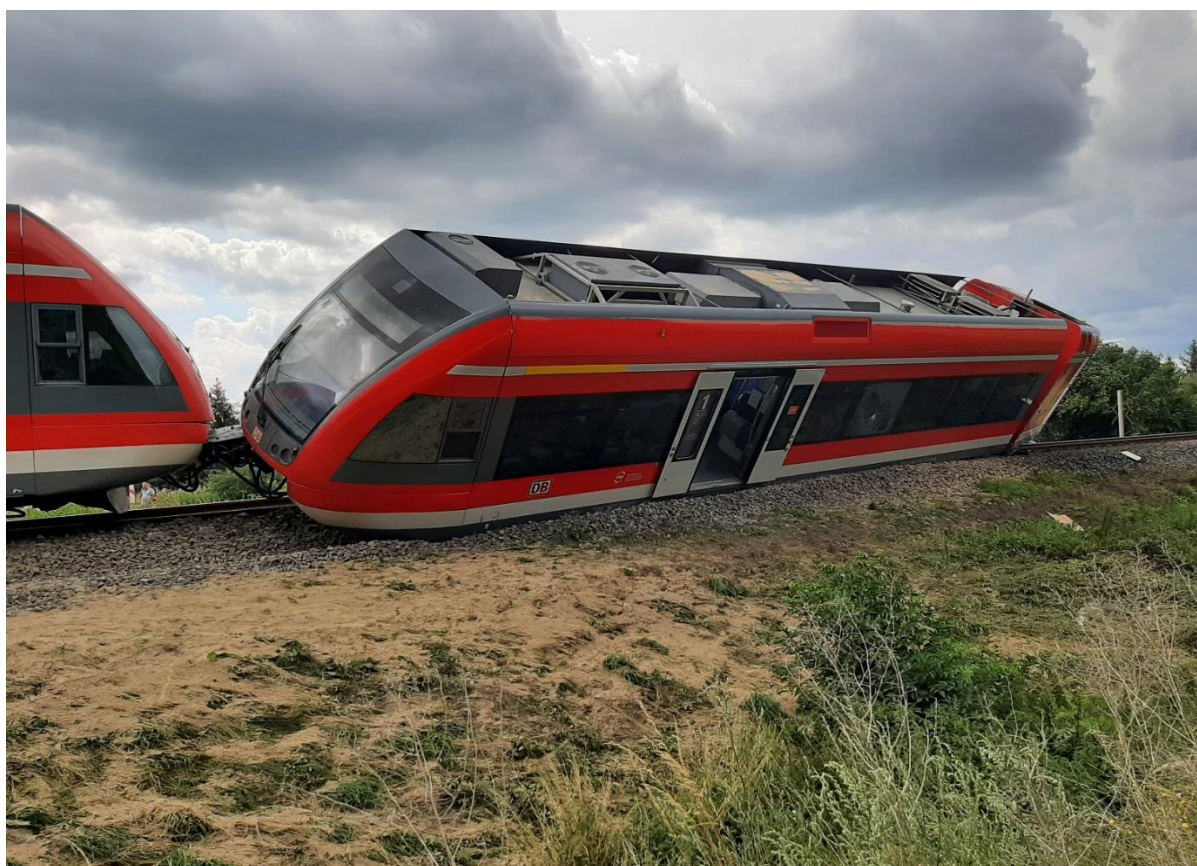
**Photograph 3 – Consequences of the Incident (SCRAI own material)**

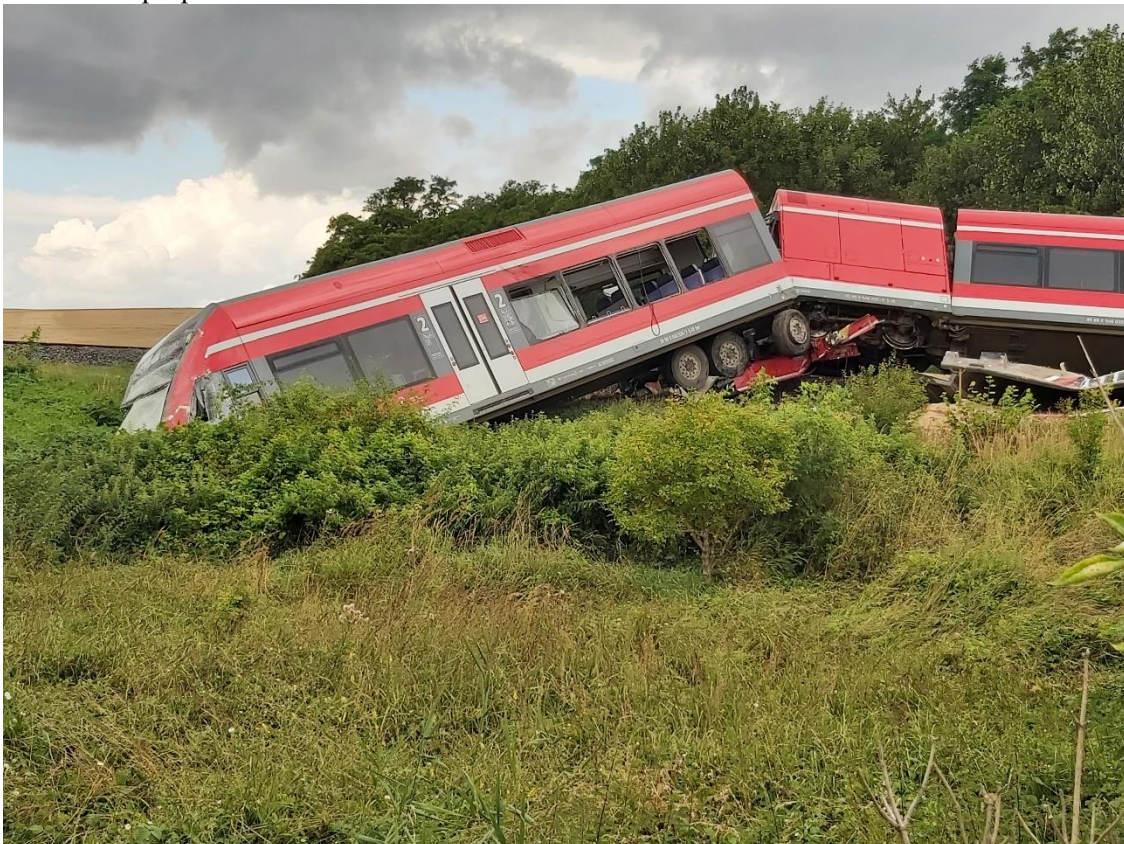
The collision caused the derailling of the first multiple units with all six wheelsets.

The bogies of multiple unit VT646 030 were severely damaged. The carriage frames and the superstructures were deformed as a result of the forces applied on them. The collision with the heavy goods vehicle caused a very serious deformation of the driver's cab.

The mechanical and electrical components connecting the individual parts of the rail bus were torn off. A large number of panes (windows/doors) were damaged.

Damage of the VT646-030 vehicle caused its inability to run on tracks.

Photograph 5 – View of the railway vehicle after the accident

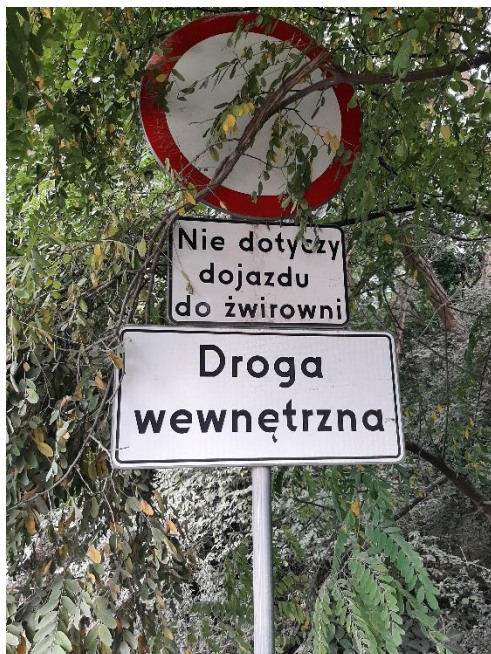
Directly in front of the crossing there is an exit from the district road, which is a connection of the district road with the road to the gravel pit and marked with a B1 sign with plates (photograph no. 6). The surface of the road to the gravel pit is bituminous at a length of approximately 200 m (counting from the junction with the district road). At a distance of 150 metres before the connection with the district road, there is a board with the information “*Attention! Railway crossing, take extra care.*” (photograph no. 7) The road to the gravel pit does not have an approved permanent traffic organisation.

Photograph 6 – Sign placed at the entrance to the gravel pit road

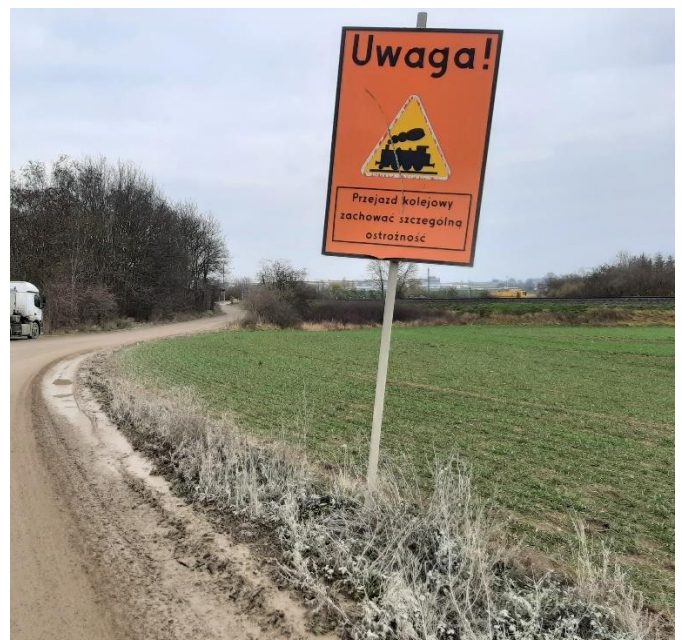
Photograph 7 – Information board placed by the road to the gravel pit

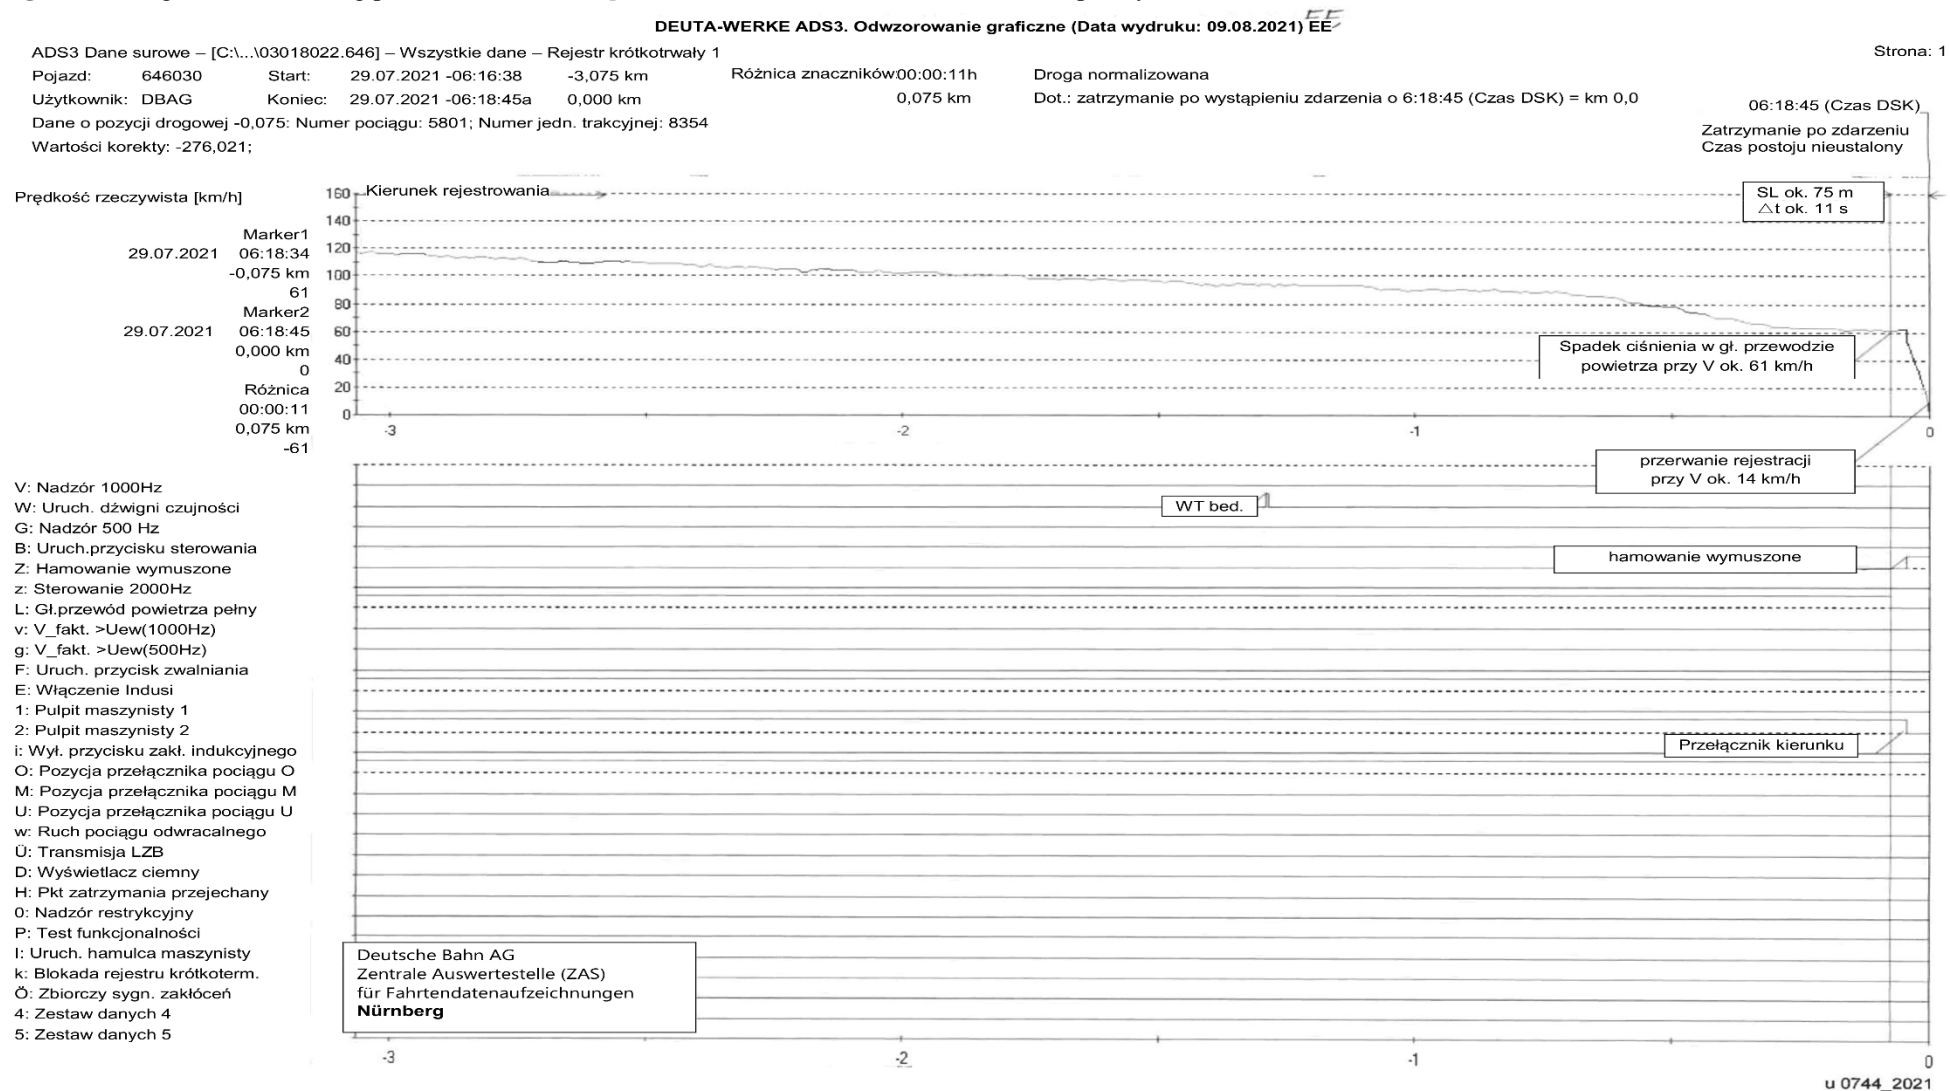
**Figure 2** – Diagram of the driving parameters of the multiple unit VT646 as a function of time (developed by SCRAI)

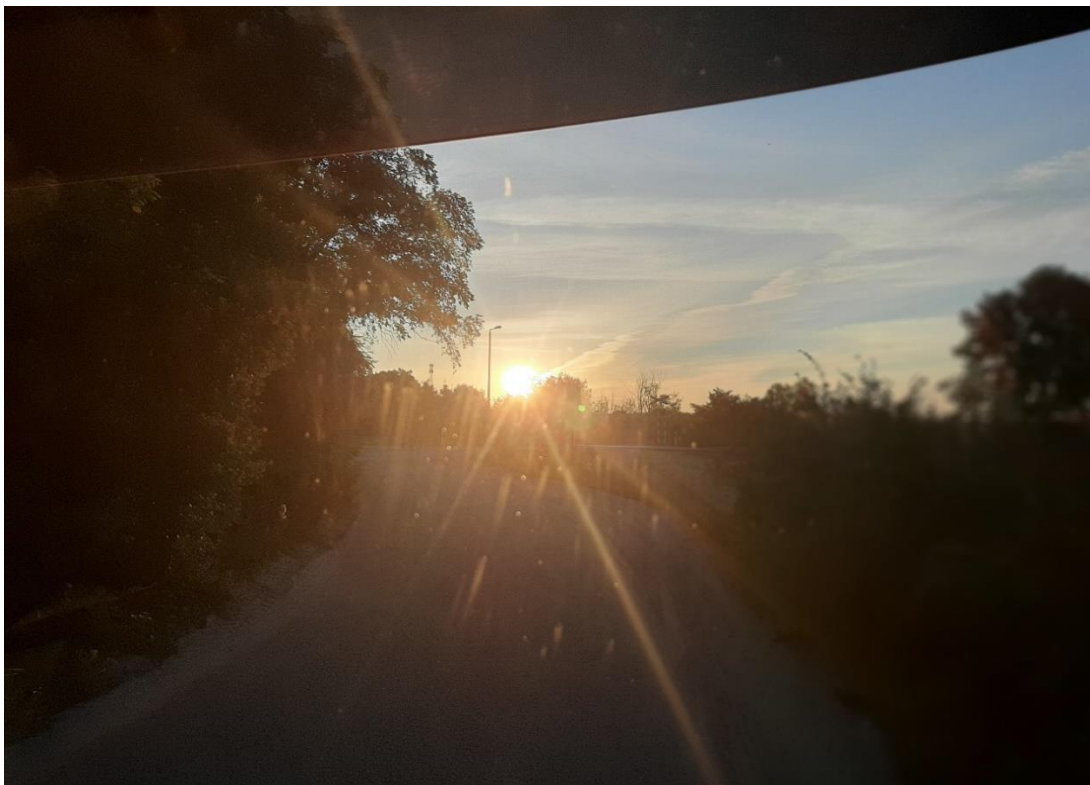
4. Sun glare (in the morning with a clear sky) on the user of the road to the gravel pit when accessing the district road and joining traffic (photograph no. 8).

**Photograph 8– View from the road to the gravel pit during access to the district road and passage from the road vehicle**  
(source SCRAI)

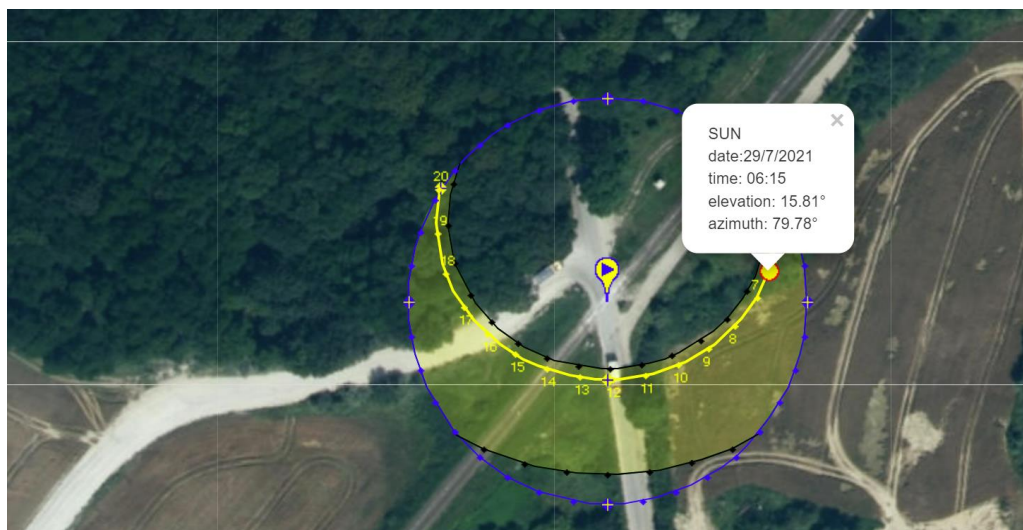
**Photograph 9 – Sun position at the time of the accident (source: <https://www.sunearthtools.com>)**

The positioning of the lenses of the traffic signal number S3 causes the phenomenon of blinding the users of the road to the gravel pit in the morning in sunny weather, making it very difficult to identify the signals transmitted by this sign.

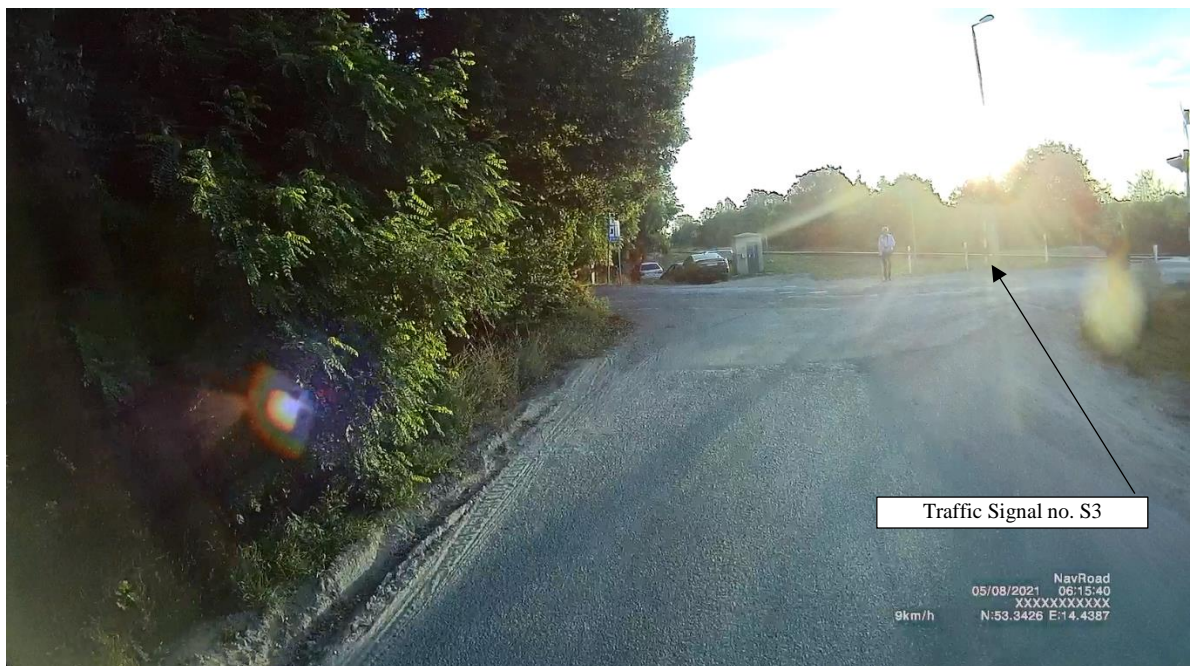
On 05.08.2021 (7 days after the incident) an experiment was conducted to determine the field of vision of the truck driver when approaching the district road and crossing. The experiment involved representatives of the infrastructure manager, the road carrier whose vehicle was involved in the incident and members of the Investigation Team. The experiment was conducted under conditions similar to those in which the event occurred. A road vehicle of the same type as the vehicle involved in the incident (a heavy goods vehicle with a semi-trailer loaded with gravel) was used for the experiment. The weather conditions were similar to those on the day of the accident (sunny, temperature +15°C, no rain or fog). The automatic crossing system equipment was activated by train no. RMM 80681/5801 (in accordance with the timetable at the same time as on the day of the accident). The road vehicle journey was carried out in a manner similar to the technique and driving of the vehicle involved in the accident. A video recorder was installed in the road vehicle at the driver's eye level. During the experiment, it was found that the driver of a road vehicle is blinded by sunlight coming directly from above the traffic signal box no. S3 when approaching the district road. When joining the traffic and entering the district road, the driver of the road vehicle is forced to take the left side of the road to the gravel pit and make a sharp right turn (90-degree angle) also occupying the left lane of the district road while driving over a steep climb. During this manoeuvre, the sun blinds the driver at all times and at some point, during the journey, the signals transmitted by signal box S3 are not visible. The road mirror intended to improve visibility onto the district road when joining traffic from the road to the gravel pit is not performing its function job as it is also located the height of the sunlight (photographs 10 and 11).

Photograph 10 – A frame from the driving recorder during the experiment (source SCRAI)

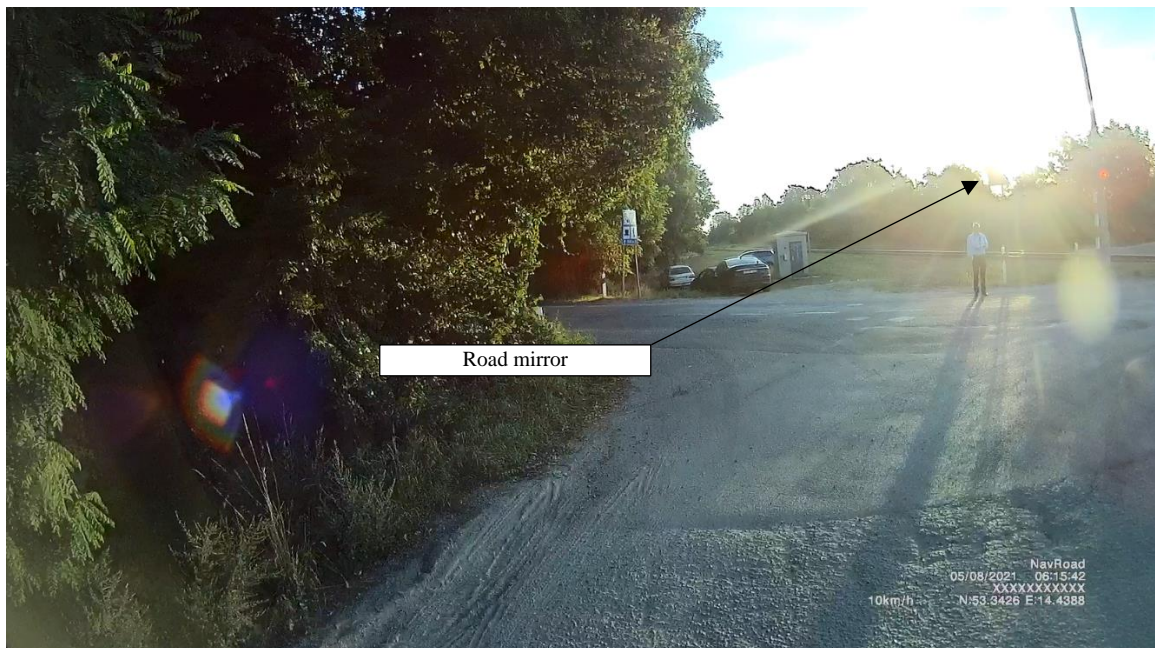
Photograph 11 – Another frame from the driving recorder during the experiment (source SCRAI)
