**STATE COMMISSION ON RAILWAY ACCIDENTS INVESTIGATION**  
**Ministry of Interior and Administration**

**REPORT No PKBWK 08/ 2022**

**on the investigation of a railway accident  
that occurred on January 14, 2022 at 10:48 am at Kolbuszowa station,  
track No 1Wb, category C level crossing at km 46.925  
railway line No 71 Ocice - Rzeszów Główny  
area of the infrastructure manager PKP PLK S.A. Railway Line Department in Rzeszów**

**WARSAW, 27/12/2022.**

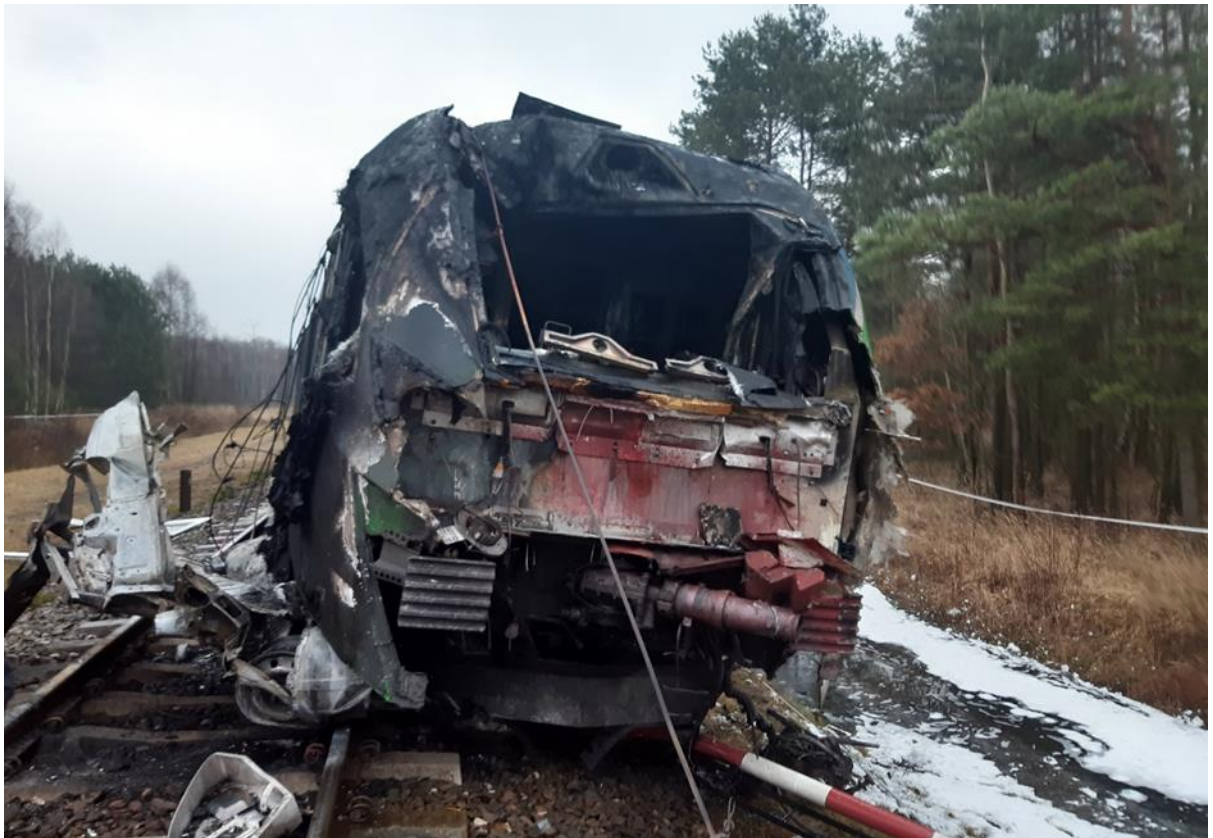
The first section of the EN63B-108 electric multiple unit was completely destroyed. The train was derailed by the first and second bogies, causing damage to the wheelsets.

Fig. 10 - View of the railway vehicle after the accident

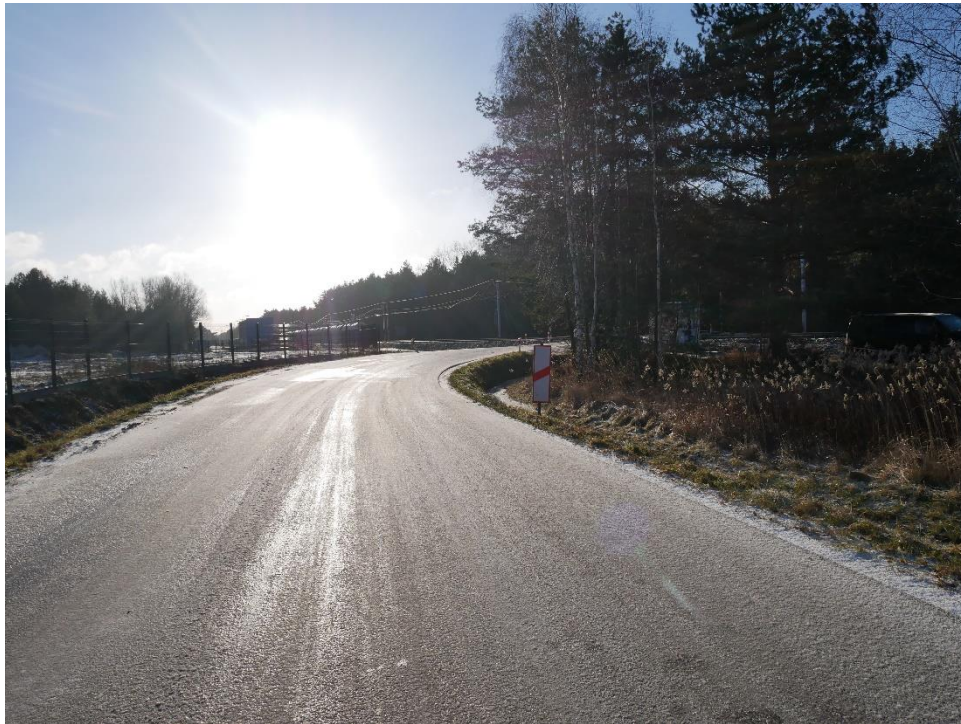
**Fig. 11 - Visibility of traffic signals from the direction of the vehicle (PKBWK material)**

(a) On both sides of the crossing, visibility conditions from the road are not provided. Lack of visibility of traffic signals from a distance of at least 100 meters due to the crowns of trees on the approaches to it, which does not meet the requirements of the provision of § 49 (1) (6) of the provisions of the *Regulation of the MINISTER OF INFRASTRUCTURE AND DEVELOPMENT of October 20, 2015 on the technical conditions to be met by intersections of railway lines and railway sidings with roads and their location*, as an implementing regulation under Article 7 (2) (2) and (3) (2) of the Act of July 7, 1994. - Construction Law.

- 1) Introducing a speed limit of up to 50 km/h on road No. 1214R on the accesses to the crossing in connection with the failure to meet the requirements of the provisions of the Regulation of the MINISTER OF INFRASTRUCTURE AND DEVELOPMENT of October 20, 2015 *on the technical conditions to be met by the intersections of railway lines and railway sidings with roads and their location*, Annex No. 3, paragraph A, 1 as an implementing regulation to Article 7 of the Construction Law.
- 2) Mark the crossing (on the side of Road 9 - the left side of the crossing) with an A-10 sign in accordance with regulations.
- 3) Mark the crossing with P-14 horizontal signs.

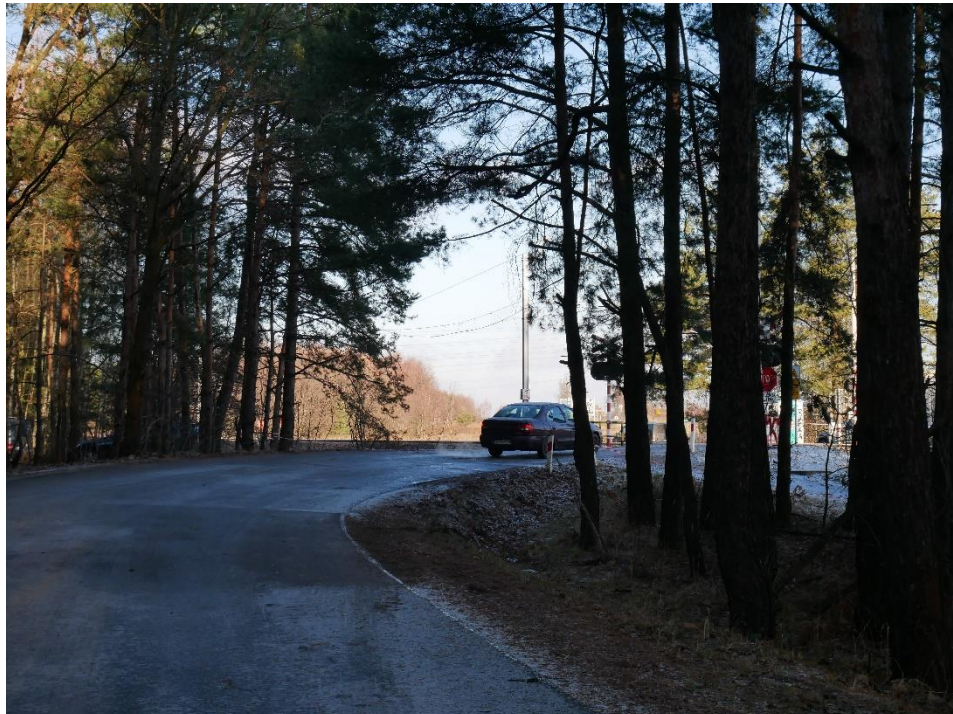
**Fig. 12 - Visibility of traffic signals from the opposite side of the crossing (PKBWK material)**
