STATE COMMISSION ON RAILWAY ACCIDENTS INVESTIGATION
Ministry of Interior and Administration

REPORT No. PKBWK 07/ 2022

on the investigation of a railway accident
that occurred on February 03, 2022, at 06:14 on the route Warlubie - Laskowice Pomorskie,
on track no. 2, category B level crossing at km 437.386
railway line No. 131 Chorzów Batory - Tczew
area of the Infrastructure Manager PKP PLK S.A. Railway Line Department in Bydgoszcz

WARSAW, December 14, 2022.

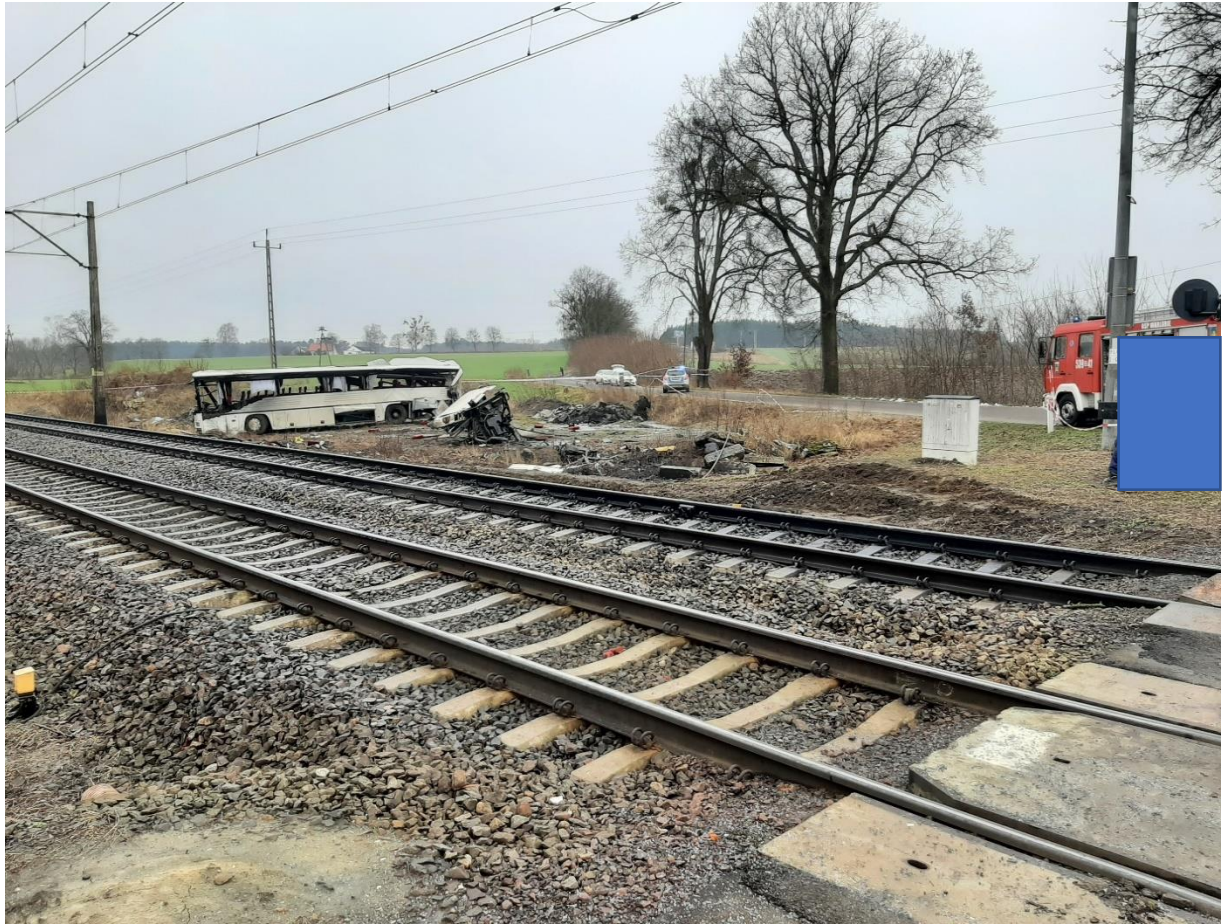
Fig. 1 - The aftermath of the occurrence (PKBWK's own material)

Implications of the occurrence: As a result of the occurrence, the bus driver died on the spot. The bus was destroyed and the EU07A-002 locomotive and two train cars were damaged.

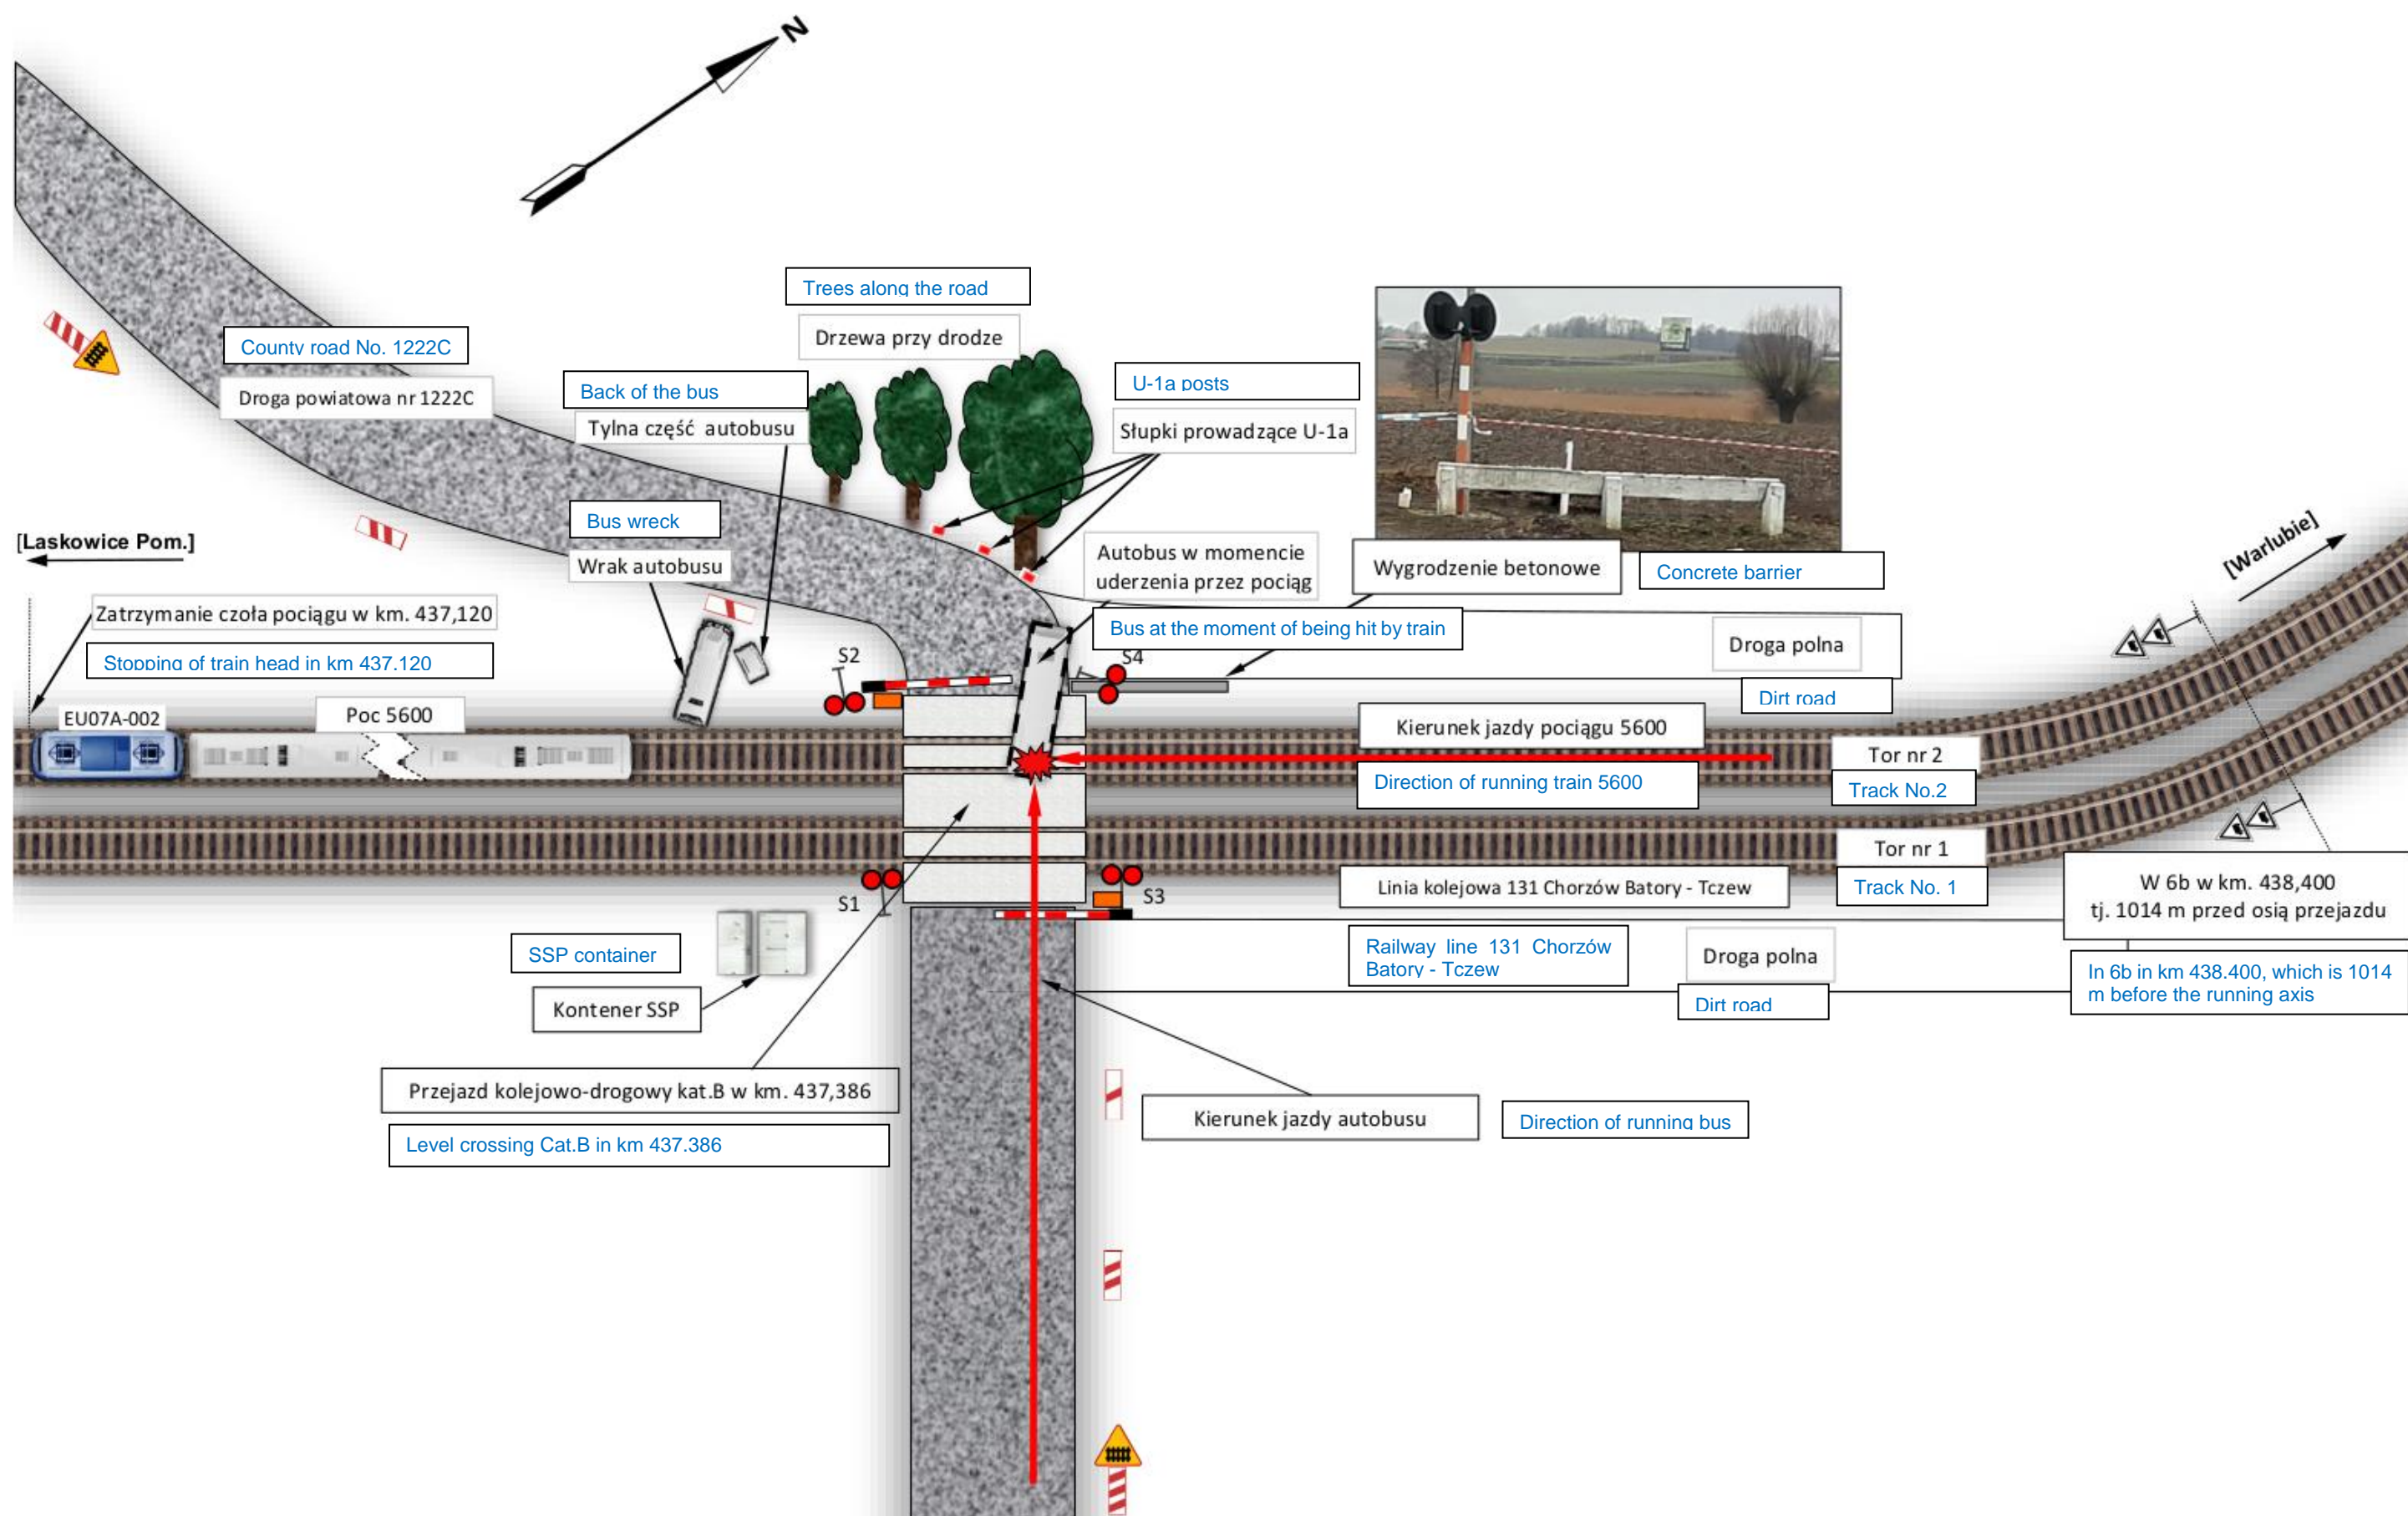
Figure 1 - Sketch of the accident (PKBWK material)

automatic crossing system. The distances of the traffic signals from the outermost rail of track 1 are: S1 - 6.5 m, S3 - 6.7 m, while from the outermost rail of track No. 2 they are: S2 - 6.5 m, S4 - 6.1 m. The crossing is equipped with semi-control barriers that close the entrance to the crossing from both directions of travel on county road No. 1222C. Visibility of signals given by traffic signals correct. At the S4 traffic signal at 5.50 meters from the outermost rail of track No. 2, parallel to the track axis, a concrete fence is built, preventing safe exit from the crossing. In the direction of the village of Bąkowski Młyn (the direction of the bus), there is a tree behind the crossing at 11 meters from the extreme rail of track No. 2, in front of which the road turns sharply to the left (Figure 1). The tree made it difficult for the bus to turn gently to the left to avoid damaging the turnpike devices and for the bus to stay in its lane while turning without occupying the opposite lane. The geographical coordinates of the crossing are 53°34'44 "N 18°36'54 "E. The occurrence occurred during dark season without precipitation or fog, with an ambient temperature of -2°C. No work was carried out in the area of the crossing affecting the occurrence.

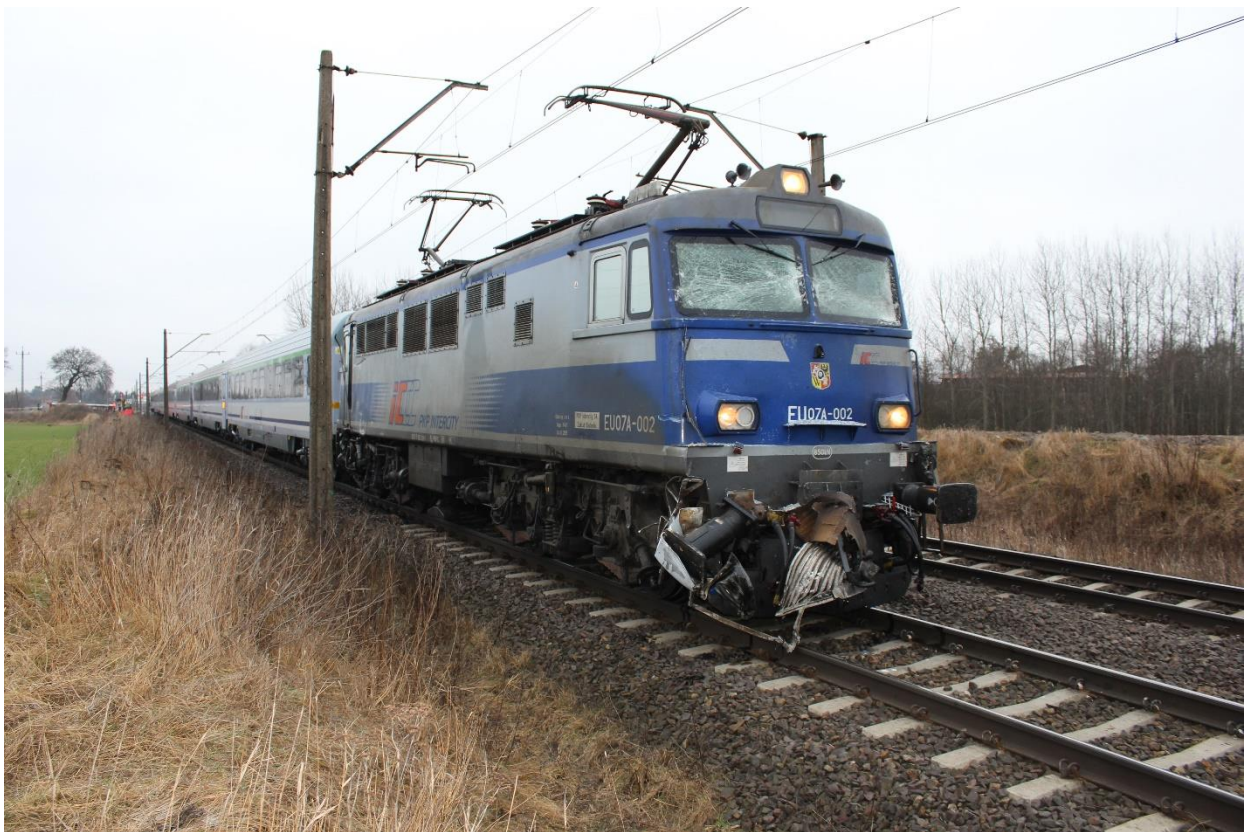
Fig. 4 - View of the railway vehicle after the accident

The train was not derailed. The front end of locomotive EU07A-002 - cab A was damaged, i.e. windshields, bumpers, scrapers power and brake lines, windows. In addition, the side plating of the locomotive was damaged, along with brake cylinders and shock absorbers, and the side window of cab B was broken. As a result of the application of sudden braking of the train, flat spots on the wheels in two wagons (the restaurant wagon and the last one in the train) appeared. As a result of the impact of the spare wheel from the road vehicle, the ventilation duct on the chassis of the second wagon in the train set was damaged.

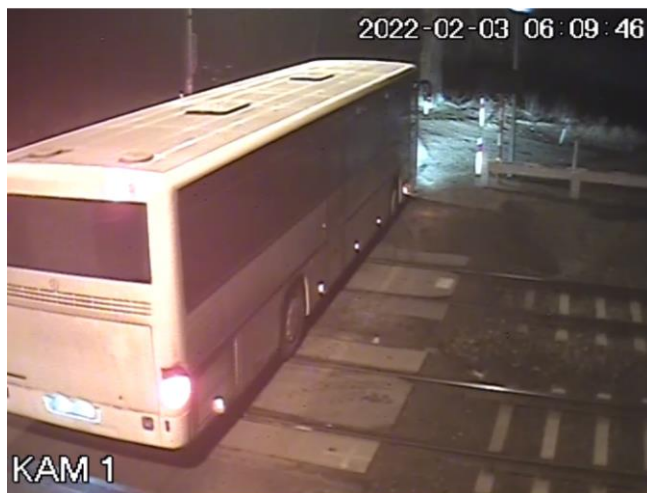
Fig. 5 - Bus stopping

On February 03, 2022, at approximately 06:10 a.m., a bus left Warlubie, which, according to the planned route, was to pick up children from Lipinki and take them to school in Warlubie. In the bus, in addition to the driver, there was a caretaker of the children. The route of the bus was along district road No. 1222C toward the village of Rulewo, where there is a category B level crossing. The automatic crossing system (ssp) of this crossing was in a state of warning due to a freight train running on track No. 1 in direction of Warlubie station. Due to the closed grade-crossing gate and the activated traffic light, the bus stopped in front of the crossing. After the freight train passed the crossing, the system began to open the grade-crossing gate. Before it was fully opened and the Warlubie signals given by the traffic signals were turned off, an approaching IC 5600/1 passenger train on track 2 from the station caused the warning state of the automatic crossing system to be maintained and the grade-crossing gate closed again. The lights on the traffic signals continuously transmitted signals prohibiting entry the crossing, and the grade-crossing gate immediately after opening, began to close. The bus driver, not paying attention to the signal forbidding entry emitted by the traffic signals (S1 and S3 visible to him), entered the crossing while the grade-crossing gate was closing. The bus driver reached the gate-crossing gate on the other side of the crossing and stopped the bus. During the stop, he instructed the children's caretaker to get off the bus and raise the grade-crossing gate manually.

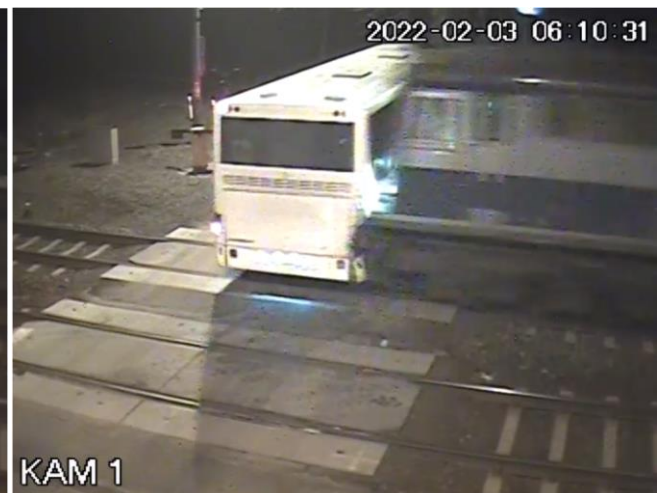
Fig. 6 - Moment of impact

The caretaker, after several unsuccessful attempts to raise the grade-crossing gate, noticed that a train was approaching from Warlubie station. He immediately instructed the driver to leave the crossing. The bus driver slowly moved to exit the crossing and bypass the grade-crossing gate without damaging it.

The driver of train IC5600/1, after passing Warlubie station and exiting the curve, noticed a standing bus at the crossing. He implemented emergency braking of the train and gave the audible signal "Attention". The train hit the rear of the bus traveling at a speed of about 90 km/h.

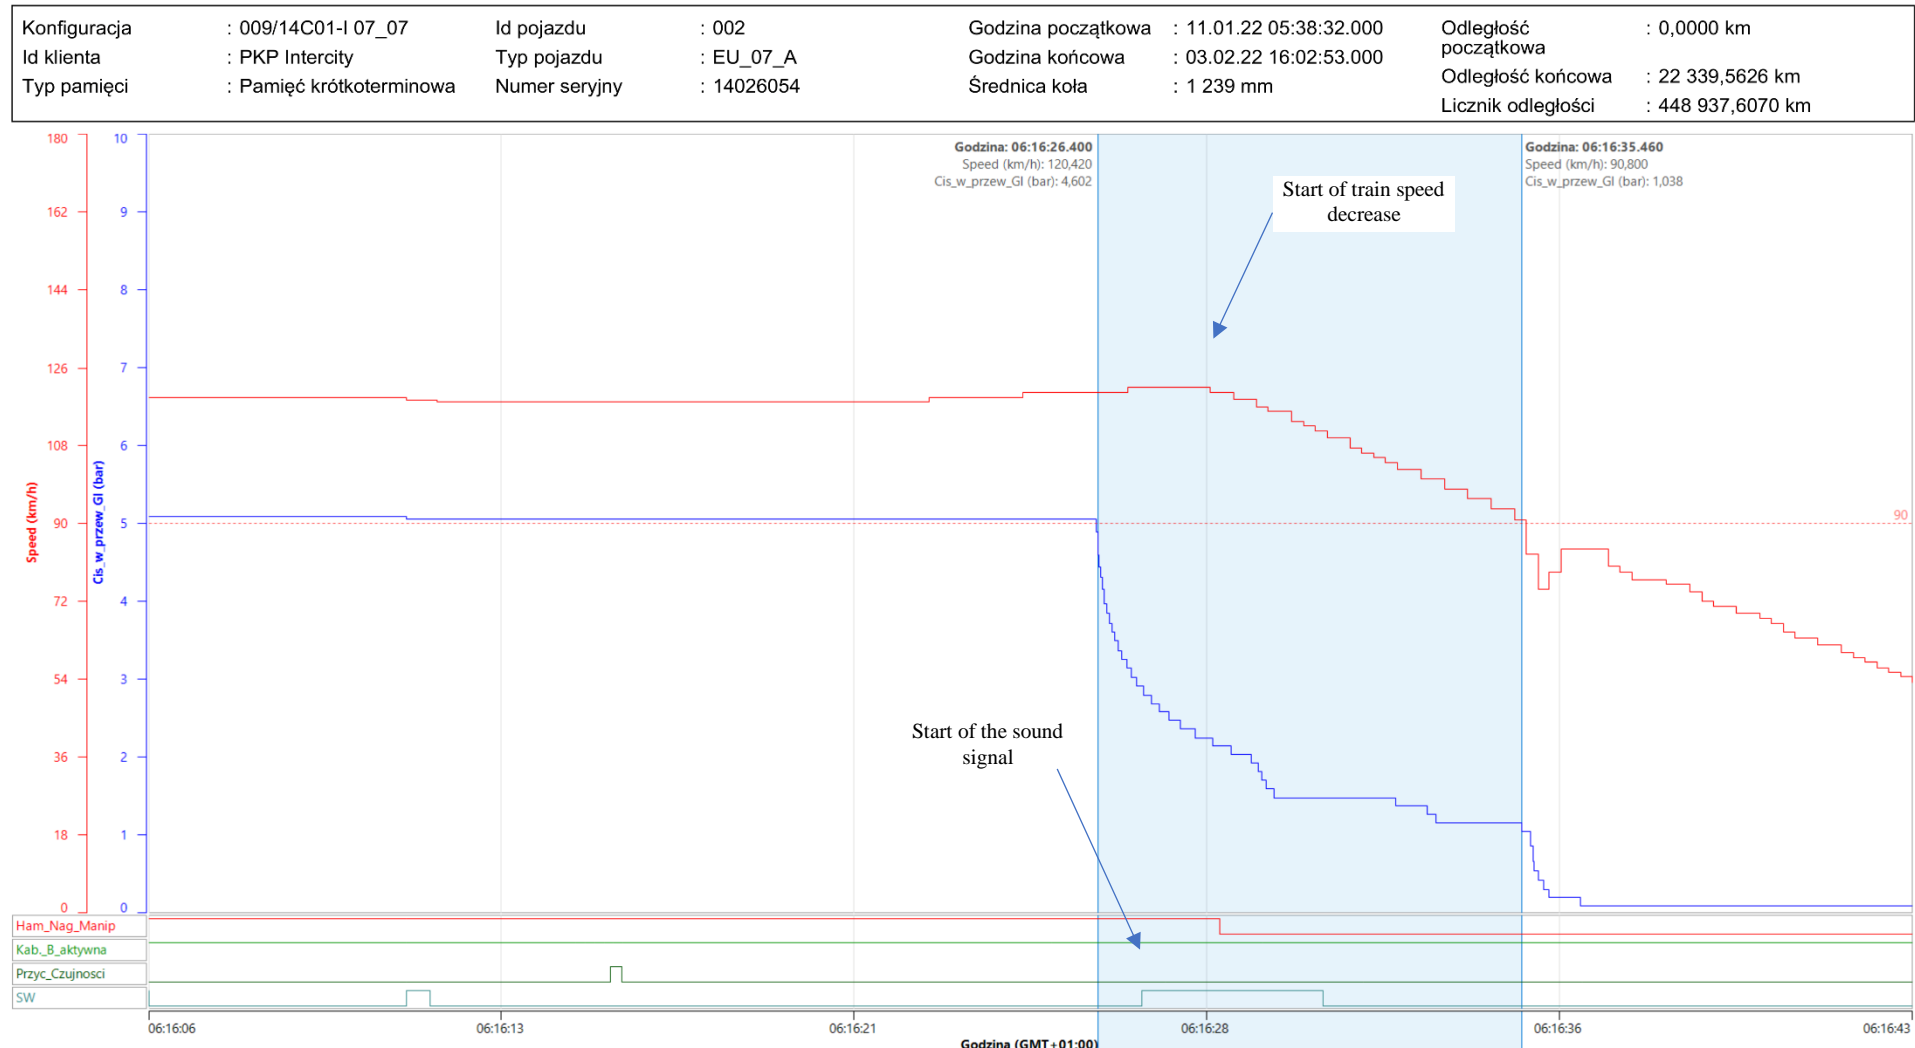
Figure 2 - Graph of driving parameters of locomotive EU07A-002 as a function of time (PKBWK material)

- After passing Warlubie station, the train speed increases to 120.4 km/h,
- At 06:16:26 (km 22,322.8322), the driver noticed an obstacle at the crossing, applied the braking travel setter and the air pressure in the main line dropped,
- From 06:16:27 to 06:16:31 - emitting the sound signal "Attention",
- From 06:16:28 to 06:16:35 - a drop in speed from 120.4 km/h to 90.8 km/h,
- 06:16:35 - at a speed of 90.8 km / h, he ran into an obstacle and the pressure in the main line dropped to 1.03 bar,
- 06:16:52 - stopping the train after 17 seconds and covering about 239 m.

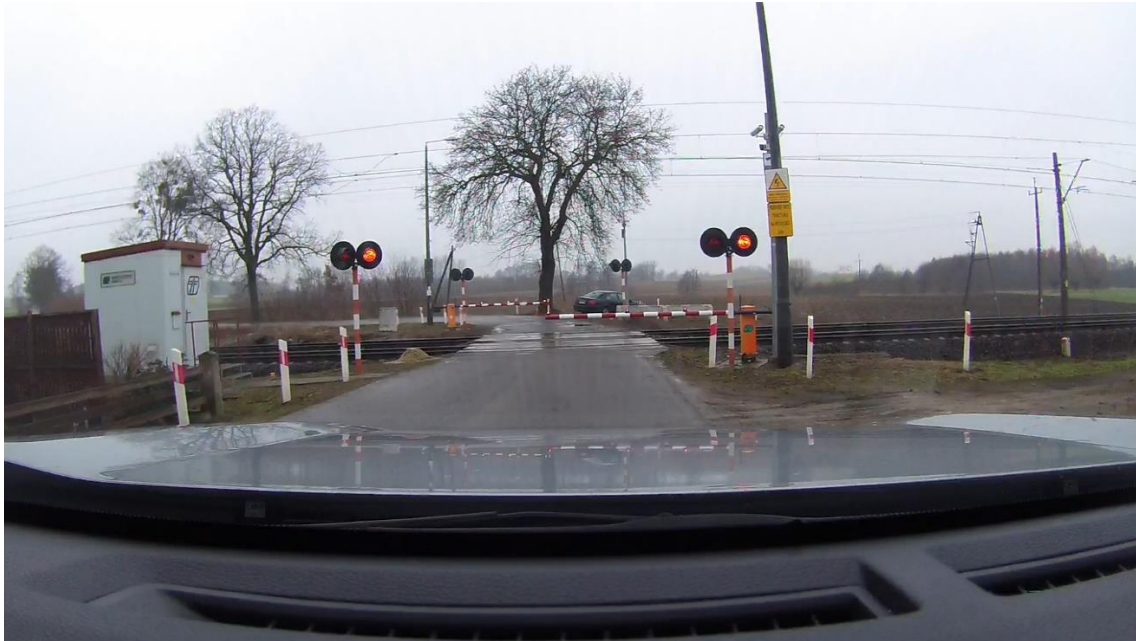
Fig. 8 - View of the crossing from the direction of the bus (PKBWK's own material).

The above Figure shows a view of the crossing in question from the position of the driver of a road vehicle. The essence of the design of Category B level crossings equipped with two half barriers is to protect road users from entering the crossing (inrun half barrier closing the right lane of the road) and to allow safe exit from the crossing (an unclosed exit lane of the road from the crossing) in the event that a road vehicle is on the crossing after the grade-crossing gates start to close. Factors that significantly limit the functionality of the crossing in question are the narrow road, the concrete fence, the sharp left turn of the road behind the crossing and the tree growing on the side of the road 11 meters from the extreme rail. It was difficult and even impossible for trucks and buses to leave the crossing without damaging elements of the railway infrastructure and the road vehicle.

In addition, a recommendation has been made by the Chairman of the PKBWK to remove the tree growing on the left side of the crossing going from the village of Baikki Mill.

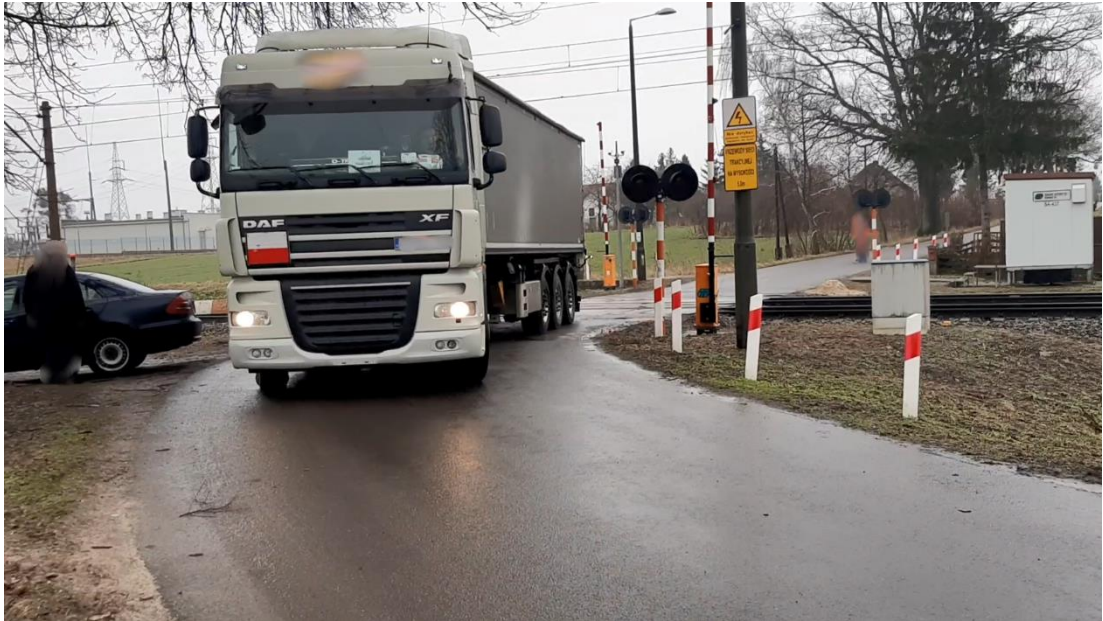
Fig. 9 -Truck crossing with open grade-crossing gates (PKBWK's own material)

During the on-site visit to the crossing, the Investigation Team observed the way trucks crossed the crossing (Fig. 9 and 10). As can be seen from the location of the road behind the crossing (the width of the road lane is 4.2 m, the growing tree in front and the sharp curve to the left), the drivers of road vehicles, especially trucks and buses, occupy the opposite lane when passing through the crossing with the grade-crossing gates open in the direction of the village of Bąkowy Młyn. Vehicles driving in the opposite direction are exposed to collision. To avoid collision situations, the organization of traffic in the area of the crossing should be changed in such a way that vehicles traveling from the direction of the village of Bąkowy Młyn have priority to pass through the crossing.

- 3) The road manager will develop a new traffic organization project in the area of the cat. B level crossing, considering the topographical conditions of the intersection of the railway line and the road, in such a way that vehicles coming from the direction of the village of Bąkowski Młyn will have priority to cross the crossing.
