STATE COMMISSION ON RAILWAY ACCIDENT INVESTIGATION
Ministry of Interior and Administration

REPORT No. PKBWK 02/202 3

**on the investigation of a railway accident
that occurred on June 20, 2022 at 12:55
at the Regalica junction station,**

Poznań Główny POD - Szczecin Główny railway line No. 351 at km 204.079

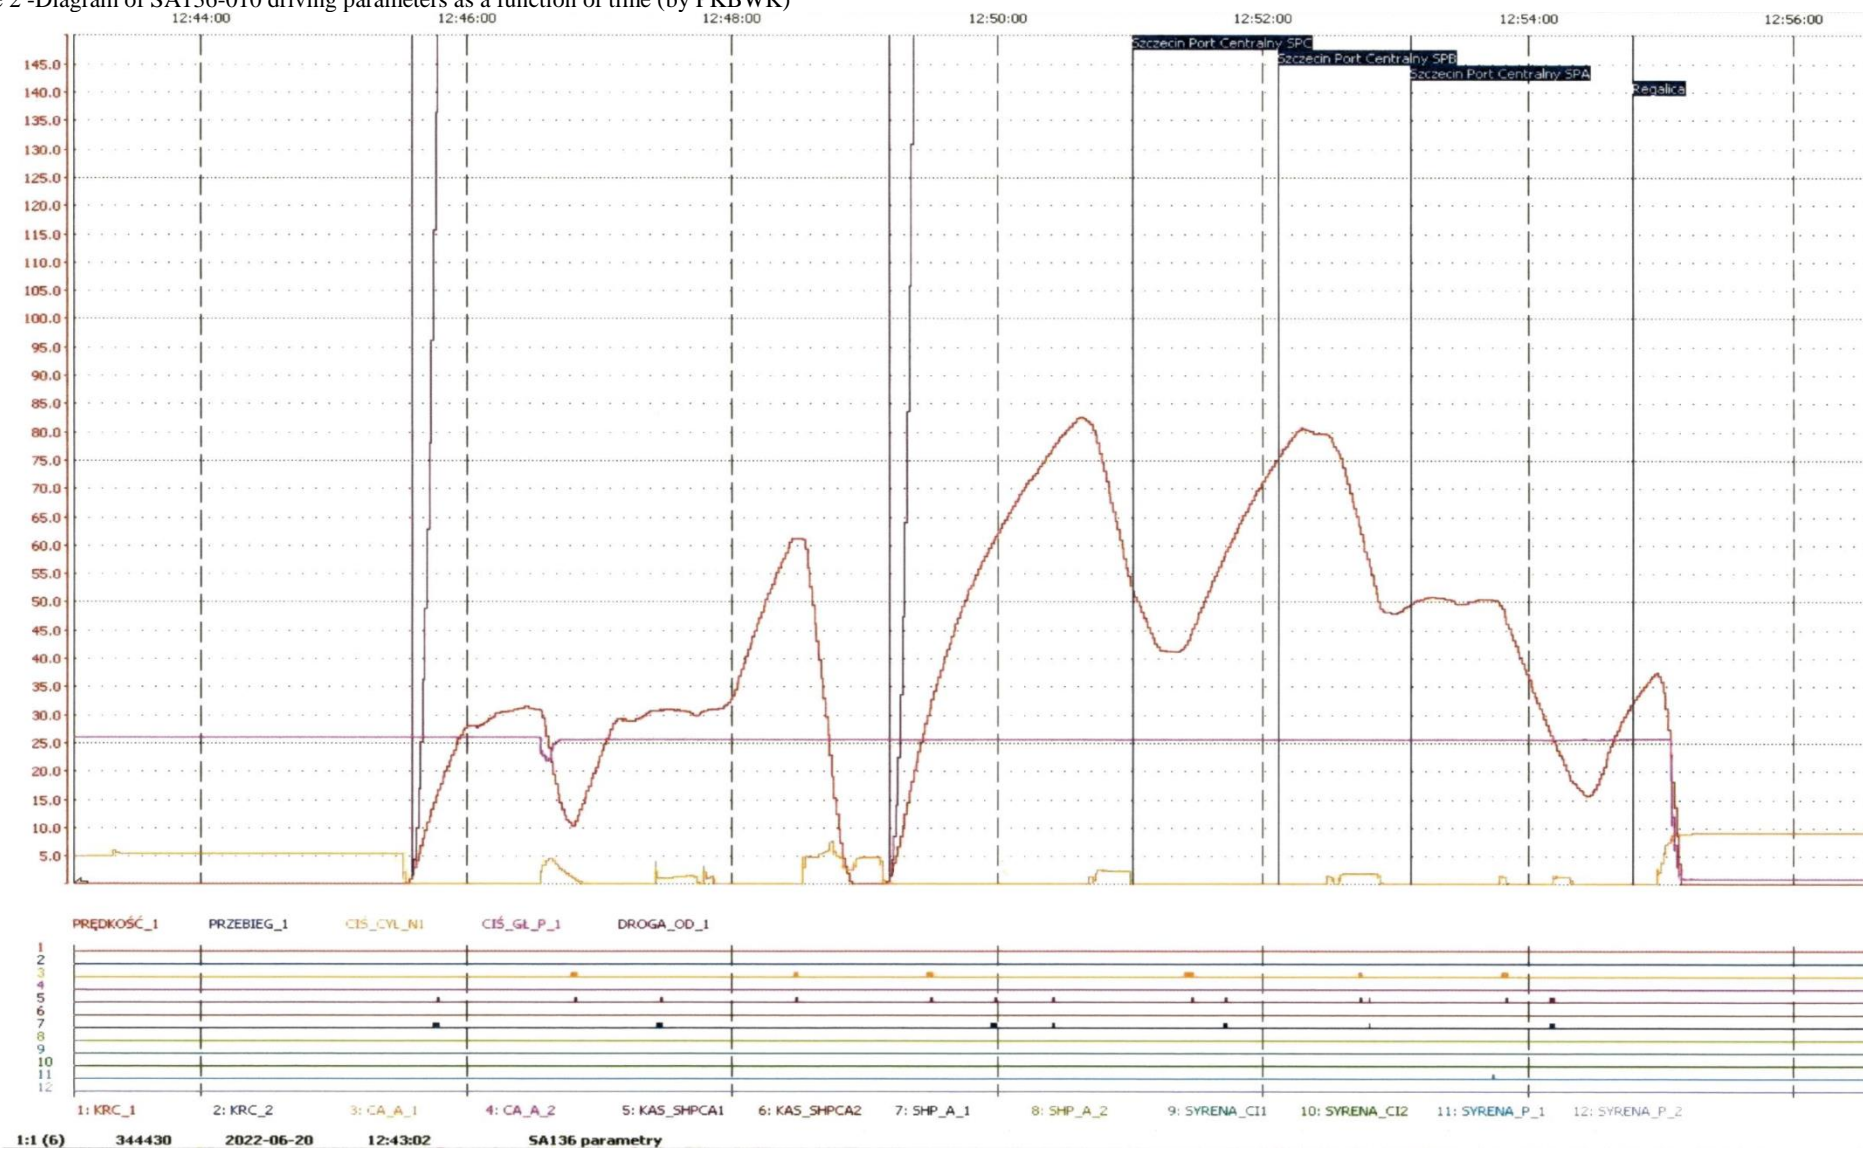
Figure 2 -Diagram of SA136-010 driving parameters as a function of time (by PKBWK)

The Investigation Team analyzed selected parameters of the train ROM 88628/9, recorded in the electronic data recorder, to study the train's driving characteristics up to the moment of the occurrence. The driving parameters of the train on section from Szczecin Central Station to the moment of stopping at Regalica junction post are shown in the diagram below with a description.

The parameters of the ROM 88628/9/9 train recorded from 12:45:34 to 12:55 were analyzed.

- 12:45:34 start of the train at the departure station Szczecin Główny, increase of speed to 30 km/h and performing control braking, reducing the speed to 10 km/h,
