STATE COMMISSION ON RAILWAY ACCIDENTS INVESTIGATION
Ministry of Interior and Administration

REPORT No. PKBWK 0 1/2023

**on the investigation of the railway incident
that occurred on October 16, 2019 at 13:51
at Leszczyny station, at km 31.738
railway line no. 140 Katowice Ligota - Nędza**

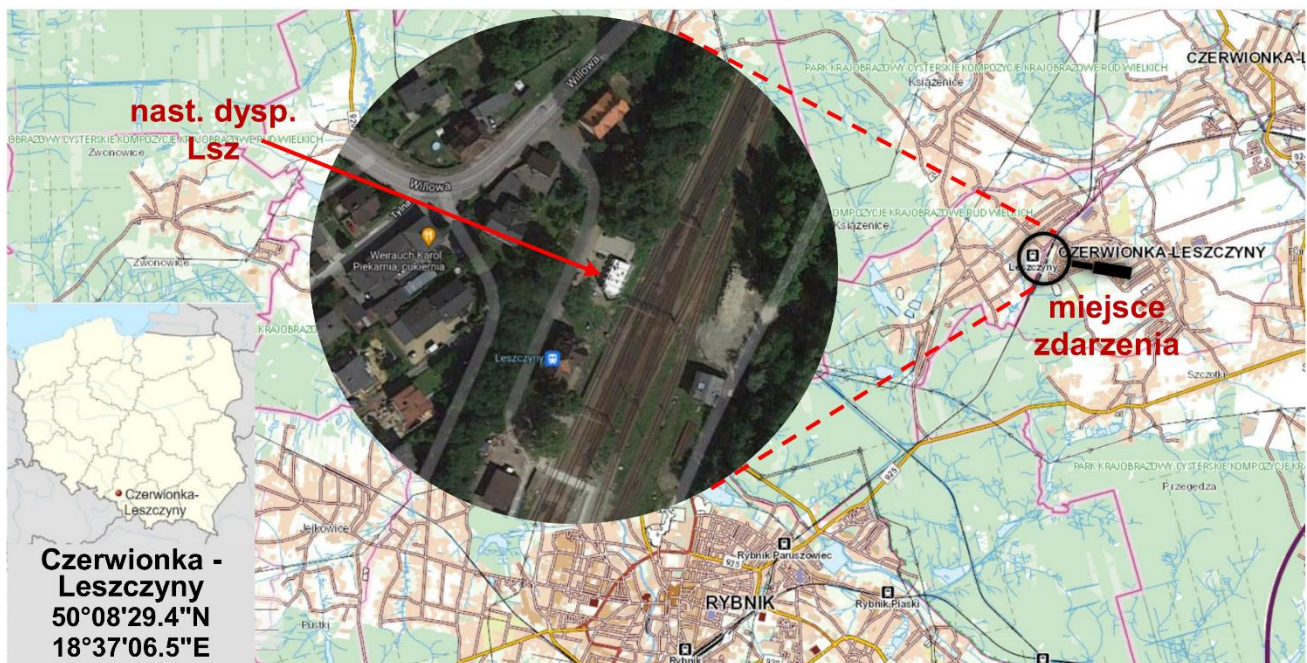
Photo No. 1 - General view of the site.

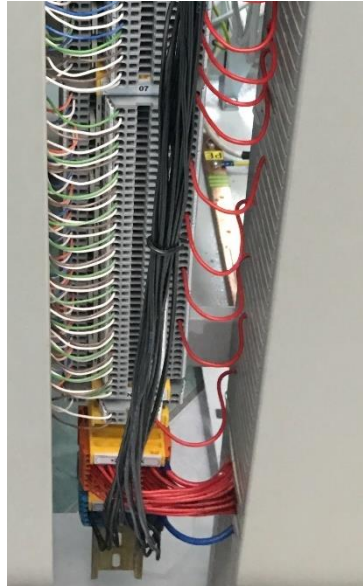
Non-factory connections with wires of 1 mm² cross-section were found on this strip. These connections were not made during the production of the MOR-1.01 system. As a result of the modifications made to the cabinet connections and connections without the knowledge of Z.A. KOMBUD S.A. as the manufacturer of the system, the internal connections in the head No. 07 used for zeroing the axis counter sections were dismantled.

Photo No. 2 - MOR-1.01 cable connections during internal acceptance

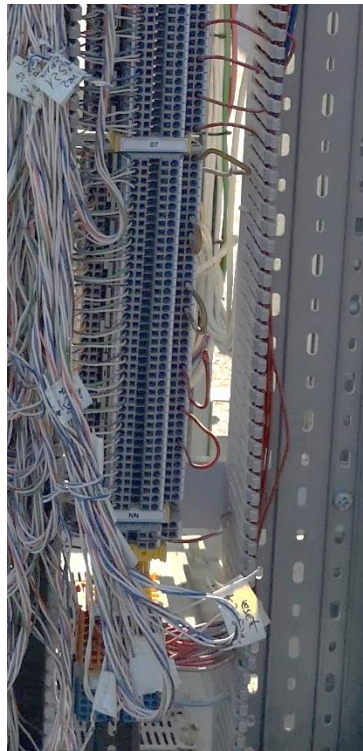
Non-factory bridges were installed in this place. In addition, the cable was installed on top of the 07 head, thus changing the internal connections of the MOR-1.01 cabinet.

The Investigation Team concludes that the factory wiring of the cabinet has been tampered with.

Photo No. 3 - Cable connections after the occurrence

The above-mentioned incorrect connection (contrary to the design) of the power supply to the input module (applying the positive voltage of Ukomp. instead of Usrk.) resulted in a doubling of the supply voltage due to the grounding of the opposite potentials of the two batteries, i.e. SRK battery and Komp. battery.

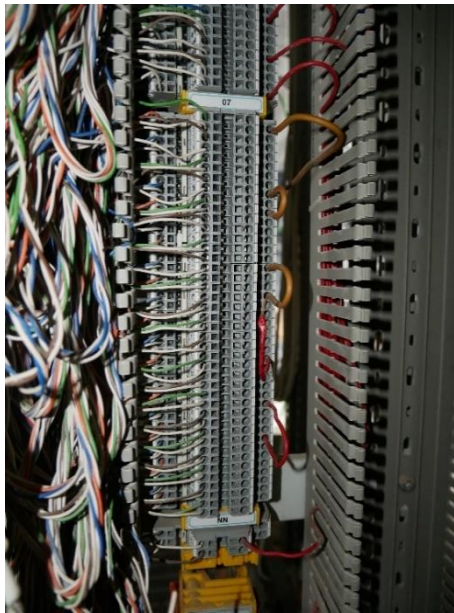
Other connections were made according to the documentation with 0.8 mm² wires. Below are the connections of terminal block #7, which show traces of melting insulation of wires and terminal block inputs not caused by the cabinet fire. The terminal strips show signs of mechanical damage caused by the use of non-factory connections in the form of bridges, which have been repeatedly assembled and disassembled on the strip. The method of attaching wires to the strip, with wires repeatedly inserted and removed, did not ensure proper current flow in the cabinet's circuits, as evidenced by overheating of the wires and terminal strip receptacles not caused by the fire.

According to the Investigation Team, the use of wiring connections in the MOR-1 system cabinet contrary to the manufacturer's solutions and improper connections on the terminal blocks were causal factors in the occurrence.

Photo No. 4 - Terminal strip No. 7 in the MOR-1 cabinet (Photo No.: PKBWK)

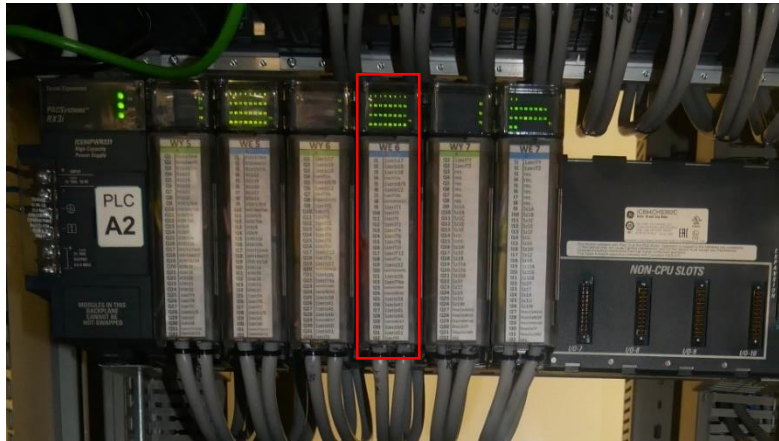
1. Excessive temperature rise of the components of module 4 in the expansion bay of PLC A due to an increase in voltage relative to the internal resistance of the module, which caused an excessive increase in power consumption and the value of the current flowing. Damage to the module due to prolonged power supply at a voltage higher than the maximum allowed by the manufacturer.
2. Unauthorized modification of the computer cabinet wiring, consisting in use of wiring connections in the MOR-1 system cabinet that do not comply with the manufacturer's solutions.
3. Failure of the thermostat to detect the increased temperature of the upper PLC cabinet due to excessive air circulation caused by leaving the door of this cabinet open for a long time.

Photo No. 5 - View of Module 4 - which first reported damage on the day of the occurrence (photo by PKBWK, taken on 05/10/2020 in the new MOR-1 cabinet)

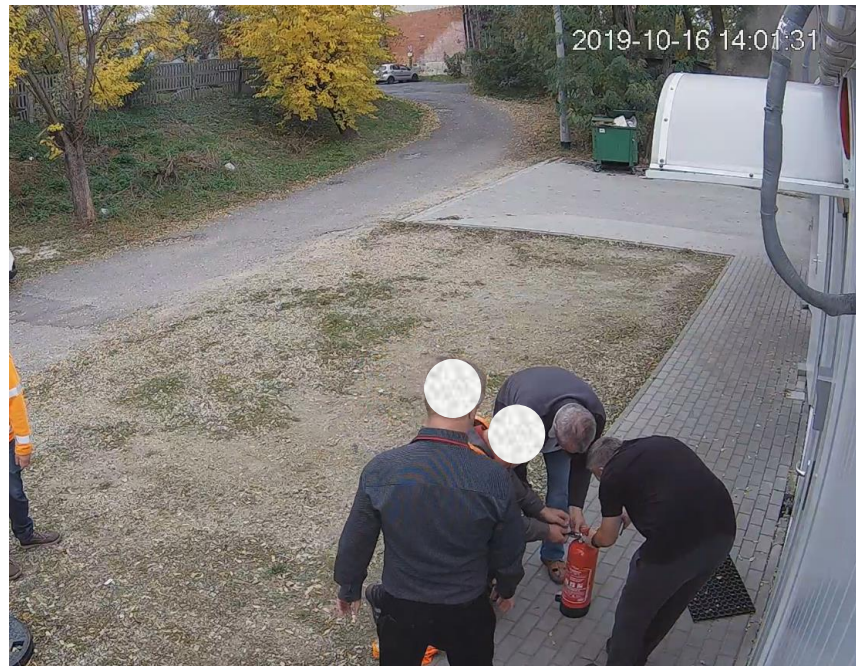
It took 13 minutes from the time the fire alarm was activated until the smoke stopped coming from the relay room, and 8 minutes until the fire extinguisher was used. No attempt was made to activate the automatic extinguishing system during the entire firefighting operation.

Photo No. 6 - Installation of a fire extinguisher performed during a fire

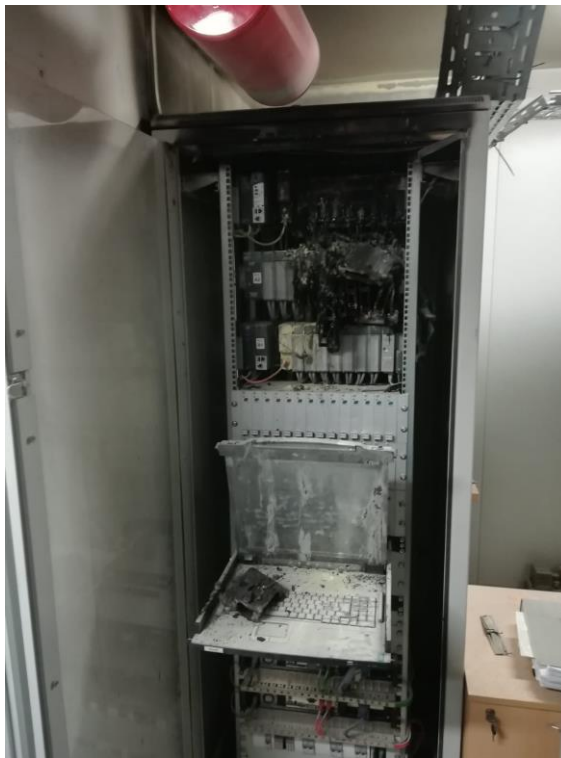
After the fire, all I/O modules in PLC cassette A1 were completely destroyed due to the direct impact of the fire that occurred in one of the modules in PLC cassette A2. The cable bundles connected to the modules burned along with the cable tray. PLC A1 showed no signs of damage. However, the front panel of the power supply of this PLC was found to be deformed. In the PLC A2 expansion tray, the I/O modules from slot 4 upward were destroyed.

Photo No. 7 - Open computer cabinet (Photo: railway commission)

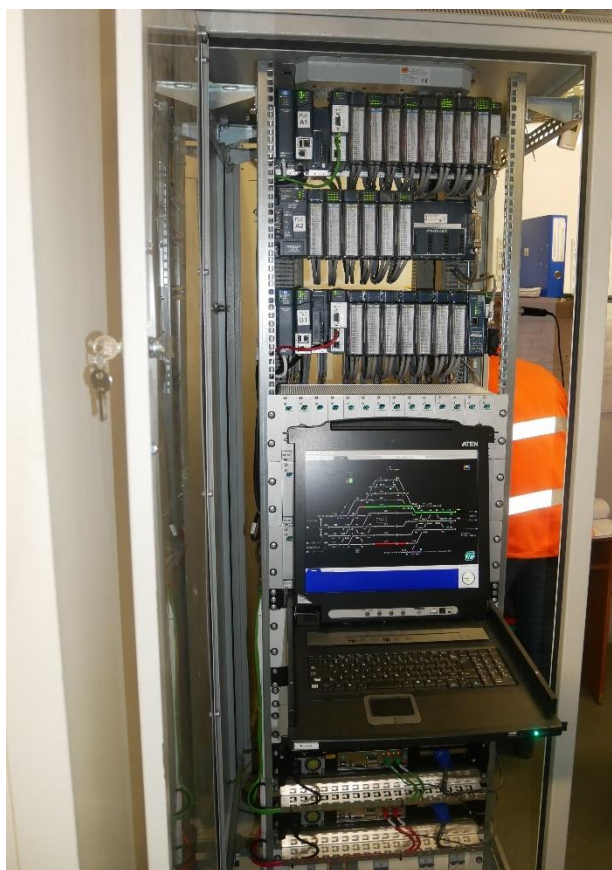
Photo No. 8 - Arrangement of devices in the MOR-1 computer cabinet

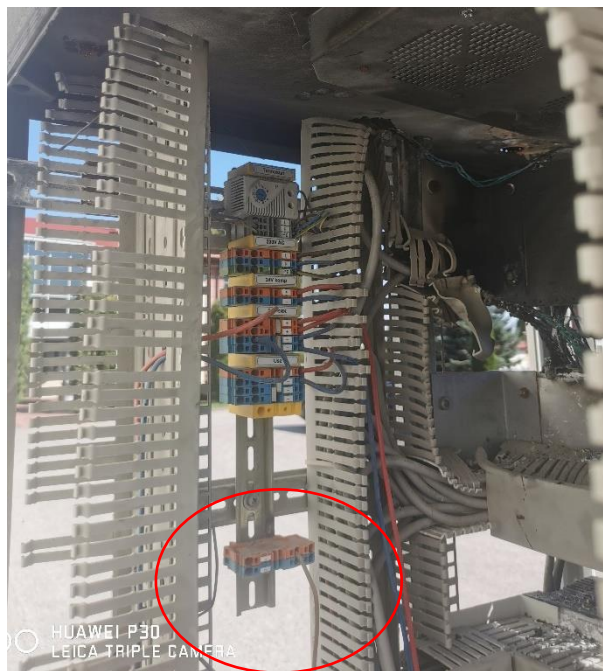
Photo No. 9 - Connections in the computer cabinet of unknown origin that do not correspond to the solutions of the equipment manufacturer (the cabinet was dismantled after the fire and the wires of the connecting cables in the cabinet were cut).

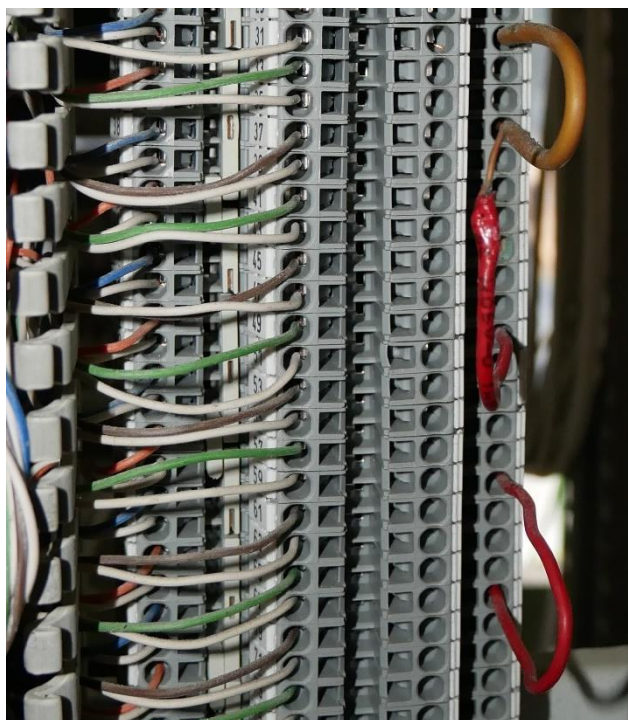
Photo No. 10 - Incorrect connections on terminal block #7 with visible signs of overheating and melting.

According to the Investigation Team, permanent heating at the connection point caused by improper terminal block connections and permanent heating at the top of the computer cabinet caused by a lack of proper cooling contributed significantly to the occurrence.

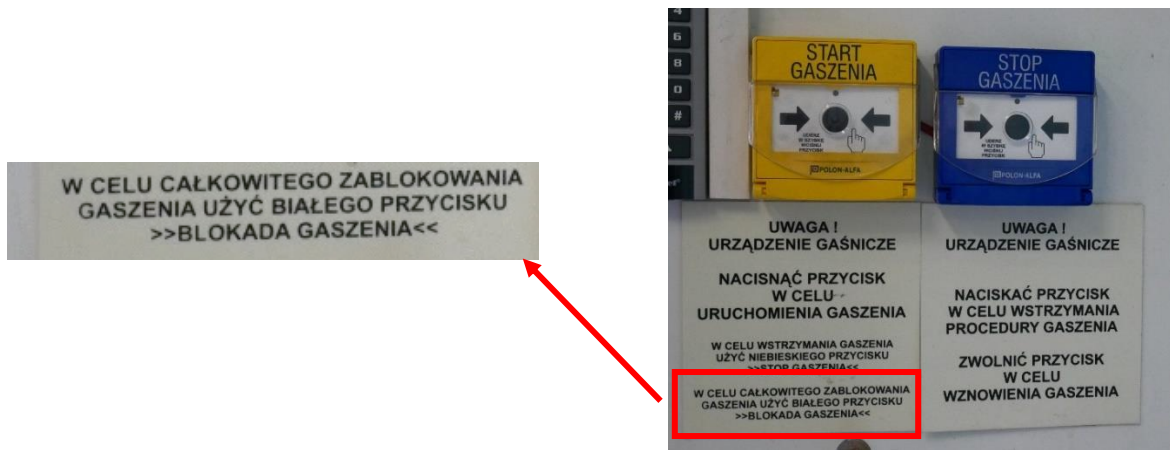
- Lack of all declarations of conformity to the type of the MOR-1 system in the railway traffic control industry's collation report,
- In the relay room of the Leszczyny control room, the fire switches were installed on the wrong side of the entrance door, and the white "extinguishing interlock" button was not installed.

Photo No. 11 - Fire buttons in the relay room

- 4) PKP PLK S.A. shall supplement the records of the Hazard Register in terms of diagnosed risks of fire source of railway equipment.
- 5) PKP PLK S.A. shall change the location of fire switches in the Leszczyny switchyard relay room from the right side to the left side of the door leading out of the relay room, and will install a white "extinguisher interlock" button.

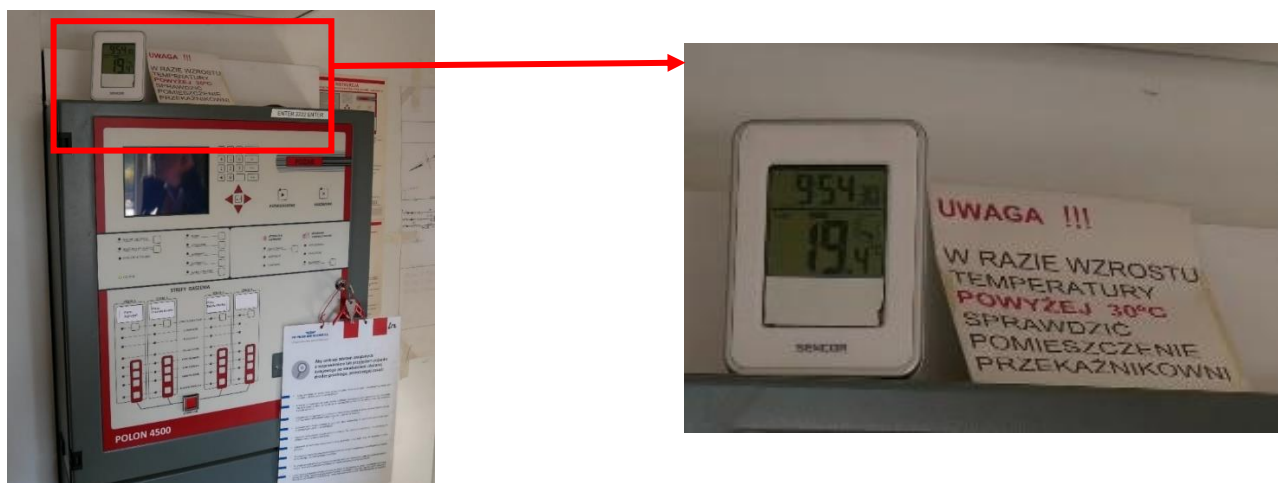
1. Failure on the day of the occurrence to turn on the automatic extinguishing system on the control panel located in the traffic control room after the receiving committee left the relay room.

Photo No. 12 - The control panel in the room of the traffic officer on duty
