**Gabinete de Investigação de Segurança e de
Acidentes Ferroviários**

Accident with passenger at Algueirão-Mem Martins, on 10/11/2014

INVESTIGATION REPORT *- English extended summary -*

Report nr. 2016/01en

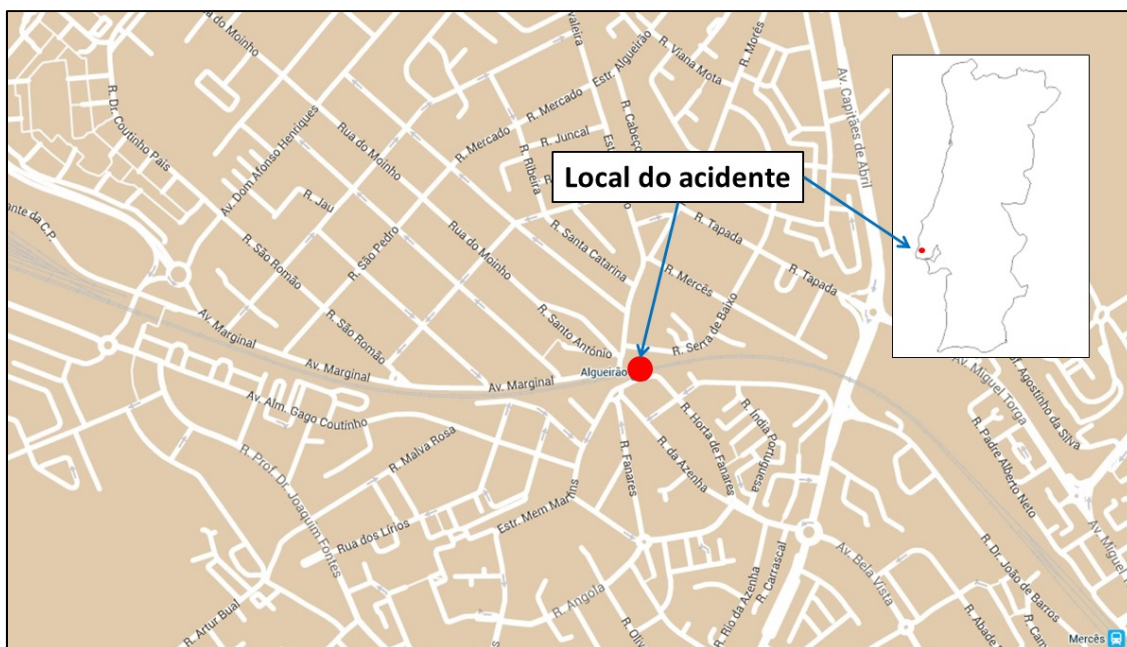
Figure 1: Accident location

On the 10th November 2014, around 19h11m, commuter train 18807, composed of two EMUs totaling eight vehicles, stopped at Algueirão-Mem Martins halt (Lisboa to Sintra line, at km 23 ¹) about 30 metres short of its designated stopping point, leaving the last four doors of the train outside the platform.

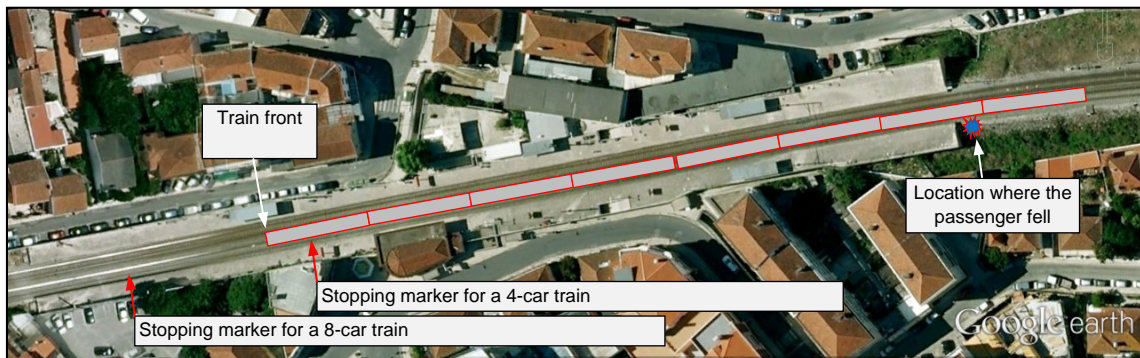
Figure 2: Reconstitution of the stopped train when the accident occurred

As soon as the train stopped, a visually impaired passenger, pressed the handle for opening the automatic door where he stood, which was the first one outside the platform. The door opened and he stepped out, falling into the cess from a height of about 1,50 metres. The fall caused the passenger minor injuries and difficulties in breathing.

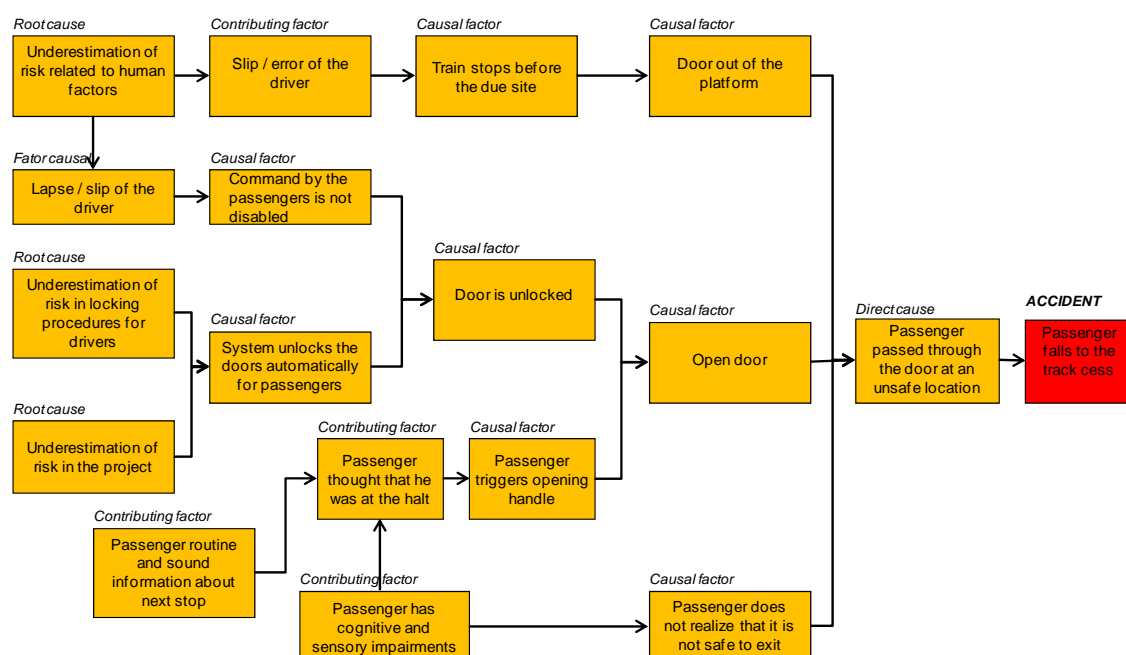
Accident causal tree

- The automatic door command system of EMUs class 2300/2400 is not designed in an intrinsically safe logic;
- Safety against the opening of doors at an unsafe location, with the train at a speed below 5 km/h, relies exclusively on a deliberate action of the driver;

- The train driver, for a number of reasons, may not be in a condition to make the required action to ensure safety, either by physical or cognitive incapacity;

- There is no safeguard built into the door command system against human failure;
- The RU hasn't made any risk analysis to the door command system of EMUs class 2300/2400;

- The risk of doors opening at an unsafe location is internationally identified, is relevant and can have serious consequences to passengers;
- This logic of door command system (also present on other EMUs in Portugal), is contrary to the general practice on rolling stock with automatically powered doors, whether in Portugal or abroad, regardless of building date or design origin;

- The stopping of the train short of the designated place, being a causal factor to the accident, is not determinant as the same result could have happened from any stop on plain line;

- The investigations carried out by the train operating company to similar occurrences in the past were not carried out in a way conducting to the identification and control of the existing risks to passengers, as far as reasonable.

2016/01: IMT is recommended to ensure that, within a timeframe accepted by it, CP assesses the risks to passengers resulting from the opening of automatic doors at unsafe locations, and implements the measures considered adequate to mitigate, as far as reasonable, the identified risks.

2016/02: IMT is recommended to ensure that, as soon as possible and while the measures resulting from the risk assessment mentioned in safety recommendation 2016/01 are not applied, **CP** implements an operating procedure on rolling stock with automatic doors, where necessary, so that the enabling of normal door command to the passengers control is only effective after safety conditions to do so are confirmed.

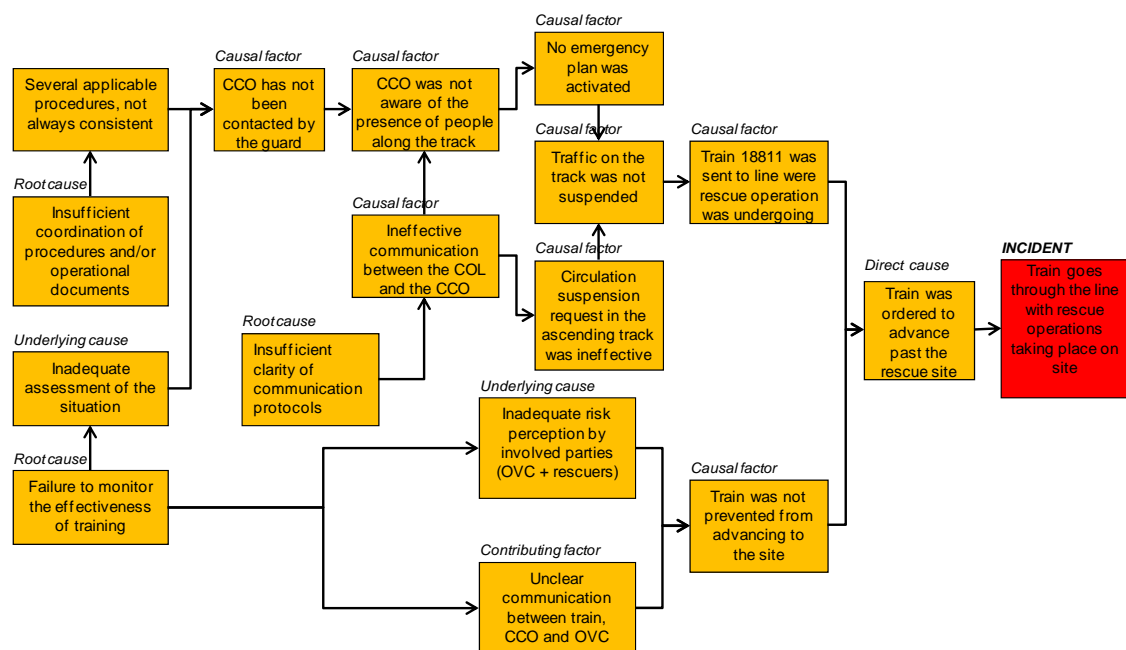
Causal tree for safety incident during rescue operations

- The type of accident, according to regulations, was not identified by the intervening agents, this leading to the applicable procedures not being followed;

- The accident was treated as a passenger falling on the platform and not as a passenger falling to the track;
- Successive lack of information clarity during the communications between several parties led to the fact that the occurrence was not correctly perceived by the command centres, and the procedures not being adopted – emergency status and traffic suspension on the affected section of line;

- By this same reason, rescue was delayed;
- The risk associated with a train passing on the track with rescue operations being carried out on the cess was not sufficiently perceived by the involved staff, subjecting themselves to unnecessary risks;

- There is no evidence that the training given by the RU to its staff relating to procedures during accidents, is adequate to give them proficiency in applying those procedures;

- The staff involved considers that the rescue operations worked normally and that, on similar circumstances, would take the same actions, an evidence which might imply that the established procedures, in this specific issue, may not be in full accordance with reality and the natural instinct of the users.

2016/05: IMT is recommended to ensure that, as soon as possible, the operating procedures' framework applicable to emergencies is evaluated and, if necessary, reviewed, in order as to minimize the risk of error by the intended users regarding actions to be taken.

2016/06: IMT is recommended to ensure that, within a timeframe accepted by it, CP establishes communications protocols, for use between their operational staff and between them and the IM control centres, adequate to minimize the risk of information not being transmitted accurately in emergency situations, so that the issuing agent gets assurance that the receiving agent fully understood the content of the information and receives confirmation that the required actions were implemented.

2016/07: IMT is recommended to ensure that, within a timeframe accepted by it, CP establishes a training program adequate for staff expected to intervene in emergencies, to develop competencies, proficiency and confidence in applying, under stress, the required procedures.
