**Gabinete de Investigação de Segurança e de  
Acidentes Ferroviários**

## Fatal accident at level crossing 324,964 Algarve line, Estômbar, on 28-01-2015

### **INVESTIGATION REPORT** *- English extended summary -*

Report nr. 2016/02en

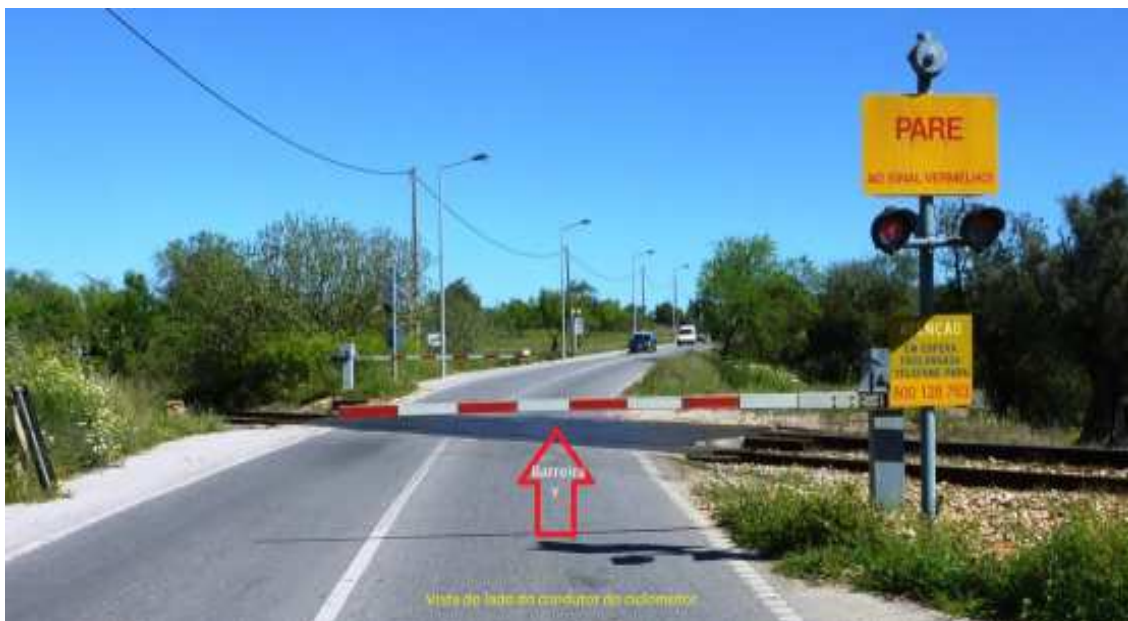
Figure 2: Level crossing viewed from the west

The level crossing is composed of automatically activated half-barriers, flashing red lights for road vehicles and audible warning for pedestrians. At the moment it was activated by the approach of regional passenger train 5900 consisting of a DMU totalling two vehicles.

From the collision resulted the fall of the driver and its vehicle to the level crossing plank, between the running rails, being shortly after run over by the approaching train with fatal consequences.

**Nr. 2016/08:** IMT is recommended that, within a timeframe that it finds acceptable, the Infrastructure Manager Infraestruturas de Portugal, S.A. study and implements adequate improvements to level crossing 324,964 (Algarve line), based on good and best international practice on the subject, in order as to maximize the conspicuity to road users of the crossing and its road signals and signs, especially under adverse low sun conditions.

**Nr. 2016/18:** Câmara Municipal de Lagoa is recommended to study and implement, within the shortest timeframe possible and in concertation with the rail Infrastructure Manager Infraestruturas de Portugal, S.A., adequate improvements to the road approaches to level crossing 324,964 (Algarve line), based on good and best international practice on the subject and relevant knowledge of road engineering, in order as to maximize to road users the conspicuity of the crossing and of its road signals, as well as to induce drivers to adopt the necessary precaution.

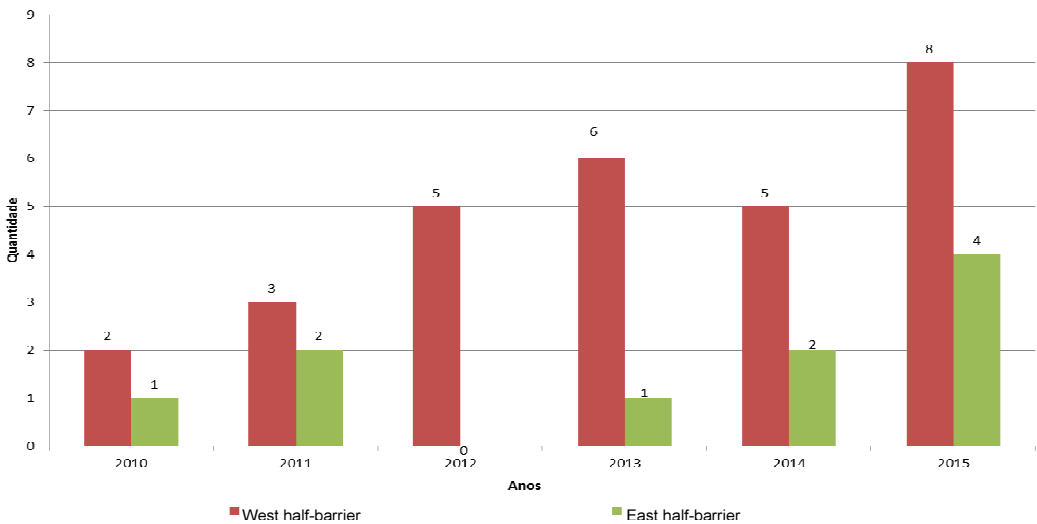
Graph 1: Collisions with half-barriers at the level crossing in the period 2010-2015, per year.

Investigating the history of occurrences at the level crossing on the five years preceding the accident, it was determined the existence of an important number of past collisions with half-barriers, but without causing any fatality or involving any train. Investigating further, it became clear that there was a significant predominance of occurrences involving the half-barrier struck by the motorcyclist, most of them during the morning hours, as can be appreciated from the following graphs.

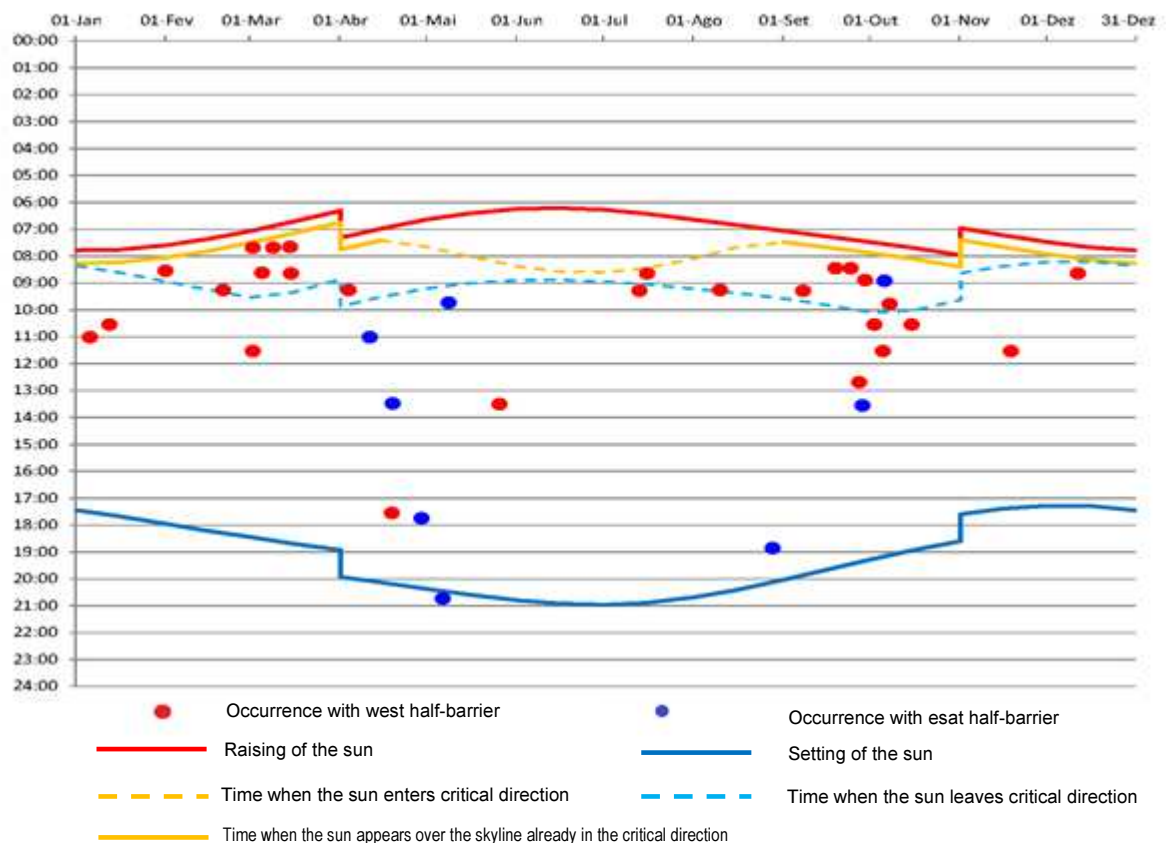
Graph 3: Yearly hours when the sun is most likely to affect roads users travelling from west to the east and collisions with half-barriers at the level crossing in the period 2010-2015 when there was a clear sky.

Half-barrier west is the most struck in the morning period in a large proportion (24 against 3), so in the direction prone to be subjected to the effects of sun glare.

56% of collisions with the west half-barrier happen during the critical time-slot where it was determined that the sun causes significant glare (the area between the orange and light blue lines)<sup>2</sup>, a period that represents only 11 % of the total sunlit period. This means that the frequency<sup>3</sup> of collisions with the West half-barrier in that short period

The graph also clearly evidences the concentration of occurrences in the two yearly periods when the sun is longer in the position that was determined to cause glare (February, March, September and October). Consistently, in the months when the sun is for a very short period in the position where it causes glare (April to August and November to January) there are very few occurrences; there being no evidence to suggest that the road traffic pattern changes precisely in these periods so as to justify the pattern of occurrences.

It is also of note the fact that there is no registered collision before the raising of the sun.

Therefore, GISAF considers that there is strong evidence to conclude that the position of the sun at certain day periods variable along the year can (i) disturb the concentration and vision of road drivers, as well as (ii) cause the level crossing, its half-barrier and its signaling to be less conspicuous to road users, factors that combined have the effect of making it difficult for road drivers to see that the level crossing is activated. GISAF considers that there is a very high degree of probability that these effects are a relevant causal factor in the numerous collisions with barriers registered at this level crossing and of the fatal accident subject to the investigation.

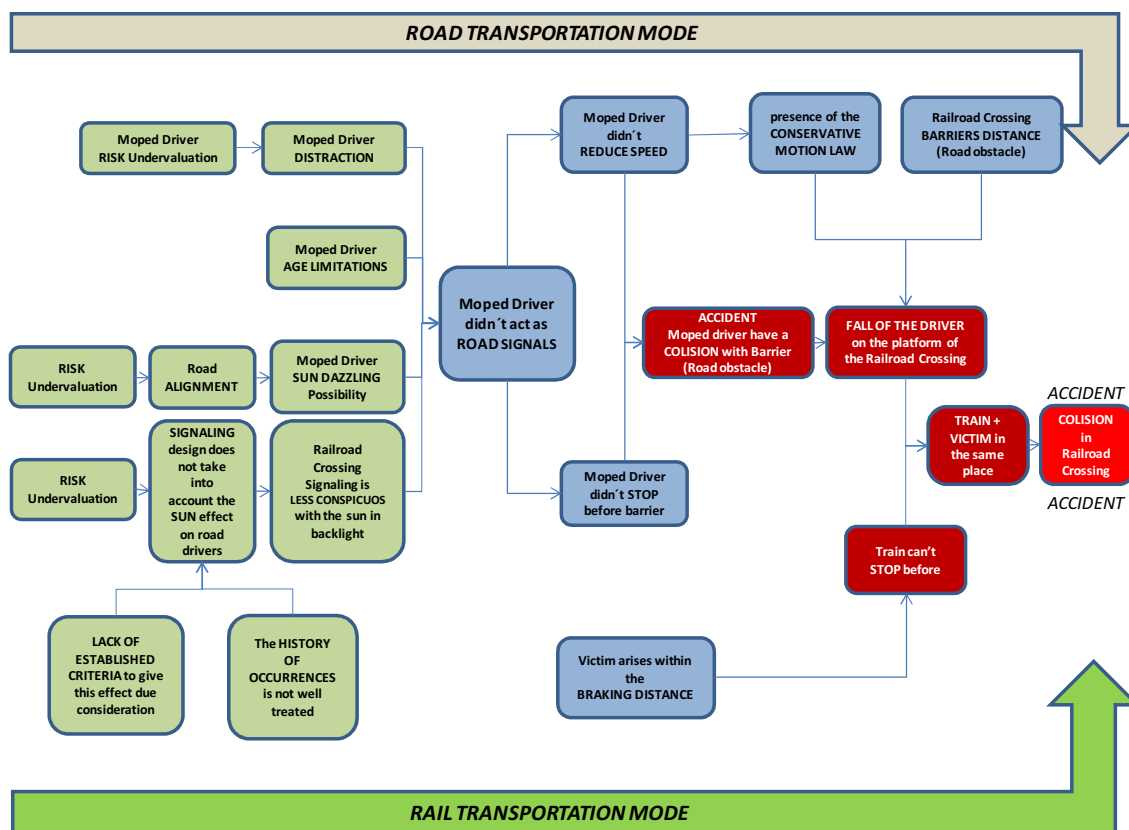
#### Accident causal tree:

The moped driver hitting the level crossing lowered half-barrier because he didn't stop before reaching it, and in consequence being projected to the crossing pavement, stopping over the track instants before the passage of the train.

The combined effect of the distance of the half-barrier to the track and the moped and driver velocity and mass, had the result of the fallen moped driver stopping over the track.

The moped driver didn't respond accordingly to the activated signals of the level crossing, not reducing its speed so as to stop short of the lowered half-barrier.

The investigation determined that there is a variable annual time-slot, within which the time of the accident is included, when the low sun may cause significant glare and reduce the conspicuity of the half-barrier and level crossing signals to road users approaching from the west, due to the road orientation.
