Rail Accident Report

**Near miss at Poplar Farm level crossing,
Attleborough, Norfolk
1 July 2008**

Near miss at Poplar Farm level crossing, Attleborough, Norfolk, 1 July 2008

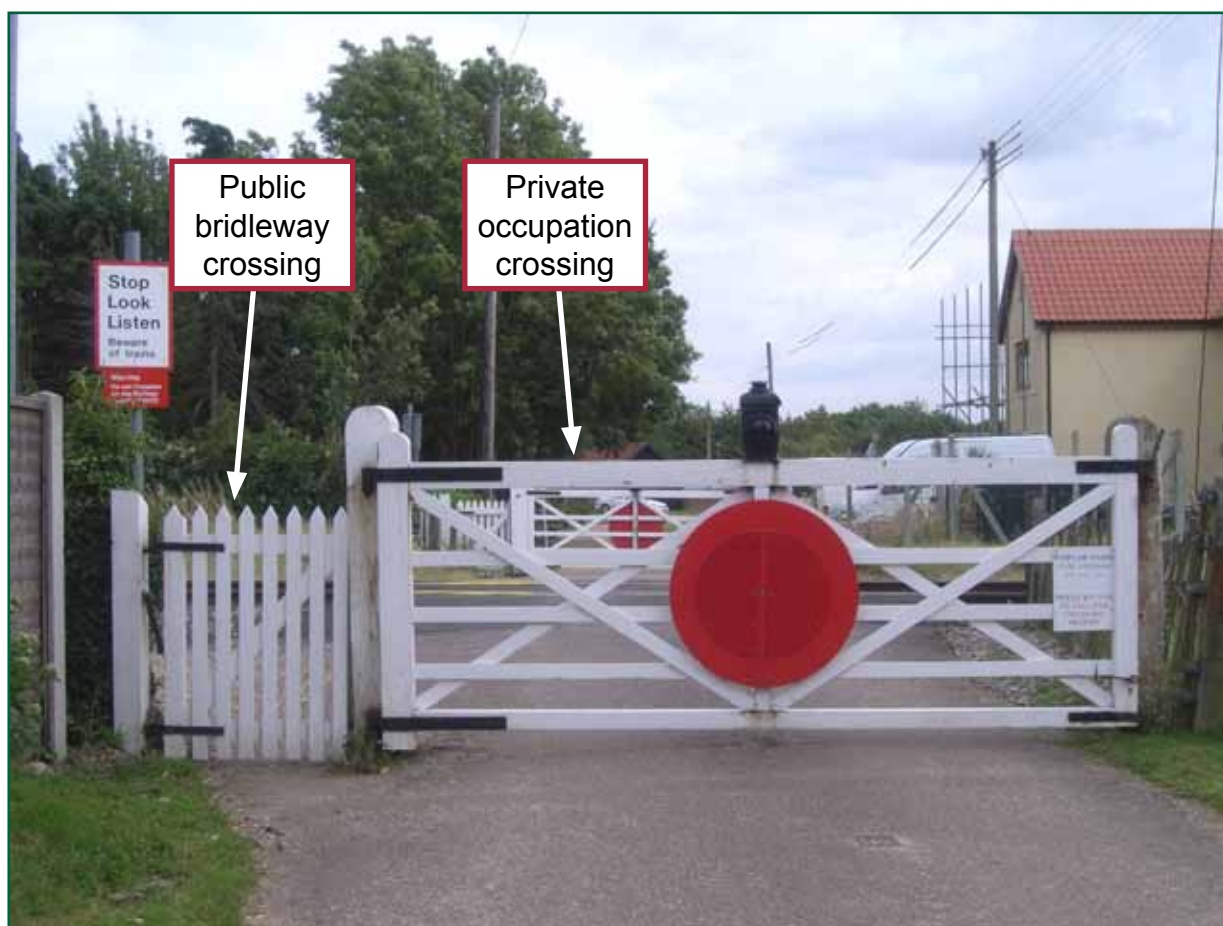
Figure 2: Poplar Farm level crossing from the down side of the railway (the direction approached by the mobility scooter)

- 9 The level crossing, although appearing to be one crossing, consists of two discrete parts (see Figure 2) with both having a boarded timber surface at rail level:

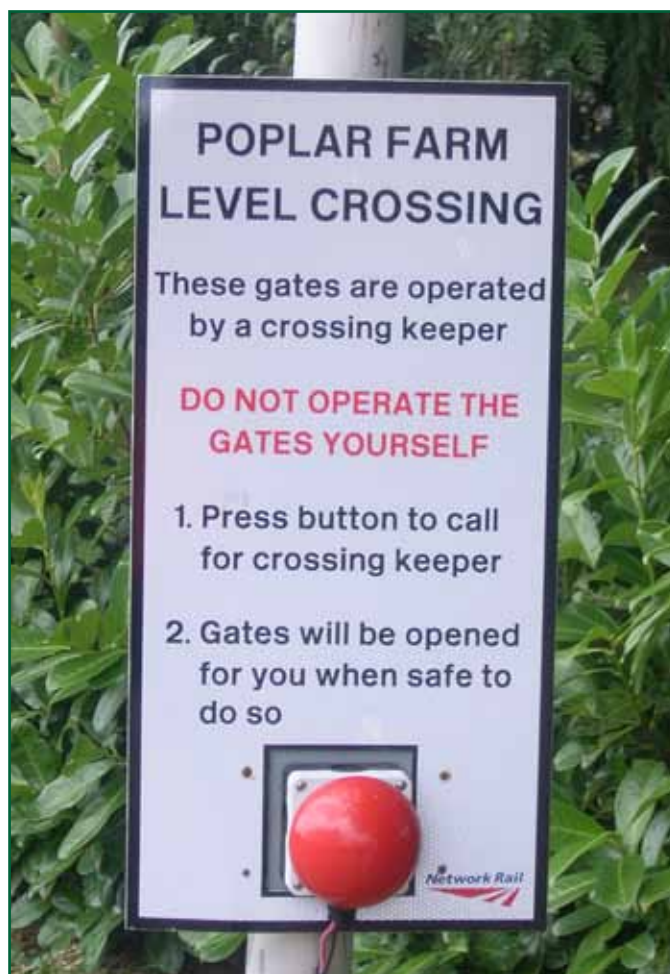
Figure 4: User instructions, Poplar Farm level crossing

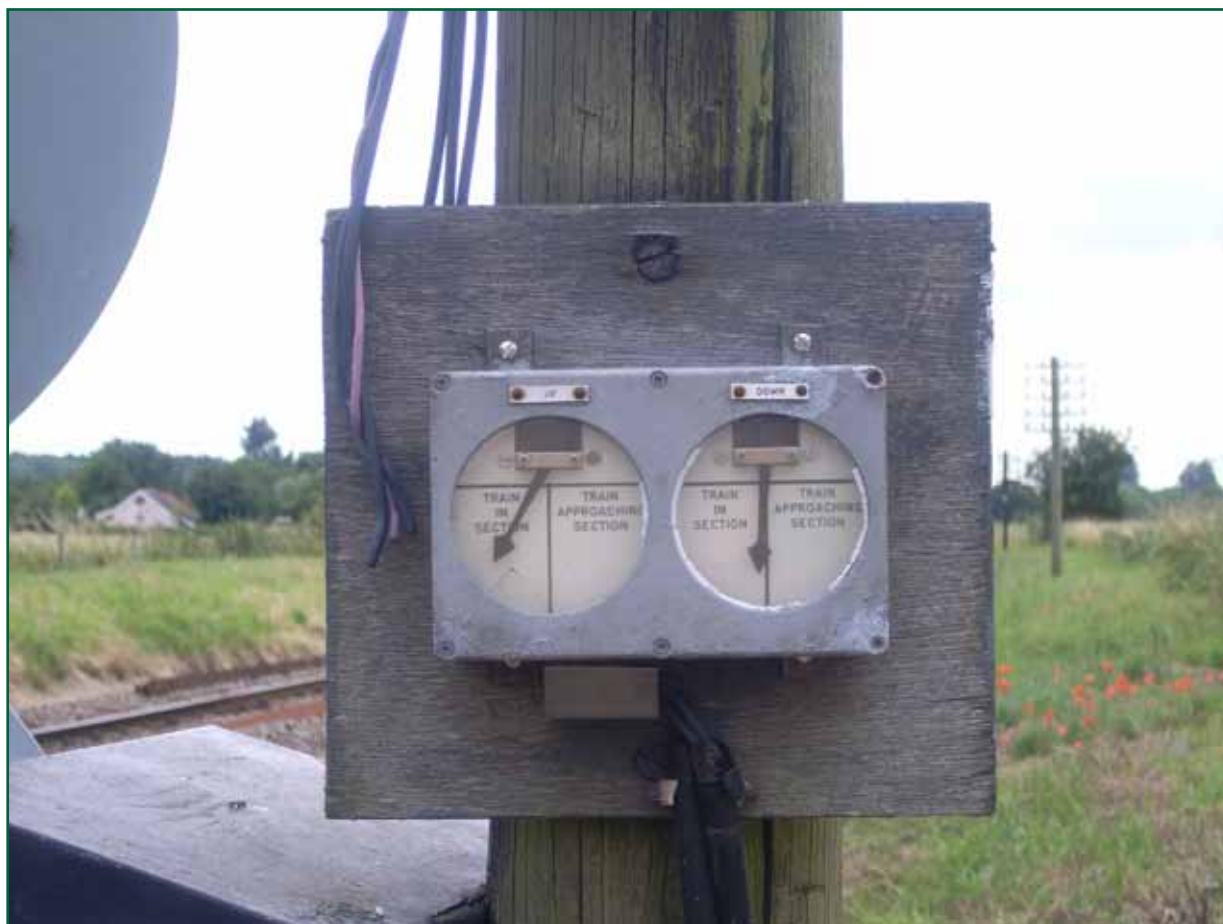
- 14 Indicators operated by the *block section circuit* between Attleborough and Eccles Road signal boxes are provided on both sides of the crossing on the Eccles Road side (Figure 3) to give guidance to the crossing keeper on whether it is safe to open the gates to allow vehicles to drive over the crossing. There is one indicator for each line and when energised through the block section circuit, the needle indicates either 'train in section' or 'train approaching section'. When the indicators are de-energised, they are referred to as being 'normal'. Figure 5 shows one of the sets of indicators.

Figure 5: Poplar Farm level crossing indicators (note the up line indicator is showing 'train in section')

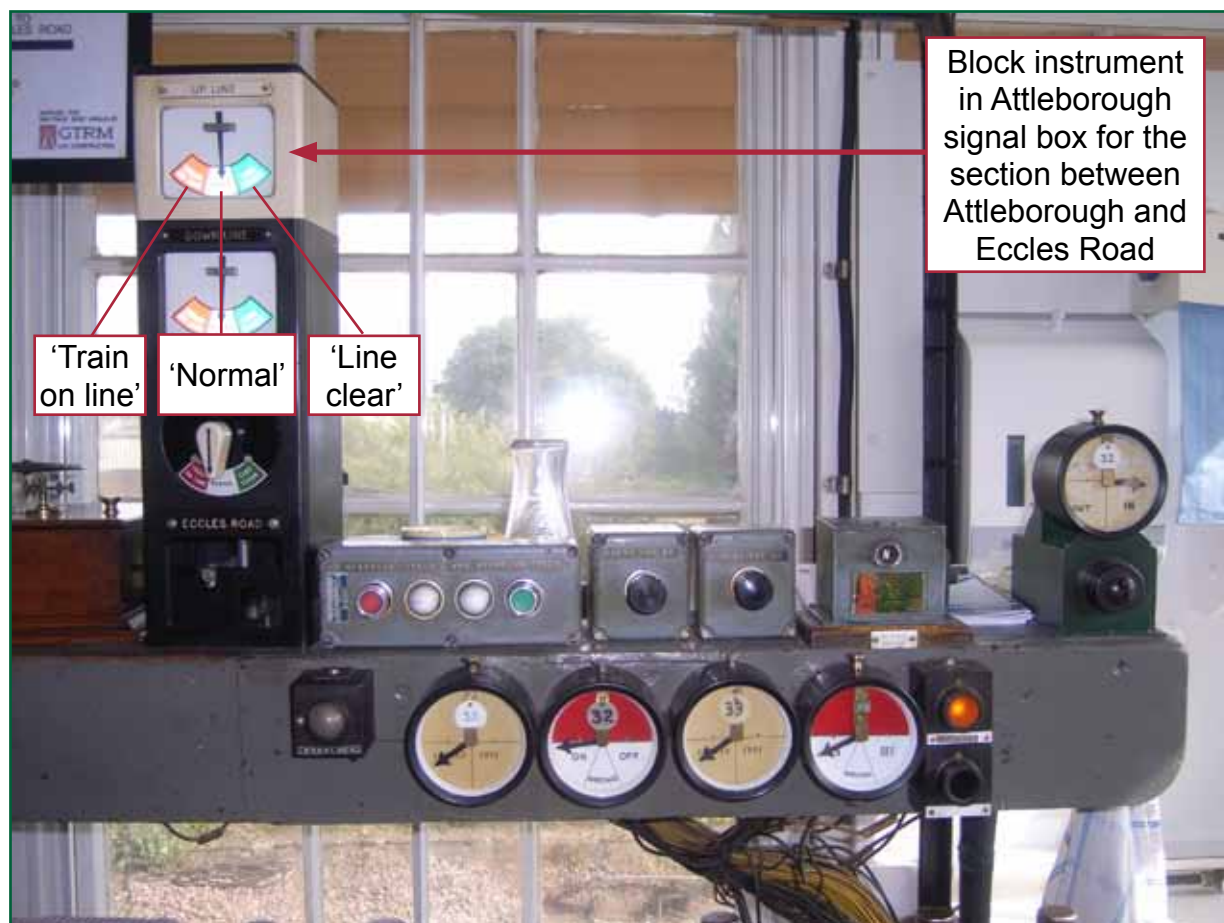
Figure 6 shows the block instrument in Attleborough signal box for the block section to Eccles Road. The top indicator repeats the indications following the operation of the block instrument for up trains by the signaller at Eccles Road.

Figure 6: Block instrument in Attleborough signal box for the section to Eccles Road

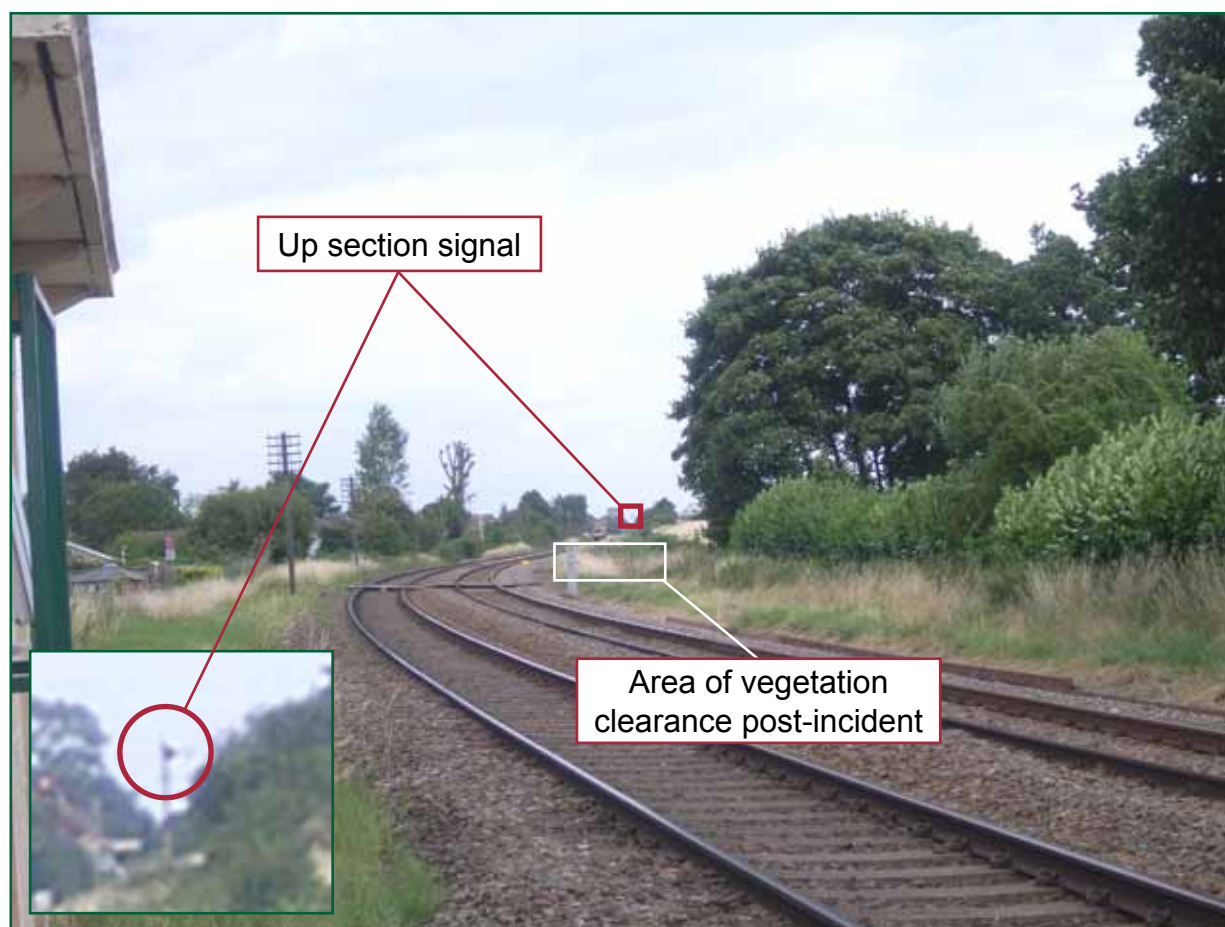
Figure 7: View from the down side of Poplar Farm level crossing to Attleborough station

- 49 The growth of lineside vegetation on the up side of the railway between Attleborough station and Poplar Farm level crossing did not allow a continuous view of trains approaching from Attleborough. The Attleborough signaller replaced his section signal to danger for the stopping train, 1M30, as soon as it had passed the signal. The train was then hidden from the view from Poplar Farm level crossing by the lineside vegetation.

- 58 In this incident, the crossing keeper looked along the railway towards Attleborough station, but the train concerned was hidden by vegetation. The maintenance of clear sight lines to help the crossing keeper to decide whether or not a train had already passed over the crossing was not appreciated by those who were carrying out the crossing inspections because the crossing was inspected as a manned gated crossing which did not require sighting to be checked (paragraph 40).

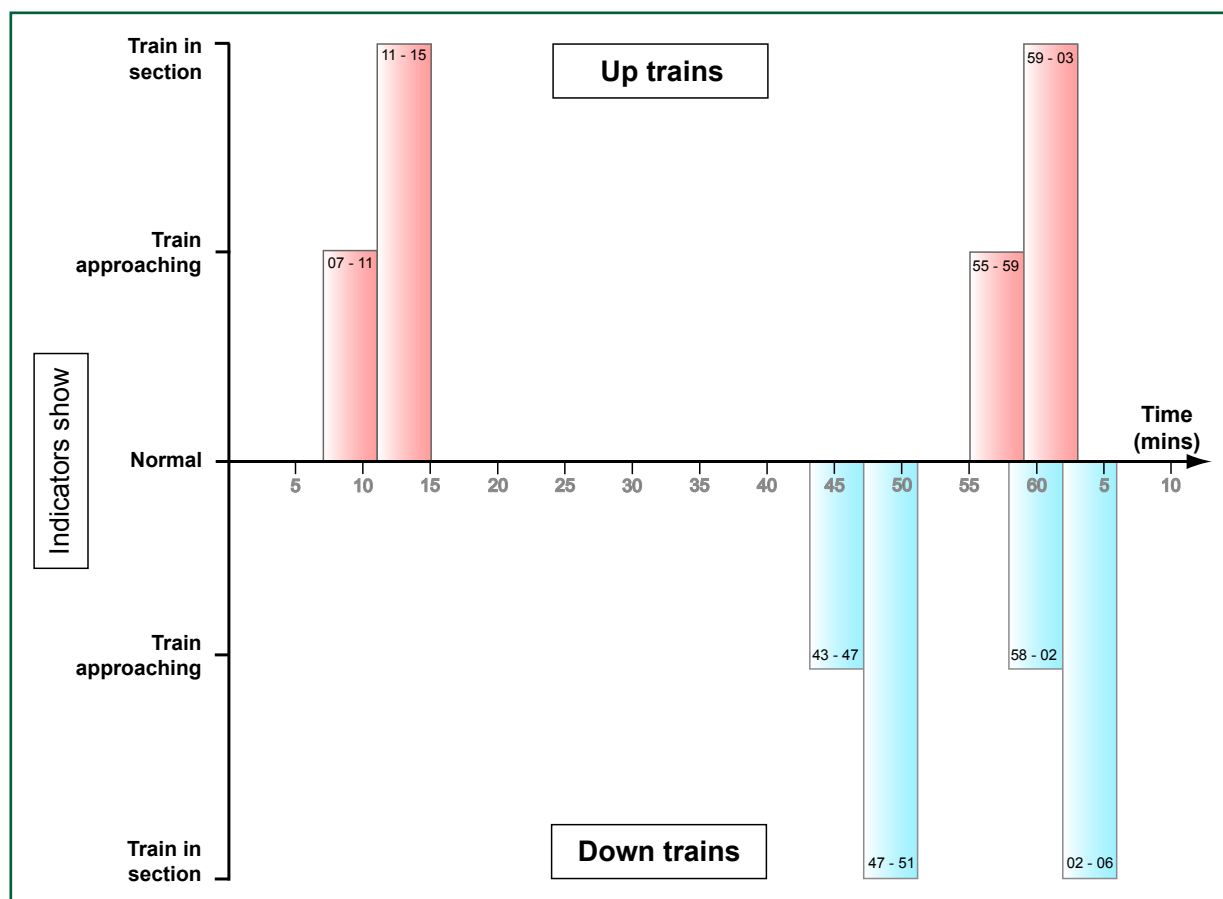
Figure 8: Operation of crossing indicators during any typical 60 minute period

- 31 Table 1 also shows that for an up direction train, the indicator at Poplar Farm crossing typically shows 'train approaching section' for four minutes, followed by 'train in section' for four or five minutes (depending on whether the train is one that stops at Attleborough). The running time from Poplar Farm crossing to Eccles Road is about three minutes and unnecessary closure of the road and delay to road users would occur if the crossing keeper were required to wait for the indicator to de-energise having already seen the train concerned pass over the crossing and being certain that this was the train indicated.
