# Rail Accident Report

## **Serious operational irregularity at Balham 20 April 2019**

Report 01/2020  
February 2020

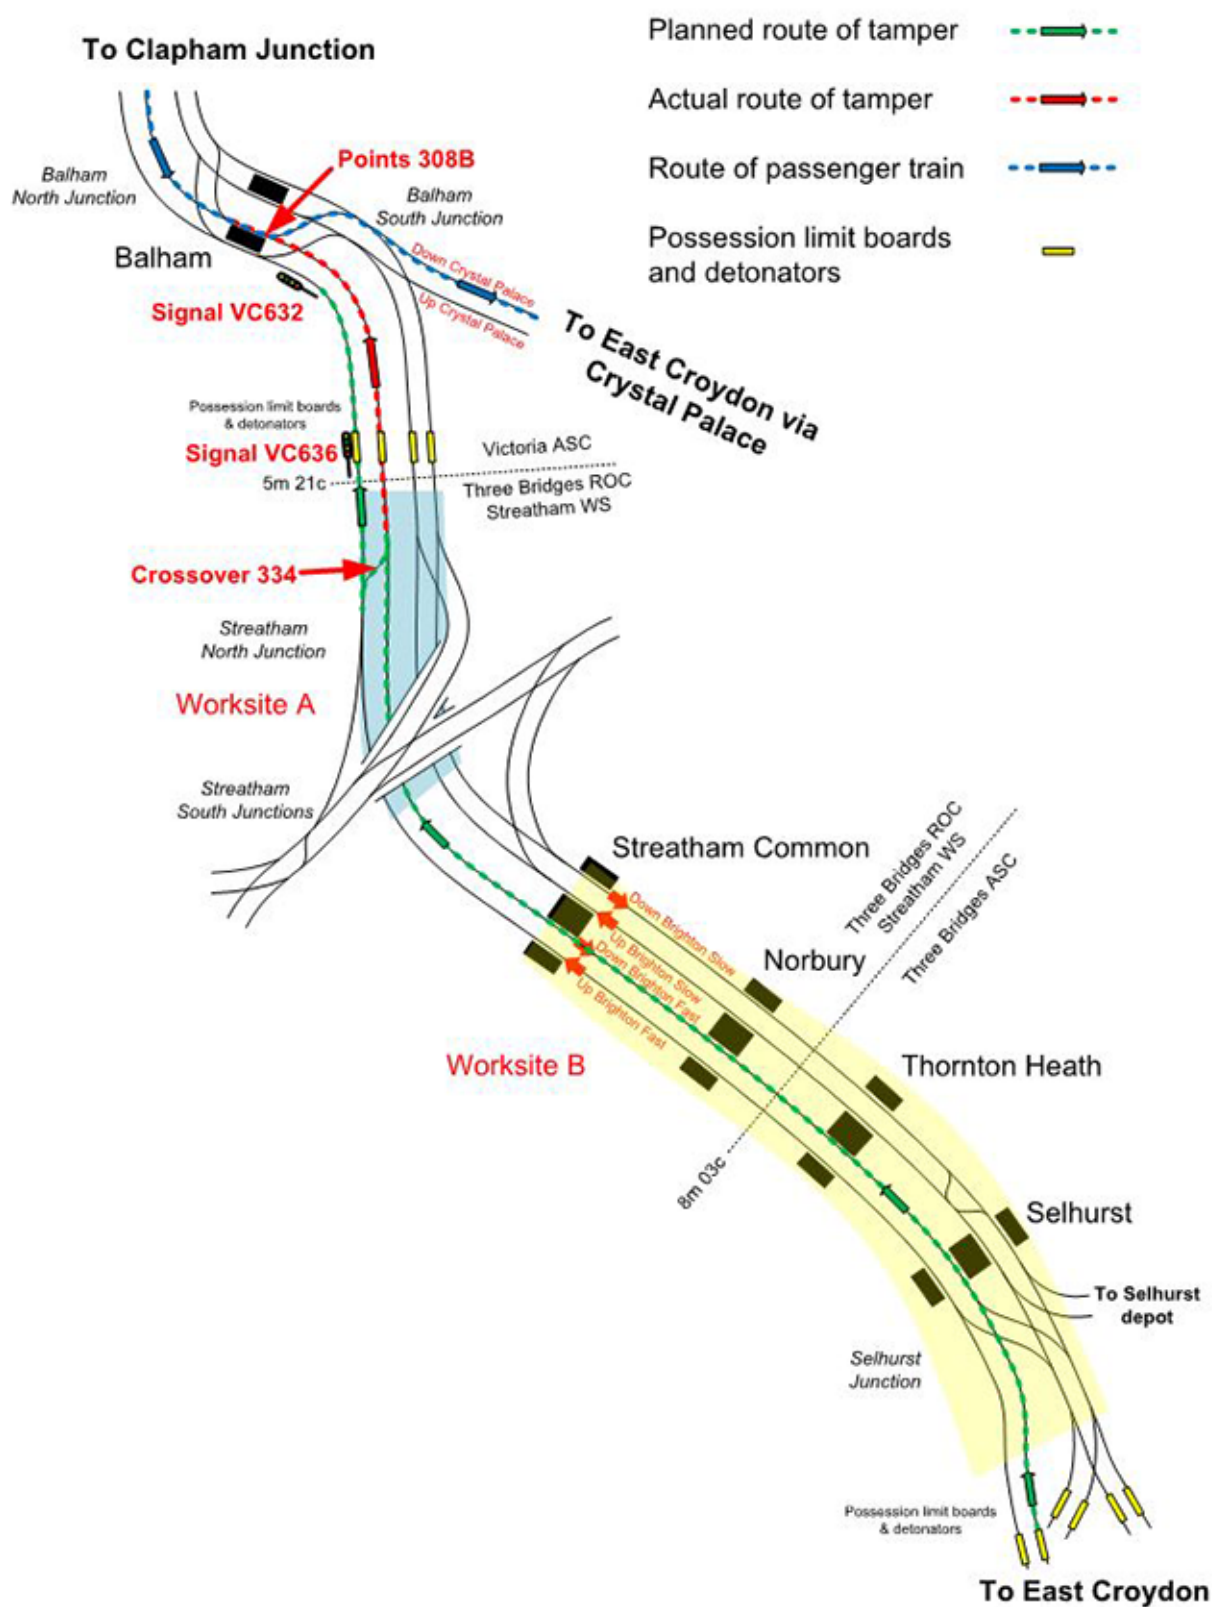
Figure 2: Overview of incident showing geographical relationship of key features

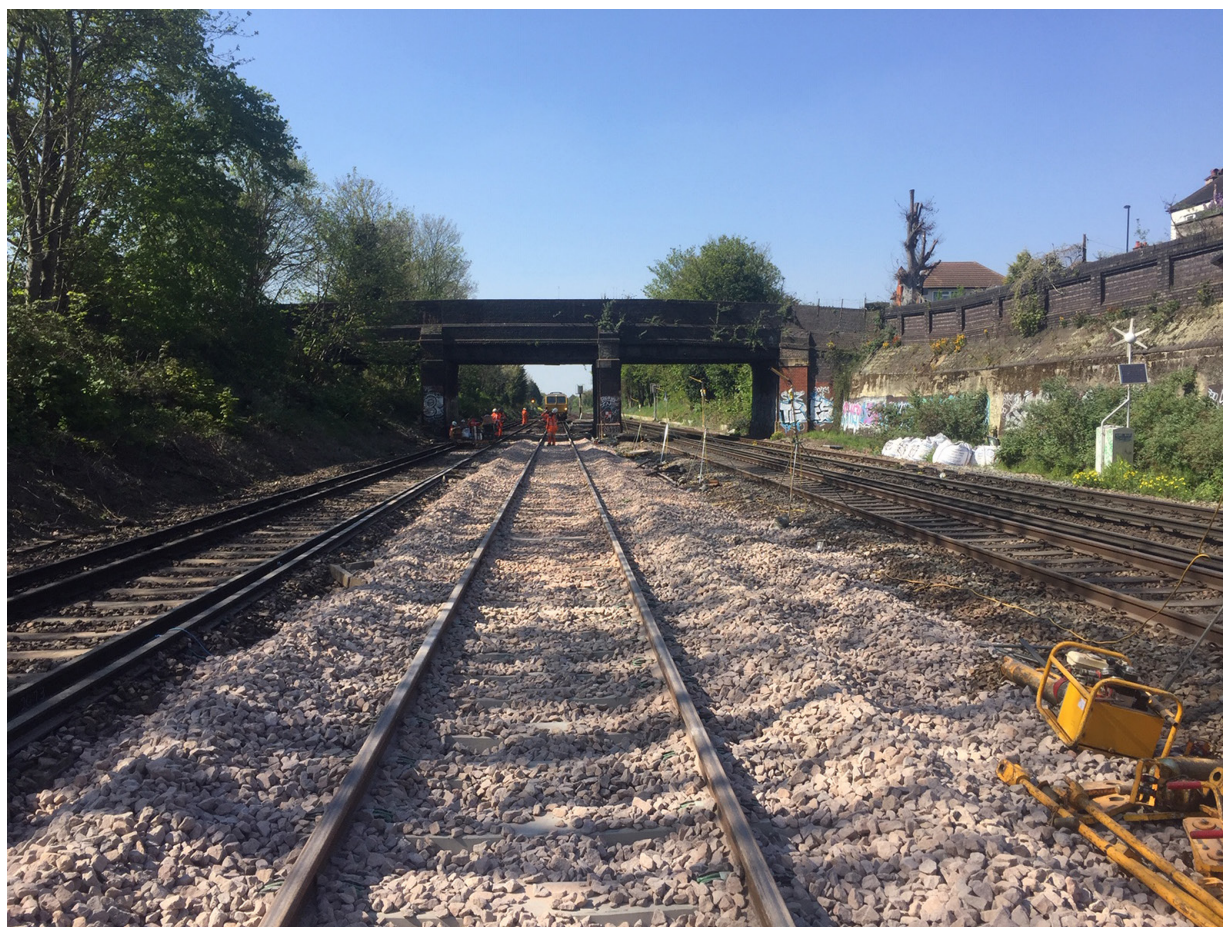
- 35 The possession continued through Saturday morning, with train 9 entering the possession on the up Brighton fast line during the early hours. At 04:01 hrs, train 6J91, referred to as the tamper for the remainder of this report, entered the southern end of the possession on the down Brighton fast line, before entering worksite B. It was due to work in worksite B on the down Brighton fast line from south to north, colloquially referred to as 'Country to London' (C-L, see figure 5), the opposite direction to the normal use of this line (also sometimes referred to as running 'bang road'). The tamper was the only engineering train working on the down Brighton fast line.

Figure 6: Train 6J91 within worksite B on the down Brighton fast line at Thornton Heath

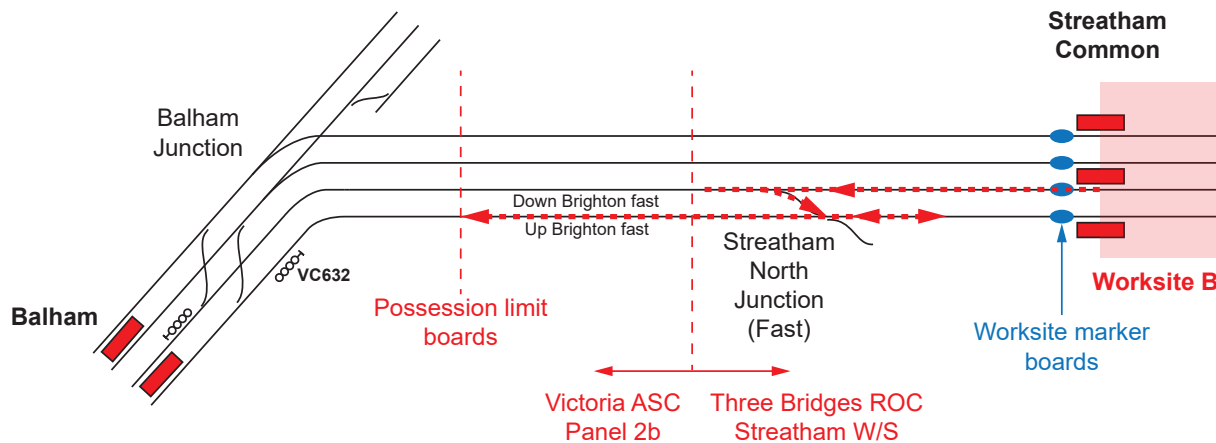
- 41 As the boundary between the area of control of Victoria ASC and Three Bridges ROC (figure 7) was within the possession, the day PICOP would have needed to contact the signaller on the Streatham work station at Three Bridges ROC to arrange for the planned move of the tamper over points 334 from the down Brighton fast line to the up Brighton fast line. At 17:04 hrs the day PICOP called that signaller to enquire if the up Brighton fast line from signal TVC 660 at Streatham Common was clear to the northern limit of the possession and signal VC 632. The signaller confirmed that as far as he knew the route was clear, and requested the day PICOP to instruct the tamper driver to observe and check any points in the route.

Figure 7: The planned route of train 6J91

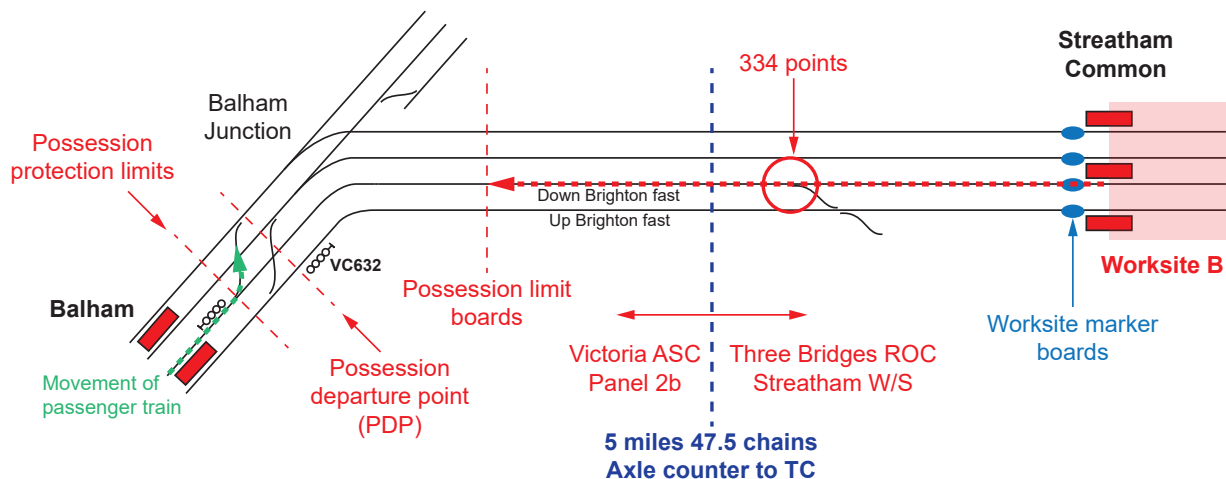
- 43 At around 17:24 hrs, the ESA called the day PICOP, who returned the call at 17:33 hrs. The ESA passed his phone to the conductor driver, who had now taken charge of the movements of the tamper. The day PICOP instructed the conductor driver to proceed to the detonator protection once the worksite marker board was lifted. The ESA moved the worksite marker board and the tamper left worksite B at 17:34 hrs travelling in the up direction on the down Brighton fast line, arriving at the PLBs south of Balham Junction at 17:40 hrs (figure 8). When it arrived there, there was no COSS or possession support assistant present. The tamper was not scheduled to leave the possession until 19:00 hrs.

Figure 8: The actual route of train 6J91

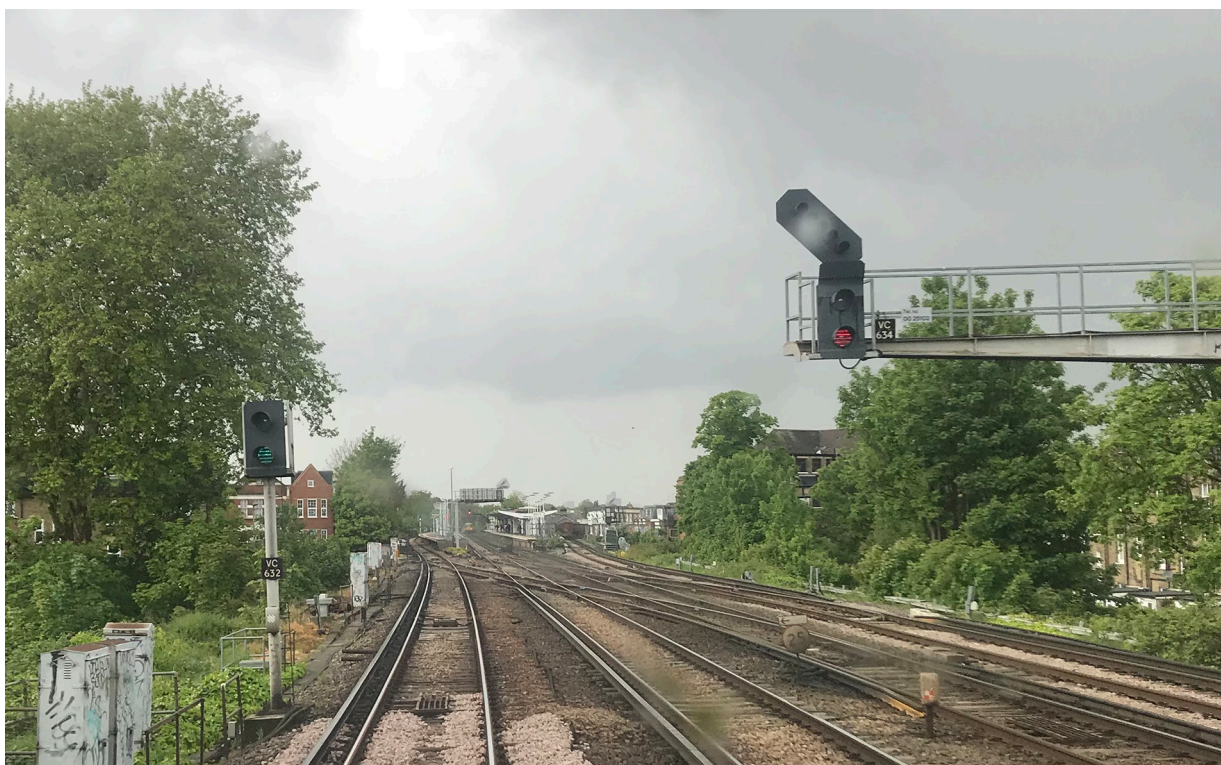
- 74 When the tamper arrived at the PLBs, there was an opportunity for its correct location to have been identified. The conductor driver's phone calls did not meet Network Rail's requirements for safety critical communications, as was evident from the recordings of his conversations with signallers 1 and 2, and when he received the instructions for the tamper to leave the possession (paragraphs 134 to 135). Although he evidently referred to the train running document during his conversation with signaller 2 (figure 11), he did not identify that the tamper had not been crossed over to the up Brighton fast line as planned. The conductor driver and tamper driver did not challenge the signallers, and followed the instructions they were given. However, the conductor driver could not explain why he did not notice signal VC 632 on the adjacent line or instruct the tamper driver to stop adjacent to it (figure 14). RAIB considers that this may have been because signal VC632 did not apply to the line that the tamper was on, and so the conductor driver did not consider that it was likely to be relevant to him.

Figure 14: View looking north towards Balham station, with signal VC 632 on the up Brighton fast line (left) and VC 634 on the up Brighton slow line (right)
