Rail Accident Report

Runaway locomotive at Beddgelert, North Wales 16 April 2019

Report 02/2020
February 2020

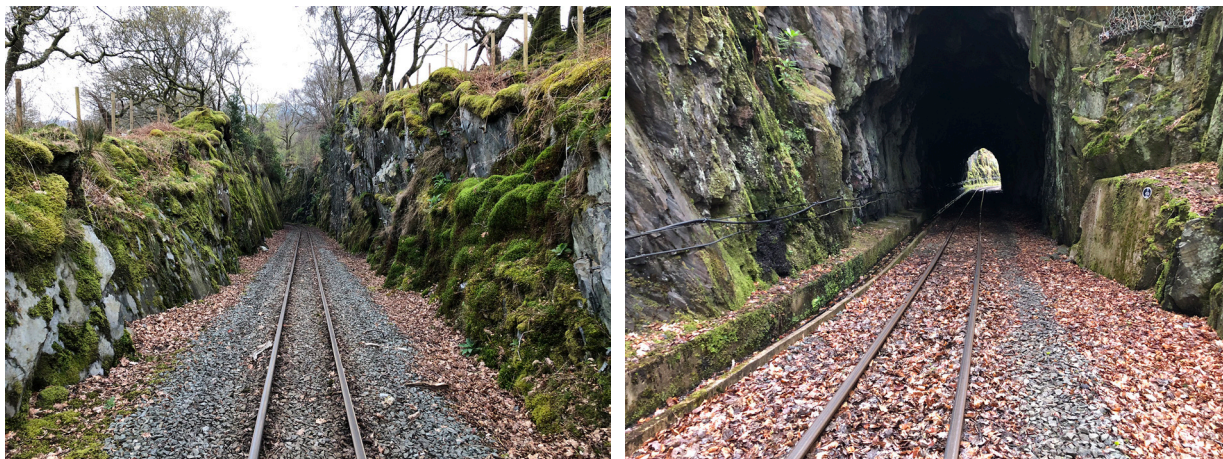
- 21 The rails throughout the area of the incident were wet. There were leaves around the rails, particularly in the areas around Cutting Mawr and Goat Tunnel (figure 5). Some wheelburns, which can occur if train wheels spin on the rails, were noted in the area, indicating the presence of low adhesion conditions. However, it was clear from the spacing and arrangement of the wheelburn marks that they had not been caused by 'Vale of Ffestiniog'.

Figure 5: Photographs showing the general aspect and track conditions a) looking south into Cutting Mawr; and b) looking north into Goat Tunnel

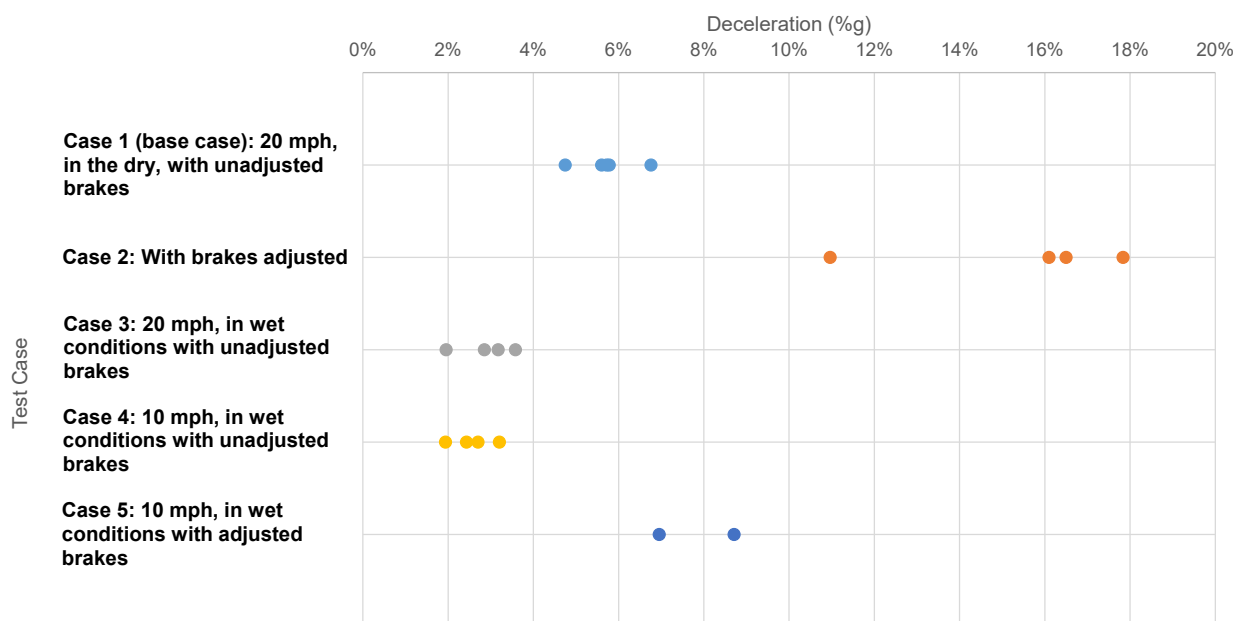
- 45 The resulting decelerations, expressed as a percentage of the acceleration due to gravity⁶ are shown in figure 6, in each of five different test cases. There was some scatter in the results due to imprecision of the speedometer, and the differing temperatures of the brake blocks as the tests were repeated.

Figure 6: Graph showing the decelerations achieved by 'Vale of Ffestiniog' in the five different test cases

- 46 The tests showed that, regardless of speed, when the brakes are adjusted as they were on the day of the incident and the rail is wet, the locomotive achieves a deceleration of between 2%g and 4%g. In the incident, this low level of braking would have been more or less balanced by the accelerating effect of the downhill gradient of 1 in 40 (which would cause an acceleration of around 2.5%g), and the idling tractive effect of the locomotive being left in gear. The braking would have been assisted by a small amount of rolling resistance from the wheels. The tests also showed that adjusting the brakes resulted in much higher deceleration, regardless of the speed or conditions.

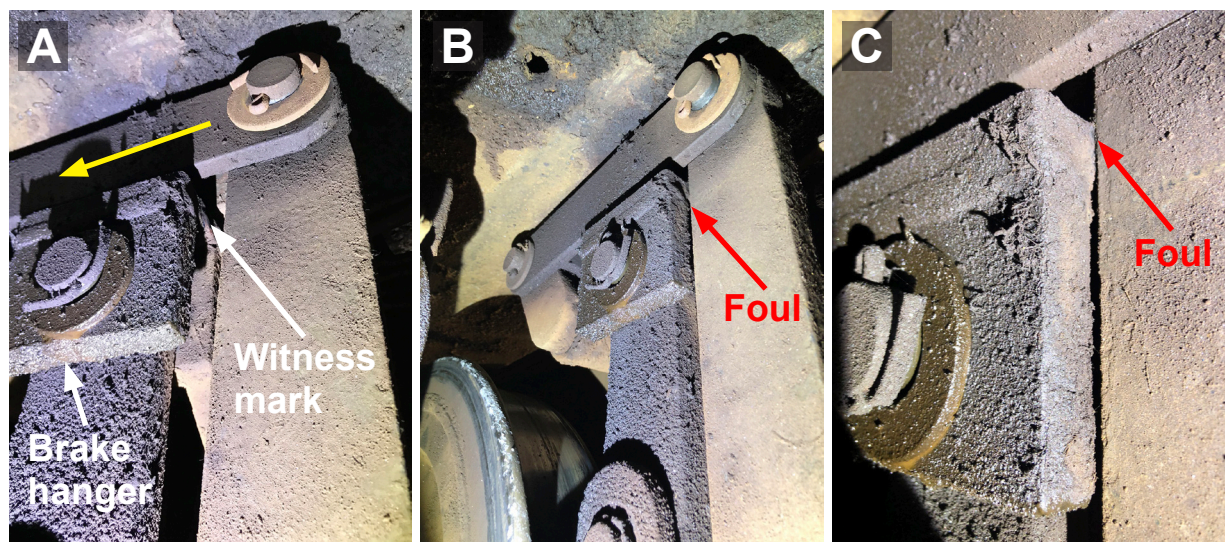
51 Following the incident, the locomotive was hauled to Boston Lodge works for a detailed inspection by FRC and RAIB. This inspection identified that the four sets of brake equipment, one in each corner of the locomotive, which operate independently of each other, had the same mechanical fouling problem. As the brakes were applied, a link in the brake mechanism was found to foul on the associated brake hanger⁷. With the brakes released, witness marks on both components were evident (figure 7).

52 The foul meant that the movement of the brake linkage, and hence the brake blocks, was obstructed, preventing full brake force being applied to the wheels.

Figure 7: Photographs showing the location of the foul in the brake linkage (red arrows), (a) with brakes off; (b) with brakes on and (c) close-up view with brakes on. The yellow arrow in (a) indicates the movement of the link when the brakes apply.

- 58 At some point during the operation of the locomotive, the clearance within each brake mechanism, indicated by the blue arrow in figure 9, reduced to zero, resulting in the fouling noted in figure 7. Once the foul occurred, any further force applied by the brake cylinder would not translate to additional movement of the brake blocks against the wheel, hence limiting the brake force applied.

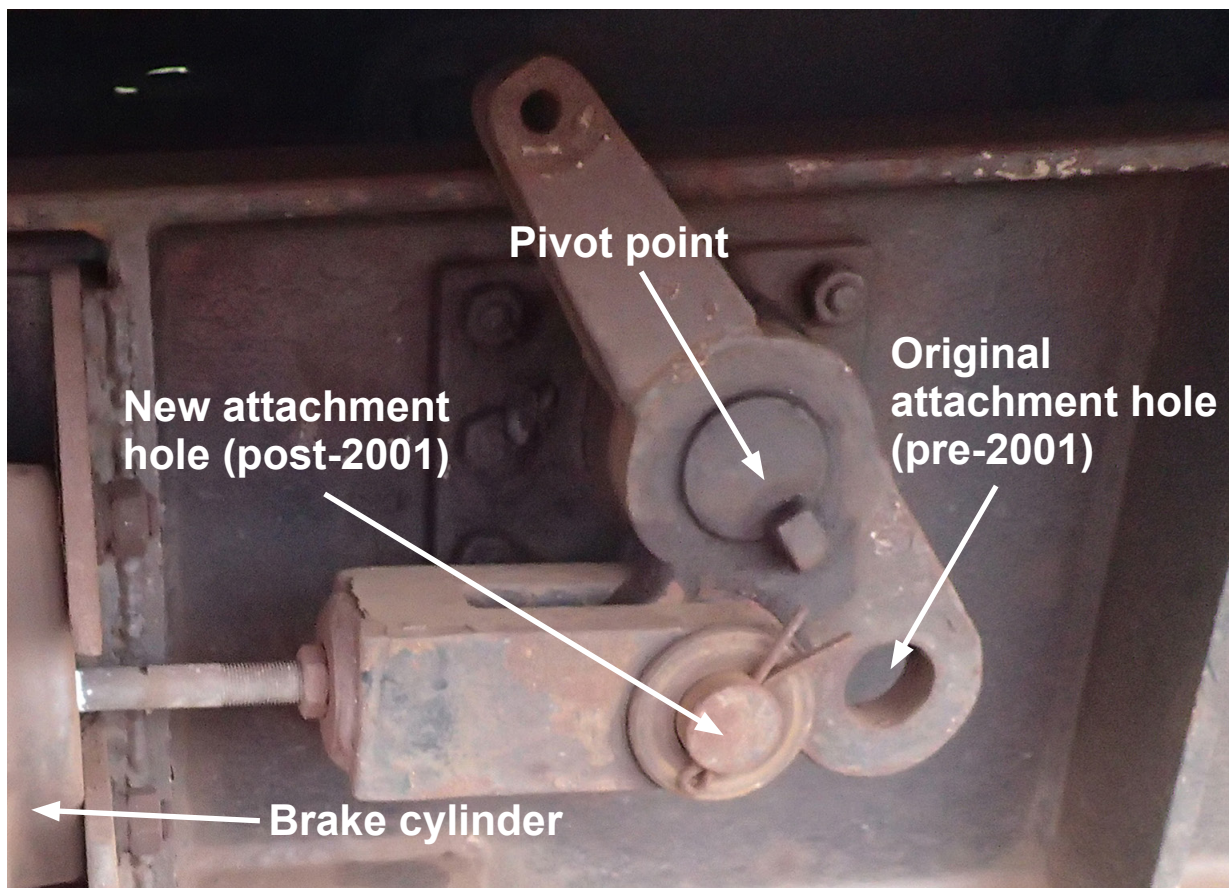
55 Around 2001, after operating the locomotive for a few years, FRC found it was experiencing an issue with leaking seals on the locomotive's brake cylinders. FRC was unable to source replacement seals, so the engineer who had originally rebuilt the locomotive (paragraph 14) proposed to increase the cylinder air pressure to alleviate the issue. The associated increase in the locomotive's braking force would lead to undesirable differential braking between the locomotive and any hauled carriages, causing a jerky ride for passengers. To prevent this, the engineer decided to reduce the leverage applied by the brake cylinder, which would return the brake force to the 'pre-modification' level, despite the increased air pressure. He achieved this by reducing the distance between the brake cylinder attachment point and the first pivot in the linkage (figure 8). To prevent a clash with the original attachment hole, he welded a metal lug onto the side of each of the first links, with a new attachment hole.

Figure 8: The original and new (2001) brake cylinder attachment positions

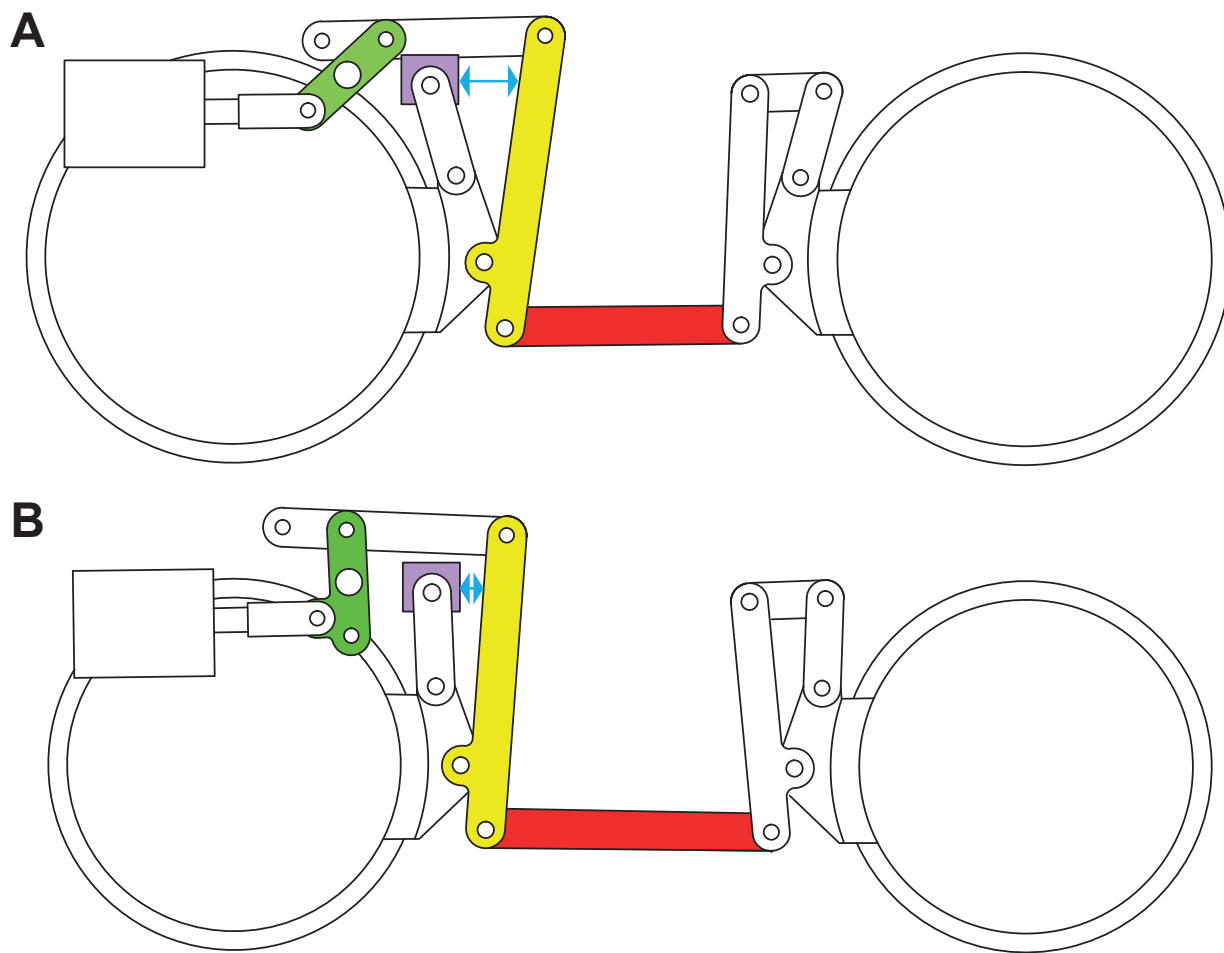
56 The change in the attachment position altered the angle of the first link in the brake mechanism. This resulted in a change to the geometry of the remainder of the linkage, which was compensated for using a turnbuckle slack adjuster (shown in red in figure 9) within the mechanism.

Figure 9: Diagram of the geometry of the brake mechanism when a) built to the original design; and b) the brake cylinder attachment position had been altered and the wheels have worn. The link altered by the railway is highlighted in green, the adjustable turnbuckle link in red and the clearance by the blue arrow.

- 57 A result of this modification was a reduction in clearance (shown by the blue arrow in figure 9) between the outboard brake hanger (shown in purple) and the long vertical link (shown in yellow) on the outboard side of the slack adjuster. Although initially there would be a clearance when the brake block positions were adjusted to be closer to the wheels with the brakes off, as the wheels and brake blocks wore, the brake blocks would have further to travel. Because of this, when the brakes were applied, the clearance (shown in blue) would reduce.

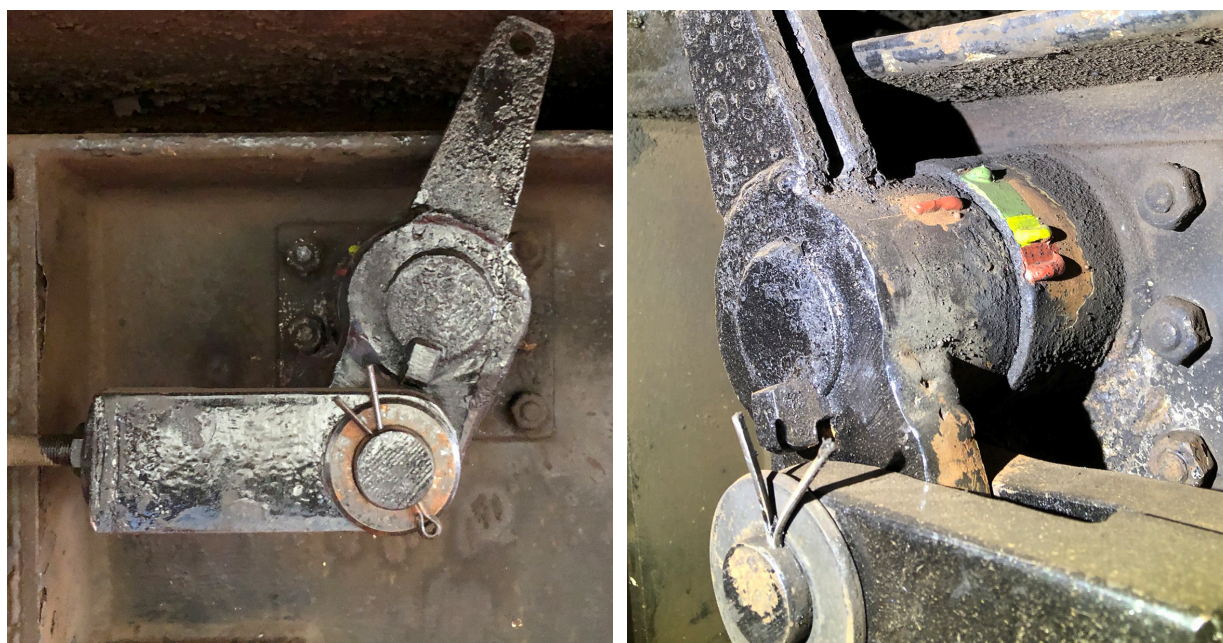
Figure 10: Photographs of the modifications made to the brake mechanism in response to the incident, showing a) the altered attachment point; and b) the tell tales used as a daily check.

- 105 FRC has added tell tales to all the brake systems to assist drivers in performing a daily check of the state of the adjustment of the locomotive's brakes (figure 10b). This is now included as part of the driver's checks undertaken before any locomotive is driven.
