Rail Accident Report

**Train collision with material washed out from a cutting slope at Corby, Northamptonshire
13 June 2019**

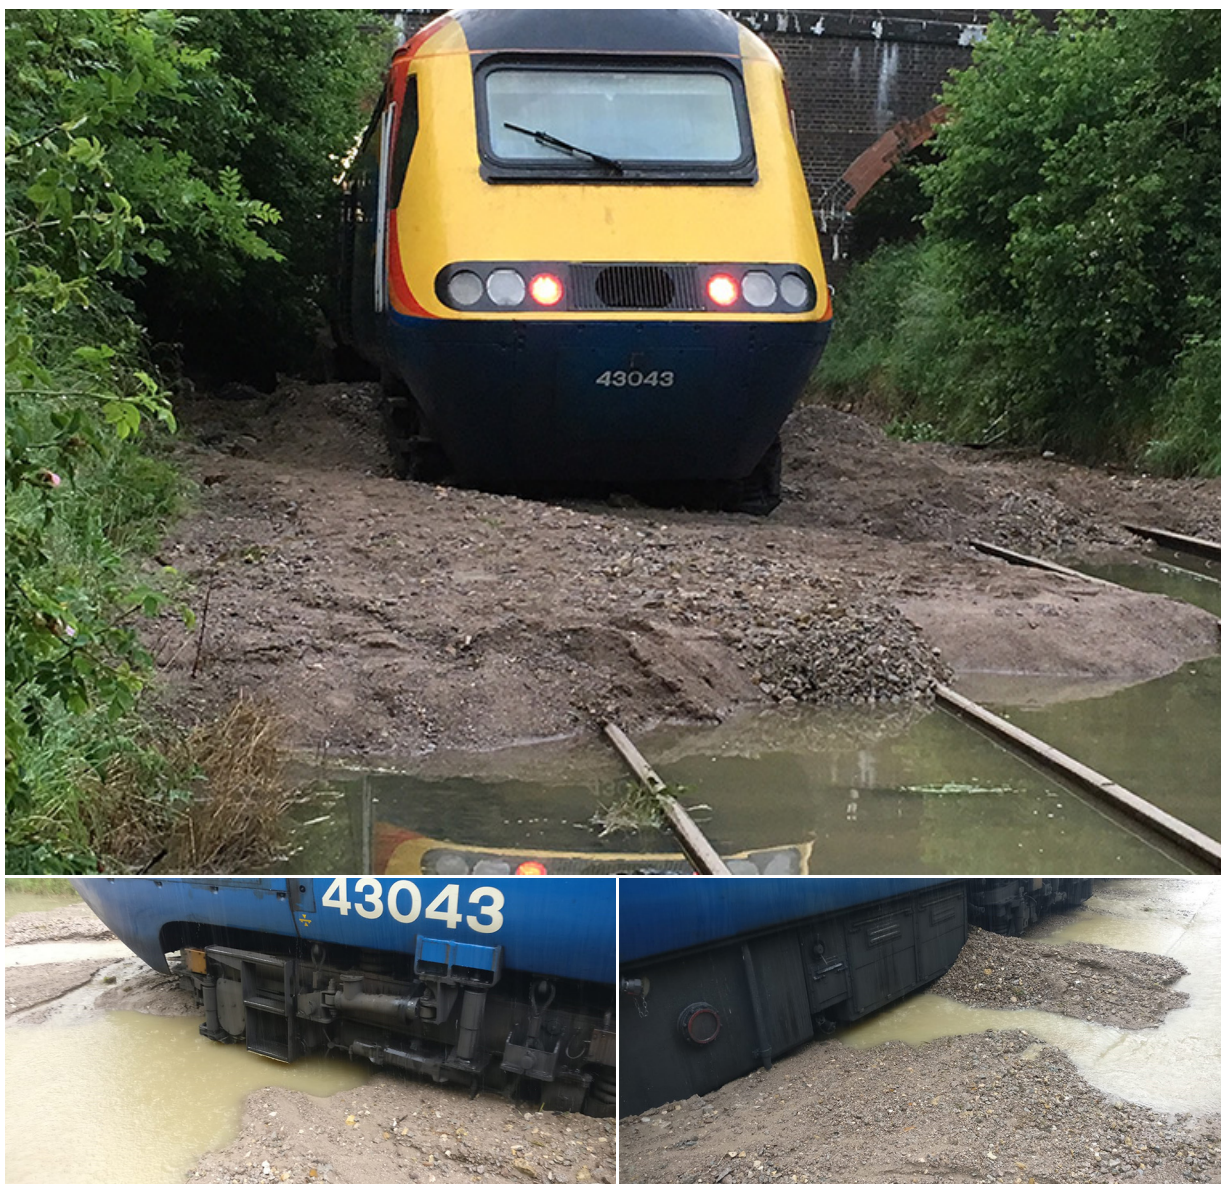
- 5 After speaking to the signaller, the driver examined the train and found that its rear two vehicles had become trapped by further sandy gravel that flood water had washed out from the cutting slope in the time since the train had stopped (figure 3). All of the passengers were later transferred to a southbound train which subsequently itself became trapped by flood water to the north and south. Once lighting and road transport were in place, all the passengers were taken off the southbound train by 23:14 hrs. One group of passengers was taken by road to Corby station and the remainder were taken to Kettering station, to continue their journey by rail.

Figure 3: The rear of the train after further sandy gravel washed-out around it (main image courtesy of Network Rail, other images courtesy of the driver of train 1C52).

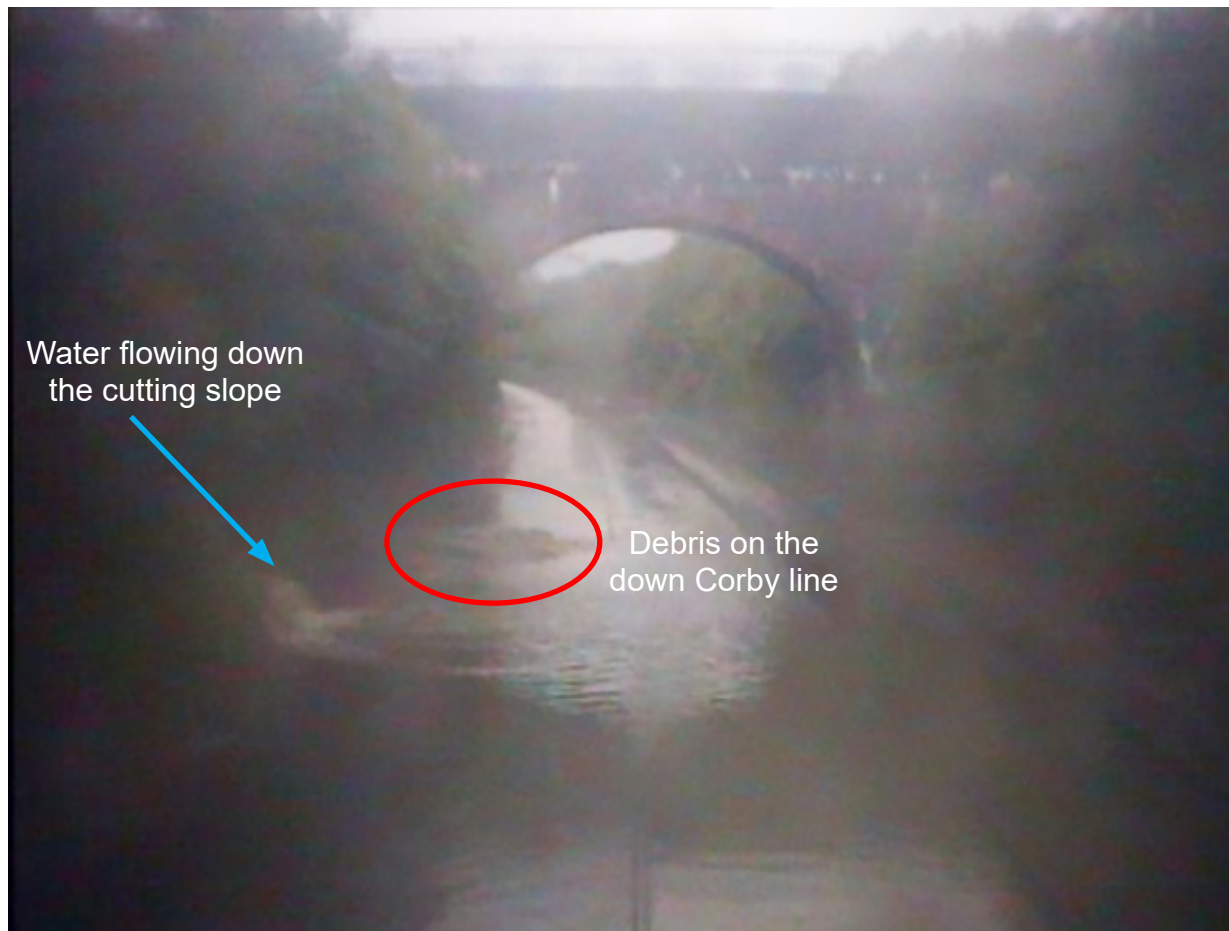
- 27 As the train entered the cutting at Pen Green Lane on a left-hand curve, the driver noticed the track ahead was flooded. As the train continued around the curve, the driver also noticed debris on the track ahead (figure 7). At 15:50:20 hrs, while travelling at 40 mph (64 km/h), the driver made an emergency brake application. At about the same time, train 1D43 struck sandy gravel and soil that had been washed out from the cutting slope onto the track. Train 1D43 stopped at 15:50:40 hrs, after travelling for a further 193 metres.

Figure 7: Image from the forward facing CCTV on train 1D43 showing the flooding and debris on the down line.

- 54 The driver of train 1D43 reported seeing debris and flood water ahead as he rounded the left-hand curve approaching the washed out debris. The forward facing CCTV footage from train 1D43 showed a pile of debris on the down line at the foot of the cutting slope, close to where it had failed (figure 7).
- 55 Once the train had stopped, flood water continued to flow onto the railway, at the aqueduct and where the cutting slope had failed. It washed a large volume of sandy gravel and soil from the cutting slope onto the track, which flowed underneath and around the rear of train 1D43 (figure 3).

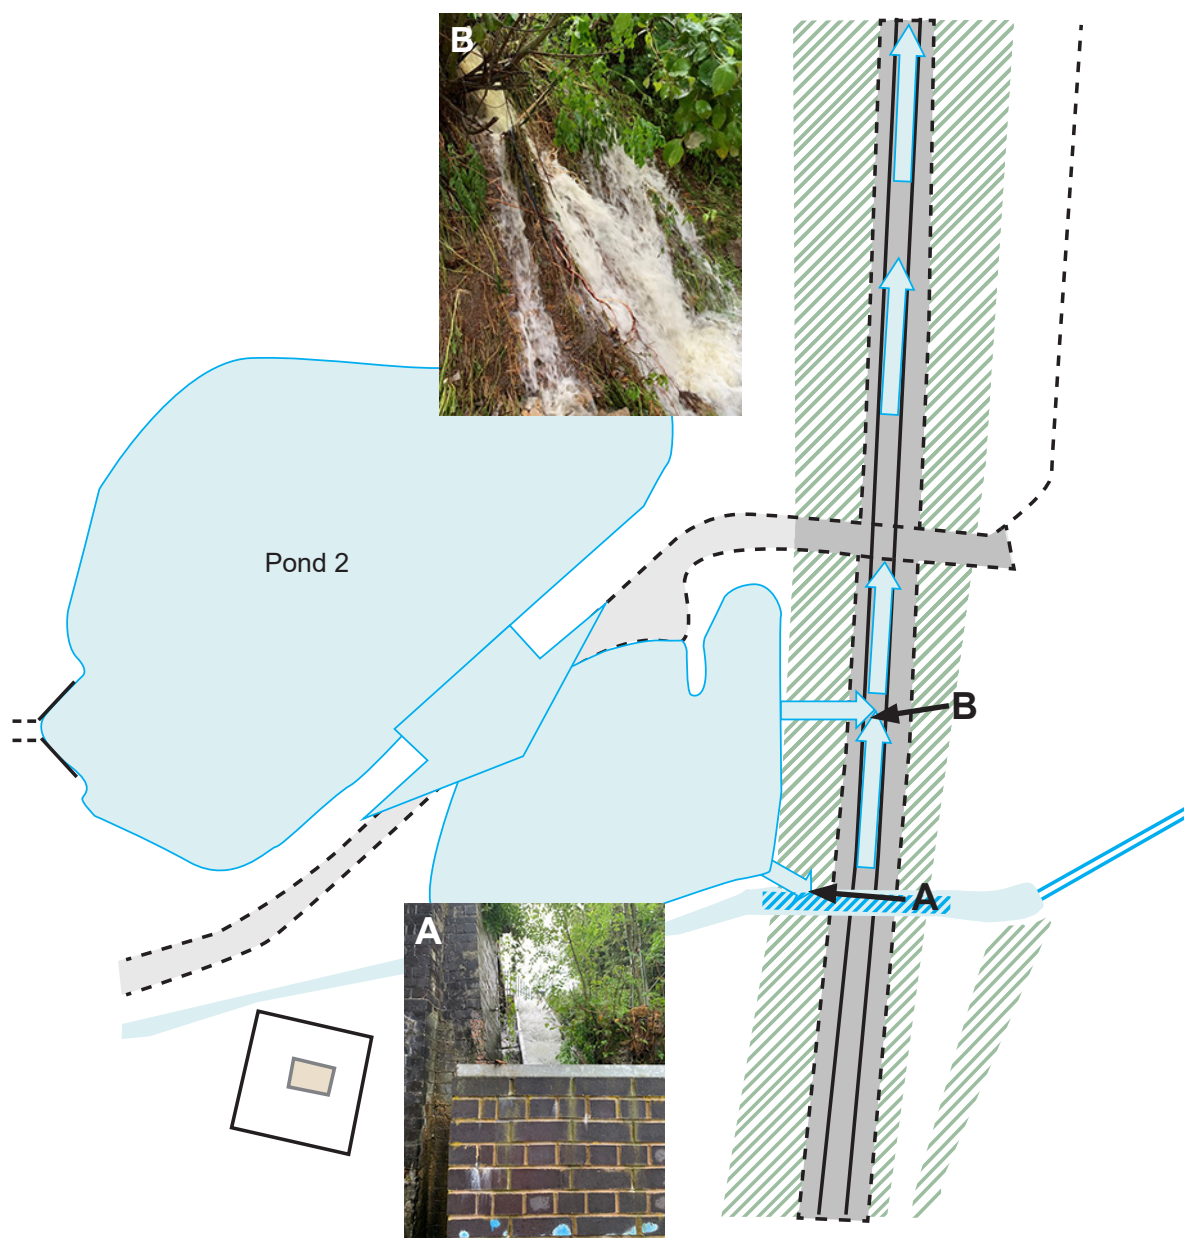
- 58 Contractors called to the site by Network Rail after the incident found a large volume of water had pooled in the field above the cutting slope. This water was coming from pond 2, pooling in the field, and then flowing onto the railway where the cutting slope had failed, and also at the northern side of the aqueduct (figure 9).
- 59 This causal factor arose due to a combination of the following:
- the flow of water in Willow Brook North was restricted at the entrance to the bridge carrying Pen Green Lane over the brook (paragraph 60);
 - the eastern bank of pond 2 was the lowest point on the perimeter of the two ponds and was lower than the emergency spillway between pond 1 and the brook (paragraph 64); and
 - the pump to reduce the water level in the ponds was last operated on 17 May 2019 (paragraph 70).

Figure 9: The flow of water from pond 2, through the field and onto the railway. Inset image A shows flood water flowing down the stepped flume on the northern side of the aqueduct. Inset image B shows flood water flowing onto the railway at the foot of the cutting slope.

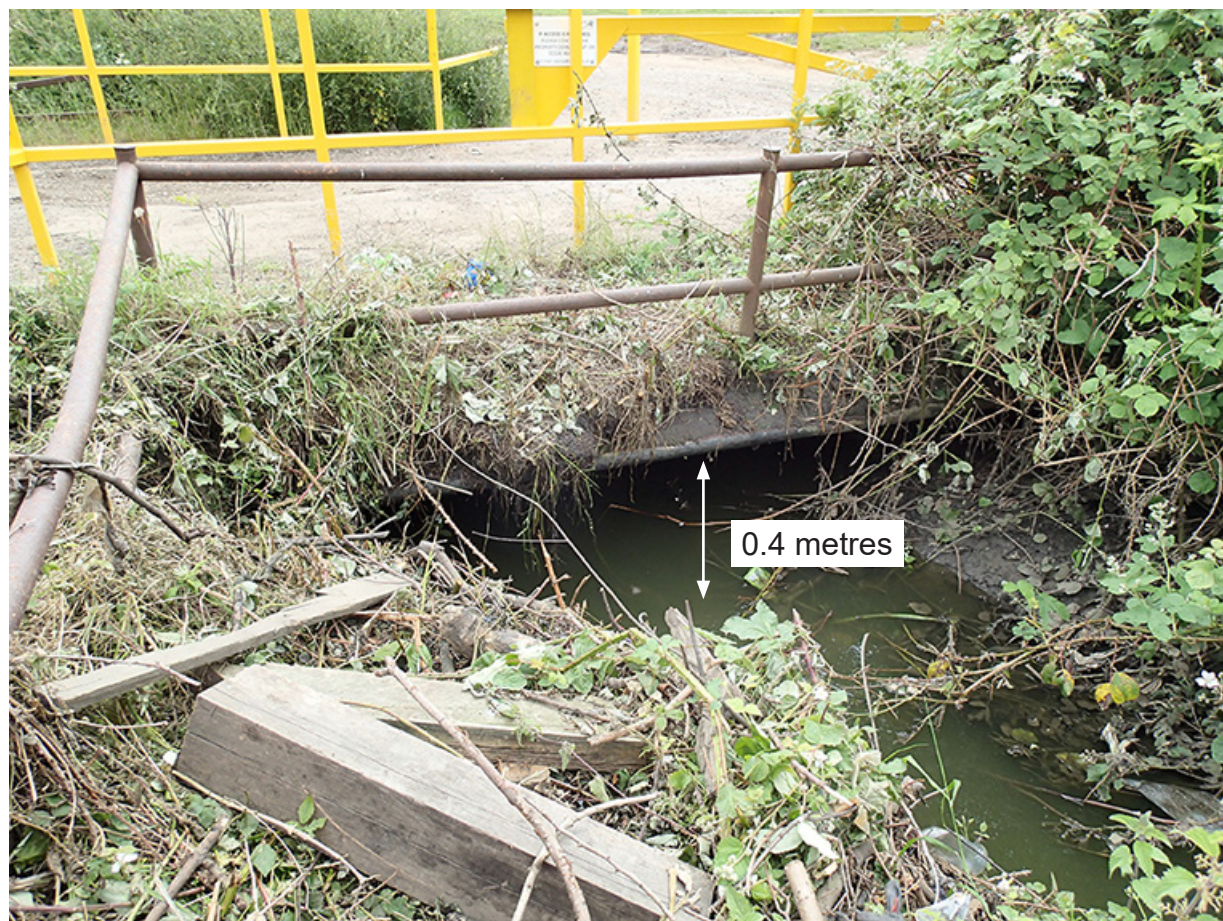
- 61 There is a clearance of around 0.4 metres between the bridge carrying Pen Green Lane over the brook and the typical water level in the brook when there has been no rainfall for several days (figure 11). Following rainfall, the water level in the brook quickly rises, reducing this clearance and increasing the likelihood of debris becoming trapped at the water's entrance to the bridge.

Figure 11: Typical clearance between the underneath of the bridge and the brook when there has been no rainfall for several days

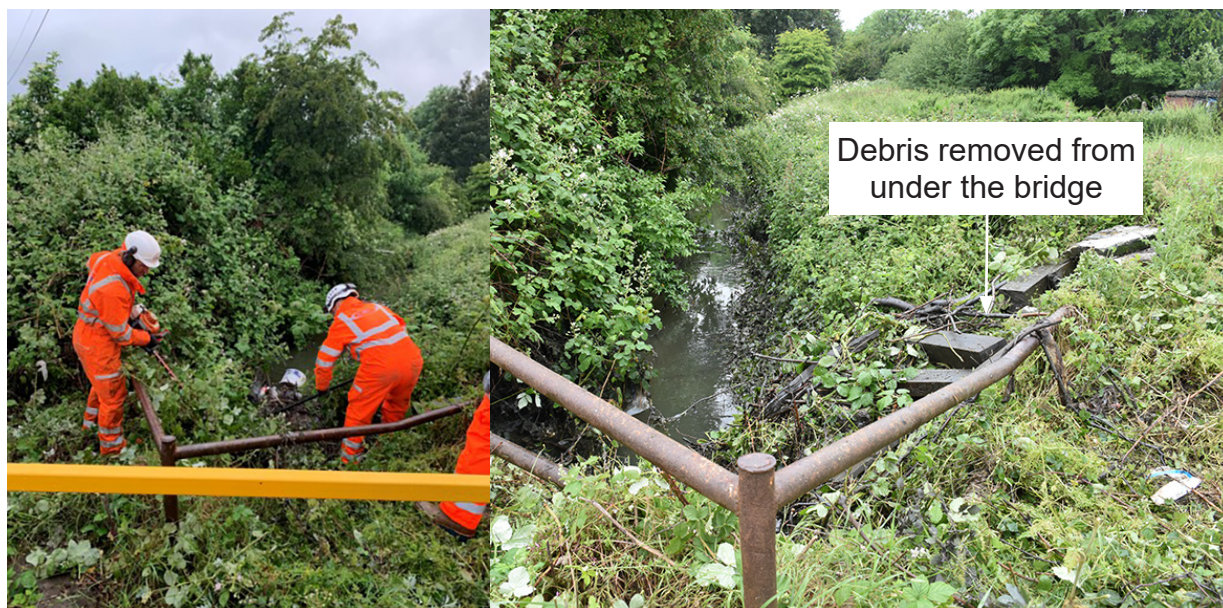
- 62 The contract staff called to site by Network Rail after the incident found a large amount of debris, mostly vegetation and large pieces of wood, trapped at the entrance to the bridge (figure 12). They removed the debris, which allowed the brook to flow freely through to the aqueduct. To reduce the likelihood of further flooding downstream, they also removed debris that had collected on the trash screen at the entrance to the aqueduct.

Figure 12: Left image: The contractors called to the site by Network Rail removing debris from the watercourse under and before the bridge (image courtesy of CML). Right image: The debris removed from the watercourse.

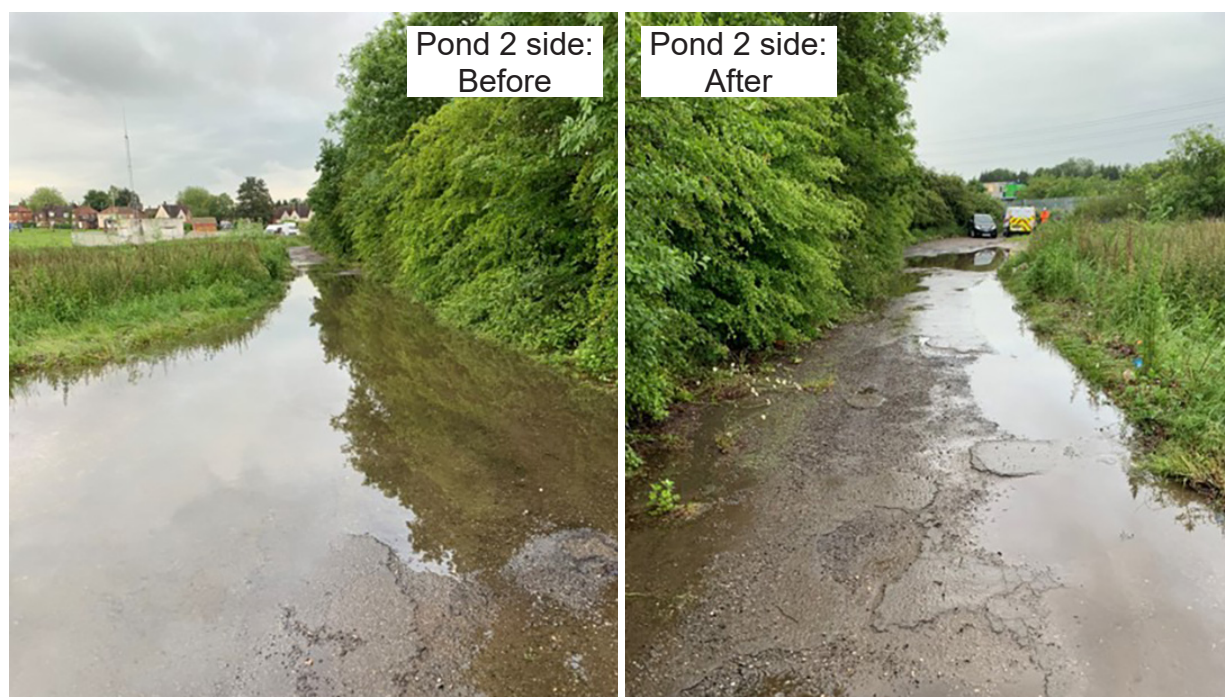
- 63 With the brook now flowing freely from the spillways to, and over, the aqueduct, the contract staff reported that the water level in the ponds soon began to fall as this allowed water to flow back out of the ponds, over the service spillway, and into the brook instead. This was evidenced by the water level in the ponds falling so that water no longer covered the path adjacent to the eastern bank of pond 2 (figure 5), which had been flooded when the contract staff had first arrived on site (figure 13). It also meant the water level in the ponds could continue to fall back to the level of the service spillway, which was the approximate water level in the ponds noted later by RAIB when on site at 21:00 hrs.

Figure 13: The drop in the water level on the path. Left image shows the path next to pond 2 before blockages were cleared and right image (looking in opposite direction) shows the path after the blockages were cleared (images courtesy of CML).

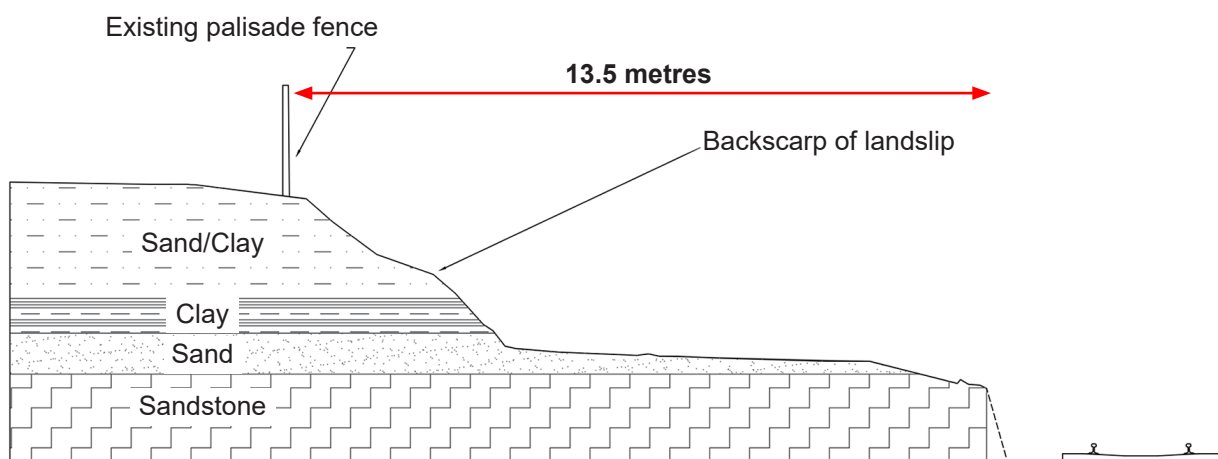
- 80 The geology of the cutting slope comprises a sandstone rock base with layers of sand and clay above it (figure 17). The cutting slope was damaged by flood water in 1999 (paragraph 43). At the time, the earthwork engineer who attended reported that the failure was due to material washing off the cutting slope onto the track, but the earthwork itself was stable. This allowed the railway to reopen within four hours of the landslide first being reported. Photographs taken by Network Rail in 2004, during an earthwork examination, show material from the cutting slope was partially filling the cess and contaminating the track ballast. No records can be found to indicate that any work took place on the cutting slope after the landslide in 1999, until it was repaired in 2009 (paragraph 45).

Figure 17: The geology of the failed cutting slope

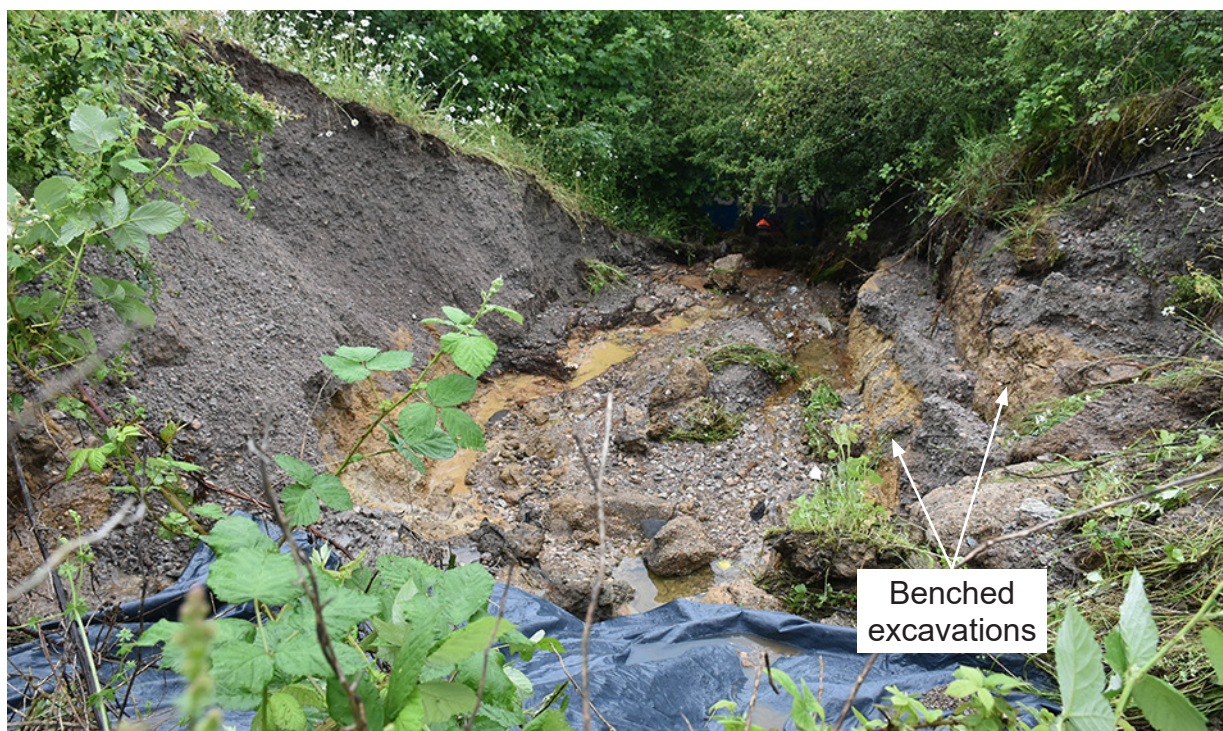
- 86 Once the sandy gravel was washed out from the cutting slope during this incident, it flowed underneath and through the gaps in the underframes of the vehicles at the rear of train 1D43 (figure 3). Afterwards, the void left in the cutting slope revealed the benched excavations made when the 2009 repair was carried out (figure 20), showing that the flood water had only washed away the fill material.

Figure 20: The void left in the cutting slope showing the benched excavations from the 2009 repair, viewed from the top of the cutting slope looking towards the railway

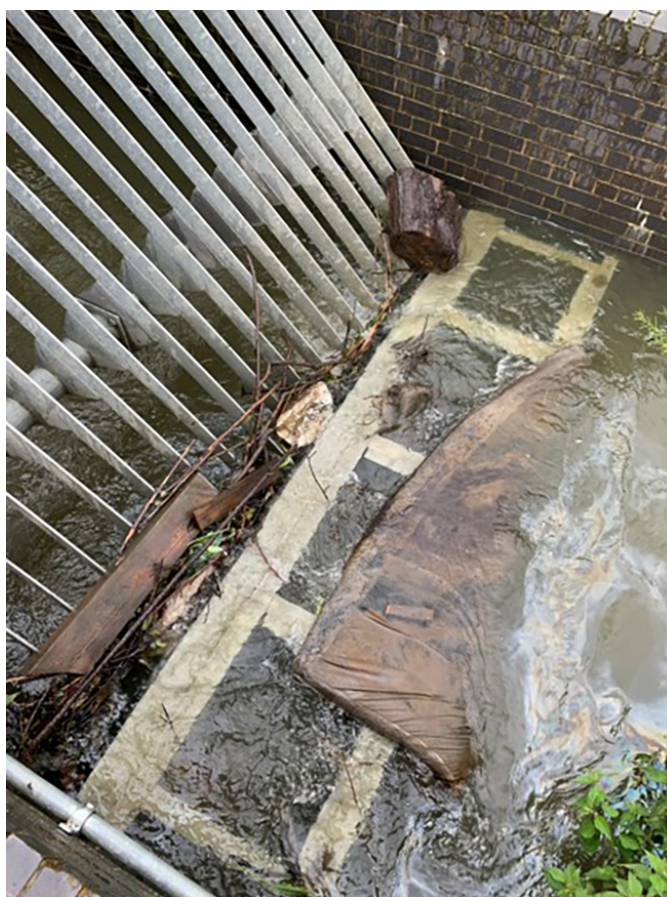
- 104 Anglian Water and Network Rail reported that the effectiveness of the flood management system at Pen Green Lane was also affected by high levels of antisocial behaviour. The automated pumping system stopped working due to frequent vandalism. The location also suffers from significant amounts of rubbish and items being thrown into the channels of Willow Brook North, causing blockages in the channels which reduce the flow of water. Debris also collects to form blockages at restrictions, such as under bridges or at trash screens, which also affects the flow of water in the brook. During checks on 13 June, the Network Rail mobile operations manager found and removed debris from the aqueduct's trash screen in the morning. It was still clear when checked again in the early afternoon (paragraphs 20 and 22) but after the incident, Network Rail's contractors found more debris had collected at the trash screen and was affecting the flow of water onto the aqueduct (figure 23).

Figure 23: Debris in the aqueduct's trash screen after the incident (image courtesy of CML)

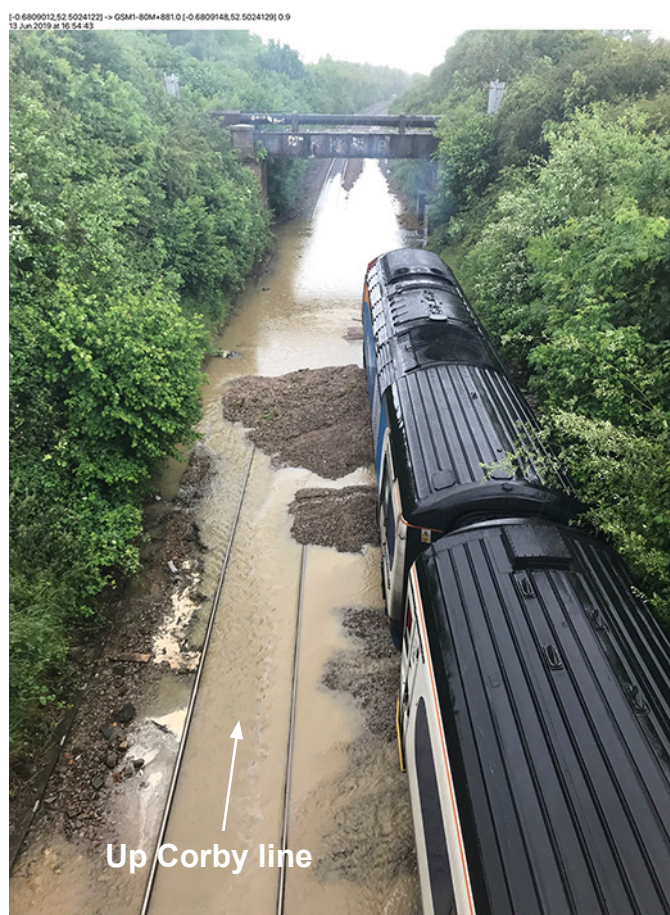
Figure 24: Flood water and sandy gravel blocking the up line (image courtesy of Network Rail)

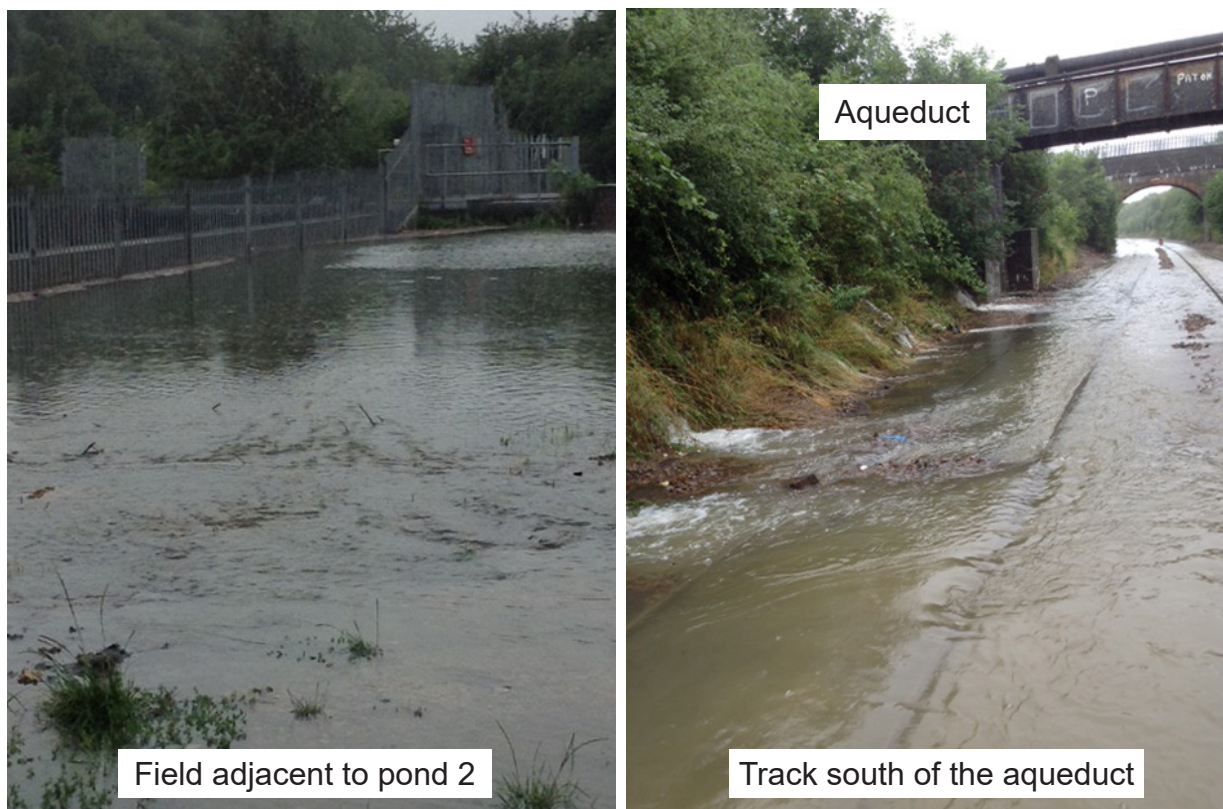
Figure 28: Images of the flooding on 28 July (courtesy of Network Rail)

- 146 The effectiveness of the repair was demonstrated on 28 July when there was further flooding at Pen Green Lane after heavy rainfall. This time the cutting slope between the aqueduct and the bridge was protected by the piling. However, the new barrier diverted much of the flood water to the southern side of the aqueduct. Here, the flood water washed out material from the cutting slope and onto the track in three different places (figure 28). Although Network Rail had protected its infrastructure in one place, lack of capacity in the local flood management system resulted in the problem being moved to another location. This showed that Network Rail cannot solve the problem of flooding on the railway at Pen Green Lane on its own, and that it needs to work with the other organisations to improve the effectiveness of the flood management system at Pen Green Lane. The 28 July flooding event also demonstrated the need for effective liaison between Network Rail geotechnical staff and drainage staff when developing geotechnical solutions to problems involving drainage issues.
