Rail Accident Report

Collision between a train and utility vehicle at Dollands Moor freight yard, Kent 4 September 2018

Report 05/2019
June 2019

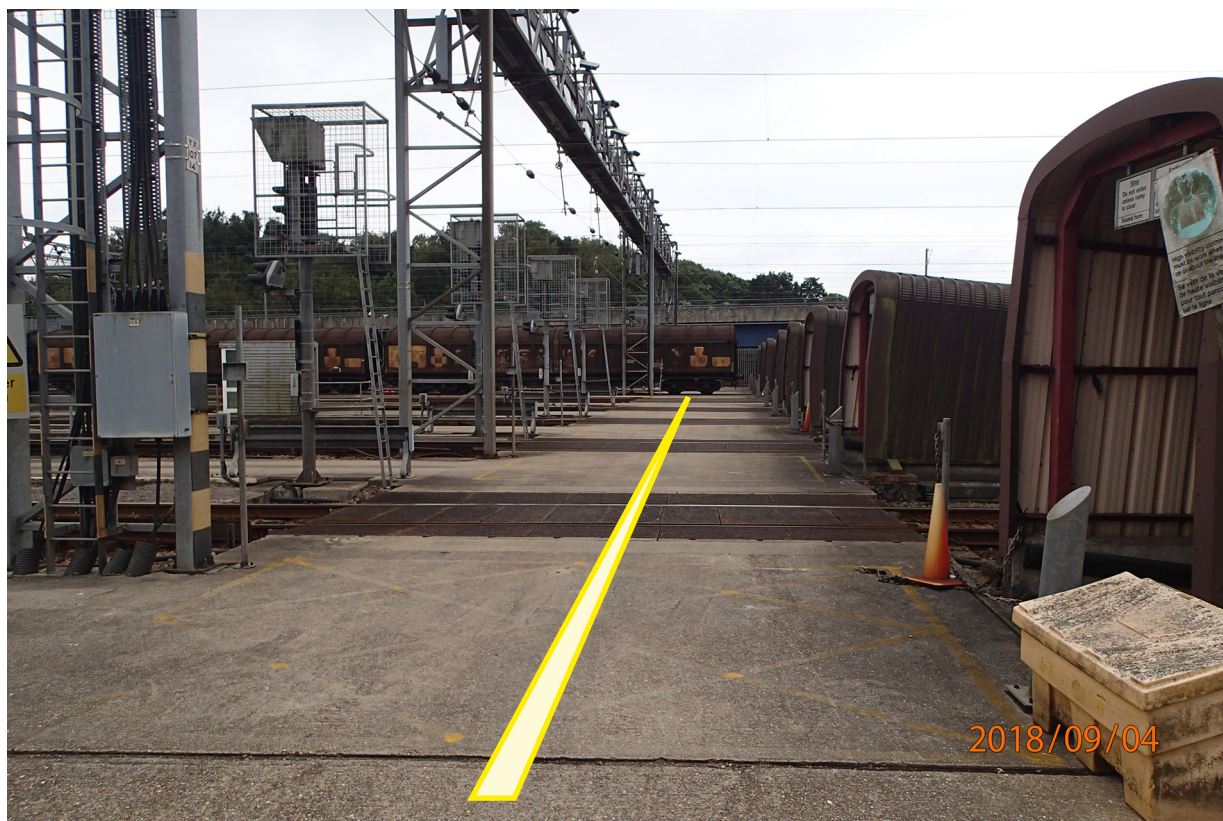
Figure 6: View looking south across the west end level crossing with subway ramps on the right. The path of the buggy is shown. A train is visible on siding 2.

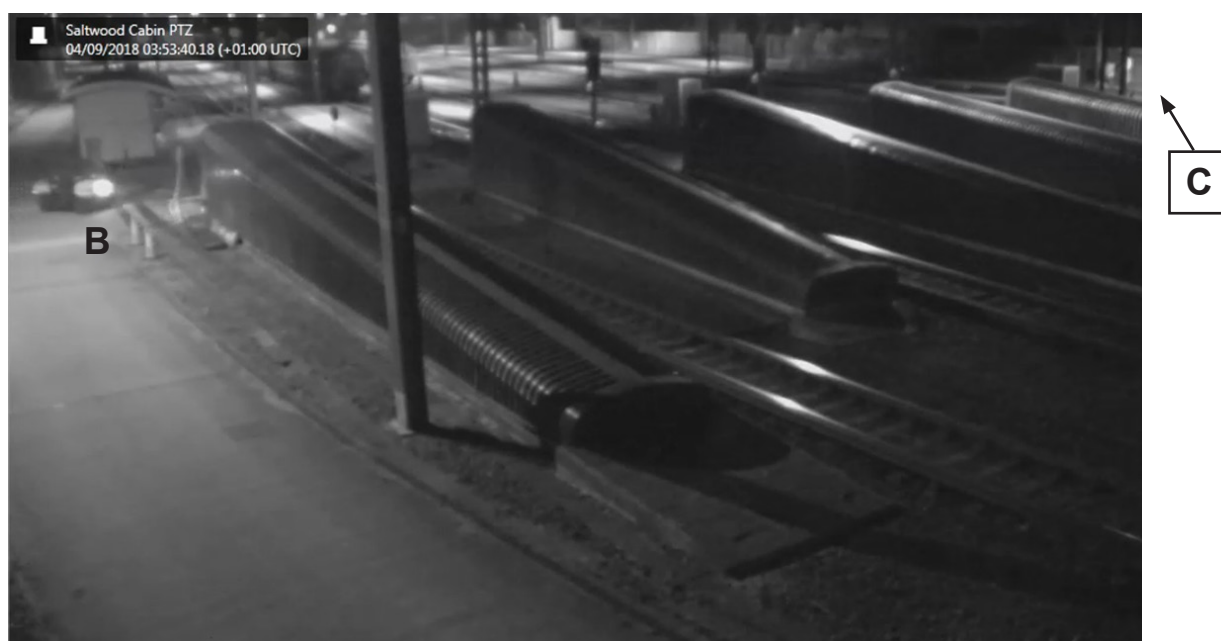
Figure 10: CCTV still image showing ramps and west end level crossing. Locations B and C are as marked on figure 8. The buggy is visible at location B, approaching the west end level crossing. The collision occurred just outside of the camera's field of view at location C.

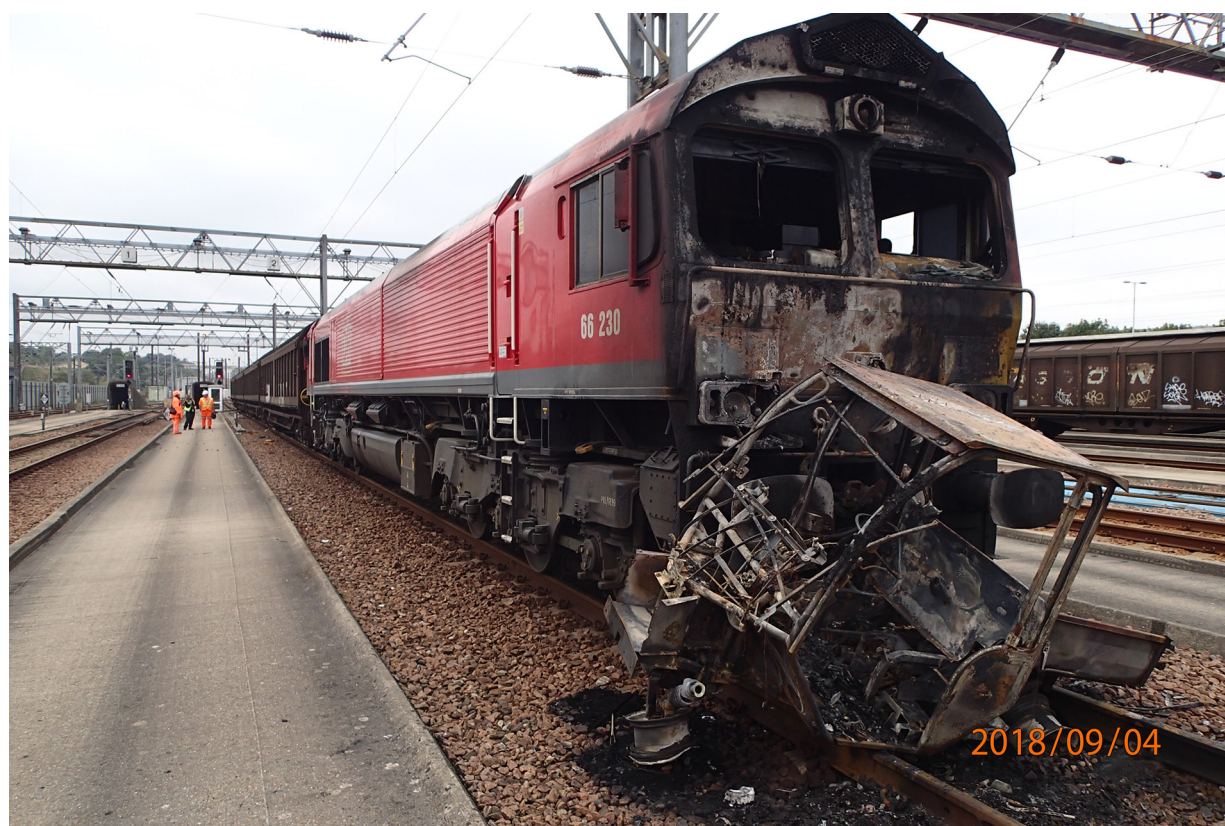
- 41 As the train was approaching the level crossing, the driver saw the buggy obstructing the line ahead and, at 03:39:41 hrs, applied the brake when the train was about 50 metres from the level crossing. He did not sound the train's horn. Immediately before the collision, he saw a person in orange overalls sitting in the buggy, who appeared to be reading a document and then looked up at the last moment before attempting to dive out.
- 42 The train travelled about 102 metres beyond the crossing before stopping 16 seconds after the collision. The buggy was pushed along the track by the train; creating sparks which ignited petrol spilt from the buggy's fuel tank as the train slowed down. The train driver left the cab immediately and before a significant fire took hold (figure 11); he was uninjured.

Figure 11: Image of locomotive and damaged buggy following accident. Concrete walkways run between each siding and are used for the inspection of trains.

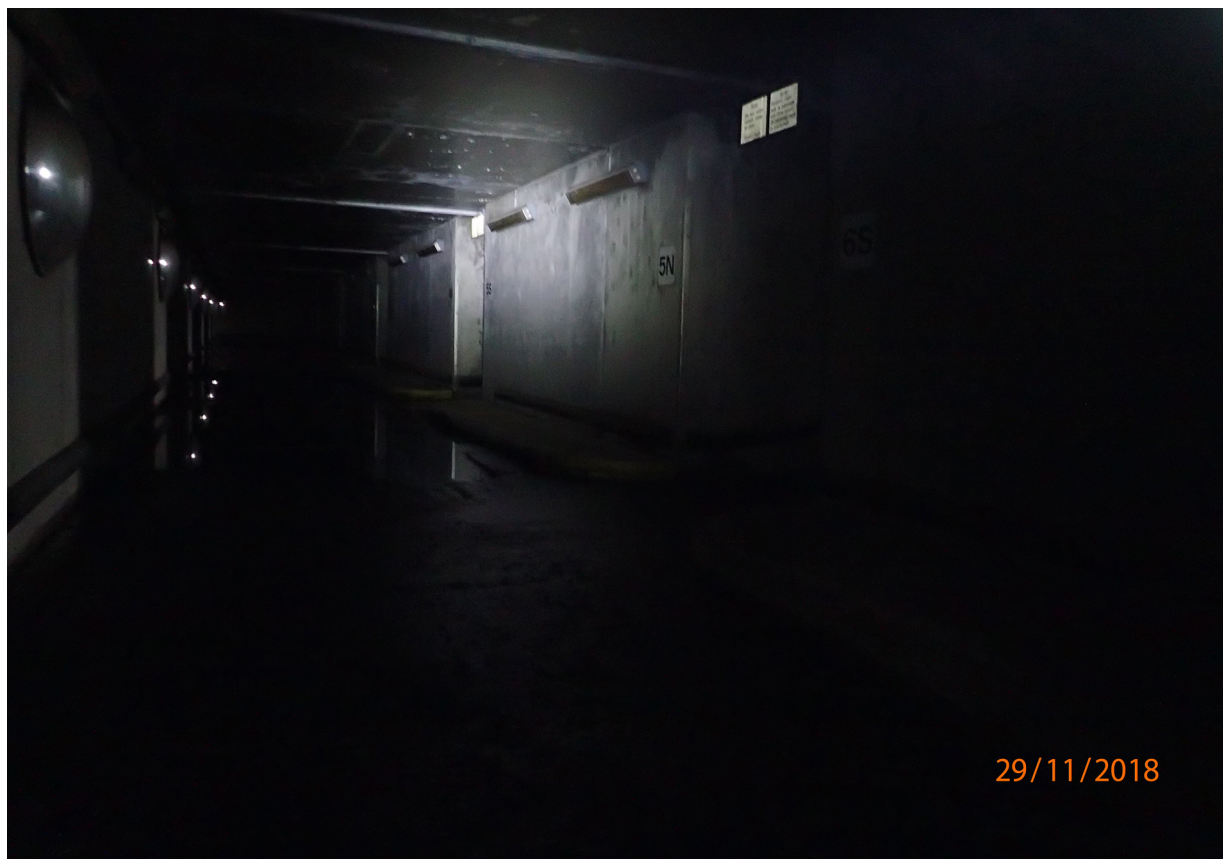
- 71 Use of the east end subway was problematic as it was often damp and, although the buggies had lights, the subway's internal lighting had failed (figure 12). It is not clear when these lights stopped working, but it pre-dated the arrival of the new group of shunters in 2014. There is no evidence that any maintenance reports were submitted requesting repair of the subway lighting between 2014 and 2018.

Figure 12: internal view of unlit east end subway in November 2018. The photograph was taken by torchlight.

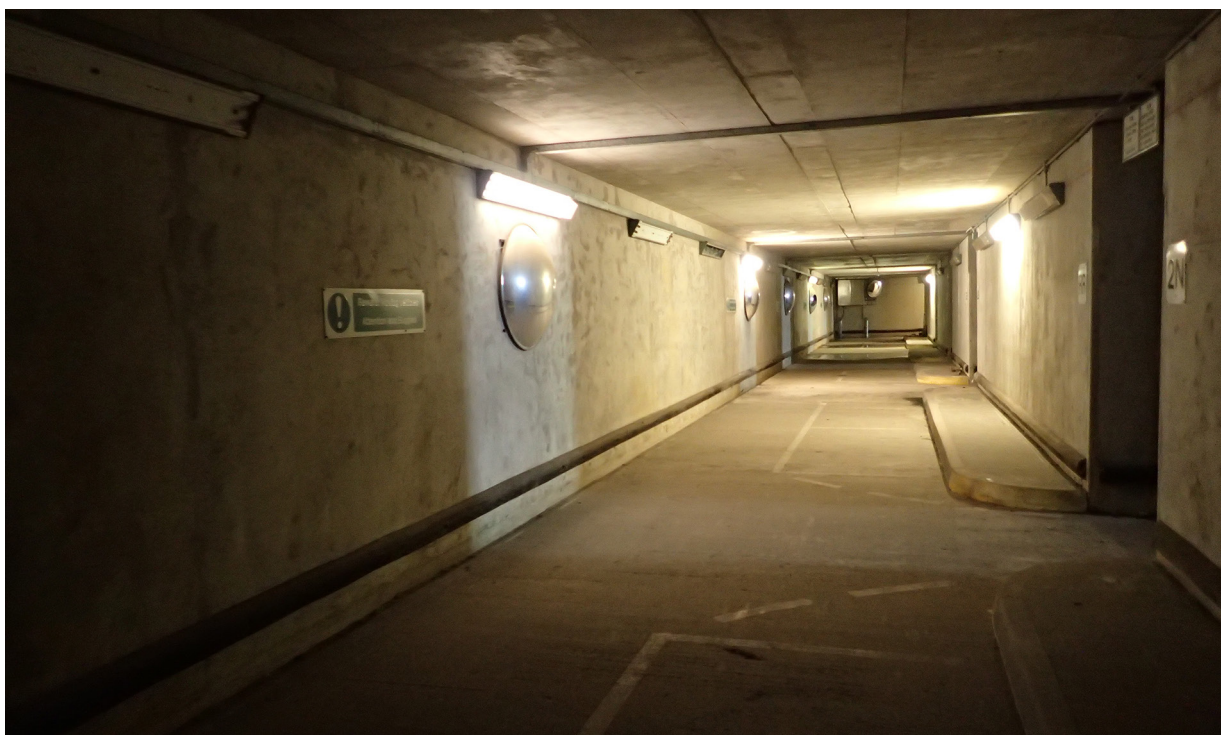
- 74 Although the condition of the west end subway was considered sufficiently poor to justify discontinuing its use in 2008 (paragraph 67), the RAIB found it was reasonably dry and most of its internal lighting was working in September 2018 (figure 13).

Figure 13: internal view of out of use west end subway with some working lighting, shown immediately after the accident in September 2018

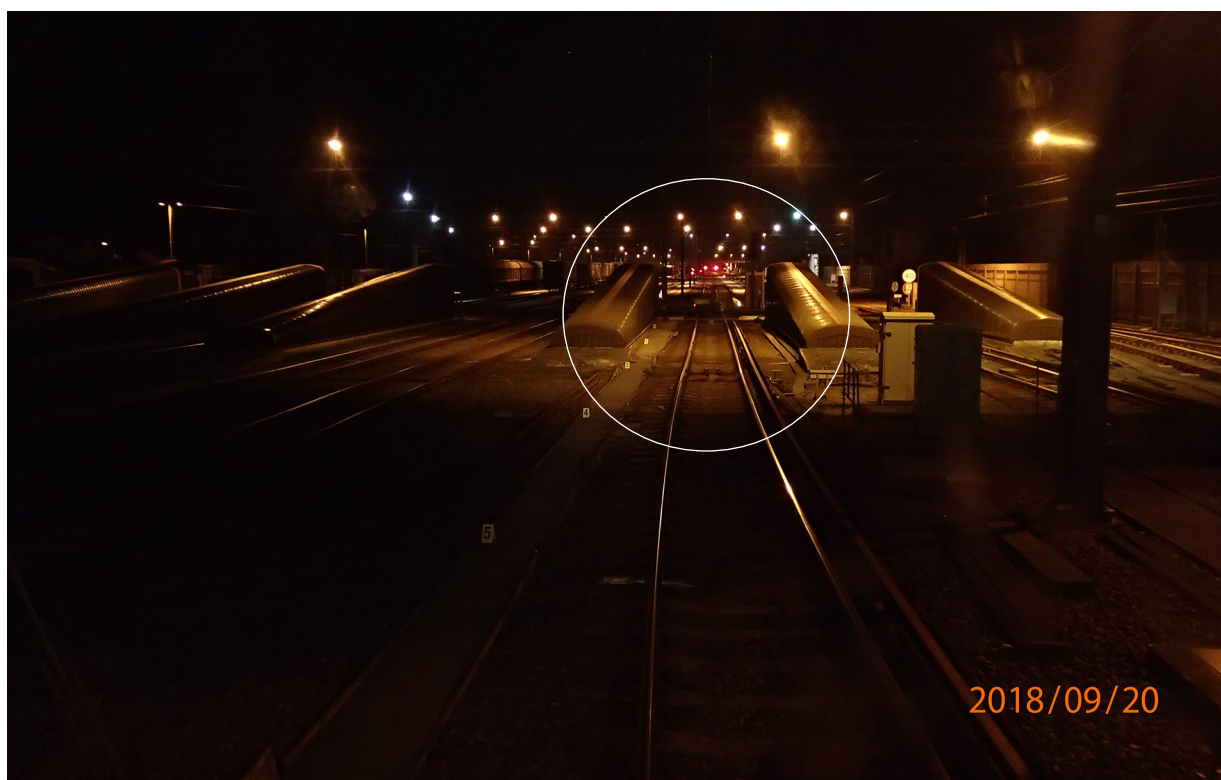
¹⁴ This is consistent with post-accident testing which showed that the left-hand headlight bulb was capable of being illuminated and the right-hand headlight bulb was broken.

- 82 The buggy was not distinctly visible before it was illuminated by the train's headlights because its yellow bodywork meant it was a similar colour to pools of light reflected off the ground from the sodium floodlighting. This effect is illustrated by a photograph taken from the cab of a stationary locomotive during the reconstruction of the accident (figure 14). The reconstruction showed that the defective right-hand headlight had no significant effect on the conspicuity of the buggy viewed from an approaching train.

- 83 The petrol powered buggies, introduced in 2014, were equipped with front and rear driving lights which were designed to work only when the engine was running. They were not equipped with hazard lights, flashing beacons, reflective strips or other features to increase their conspicuity.
- 84 Network Rail document RT3170¹⁵ indicates that it is good practice for road vehicles to show hazard warning lights when on or near the line. DB Cargo has informed the RAIB that it requires vehicles in other yards (eg reach-stackers in container-handling depots) to have an orange flashing beacon. The Health and Safety Executive (HSE) publication 'A guide to workplace transport safety'¹⁶ states:

Figure 14: reconstructed view of a buggy on the level crossing showing a train driver's view 60 m from the crossing. Note that the right-hand headlight (ie on the side nearest the train) was unlit.
