Rail Accident Report

**Signal passed at stop and near miss,
Deansgate-Castlefield tram stop, Manchester
17 May 2019**

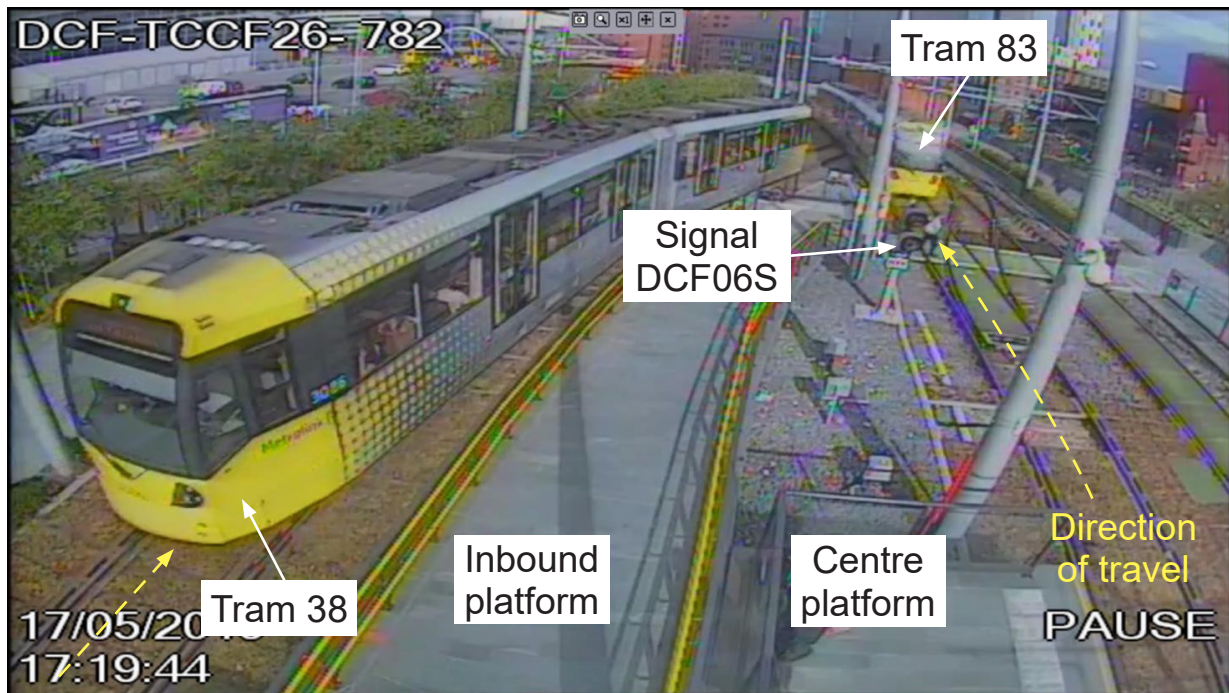
- 3 Tram 83 then entered the junction where the lines from the inbound and centre platforms join to form the single inbound line towards St Peter's Square tram stop. This placed it in conflict with Metrolink tram 38, which was approaching the same junction from the inbound platform, under a proceed signal. The driver of tram 38 glanced to his right as he neared the junction and saw tram 83 approaching. He was able to stop his vehicle in time to narrowly avoid a collision (figure 2).

Figure 2: CCTV image from Deansgate-Castlefield tram stop, showing the incident (image courtesy of Keolis Amey Metrolink)

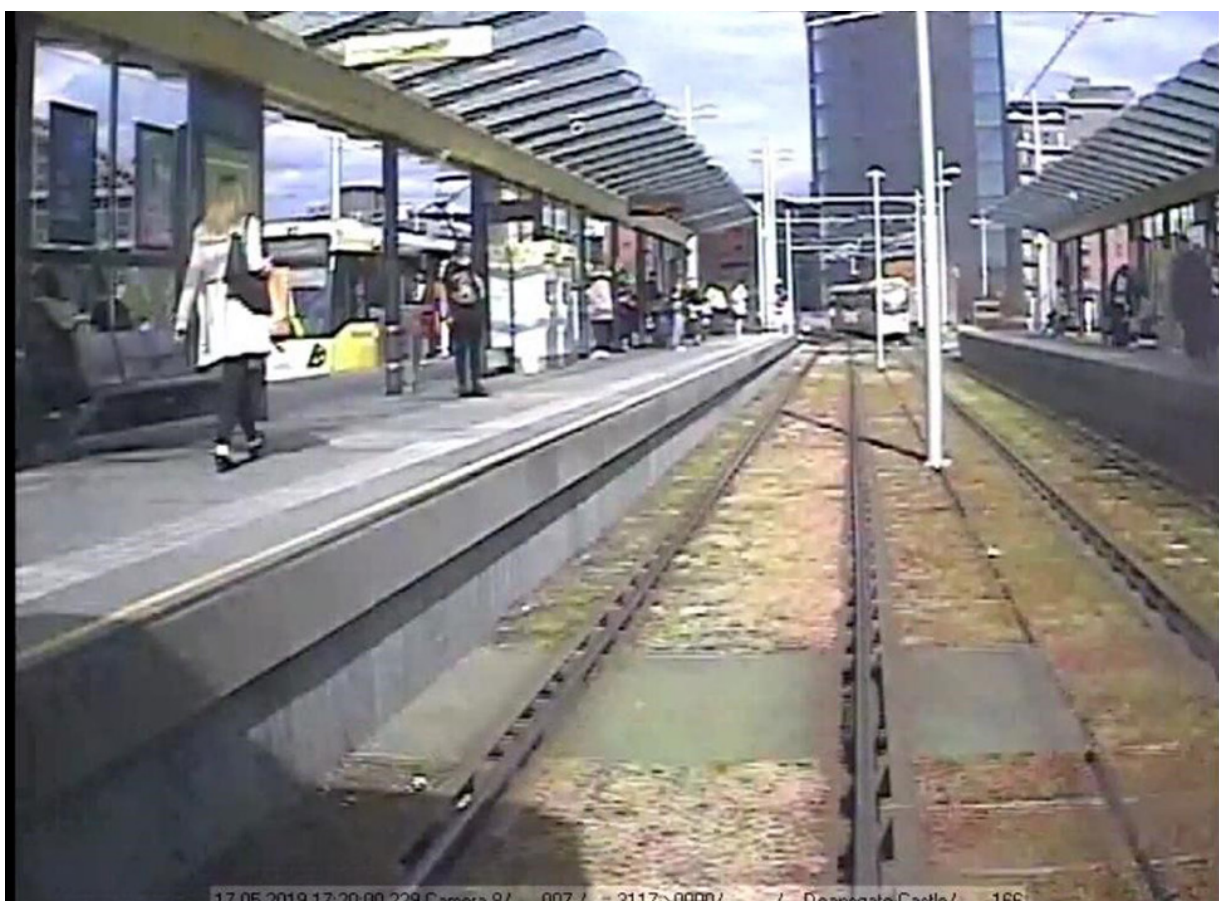
- 29 At 17:19:02⁷ hrs, tram 83 was travelling at 8 mph (13 km/h) as it approached the pedestrian crossing at the west end of the centre platform. At this point the driver moved the TBC from BRAKE into COAST. Four seconds later, with tram 83 travelling at 8 mph (13 km/h) and passing down the centre platform (figure 7), the driver moved the TBC from COAST into DRIVE, with a traction demand of +1%. Signal DCF06S is visible in FFCCTV images shortly after this point. It can be seen showing a stop aspect, which applied to tram 83.

Figure 7: FFCCTV image from tram 83 as the TBC moved from COAST and into DRIVE at +1% (image courtesy of Keolis Amey Metrolink)

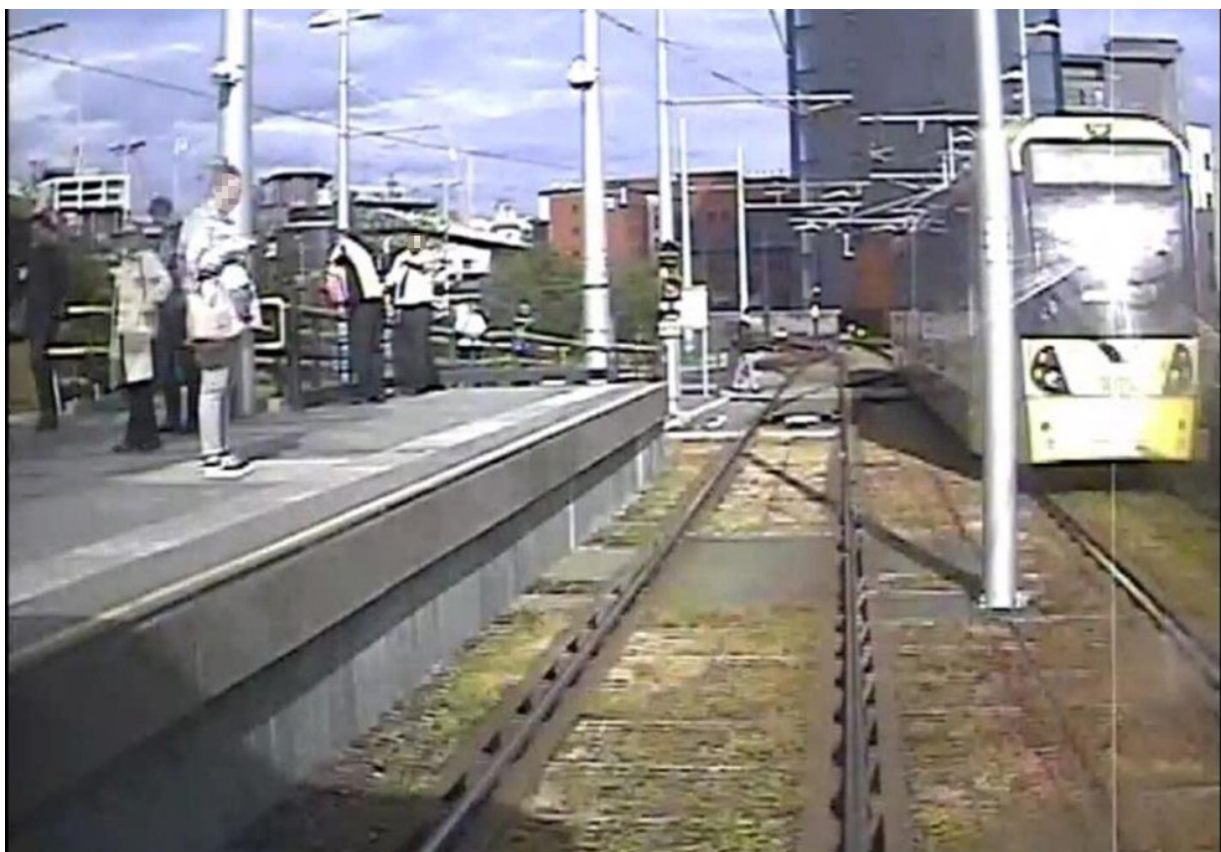
- 30 At 17:19:13 hrs, DCF07S signal changed to proceed and tram 38 started to move away from the inbound platform a few seconds later. Tram 83 was by now further along the centre platform (figure 8). FFCCTV shows that signal DCF06S was still showing a stop aspect and that PPI DCF06P was showing a left indication.
- 31 At 17:19:17 hrs, tram 83 was travelling at 10 mph (16 km/h) and approaching the end of the centre platform. The driver moved the TBC from DRIVE to BRAKE, with a brake demand of -1%. Signal DCF06S remained at stop. Two seconds later, tram 83 passed clear of the platform and approached the pedestrian crossing at the east end of the tram stop (figure 9). This was being used by members of the public. The driver sounded the tram's whistle twice and increased the brake demand to -38%.

Figure 8: FFCCTV image showing the position of tram 83 as tram 38 (extreme left) moved off from the inbound platform (image courtesy of Keolis Amey Metrolink)

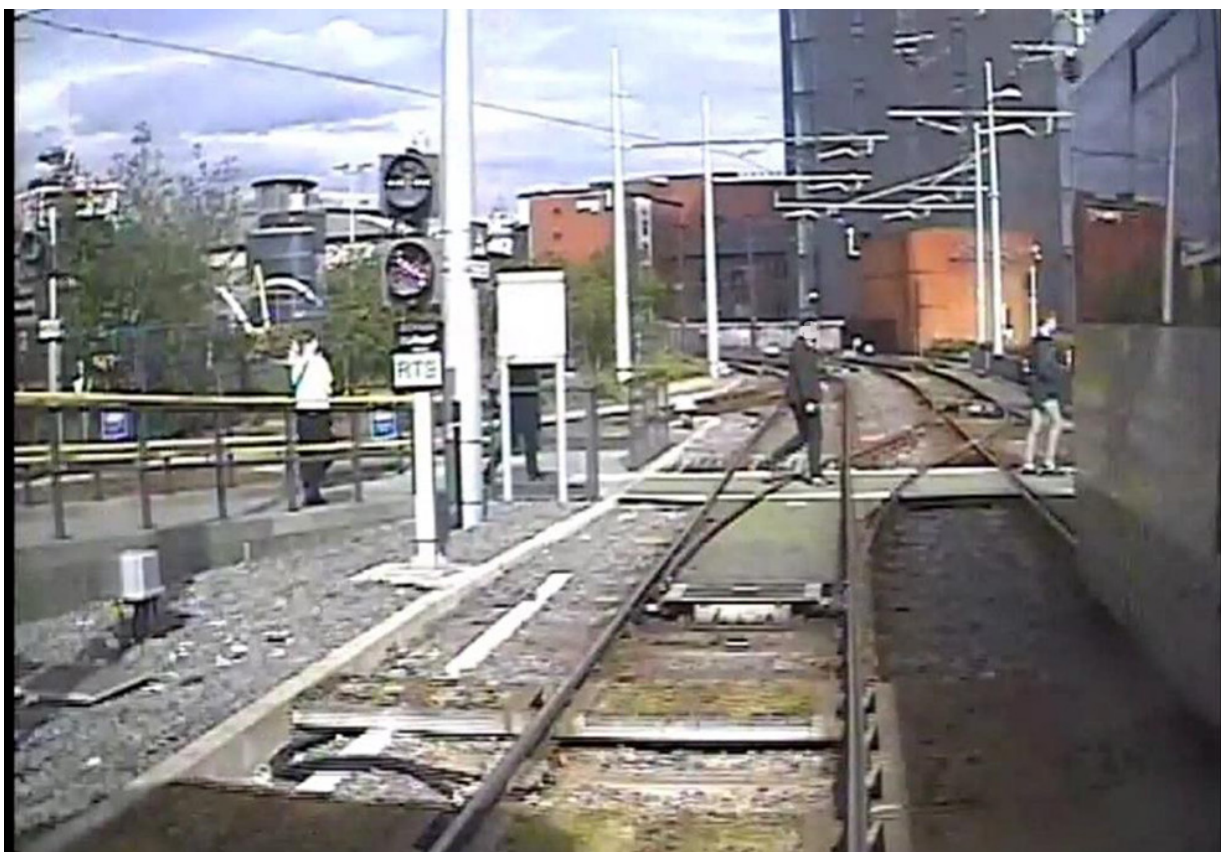
Figure 9: FFCCTV image showing signal DCF06S at STOP as tram 83 approached (image courtesy of Keolis Amey Metrolink)

- 32 Tram 83 passed signal DCF06S while it was showing a stop aspect at a speed of 9 mph (14 km/h). As the tram got closer to the pedestrian crossing, a member of the public realised that it had not stopped at the platform⁸ and stepped back to allow it to pass (figure 10). Once the front of the tram was over the crossing, the driver moved the TBC from BRAKE into DRIVE, with a traction demand of +1%. The driver of tram 83 made no further control inputs as the tram passed onto junction DCF07J.

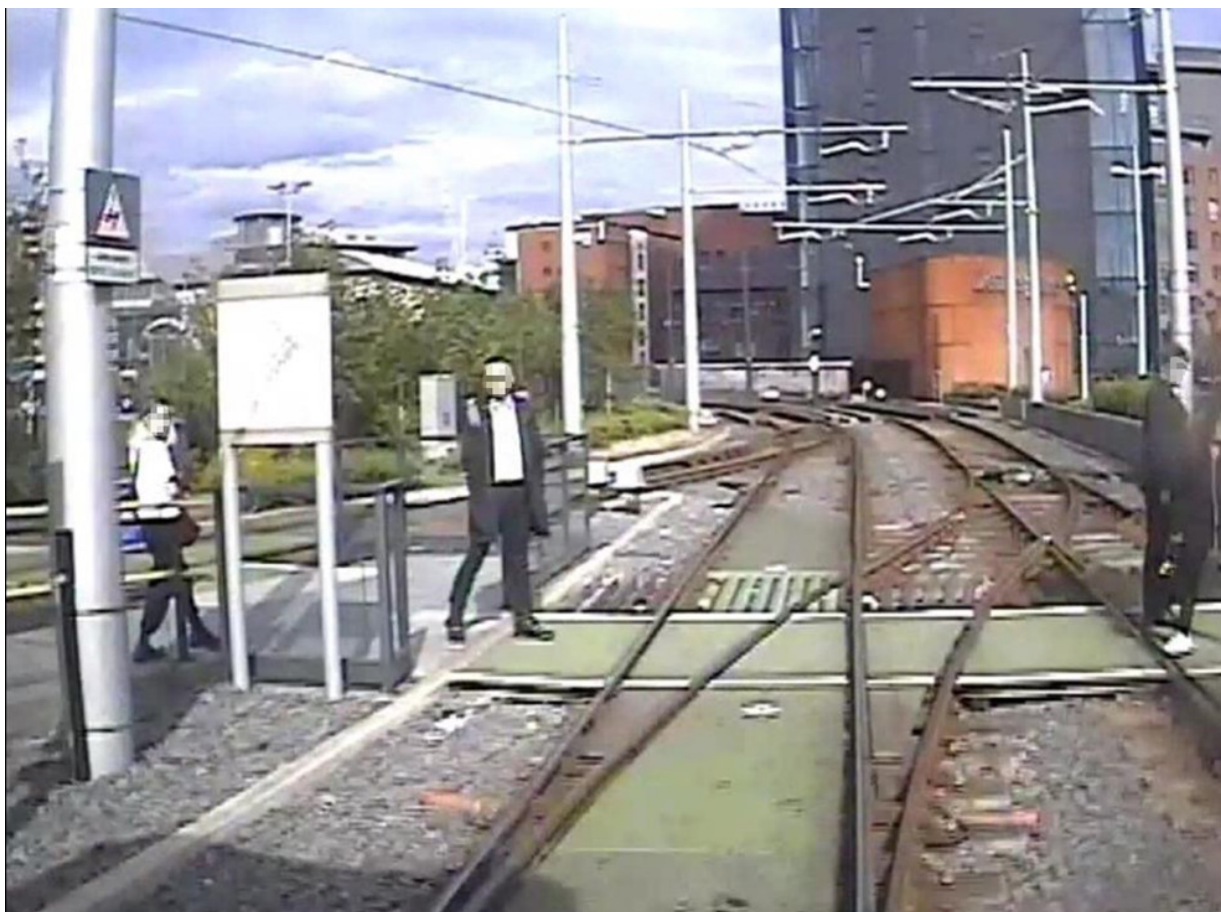
Figure 10: FFCCTV image showing the pedestrian crossing as tram 83 approached (image courtesy of Keolis Amey Metrolink)

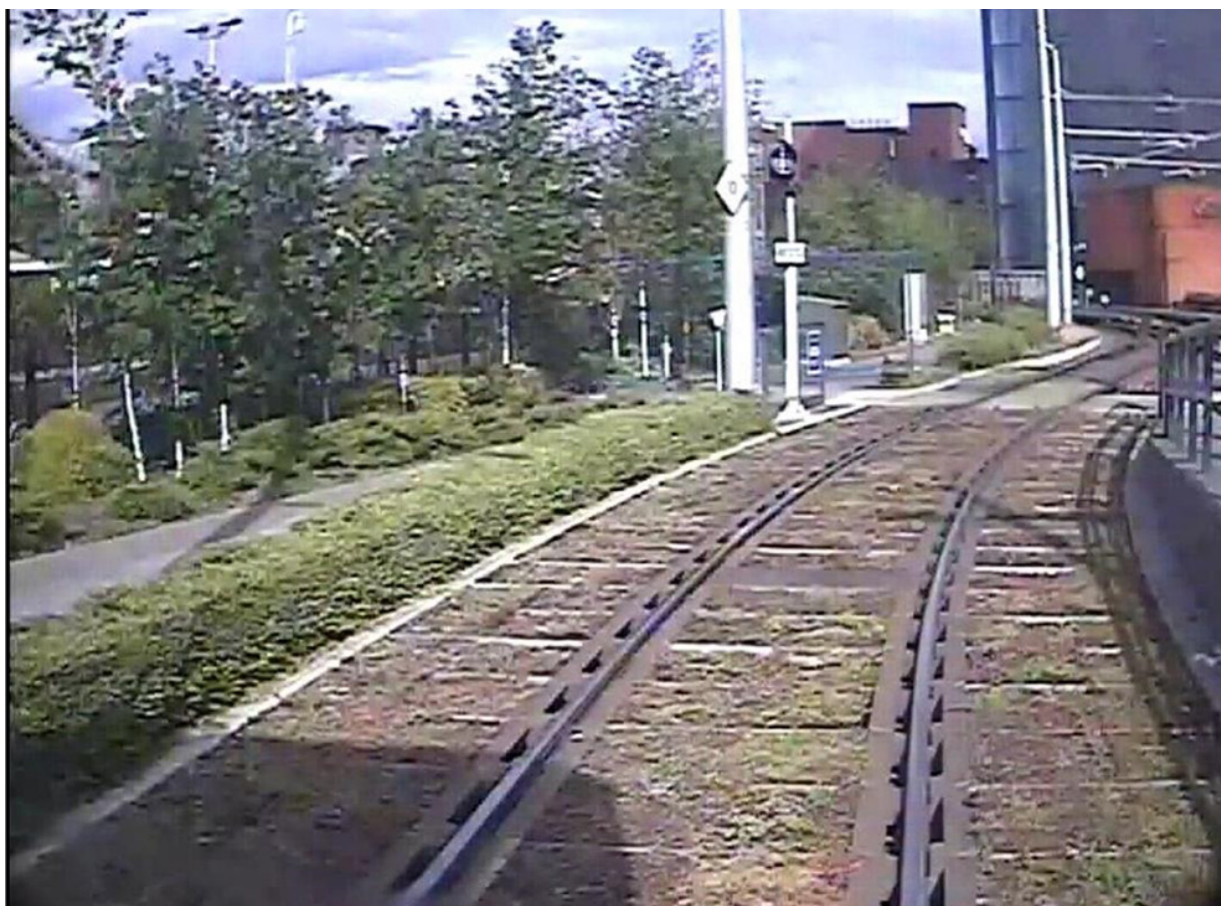
- 33 Junction DCF07J is not subject to a 'Give Way' arrangement. Under the line-of-sight principle (paragraph 9), the driver of tram 38 was therefore only required to check that signal DCF07S was showing a proceed aspect and that the line ahead was clear of obstructions, before he departed from the inbound platform. FFCCTV confirms that these conditions were met as tram 38 departed (figure 11). In this instance, the driver of tram 38 happened to glance to the right as he was approaching the junction. He saw that tram 83 was also approaching the junction and was able to bring tram 38 to a stand and narrowly avoid a collision (figure 2). The driver of tram 38 subsequently reported the near miss to Metrolink's Network Management Centre.

Figure 11: FFCCTV image from tram 38 showing signal DCF07S and the line ahead (image courtesy of Keolis Amey Metrolink)
