Rail Accident Report

Freight train derailment at Willesden High Level Junction, north-west London 6 May 2019

Report 07/2020
August 2020

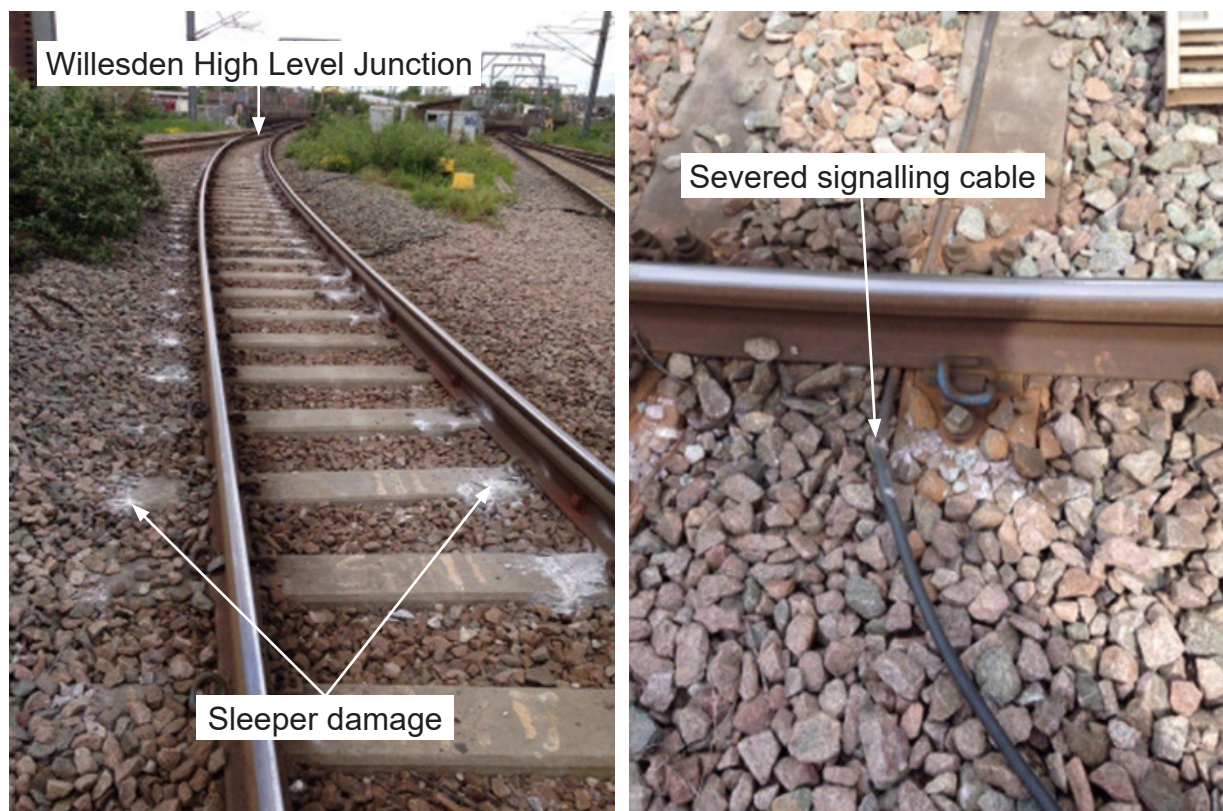
- 6 The derailment was not identified until around 14:00 hrs the following afternoon, when signalling technicians, attending to related lineside equipment faults, reported track damage and severed cables (figure 3).

Figure 3: Reported track damage (photographs courtesy of Network Rail)

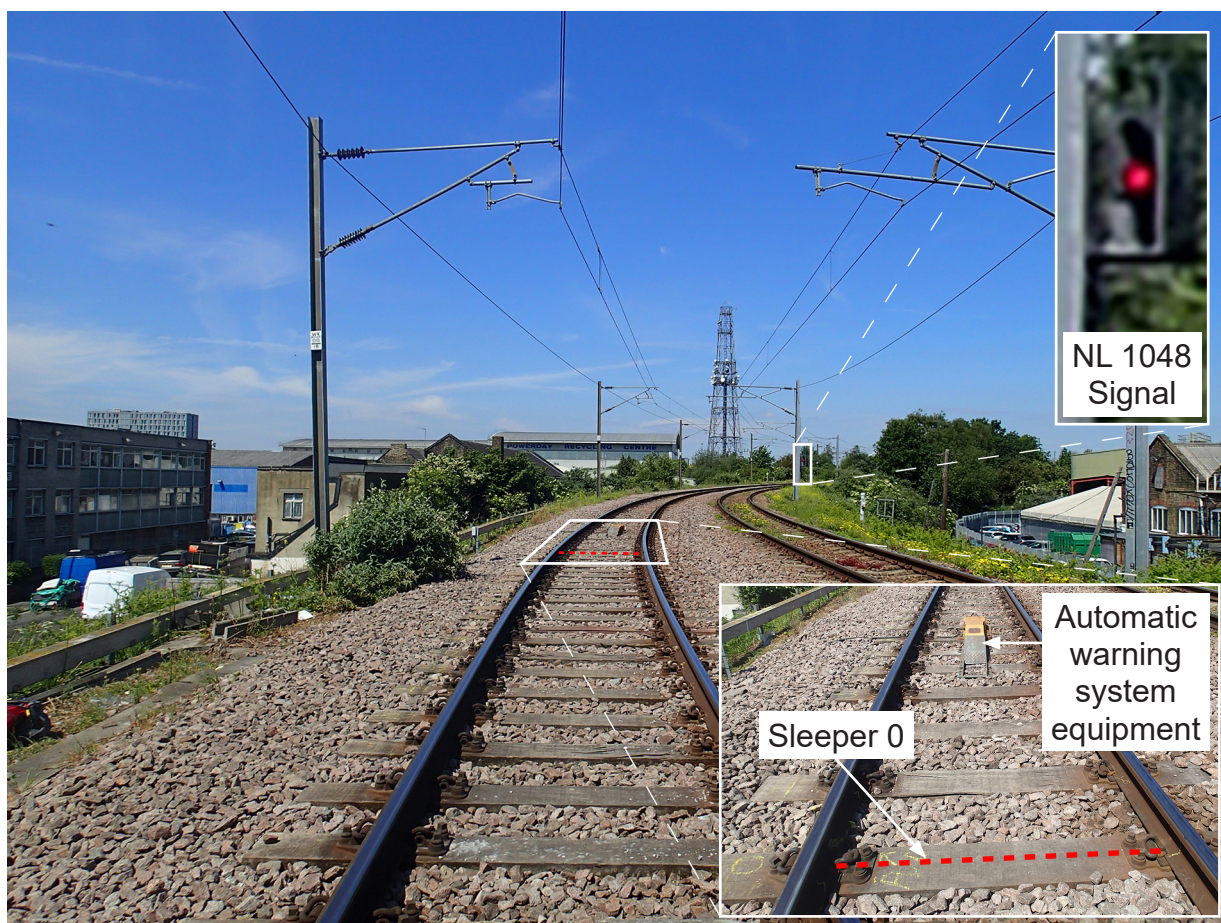
Figure 4: Up High Level line looking in the direction of travel of train 6L36, towards the point of derailment and Willesden High Level Junction. Sleeper 0 marks the designated point of derailment.

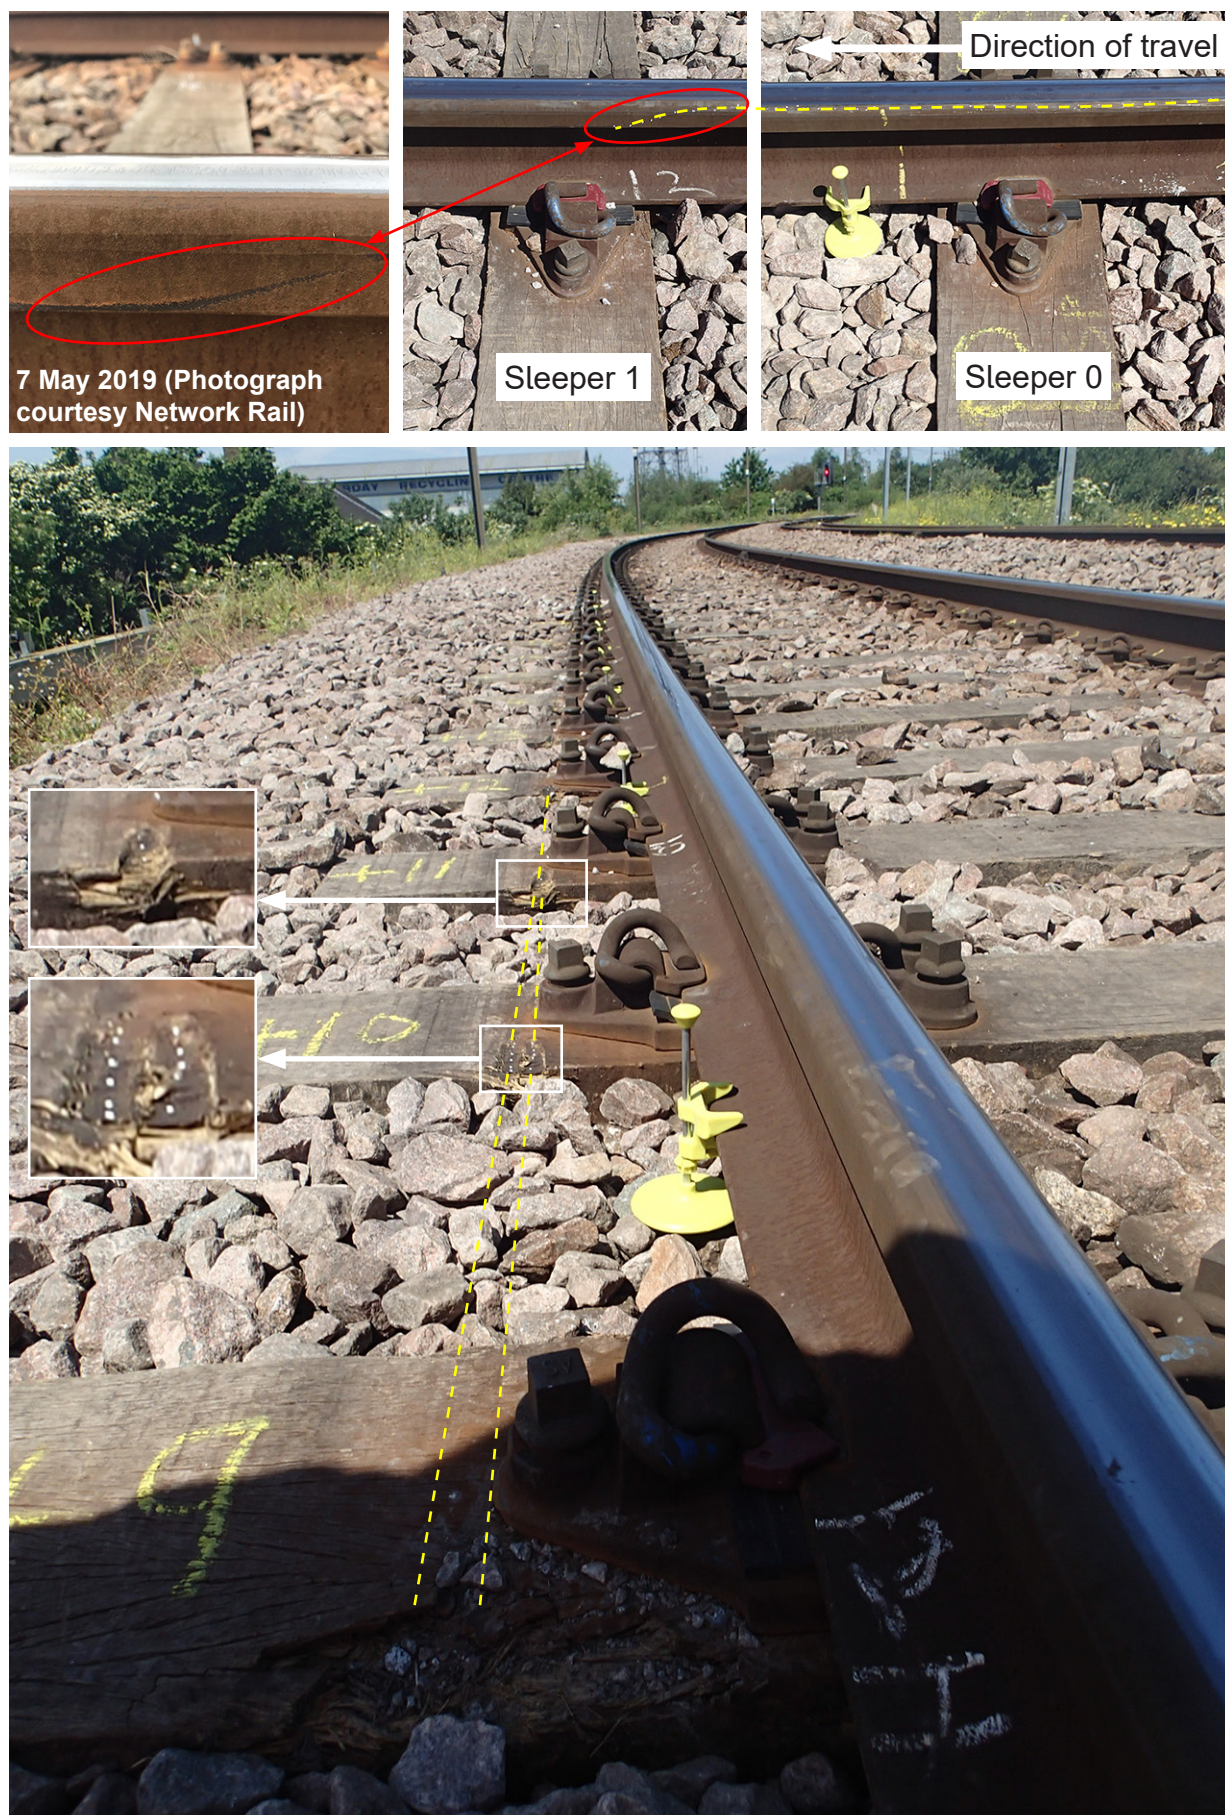
- 43 Witness marks showed that the mechanism of derailment was a flange of a left-hand wheel of wagon MPA 394228 climbing the railhead (a mechanism known as ‘flange climb’). There is a risk of derailment by flange climb when a wheel flange contacts the gauge face of the rail and the ratio of the lateral force of the wheel flange on the rail (Y) to the vertical wheel load (Q), known as the Y/Q derailment quotient, exceeds a critical limit value. Because of this, the lower the wheel load, or higher the lateral force, the greater the risk of derailment.

Figure 7: Marks showing evidence of derailed wheel flange running on the left-hand railhead, rail fasteners and sleeper ends (all photographs 23 May 2019, except as labelled)

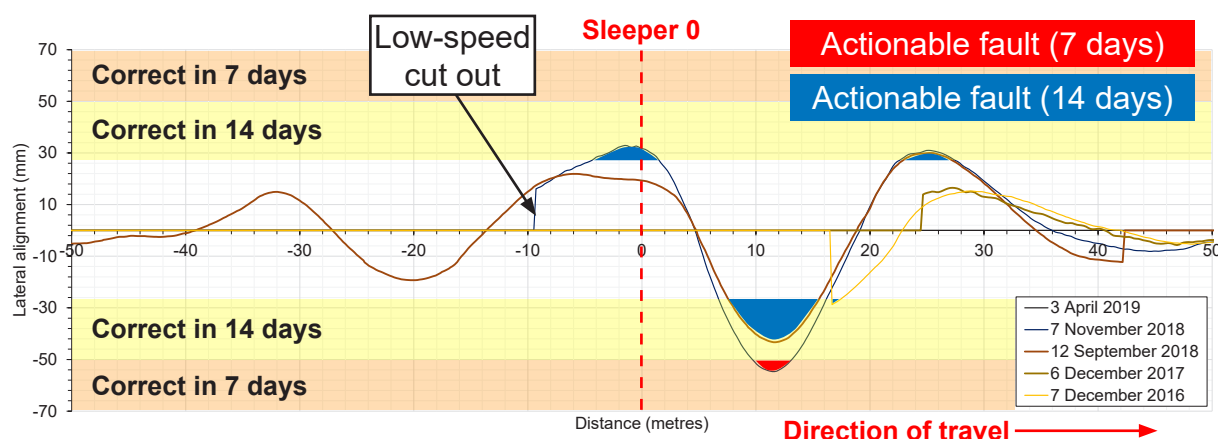
Figure 8: Lateral track alignment recorded on various track geometry measurement train runs prior to the derailment. Locations where low-speed cut out resulted in data loss are highlighted. On 3 April 2019 no lateral track geometry measurement data was recorded in the vicinity of the designated point of derailment, identified as 'Sleeper 0'.

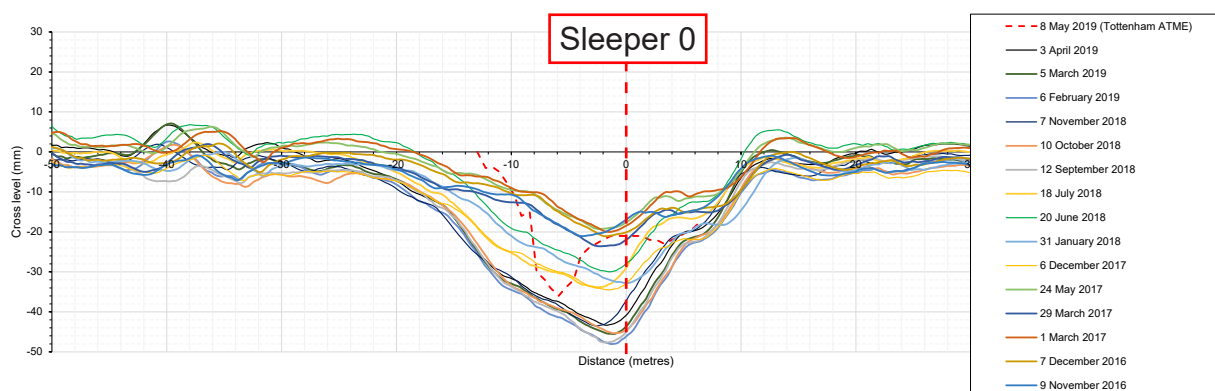
Figure 5: The inclinometer locations on the up-side slope of Mitre Bridge Curve embankment

Figure 11: Track geometry measurements showing the gradual formation of the cross-level feature close to 0 miles 27 chains on the up High Level line and how this compared with the feature that the Tottenham ATME measured after the derailment.

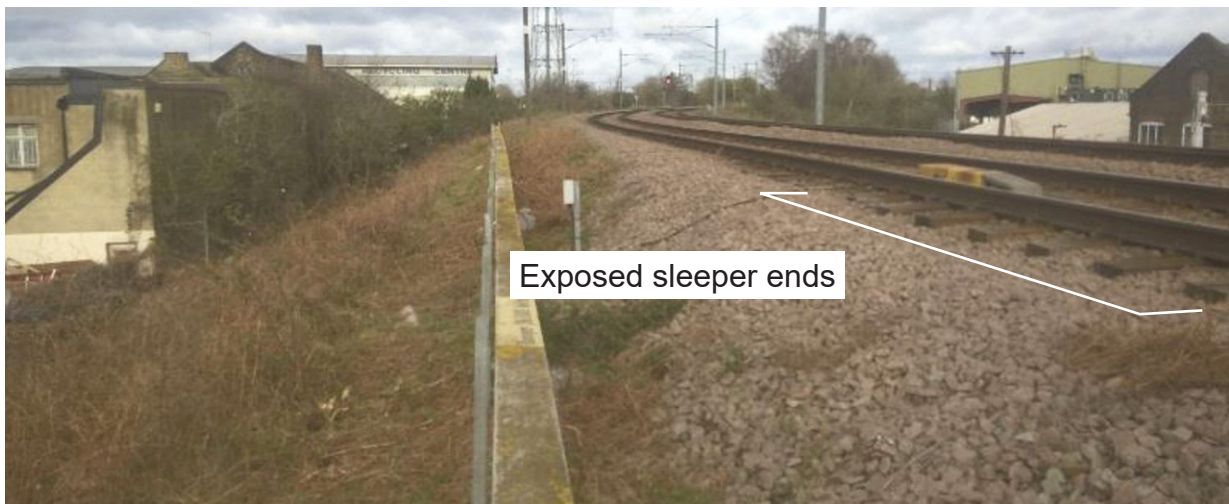
- section manager's visual inspections on 12 December 2018 and 14 March 2019, which both reported a lack of ballast on the up High Level line between 0 miles 9 chains and 0 miles 38 chains (paragraph 54)
- the cab ride by the Camden TSM on 6 April 2019, which reported the need for ballast between 0 miles 25 chains and 0 miles 27 chains (paragraph 55)
- the site visit by the Anglia AE(G) on 23 May 2016, which identified exposed sleeper ends and a reduced cess height (paragraph 58)
- the specialists who visited the location on 15 March 2019, and specifically commented on the lack of ballast around sleeper ends and the lowered cess in their report (paragraph 61 and figure 12).

Figure 12: The condition of the up-side cess and ballast around 0 miles 27 chains on the up High Level lines as photographed during the specialists' site visit of 15 March 2019 (photograph courtesy SNC-Lavalin)

- 95 These signs were consistent with ballast becoming mobile and able to escape from under the sleepers because of movements in the underlying embankment (paragraph 97). Work orders that had been raised to deliver new ballast to the site had been rescheduled (paragraph 54)²⁷ and, in the years before the derailment, no mechanised track maintenance work, such as tamping or stone blowing, had been arranged which would have helped reinstate support to the track.

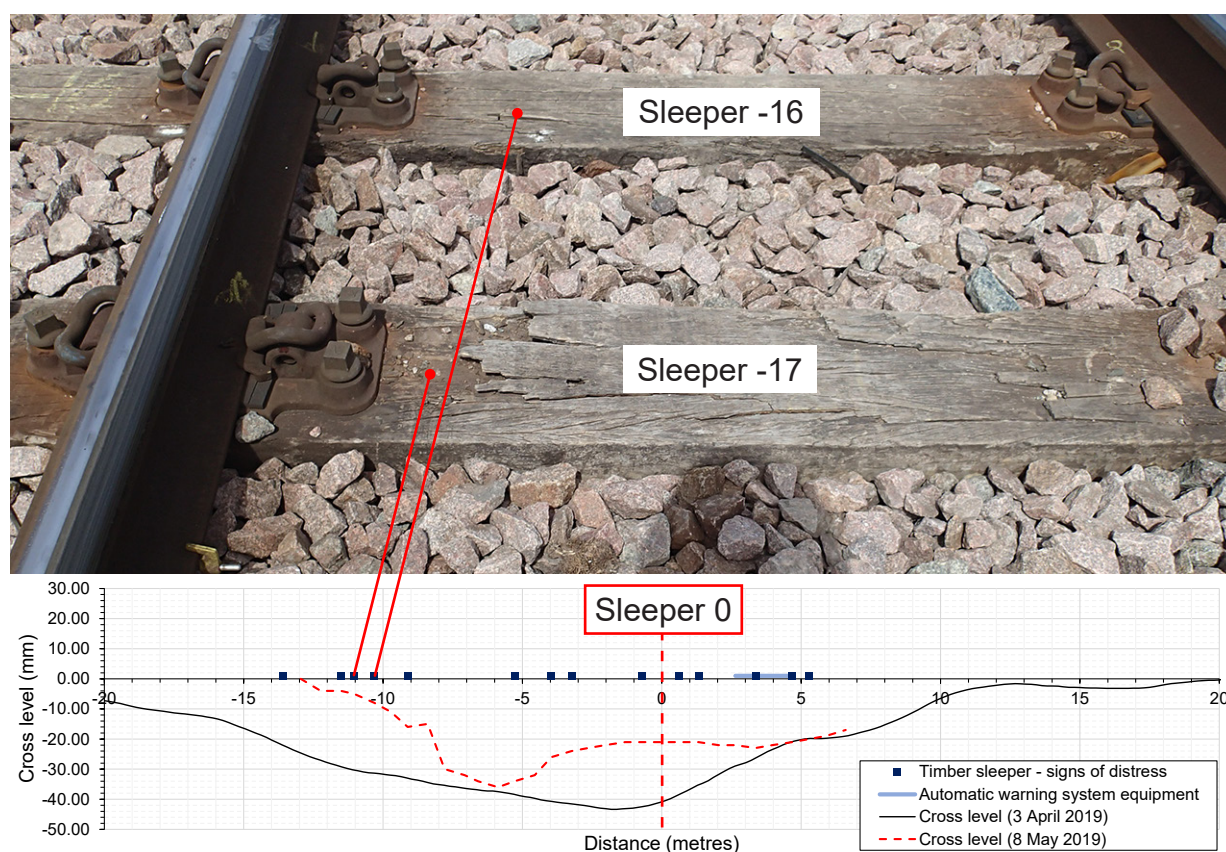
- 96 There were visible signs of distress on some of the timber sleepers close to the derailment location, suggesting they were likely to be more flexible and thus allow greater differences in cross-level on poor supporting ballast. RAIB compared the location of these sleepers, and the track-mounted automatic warning system equipment for signal NL 1048 (which is likely to have reduced sleeper flexibility), with the cross-level profiles measured by the Tottenham ATME, and those from the last pre-derailment track geometry measurement train run (figure 13). It noted a degree of correlation between the location of the distressed sleepers and the magnitude of the cross-level change. Therefore, it is possible that the condition of the sleepers contributed to a track twist being able to develop more rapidly.

Figure 13: Location of distressed sleepers and automatic warning system equipment close to 0 miles 27 chains compared to cross-level profiles measured on 3 April 2019 and 8 May 2019

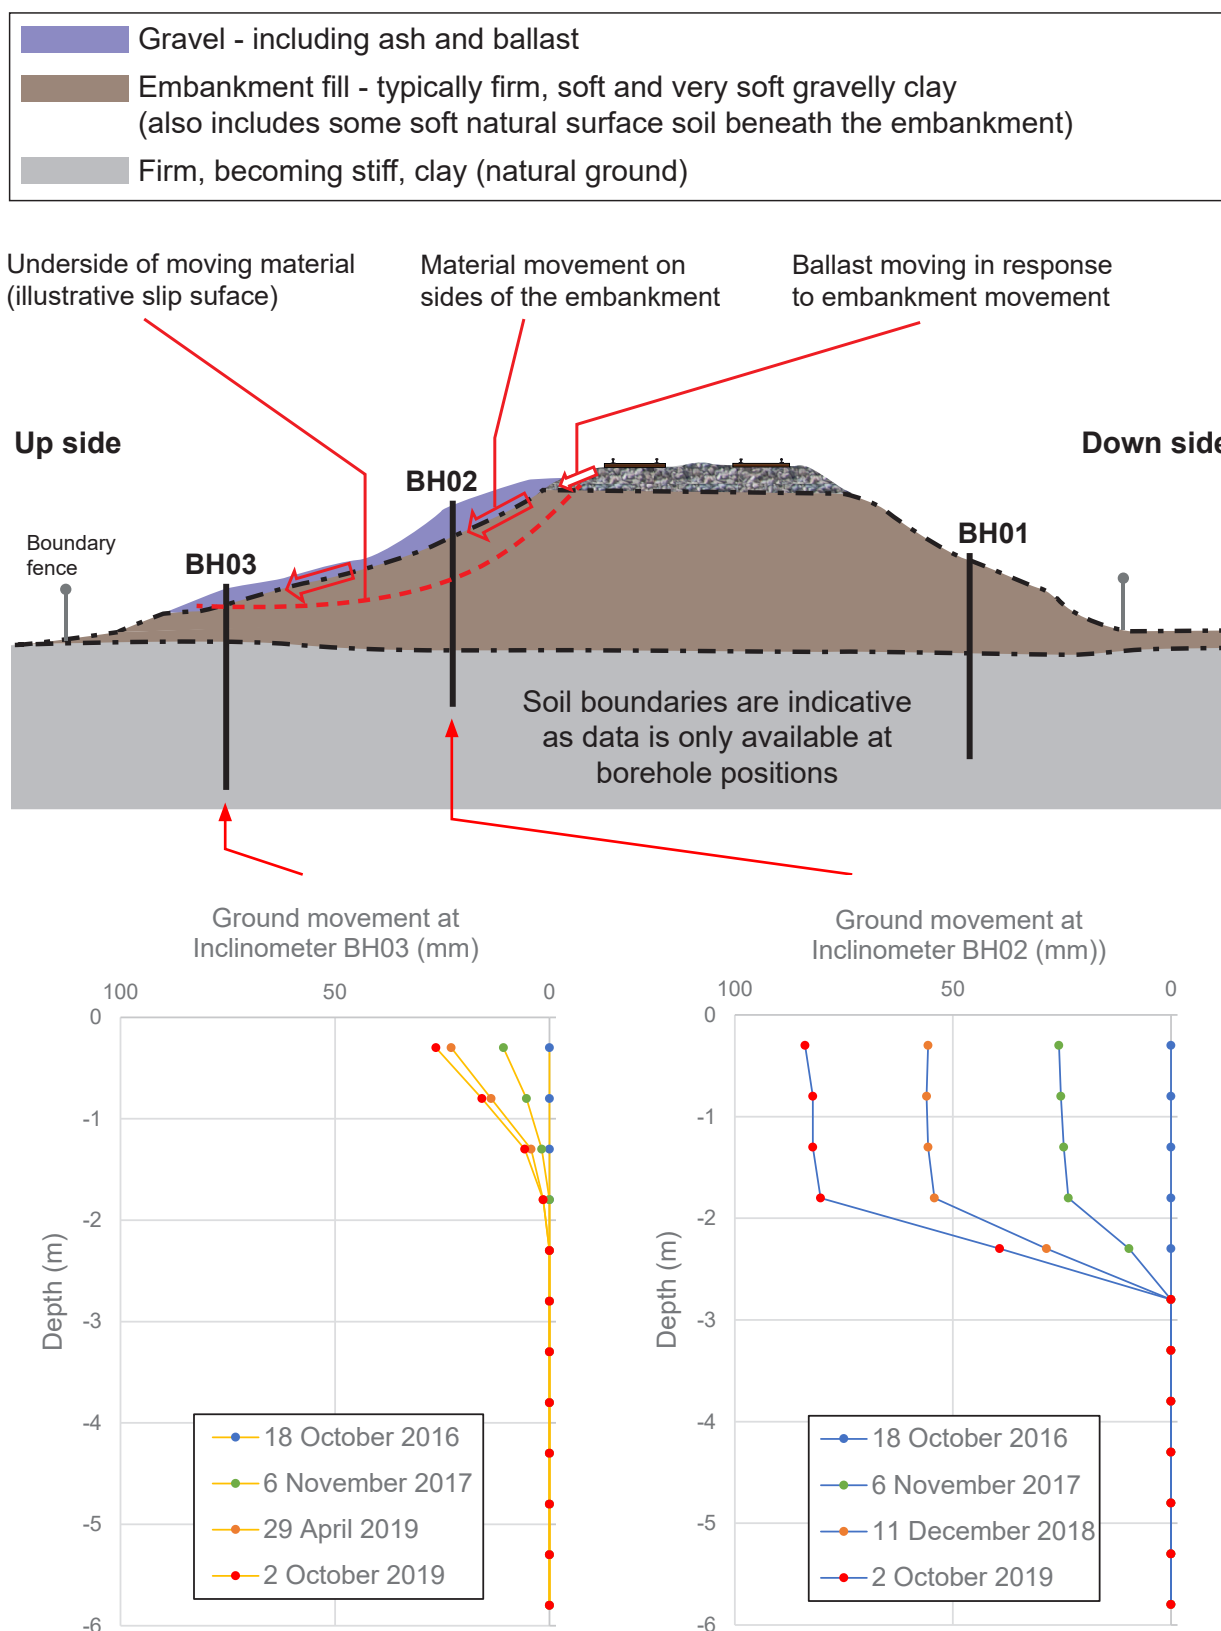
Figure 14: Cross-section of Mitre Bridge Curve embankment showing illustrative slip surface and simplified ground movement. Graphs show how the lateral movement measured at inclinometers BH02 and BH03 varied with borehole depth.

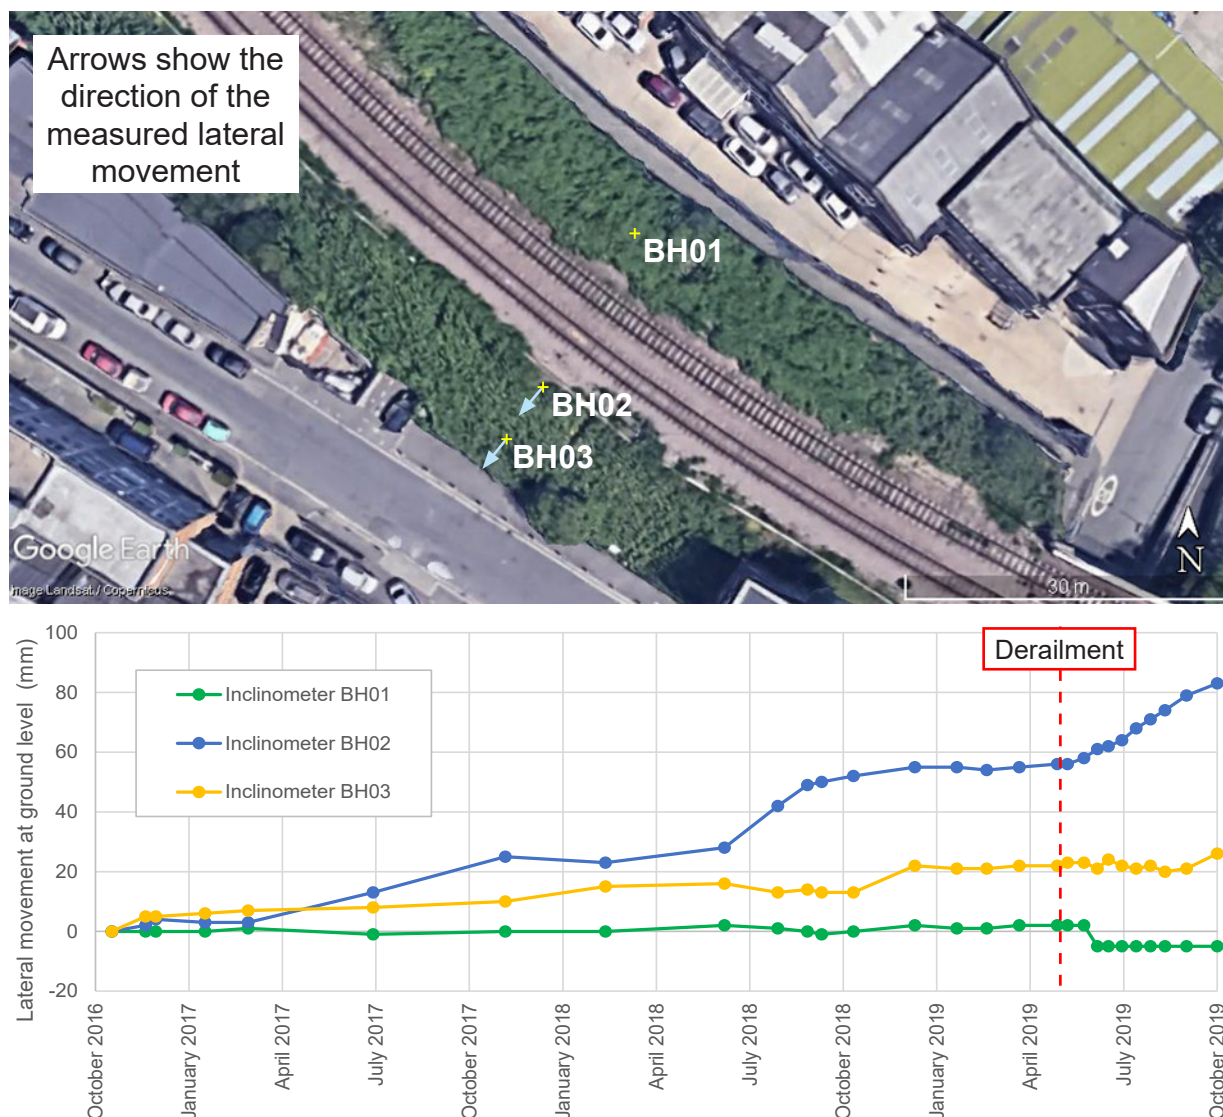
Figure 15: Lateral embankment movements measured at ground level by the inclinometers installed in the down-side slope (BH01) and the up-side slope (BH02 and BH03). Aerial image shows the location of the inclinometers.

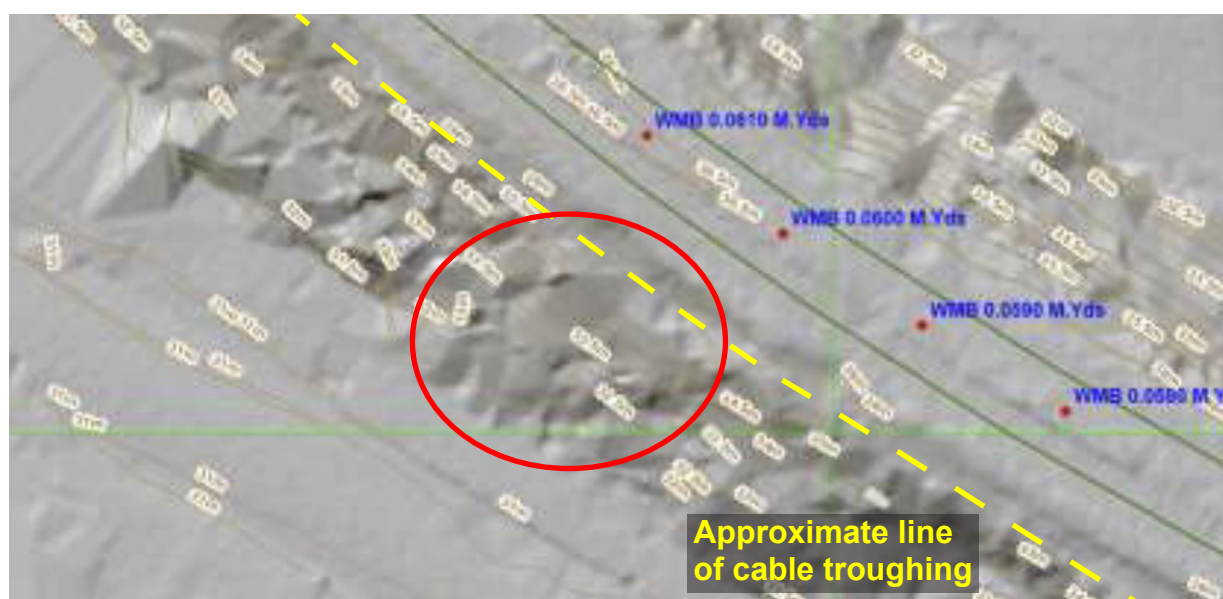
Figure 16: LiDAR survey of the embankment on Mitre Bridge Curve highlighting the flattened area on the up-side slope close to 0 miles 27 chains (image courtesy Network Rail)

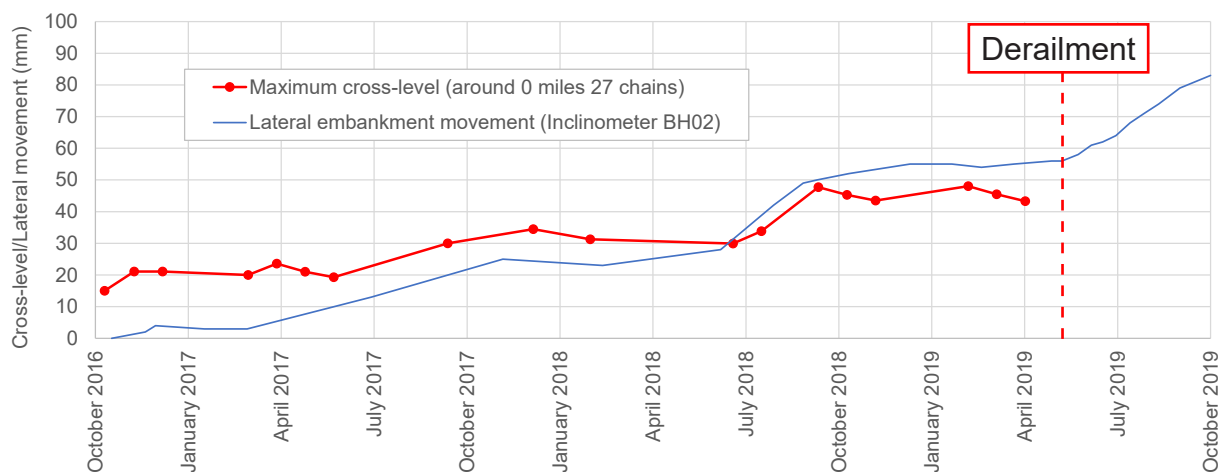
Figure 17: Development of the maximum cross-level around 0 miles 27 chains compared to the lateral embankment movement measured at ground level at inclinometer BH02

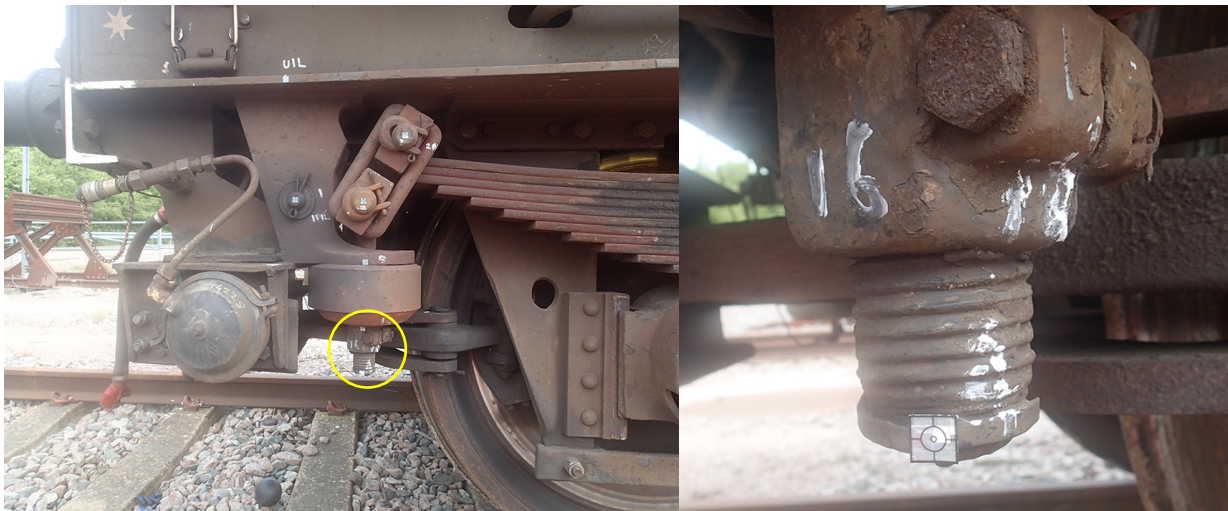
- 146 The condition of the split nuts and eye bolt threads on wagon MPA 394228 (figure 18) suggests that they had not been adjusted in recent years (possibly decades) and that the diagonal wheel load imbalance had existed for some time.

Figure 18: Typical split nut and eyebolt condition on wagon MPA 394228
