Rail Accident Report

Collision at Stainforth Road level crossing, 11 January 2018

Report 08/2018
July 2018

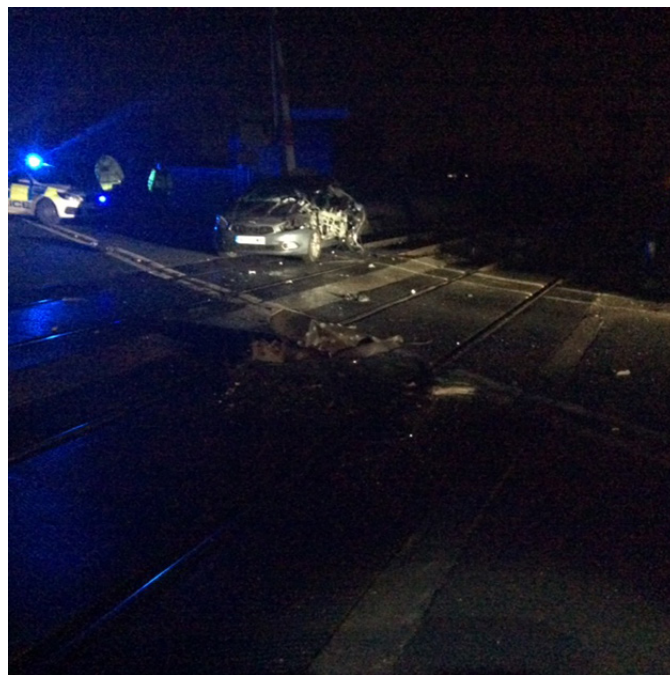
- 24 As she approached the crossing, the northbound car driver saw the wagon standing in front of her on the crossing and swerved to try and avoid a collision. Despite this, the passenger side of her car struck the wagon and the car was spun around, eventually coming to a rest pointing westwards (figure 5). Photographs of the damage sustained to the car and to the wagon involved show that the passenger side of the car collided with the headstock and buffer of the wagon (figures 6 and 7). Once the car had stopped moving, the car driver got out. As she did so, she saw the train pull away. The OTDR recorded that the train had been at a stand for 1 minute and 52 seconds.

Figure 5: Photograph of the crossing taken following the accident (image courtesy of Network Rail)

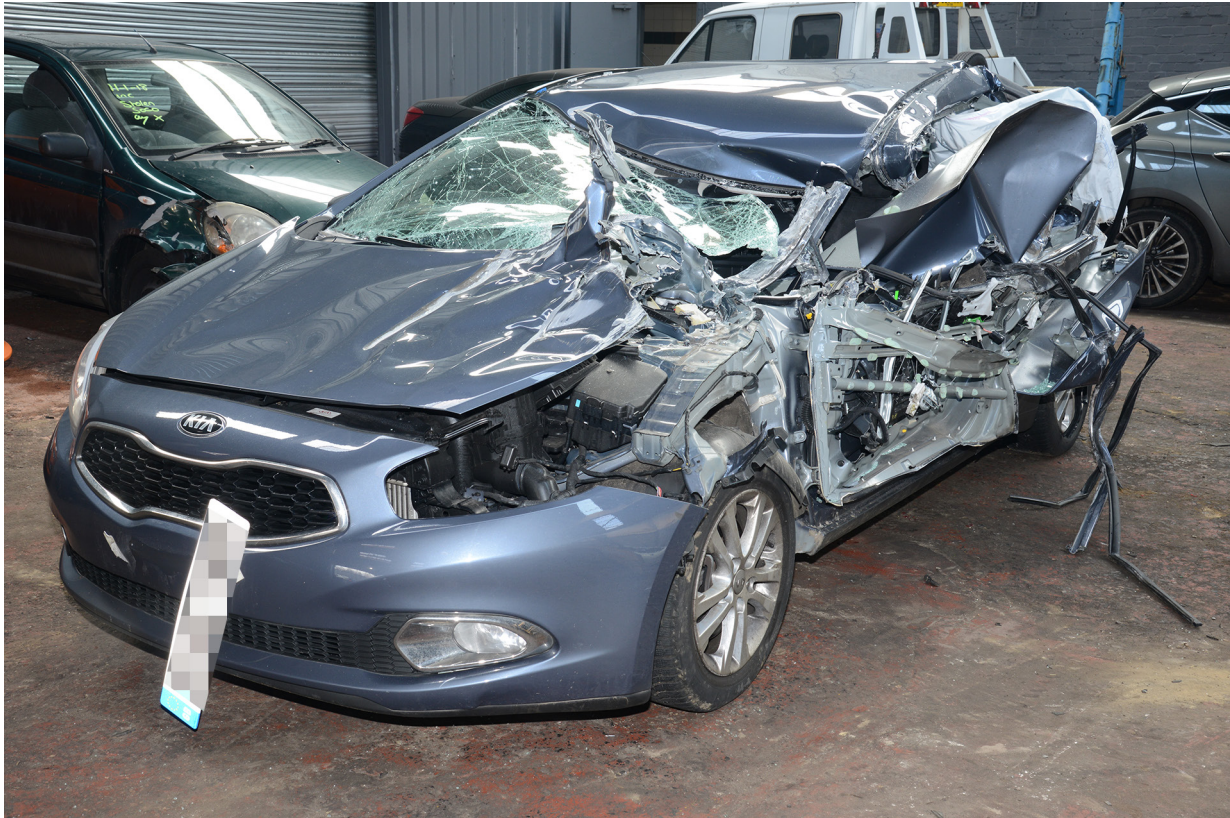
- 4 The driver of the car suffered scratches and bruises but her car was damaged beyond economic repair. The wagon sustained minor damage.

Figure 6: The damage sustained by the car as a result of the accident (image courtesy of the British Transport Police)

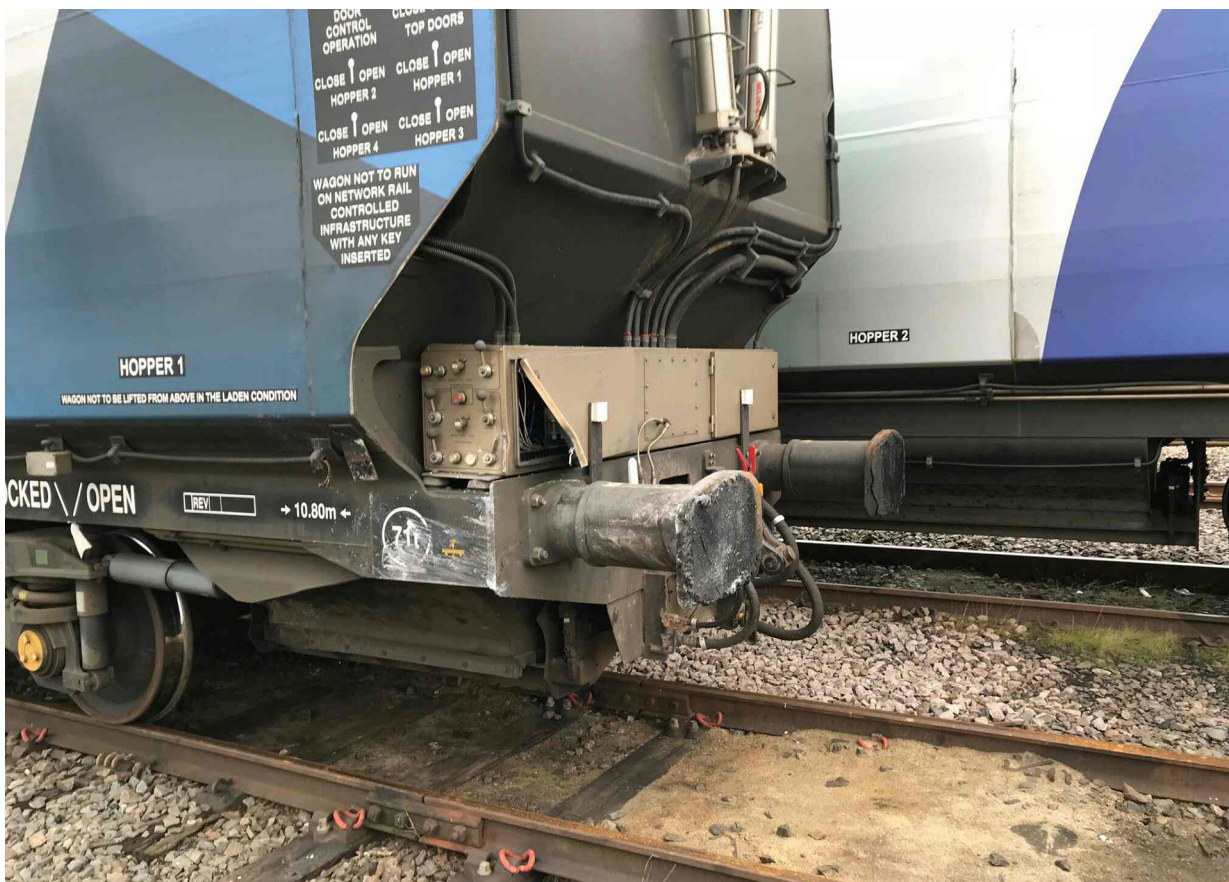
Figure 7: The damage sustained by the rearmost wagon as a result of the accident (image courtesy of Network Rail)

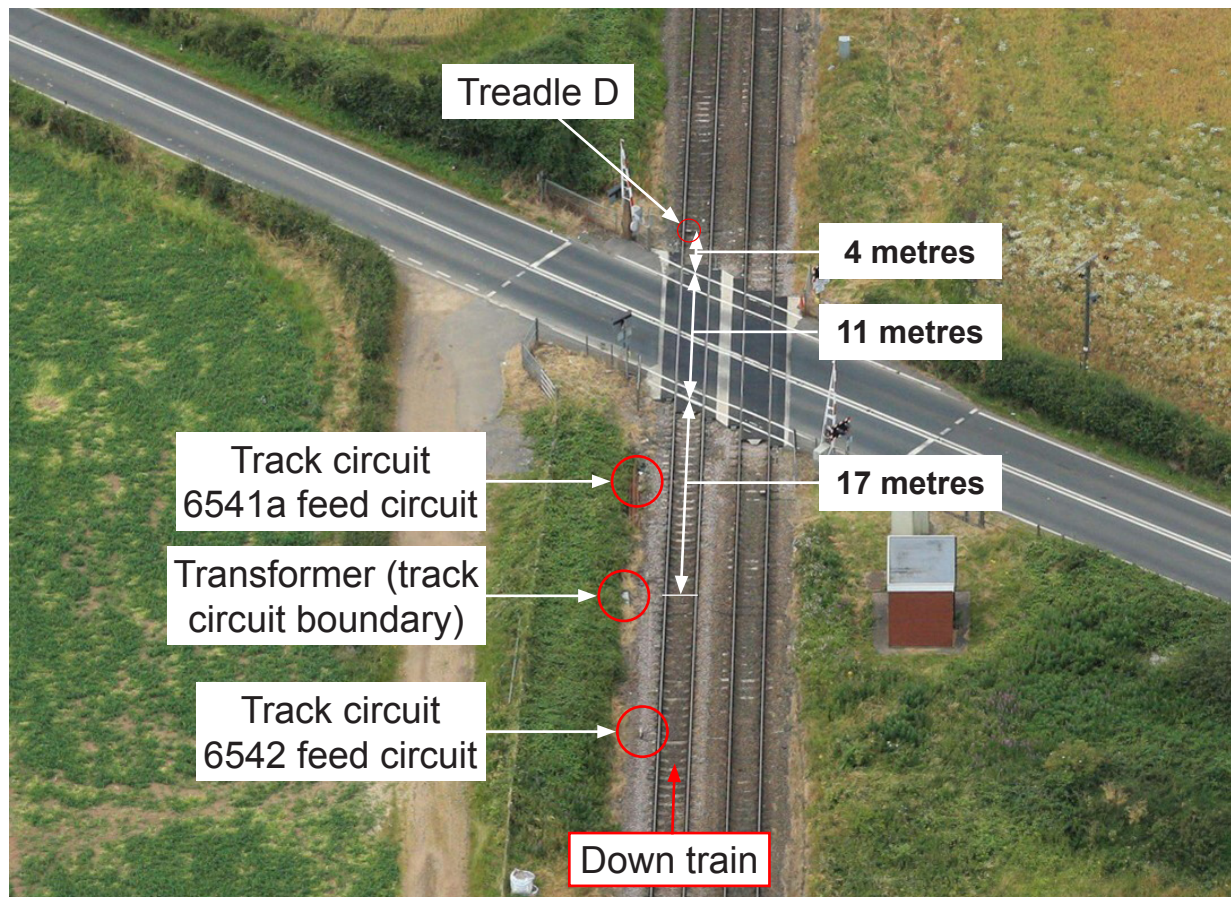
- 29 Track circuit 6542 terminates short of the crossing. The Down Skellow line immediately on approach to the crossing surface, the crossing surface itself and the track beyond it are monitored by track circuit 6541a. Occupation of this track circuit alone will not activate the road closure sequence. Network Rail stated that early designs of AHB had this arrangement so that the presence of tracked vehicles or salt in the crossing surface would not cause the crossing to close erroneously.
- 30 The track circuits in place at the crossing are of the audio-frequency type. This means there are no insulated block joints marking the boundary between circuits. Network Rail stated that the transformer unit located around 17 metres on approach to the crossing was used as the boundary between track circuits 6542 and 6541a (figure 11).

Figure 11: The track circuit and treadle arrangement at Stainforth Road AHB (underlying image courtesy of Network Rail)

- 33 Stainforth Road AHB will therefore start to re-open to road traffic when the rearmost axle of an approaching train passes a point around 17 metres on approach to the crossing. Allowing a nominal 3 metres for the overhang of a wagon's body, and taking into account the 11 metre width of the crossing's surface, trains on the Down Skellow line will therefore have to travel around 31 metres after the crossing's re-opening sequence has started, before they completely clear the crossing's surface. For a train travelling at the maximum permitted linespeed of 50 mph (80 km/h) this will take about 1.4 seconds.

- 35 Taking 6 seconds as the shortest expected time for the crossing to become fully re-opened, only trains travelling at around 11 mph (18 km/h) or below are at risk of not having fully cleared the crossing's surface when the half-barriers reach the fully raised position. The OTDR recorded that the front of train 6H58 passed over the crossing at 32 mph (51 km/h). However, the brake application subsequently caused it to slow down and for the rearmost wagon to come to a stop foul of the northbound carriageway.
