Rail Accident Report

Freight train derailment at Ely West Junction 14 August 2017

Report 09/2018
August 2018

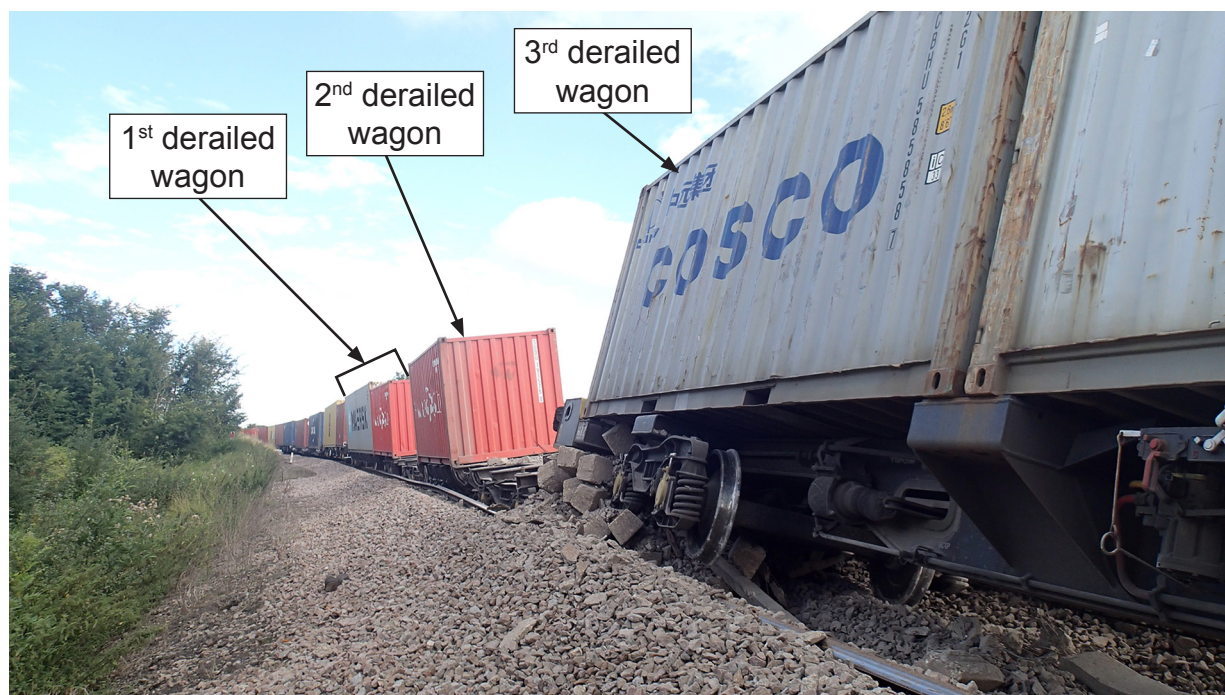
At 14:21 hrs on Monday 14 August 2017, the rear 12 wagons of a freight train carrying containers derailed at Ely West Junction on the line between Ely and March. The train was travelling at 41 mph (66 km/h) at the time of the derailment. It ran derailed for approximately 350 metres, causing significant damage to the infrastructure.

Figure 2: Derailed wagons on site

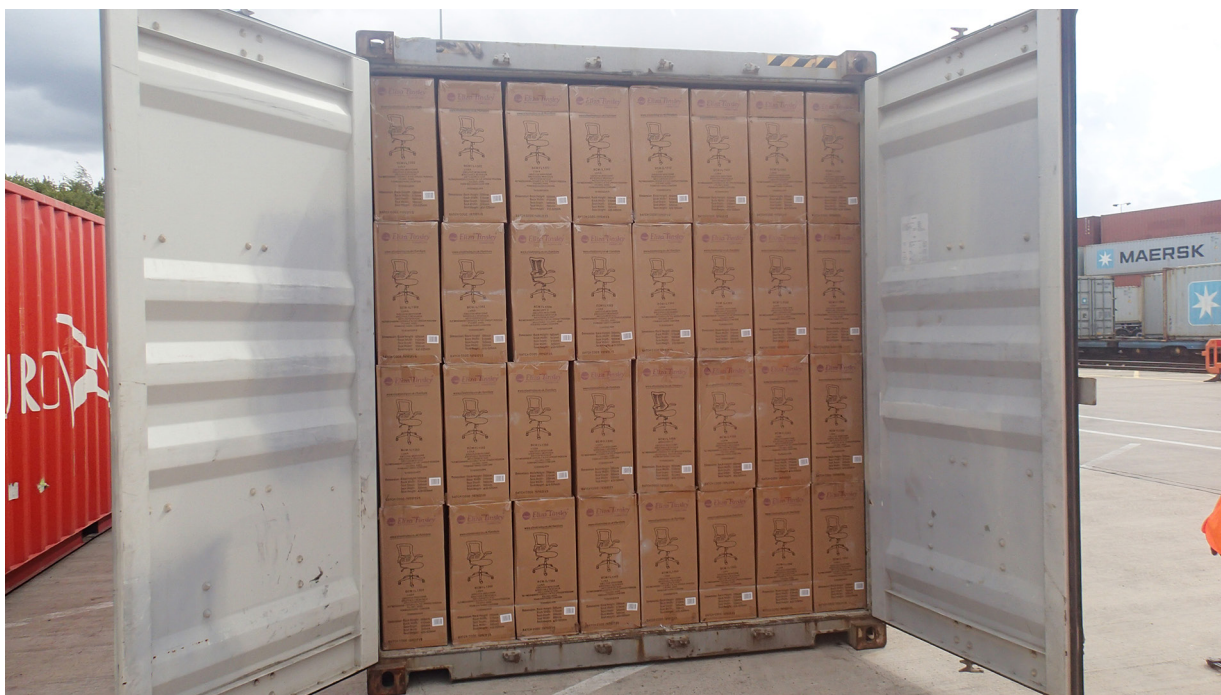
- 11 Wagon 630034 carried a 40 foot container in the leading position and a 20 foot container in the trailing position. Examination of these containers after the accident showed that the 40 foot container was packed with office furniture (figure 4) and the 20 foot container with pallets of floor tiles (figure 5). The mass of the 40 foot container was measured as 11.2 t and the 20 foot as 27.6 t. The payload in the 20 foot container was such that the centre of gravity of this container was offset both longitudinally and laterally. Photographic evidence showing the content of the container as it was packed in Izmir (Turkey) before coming to the UK demonstrated that the payload had moved marginally longitudinally and laterally, likely as a result of the derailment, between packing and post-accident inspection. The load position as recorded in Izmir was used during the investigation.

Figure 4: 40 foot container opened post-accident

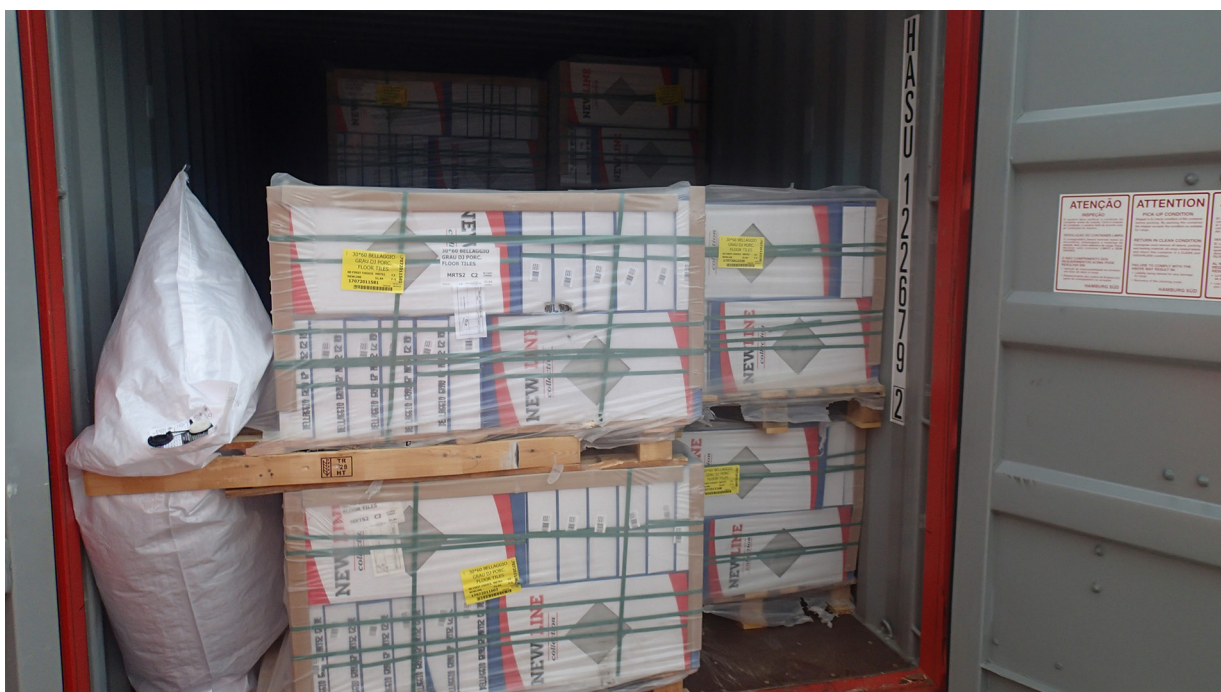
Figure 5: 20 foot container opened post-accident

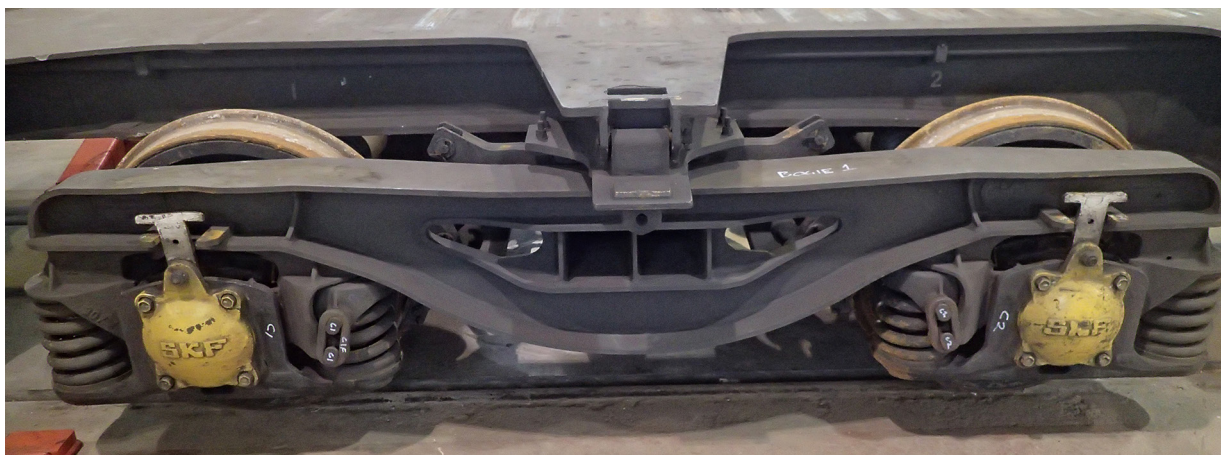
- 19 The bogies fitted to the FEA-A wagons were Y33 bogies (figure 6). They are a derivative of the Y-series family of bogies, widely used across the UK and in Europe for the past 50 years.

Figure 6: Y33 bogie (leading bogie on wagon 630034)

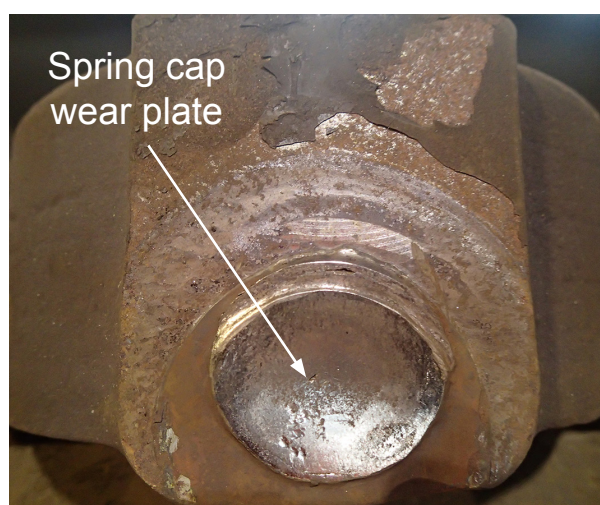
- 32 Wagon 630034 was examined at March depot after the derailment. The wagon underframe was lifted which enabled the bogies and their components to be examined. Of particular note was an unusual wear pattern on the spring cap wear plates (figure 9). This wear pattern suggested that:
- the spring cap wear plate had been sitting higher than the bush (figure 10); and
 - the spring cap wear plate had been pushing against the top of the bush instead of the plunger which suggests that the plunger was recessed inside the bush, instead of passing through and protruding from it (as shown on figure 11).

Figure 9: Wear pattern on incident spring cap wear plate

- 69 The RAIB ascertained the relative vertical position of the bush and spring cap wear plate centrelines using the dimensions contained in the VPI maintenance guidelines and standard bogie components drawings. As new, the centreline of the spring cap wear plate (diameter 36 mm) is aligned with the centreline of the bush (diameter 55 mm). As the damping components including the Lenoir links and trunnions wear, the spring cap moves up in relation to the bush position. The RAIB calculated that at the extreme of wear of the components¹⁵, the top of the spring cap wear plate may sit higher than the top of the bush. The physical evidence showed this was 4 mm in the incident axlebox (figure 9).

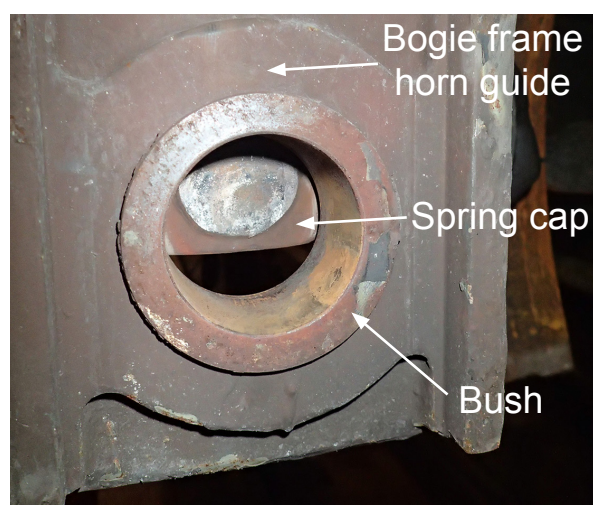
Figure 10: Position of spring cap wear plate relative to bush reconstructed on trailing axle of incident wagon (for illustrative purposes only)

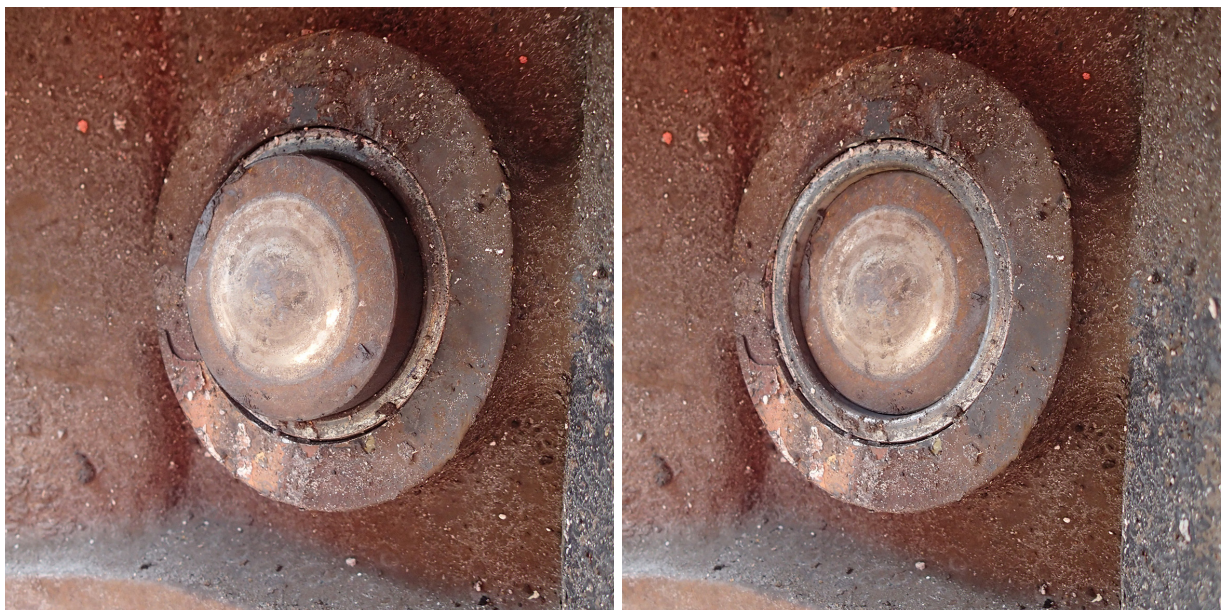
Figure 11: A plunger in normal position in a recessed position - reconstructed on a different wagon for illustrative purposes

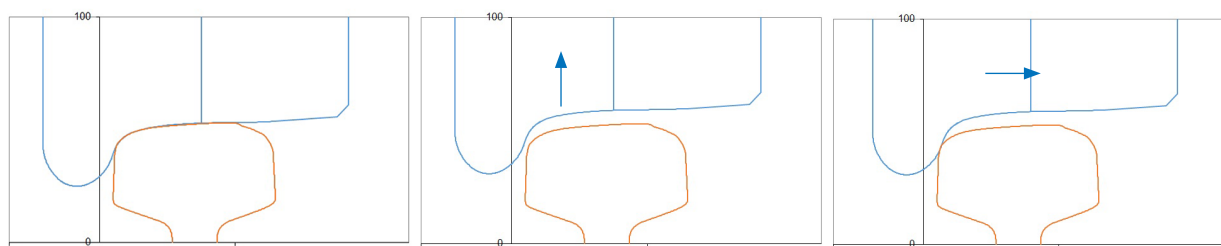
44 This simulation predicted that the leading right-hand wheel of wagon 630034 would fully unload at the point of derailment¹⁰. The leading right-hand wheel was predicted to lose contact with the railhead and to rise 6 mm (described as wheel flight) before re-contacting the rail in a partially climbed state (figure 12). At that point, the ratio of lateral load to vertical load applied to the wheel was also predicted to be high enough to continue to promote a derailment.

Figure 12: Wheel in contact with rail – normal condition (left), wheel in flight (middle), wheel landing in partially climbed state (right)

45 The level of partial climb predicted in the simulation (approximately 6 mm) is at a position at which the contact angle between the wheel flange and the rail starts to reduce. If the ratio of lateral load to vertical load is unfavourable, as was the case in the simulation¹¹, the wheel will likely continue to climb and eventually lead to a derailment. The RAIB therefore concluded that the simulation predicted a high risk of derailment at the point at which the leading right-hand wheel actually derailed.

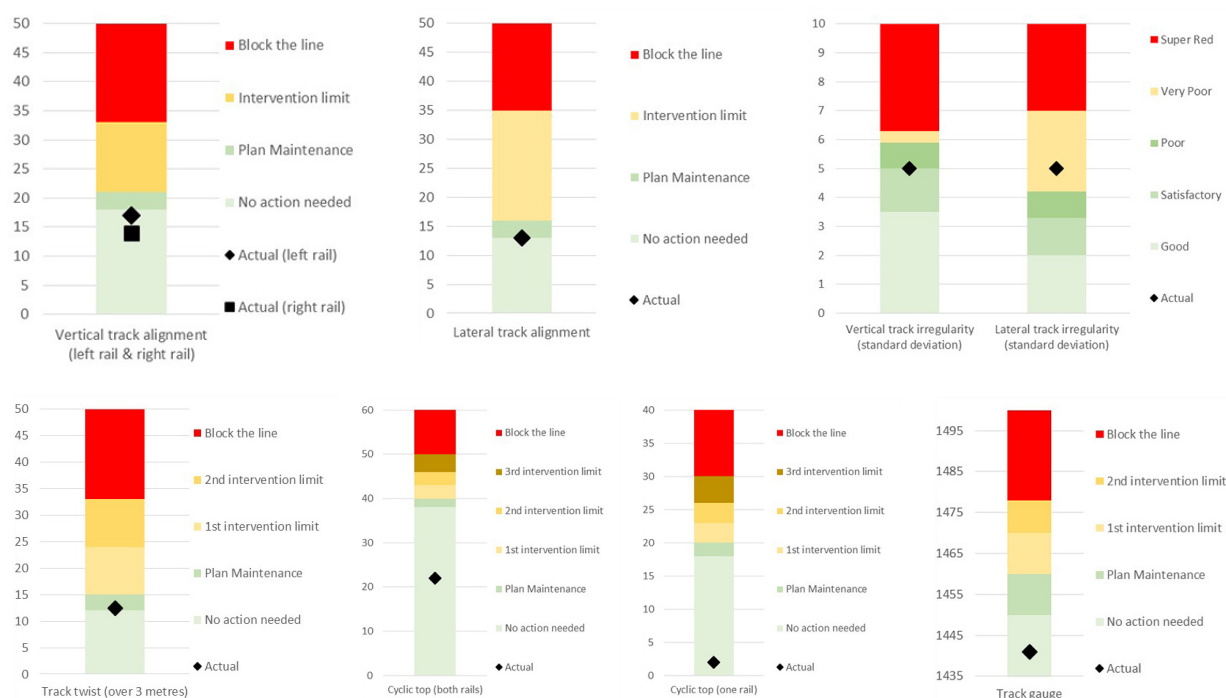
- 51 A 'poor' rating does not trigger any required action by Network Rail whereas a 'very poor' rating requires the people in charge of track maintenance to review what might be driving this rating and, where necessary, to take corrective actions. As such, the level of lateral irregularity was included in the sensitivity study. All other track factors were found to be within alert limits and hence were not included in the study. Figure 13 shows the input parameters and compares their values against the limits.

Figure 13: Track input parameters
