Rail Accident Report

Landslip and derailment at Loch Eilt, north-west Scotland 22 January 2018

Report 10/2018
August 2018

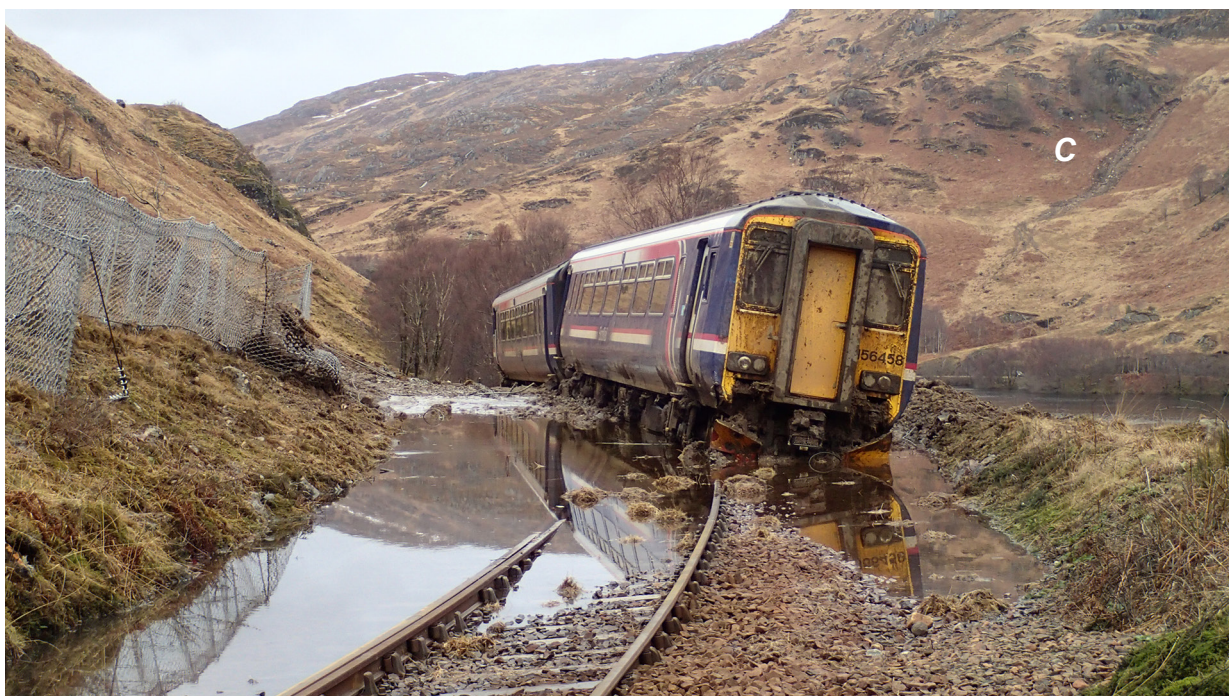
- 5 The train travelled through the debris for about 30 metres before coming to a stand with the leading vehicle derailed and tilted to the left (figures 3 and 4). After it stopped, the leading vehicle continued to shudder and was evacuated. There were no injuries to the traincrew or passengers.
- 6 The 2-carriage train was damaged and partly submerged in mud and flowing water. An estimated 700 litres of diesel fuel leaked from the damaged leading vehicle. Some diesel was carried by flowing water into the lineside drainage channel and entered Loch Eilt.

Figure 3: Front view of derailed train. Another recent landslide is visible in the distance on the opposite side of Loch Eilt (marked 'C').

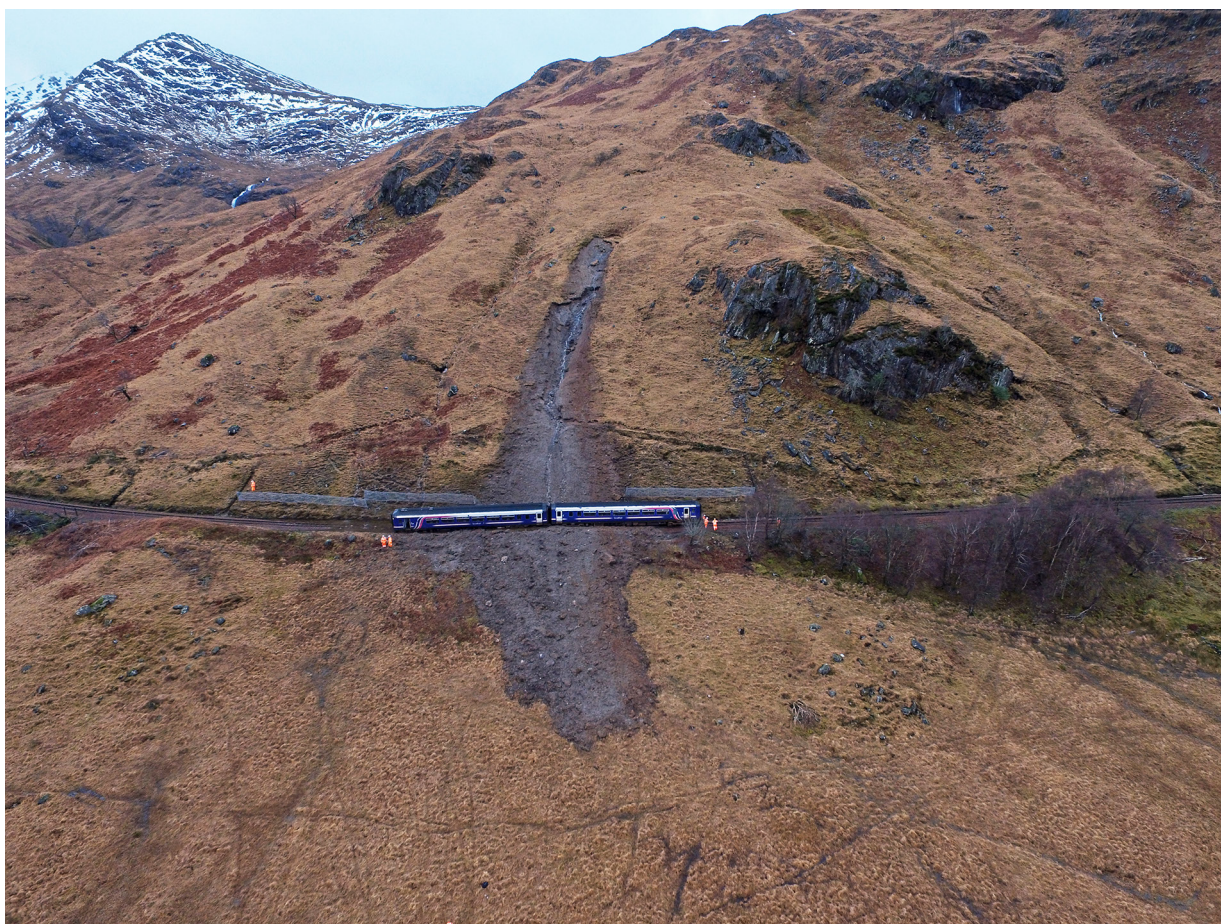
Figure 4: Aerial view of landslide

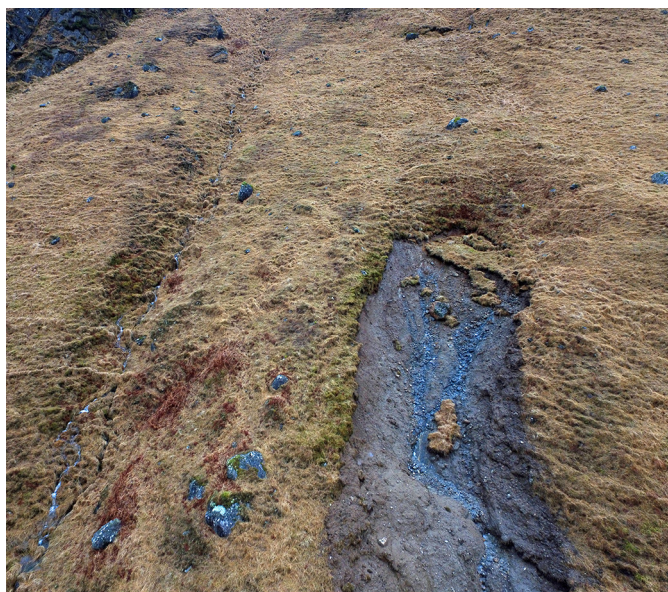
Figure 9: Existing natural hollow at top of slip

- 46 It is possible that the hollow in the ground at the top of the landslip (figure 9), a pre-existing feature, led to accumulation of snow and then melt water at a location which triggered a debris flow. Such topographical features are common on upland slopes and would not be considered a strong indicator of possible future landslips.

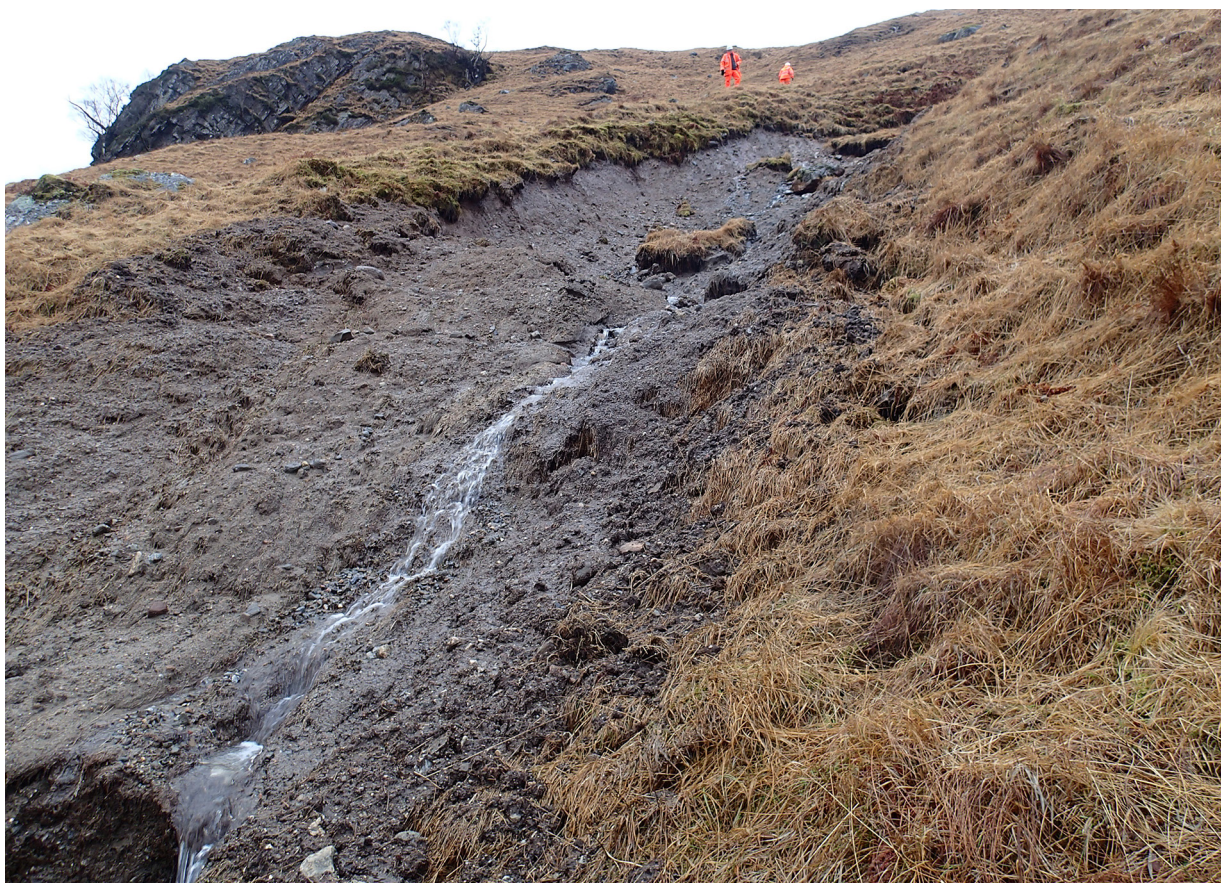
- 42 The gradient of the natural slope in the area of the landslide ranges between 25° and 30° with several streams flowing down the hillside and passing under the track into Loch Eilt.
- 43 The landslide involved an estimated 500 m³ to 600 m³ of material, weighing over 1000 tonnes. The top of the landslide started at a natural hollow about 80 metres outside the railway boundary fence, and 46 metres above track level (figure 9). The slip followed the path of an existing gully, enlarging it significantly down to the level of the underlying bedrock (figure 10).

Figure 10: Side view of upper part of slip on natural slope

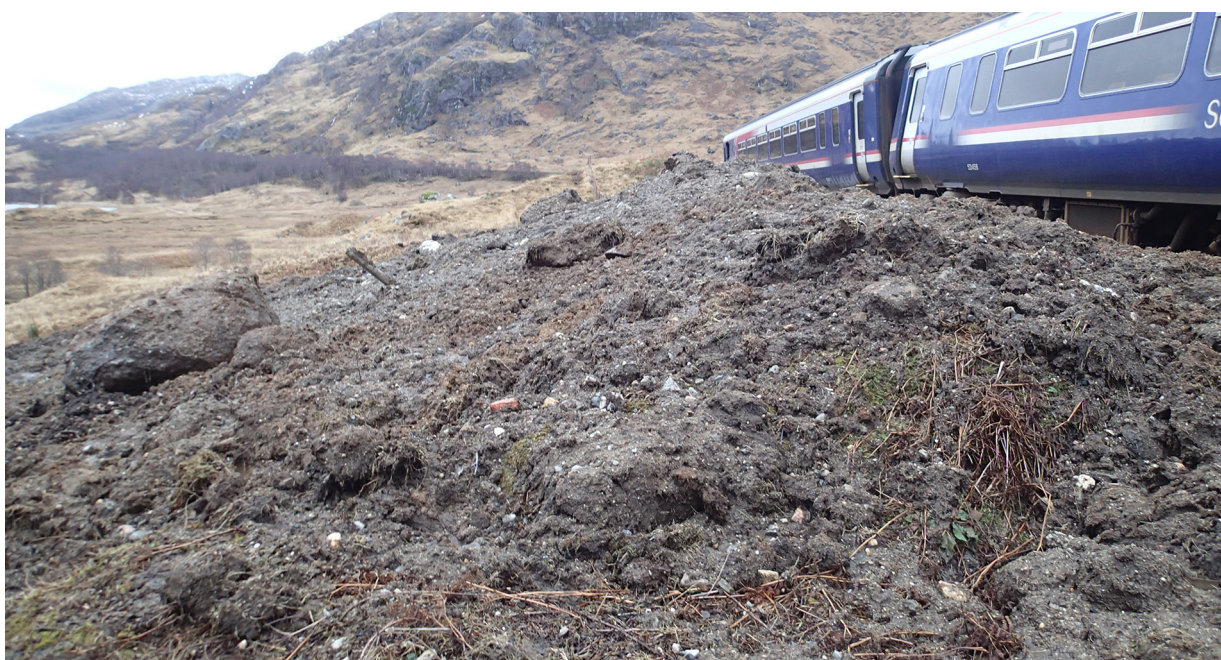
- 44 As the leading edge of the sliding debris approached the railway, it destroyed part of the catch-fence which had been installed in 2017 to trap falling rocks. It then spread out as a debris plume, 40 metres long below the level of the railway (figures 11 and 12). The displaced material included several large boulders, and a significant volume of water.

Figure 11: View showing nature of debris on downhill side of railway

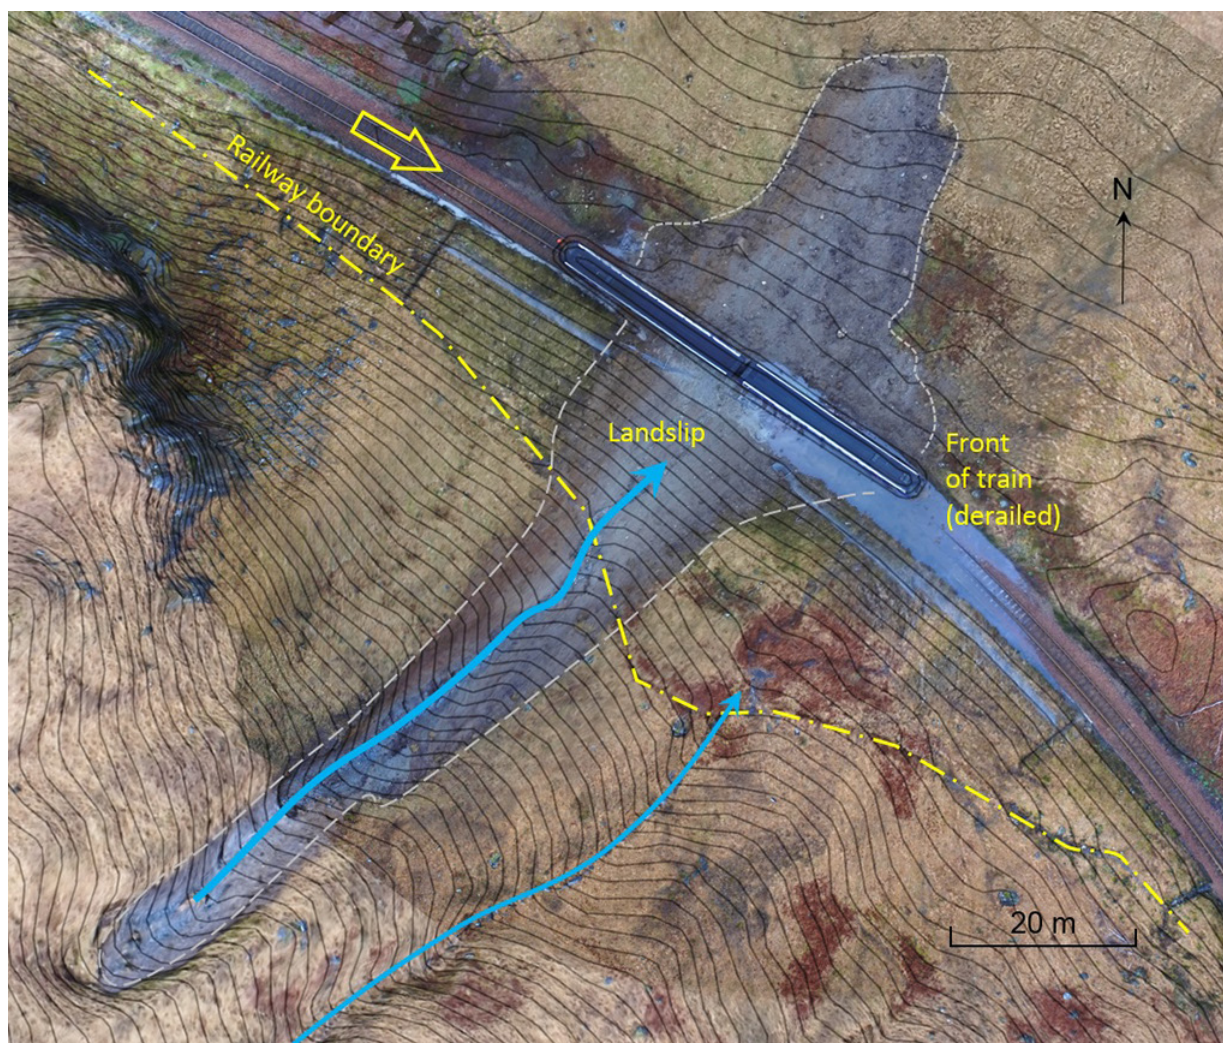
Figure 12: Landslip site showing railway boundary and post-accident contours at one metre intervals. The railway boundary on the uphill side is shown. Note: this 'orthomosaic' map is derived from multiple overlapping aerial photographs, and has been automatically adjusted for topographic relief, lens distortion, and camera tilt.

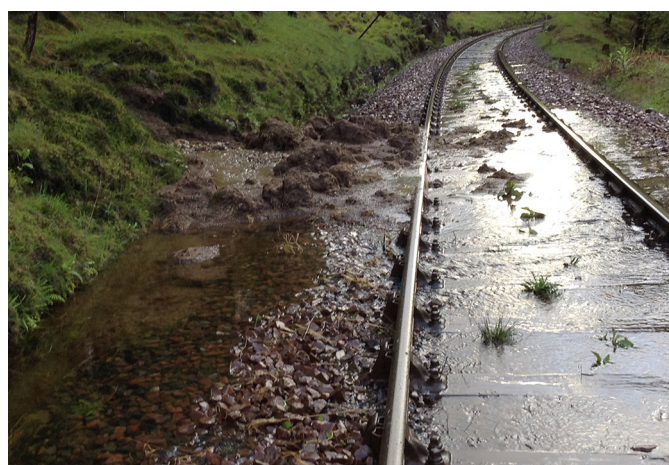
- 54 In early 2015, Network Rail commissioned Fairhurst to undertake a geotechnical study of the slopes in the Loch Eilt area because they had been identified as requiring remedial action. The initial remit focussed on mitigation against risk from rockfalls and boulder incursions. Following a minor landslide in June 2015 (figure 13, and location 'B' in figure 2), the remit was extended to include assessment of the risk from minor landslips originating outside the railway boundary. The 2015 event occurred about 150 metres west of the 2018 event, and deposited about 20 m³ of material beside the railway. Like the 2018 event, the 2015 landslide also started outside the Network Rail boundary on a natural hillside, and followed an existing minor drainage channel down the natural hillside. A number of similar small streams flow down such channels and pass under the track into Loch Eilt.

Figure 13: view of minor landslide which occurred in June 2015 about 150 metres west of the 2018 accident landslide (photograph courtesy of Network Rail)

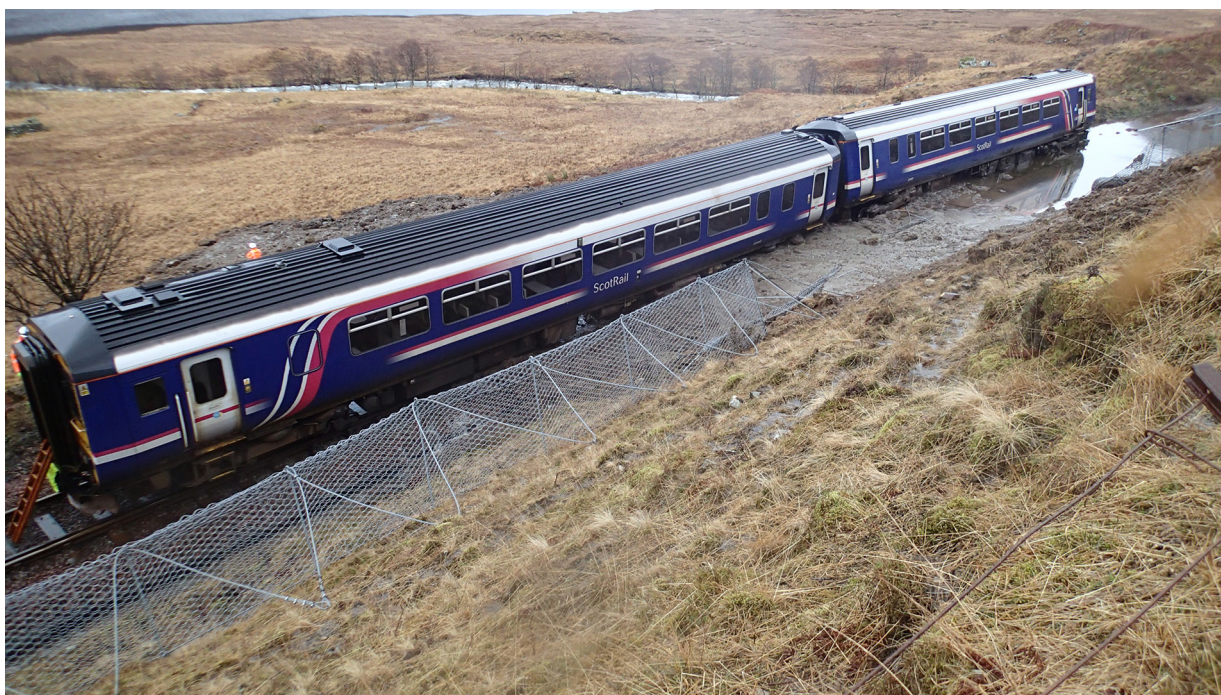
- 57 The catch-fence installed at the accident site was of a type used at other locations across Scotland route, and comprised a mesh fence supported by inclined wire ropes attached to ground anchors (figure 15). It was designed by Fairhurst, and was intended to be easy to install and maintain. The design was tested in a quarry in 2013, and found to be able to retain a 3 tonne boulder rolling down a slope 30 metres long with an angle of 35°.

Figure 14: Part of catch-fence installed in 2017 to trap falling rocks and boulders. The middle section was destroyed by the landslip. Part of the railway boundary fence is also visible in the foreground.

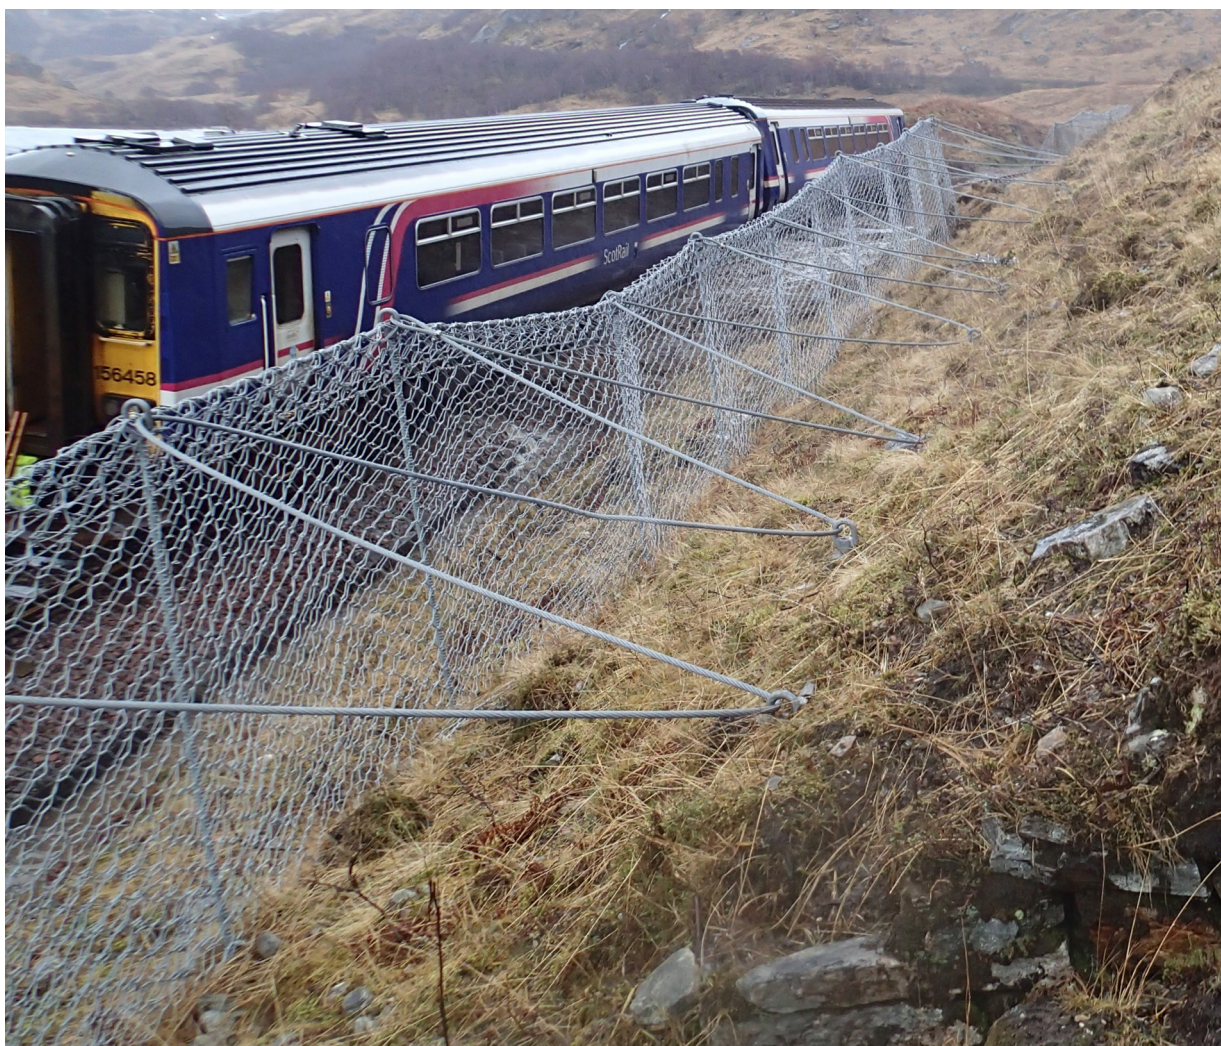
Figure 15: Detailed view of catch-fence supported by anchored cables
