Rail Accident Report

**Signal passed at danger at Loughborough
South Junction, Leicestershire
26 March 2020**

Report 10/2020
November 2020

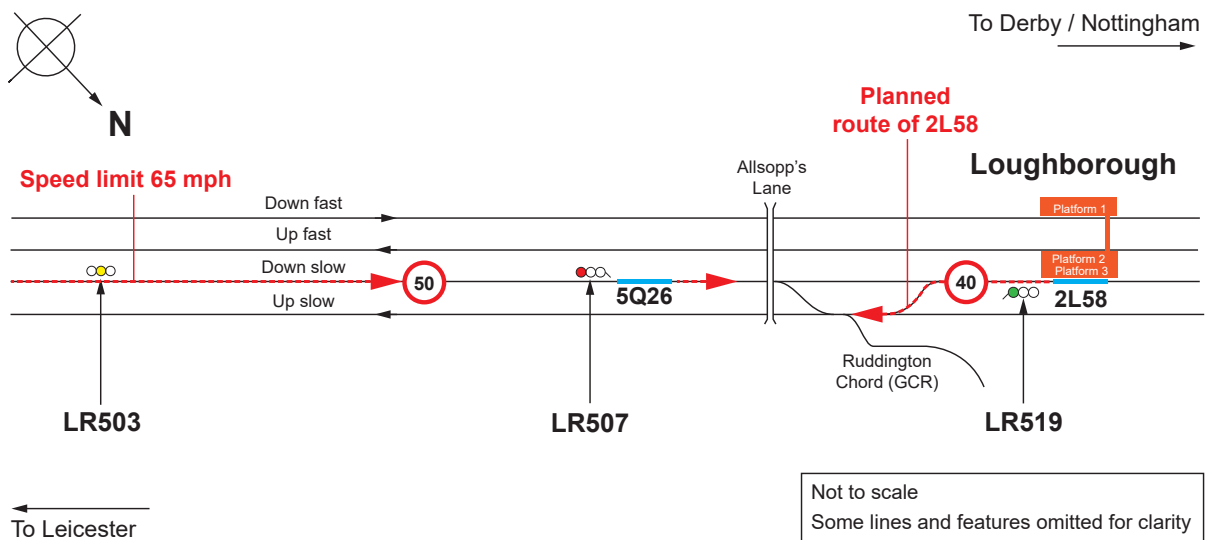
- 6 The railway at this location comprises four tracks: the up and down fast lines, and the up and down slow lines (figure 2). On the down slow line approaching Loughborough station, the maximum permitted speed is initially 65 mph (105 km/h), reducing to 50 mph (80 km/h) around 300 metres on the approach to signal LR507, then reduces again to 40 mph (64 km/h) just before Loughborough station. There is a gently falling gradient (1 in 508) until Loughborough station, where the track levels out.
- 7 Automatic warning system (AWS; see paragraph 36) equipment is fitted 186 metres on the approach to the sign indicating the start of the 50 mph speed restriction; this is to draw drivers' attention to a warning sign, co-located with the 50 mph board, for the 40 mph limit ahead.

Figure 2: Track layout on the approach to Loughborough, showing significant features referenced in the text
