Rail Accident Report

**Near miss with a track worker near Gatwick
Airport station
2 December 2018**

Report 12/2019
September 2019

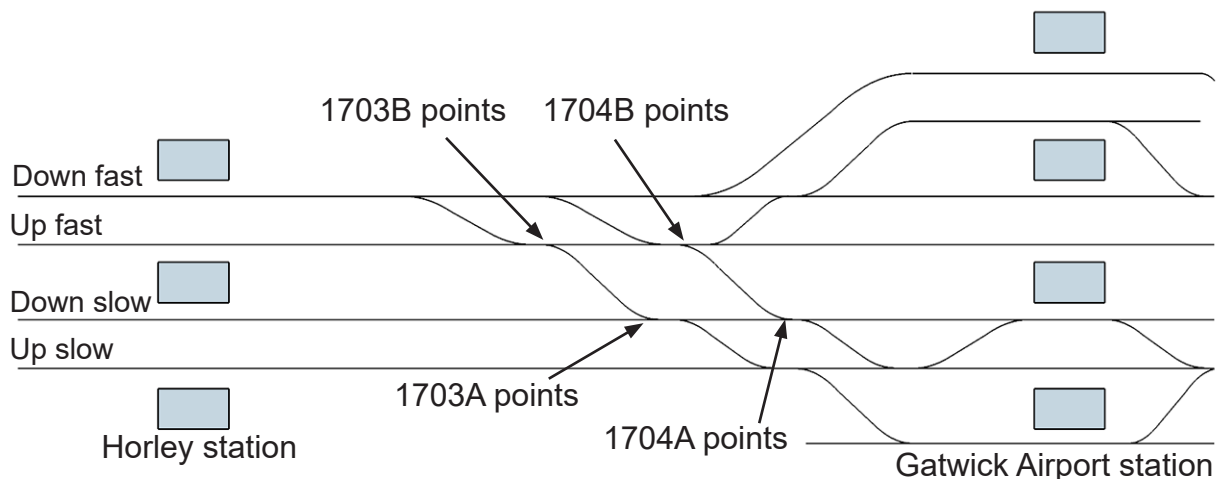
Figure 2: Track work in the area of the incident (not to scale)

- 5 The railway at this location comprises the up and down fast lines, up and down slow lines and crossovers between these (figure 2). The maximum permitted speeds for trains is 90 mph (145 km/h) on the fast lines, 70 mph (112 km/h) on the slow lines and 40mph (64 km/h) on the crossovers.

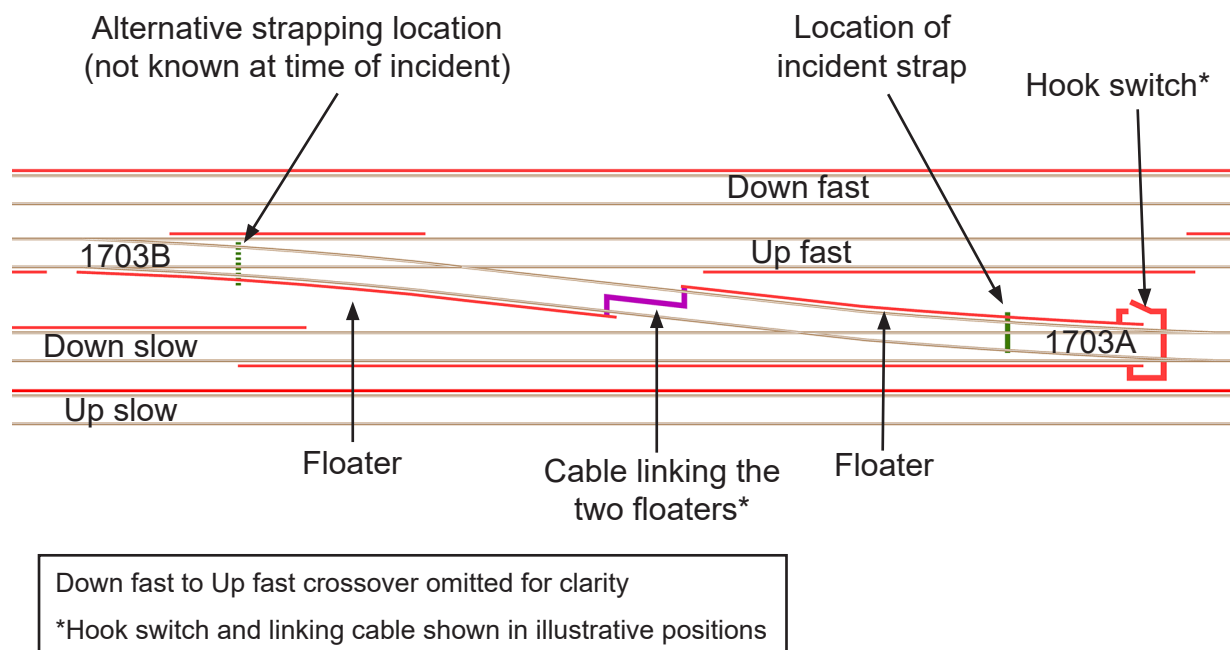
Figure 3: Crossover between 1703A and 1703B points (1704 points similar)

- 19 The infrastructure at the location of the incident includes two crossovers between the up fast and down slow lines. One, about 450 metres north of Gatwick Airport station, links 1703A points on the down slow line to 1703B points on the up fast line. The other, around 160 metres nearer the station, links 1704A points on the down slow line to 1704B points on the up fast line.
- 20 Conductor rails are provided on one side of each of the fast and slow lines. Two short conductor rails, known as floaters, are positioned alongside each crossover (figure 3). The pair of floaters at each crossover are linked by a cable, with the floater nearest the down slow line connected to the conductor rail by a cable and a hook switch, which can be opened and closed to allow the electrical feed to both floaters to be disconnected and reconnected.

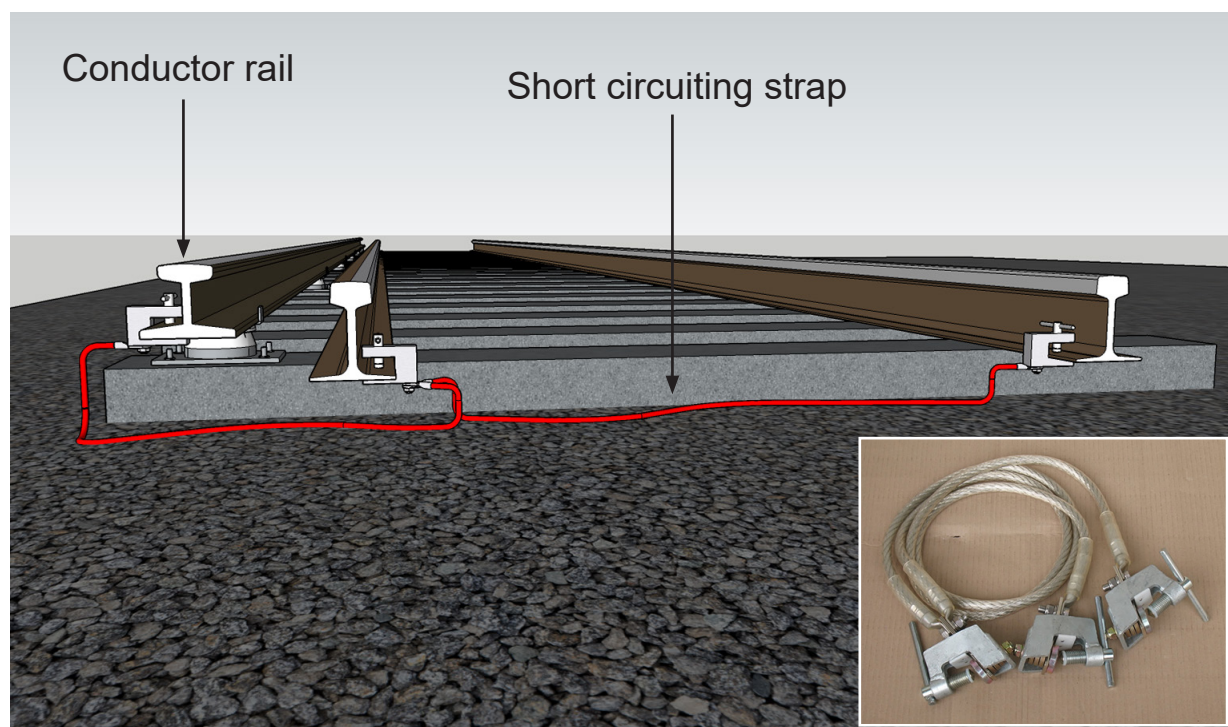
Figure 4: Short circuiting strap (inset photograph of strap (courtesy of Unipart Rail))

- 21 When engineering work is carried out on or near conductor rails, it is necessary to isolate these rails. This involves disconnecting the electrical feed and fitting short circuiting straps to temporarily connect the conductor rails to the rails which carry train wheels (figure 4). Connecting these rails causes circuit breakers to trip if power is accidentally restored to the conductor rail. This could occur if a mistake were made in a control room or if, contrary to the intended operation of trains in these circumstances, an electric train moves across the gap between a live and an isolated conductor rail allowing the electrically connected power pick up shoes at each end of a coach to touch both conductor rails simultaneously.

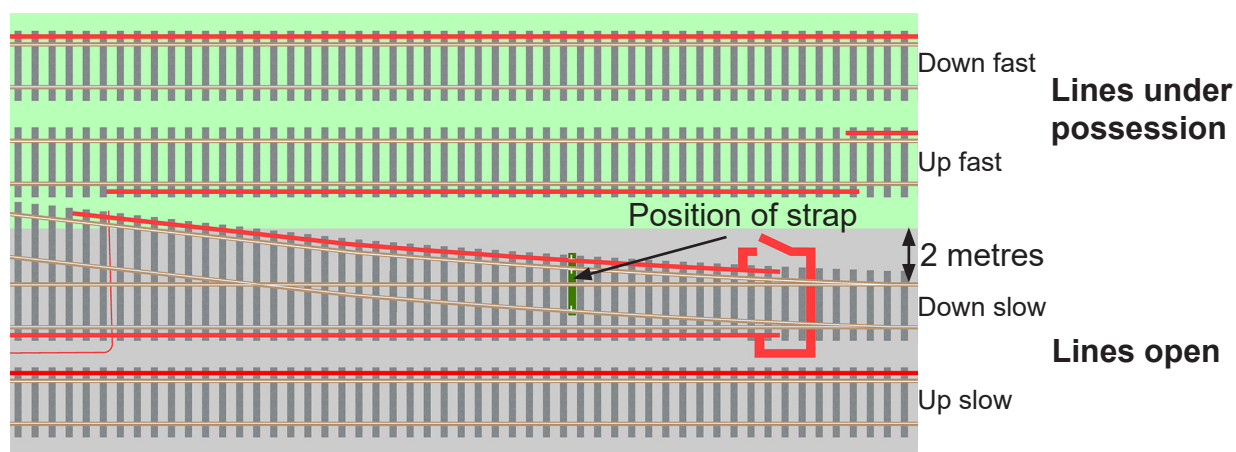
Figure 5: Strap location at 1703A points

- 36 When COSS1 and the strapping operative reached the crossovers, they fitted the straps at 1703A and 1704A points. This required work in the four-foot of the down slow line (between the rails, figure 5) which was open to traffic, but no trains passed.

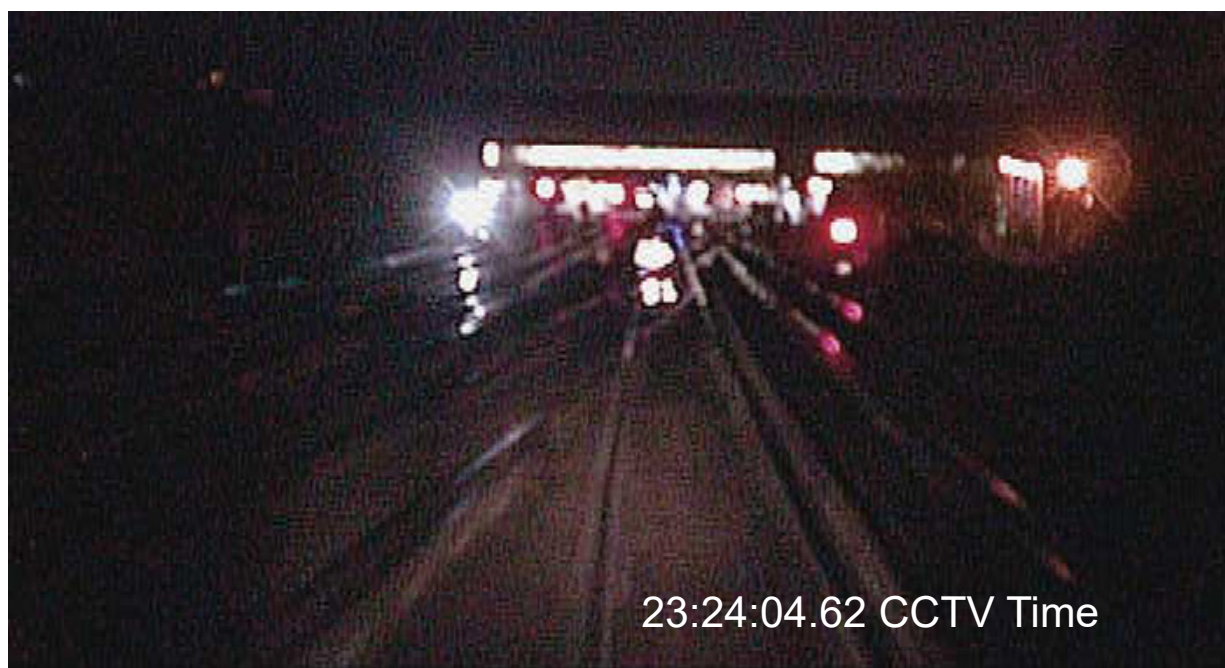
Figure 6: Forward facing CCTV image when train 1C82 was 3 seconds from COSS1 (courtesy of Southern)

47 The forward facing CCTV footage recorded by train 1C82 shows that COSS1 was in the four-foot of the down slow line at 1703A points as the train approached (figure 6). COSS1 was stationary and leaning down while removing a short circuiting strap. He moved clear of the train around one second before it passed him.

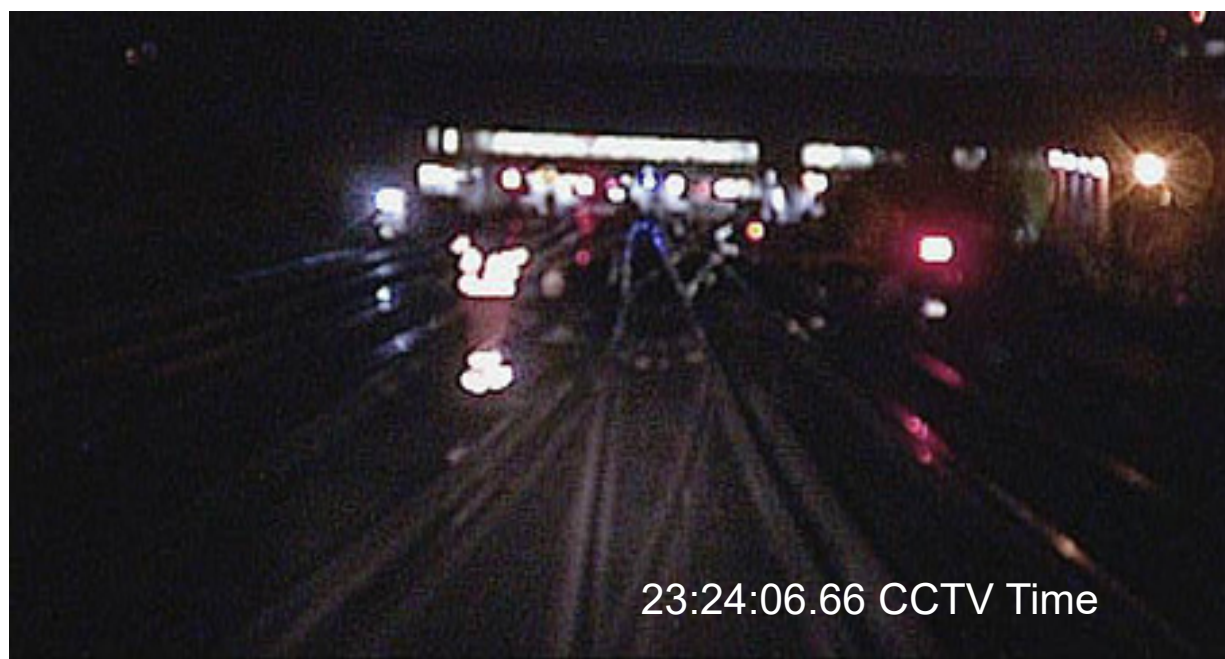
- 42 Around 6.5 seconds before reaching COSS1, when the train was about 122 metres from 1703A points, the driver sounded the horn and did so continuously for around 5.5 seconds until about 1 second before the train reached COSS1.
- 43 When the train horn was sounded for the second time, the CCTV images show COSS1 starting to stand up and then stepping sideways out of the four-foot holding the short circuiting strap (figures 6 and 7). COSS1 raised his arm to acknowledge the train once he was clear of its path.

Figure 7: Forward facing CCTV image when train 1C82 was 1 second from COSS1 (courtesy of Southern)
