Rail Accident Investigation Branch

Rail Accident Report

Derailment of a freight train near Wanstead Park, London 23 January 2020

Report 12/2020
November 2020

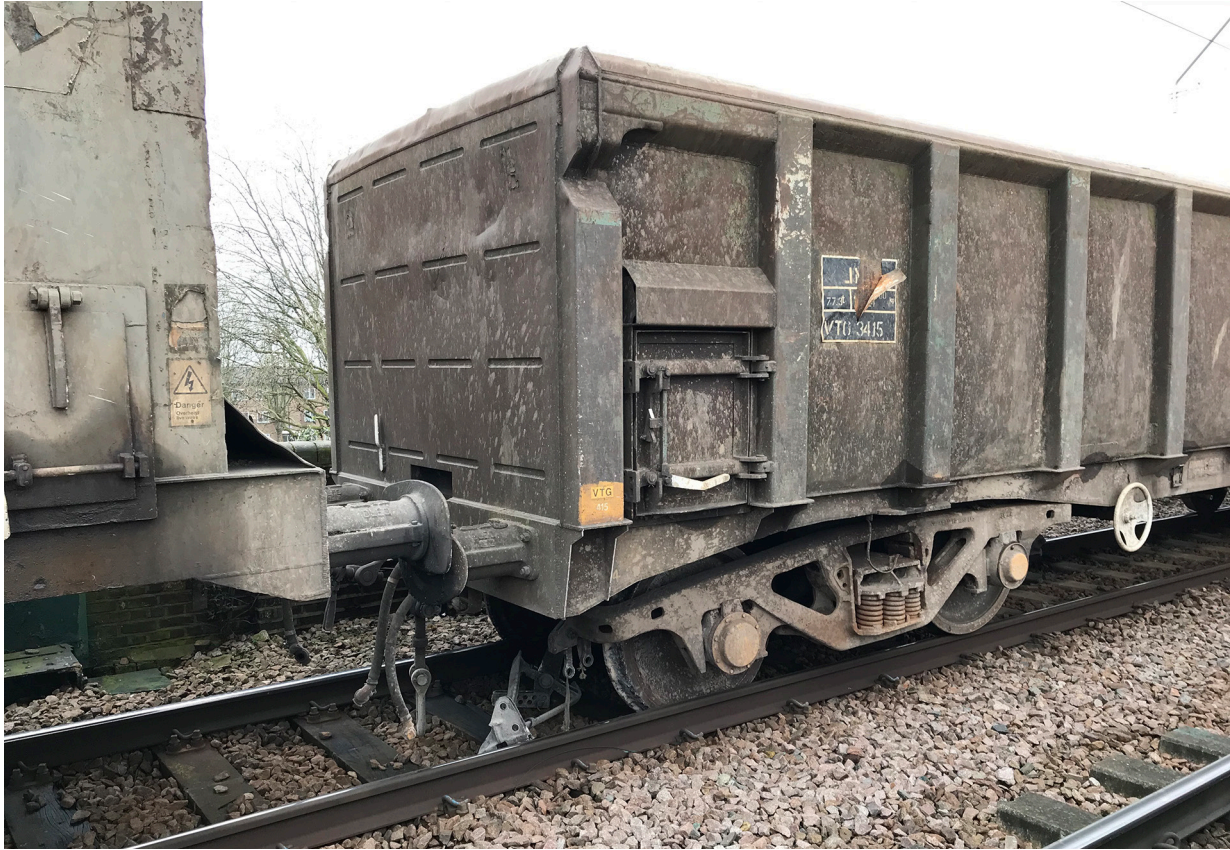
Figure 4: Wagon number 3415 with its rear wheelset derailed to the left. Part of wagon number 3114 is also visible

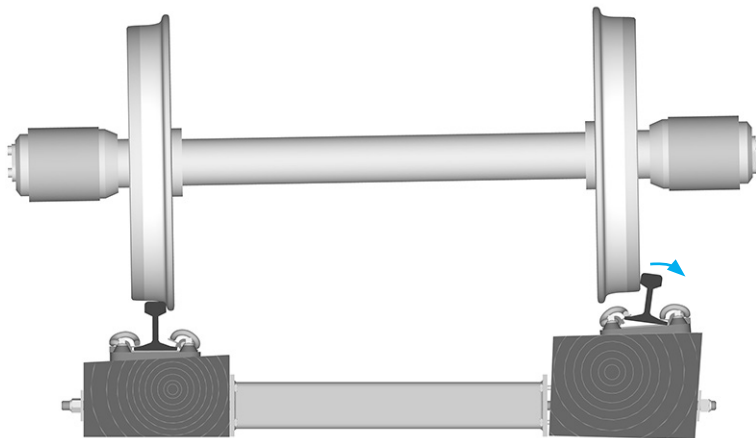
Gauge widening occurred due a combination of the rotation and compression of the right-hand timbers, baseplate movement (shuffle) and rail rotation

Figure 7: Arrangement of wagon 3415's derailed wheelset immediately after initial point of derailment

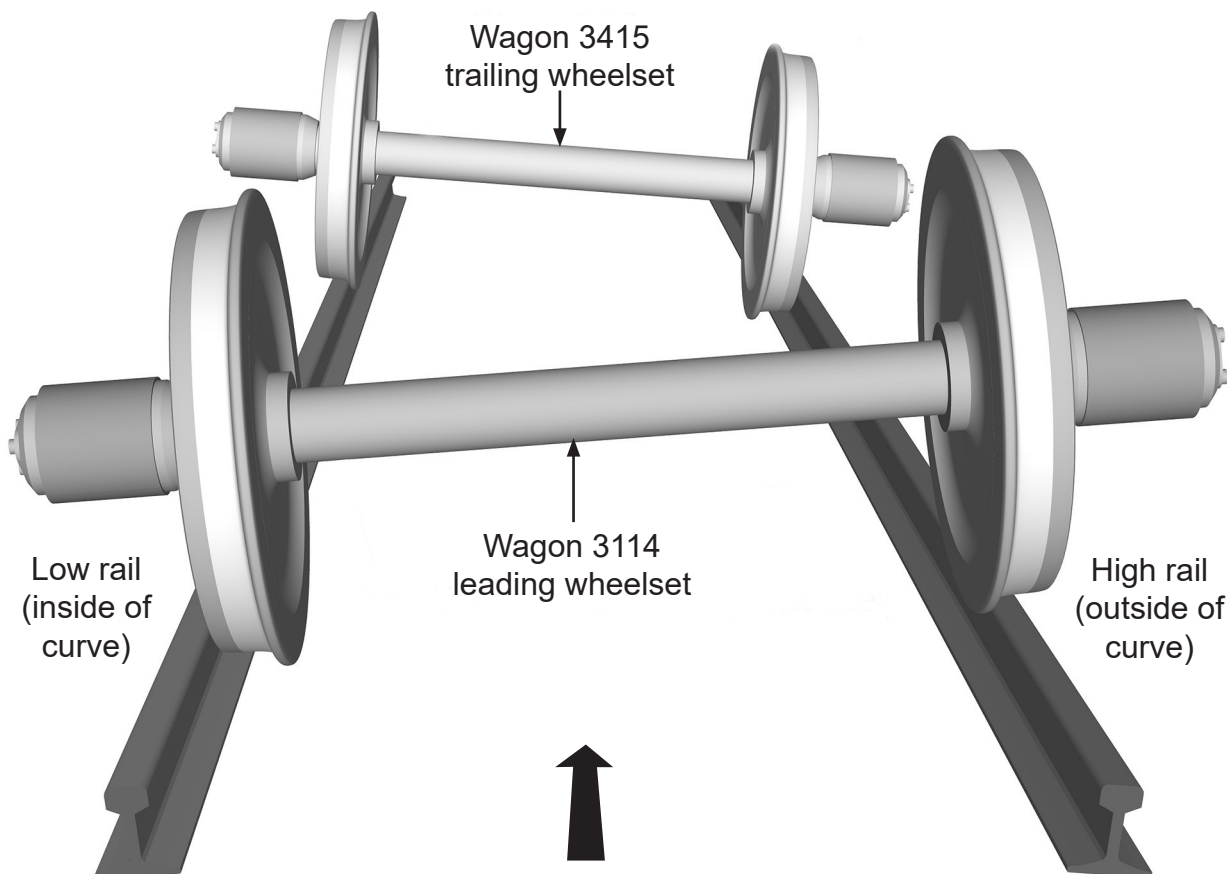
Figure 8: Arrangement of two derailed wheelsets after second derailment with both rails rotated outwards

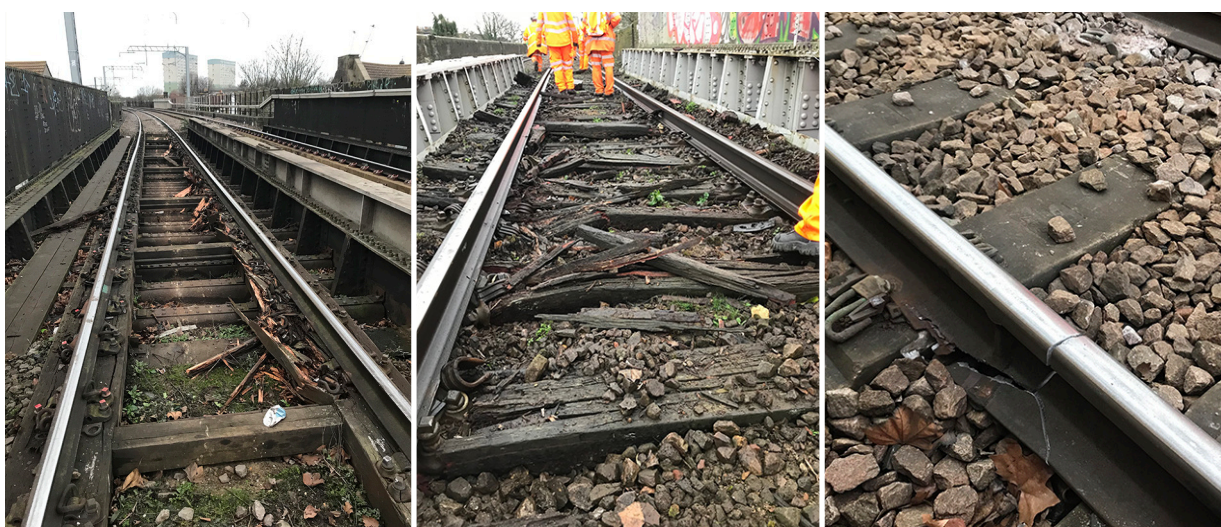
Figures 9, 10 and 11: Examples of track damage between point of derailment and location where train stopped

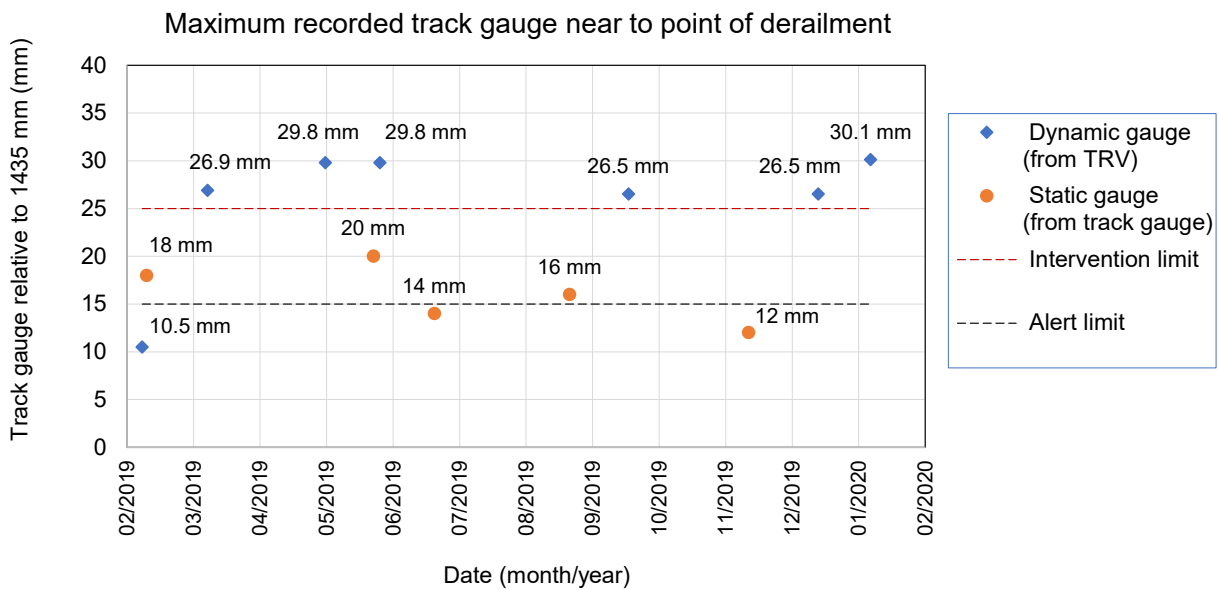
- 59 Evidence of inadequate rail restraint over a period of time is provided by Network Rail’s track gauge measurements. The gauge across bridge 456 had exceeded the alert limit since at least June 2018 when static gauge of up to 1455 mm was recorded during a detailed inspection (paragraph 96), equivalent to wide gauge of 20 mm. Track recording vehicles had recorded dynamic gauge exceeding the intervention limit at about the same location since March 2019 (figure 13). The difference between static and dynamic gauge demonstrates that the track was flexible enough for the gauge to widen significantly under train loading. Issues associated with the management of track gauge are discussed at paragraph 95 onwards.

Figure 13: Maximum static and dynamic gauge recorded near point of derailment on each site inspection and track recording vehicle run.

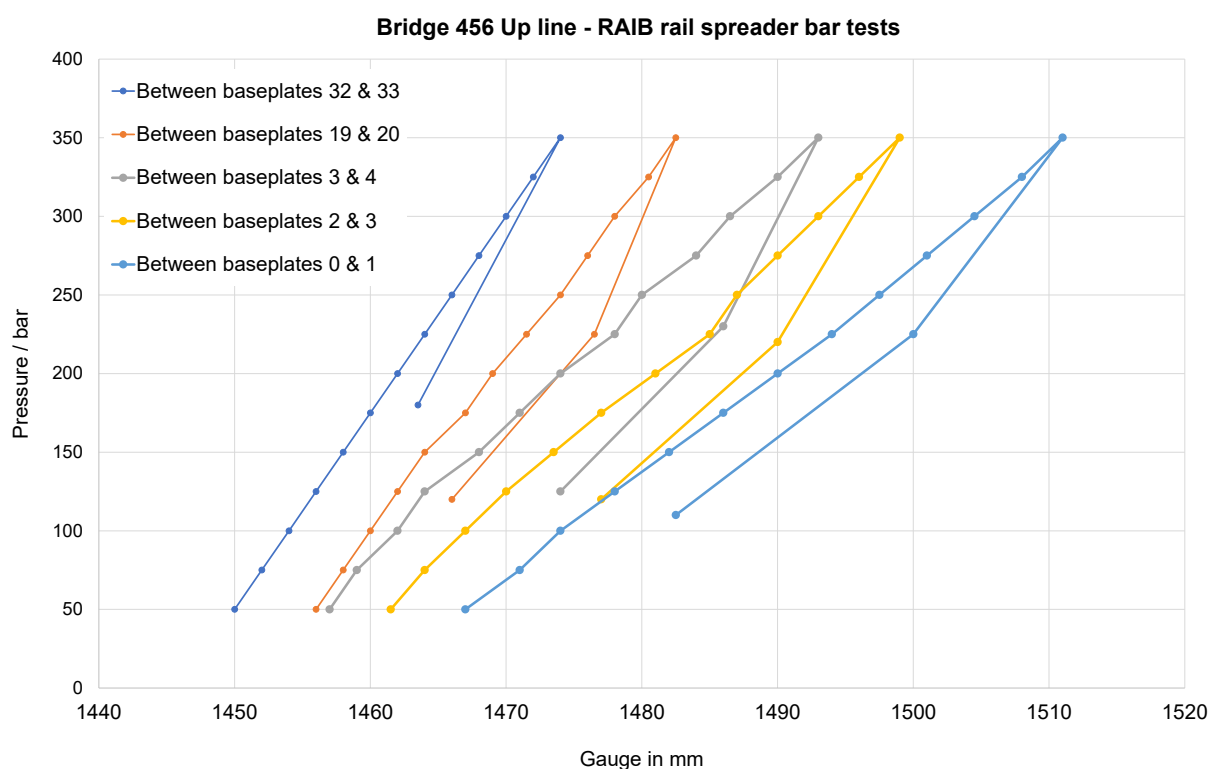
60 RAIB took post-accident measurements on the bridge to determine if the stiffness of the track varied on approach to the point of derailment. A hydraulic ram was installed between the rails, and the pressure was increased in increments, creating spreading forces up to 50 kN (equivalent to 5 tonnes). This test was repeated at five locations across the bridge. The results show that the rails were less able to resist movement under the lateral forces imposed by moving trains as the point of derailment was approached (figure 14). These results are broadly consistent with Network Rail's track gauge measurements. However, it should be noted that accident damage meant that measured stiffness in the area of significant damage will be less than before the accident and, due to distribution of load along the rails, measured stiffness will also be lower than pre-accident values on the approach to this area.

Figure 14: Change in track stiffness between baseplates. These were numbered from 34 at the start of the bridge to 0 at the point of derailment (POD1).

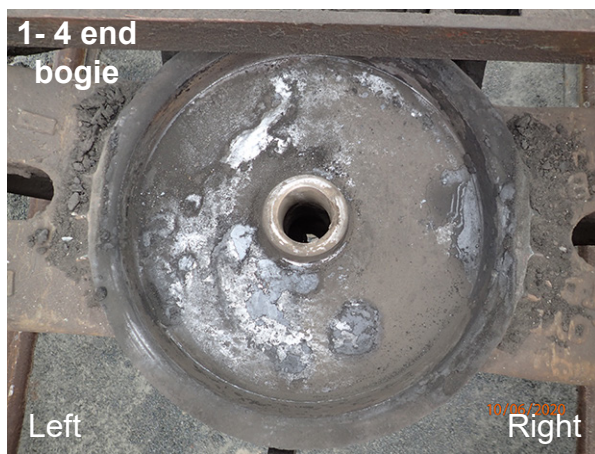
Figure 38: The 1-4 end bogie centre pivot on wagon 3415

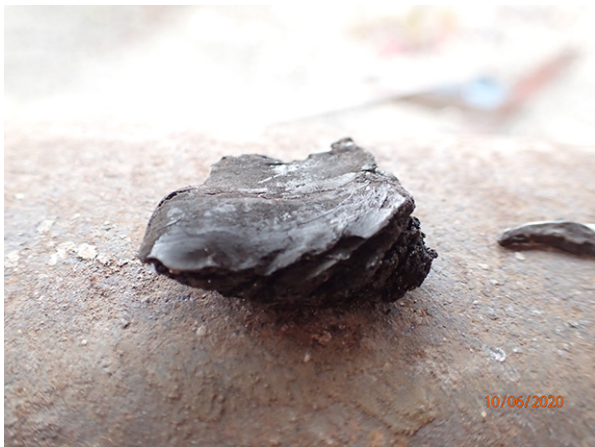
Figure 40: Part of the grease plug extracted from the 1-4 end top centre pivot recess on wagon 3415

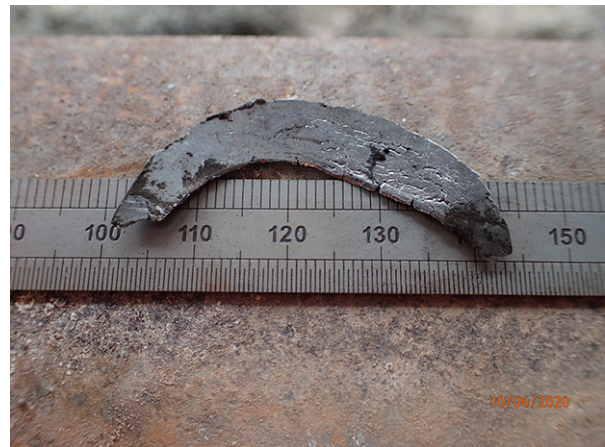
Figure 41: The largest piece of metal debris extracted from the 1-4 end top centre pivot recess
