Rail Accident Report

Fatal accident involving a train passenger at Twerton 1 December 2018

Report 14/2019
October 2019

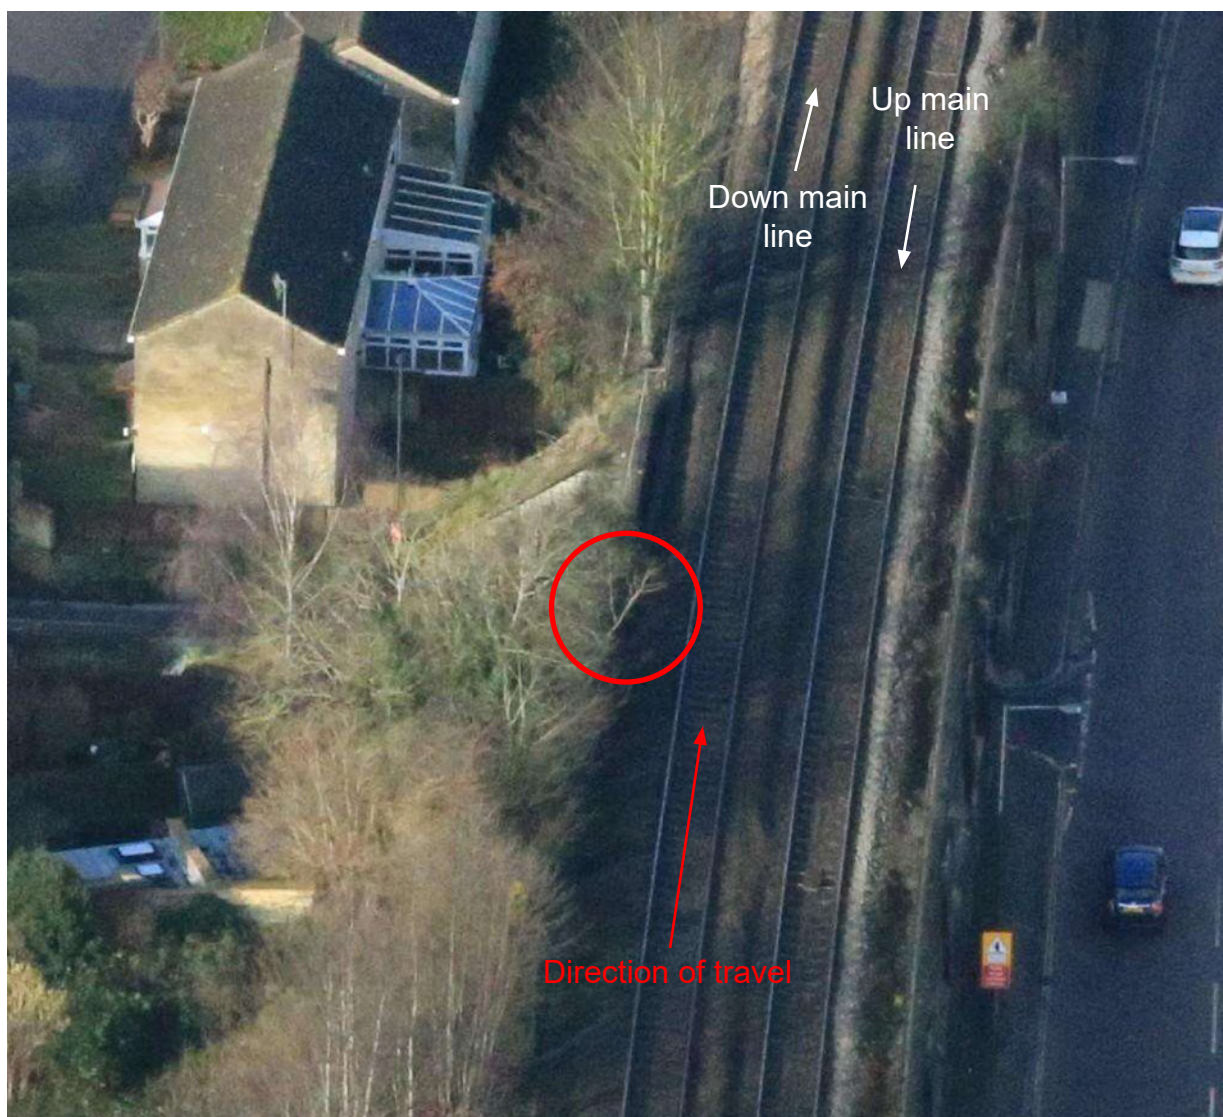
Figure 2: General photograph of the scene before the accident showing the tree branch involved (circled) (courtesy of Network Rail)

- 15 The branch which the passenger came into contact with was attached to a stem that was growing from the stump of an ash tree.

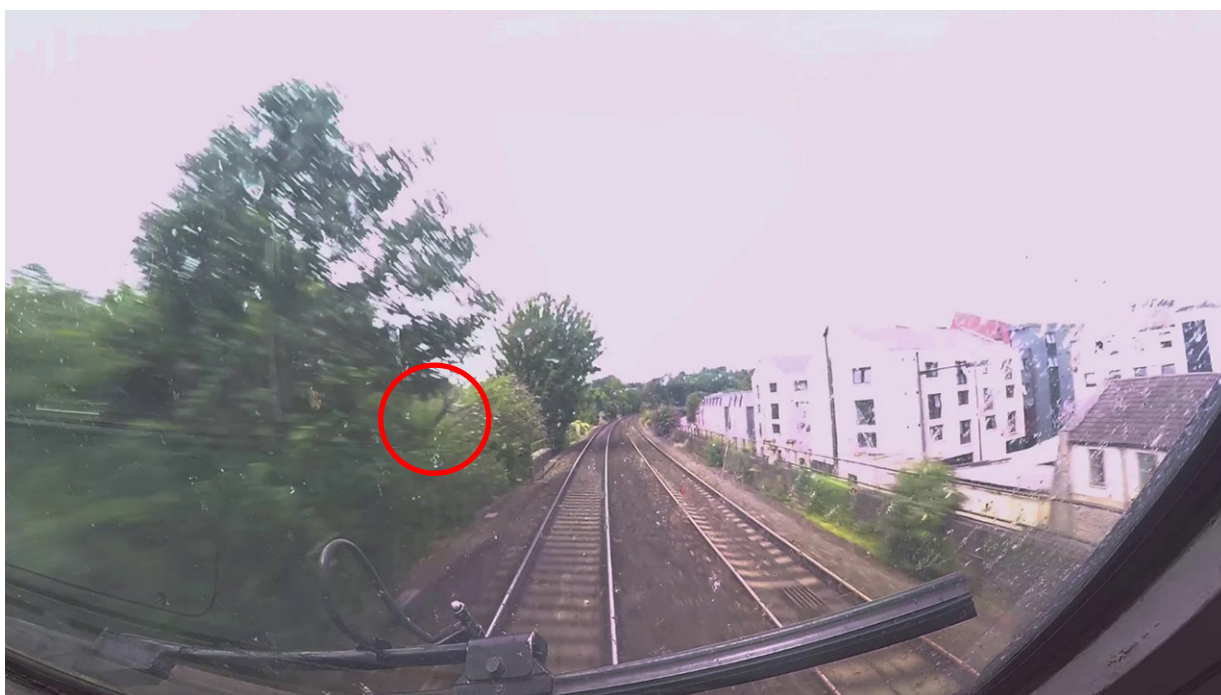
Figure 4: Forward Facing CCTV from July 2018, showing tree amongst growing vegetation (courtesy of Network Rail)

- 68 'Cab ride' inspections should be done at intervals of between 12 and 16 months. No issues were identified near Twerton from the last cab ride, undertaken on 22 July 2018. This inspection was video recorded. A post-accident review of the footage, paying particular attention to the accident location, revealed a dead tree branch amongst the green leaves of other trees. However, since this inspection was focussed on sighting and obstruction issues it would have been unusual if it identified the dead tree as a hazard.

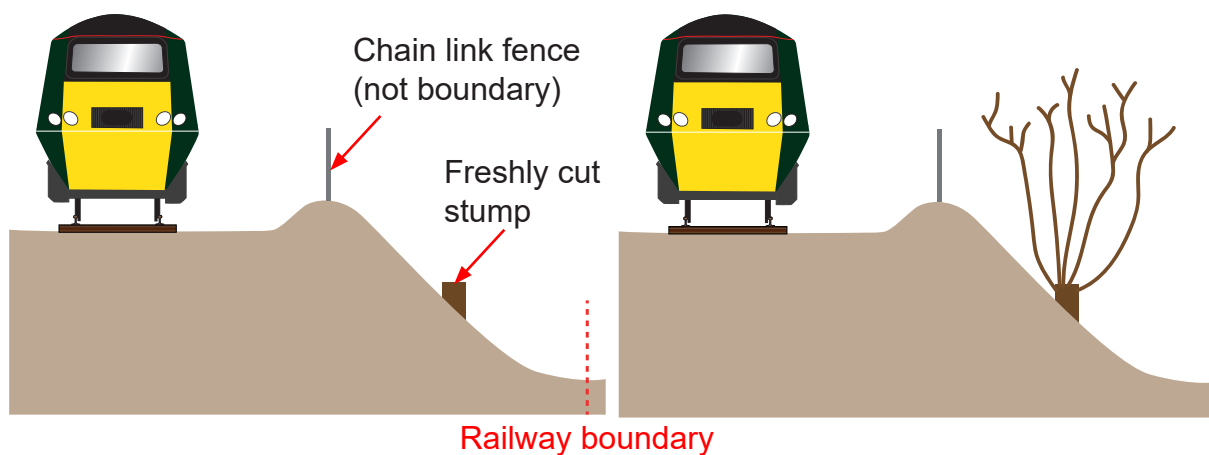
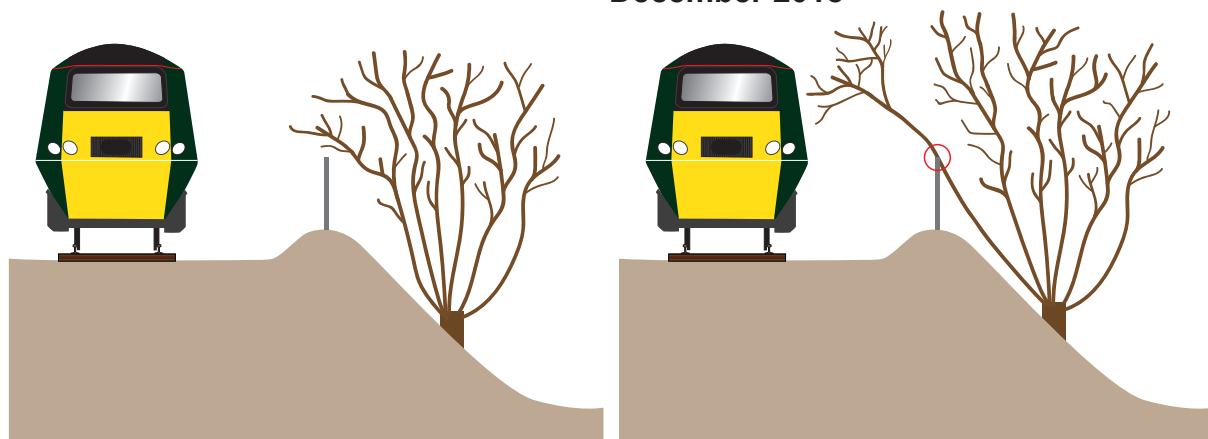
Figure 5: Tree history

- 17 The report describes how the tree was either felled or coppiced² around 1998 and after that seven stems grew out from the stump. Eventually the stump became colonised by two or three types of wood decay fungi which ultimately led to the failure of the stems. The stem involved then fell towards the railway, coming to rest on a chain link fence at the top of the embankment.

- 18 From a review of historical aerial photographs and video footage, the RAIB has concluded that the stem involved did not fail before 18 April 2015. However, by 4 February 2017, it had fallen and was resting on the fence with some branches extending out towards the railway line. The photographs and video footage also show that the tree remained largely unmoved in this position until at least late on the afternoon of the day of the accident. Given that the tree had been in this position for at least 22 months without moving significantly, it was not a particularly windy day and the RAIB is not aware of any other events that could have affected its position, the RAIB believes it is likely that it was still in that position at the time of the accident.

Tree cut down so only the stump remains circa. 1998/1999

Growth circa. 2005

Circa. 2014

(18/04/15 to 04/02/17) remaining to December 2018

- 72 The arboricultural report commissioned by Network Rail after the accident reported that the stem involved was in poor health, growing from a severely decayed stump which had been colonized by readily visible fungal fruit bodies. The report states *'A competent inspection of the tree undertaken at any time since at least 2014 would have identified the decay and, from this time onwards, the fungal fruit bodies. The decay alone, confirms the tree to have been in hazardous condition for several years, and prior to January 2018 at least three stems would have been clear threats to the railway.'*

- 1 This accident demonstrates the value of undertaking regular tree inspections within the interval specified in Network Rail standards to identify trees in poor health. These inspections provide specialist insight into the condition of trees growing adjacent to the railway and provide valuable intelligence that assists in their effective management (paragraph 71).
- 2 Although in this instance the passenger could not be saved, the train operator's response was a good example of how well briefed procedures can enable the effective management of medical emergencies on-board trains. It also demonstrates the value of having agreed processes that enable the emergency services to get rapid access to patients whilst ensuring the continued safe operation of the railway (paragraph 28).

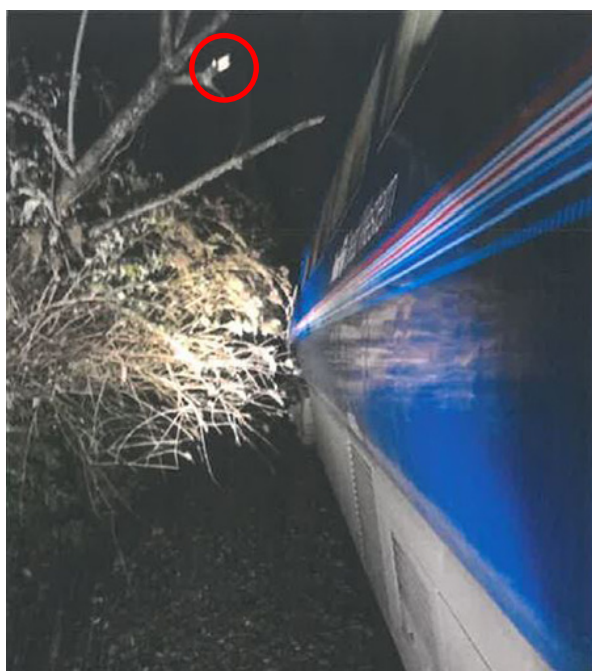
- 31 **The passenger leant out of a window while the train was moving and her head came into contact with a lineside tree branch.**
- 32 Network Rail arranged for a local Mobile Operations Manager⁵ (MOM) to ride in the cab of a later train with a view to identifying the object that the passenger had come into contact with. At approximately 00:15 hrs that train set out from Bath Spa travelling at low speed. Around 15 minutes later, when at 108 miles and 36 chains, the MOM saw the freshly broken end of a tree branch at window height, close to the train. The train was stopped and he got out and found a corresponding section of tree branch on the ballast underneath the tree.

- 33 While at the scene, the MOM took photographs and recovered the branch. It is approximately 55 cm long and 4 cm in diameter. It was handed to the BTP which was subsequently able to confirm, by way of a forensic examination, that it was the branch that the passenger had come into contact with.

Figure 6: The train's proximity to the tree (courtesy of Network Rail)

- 34 The end of the branch that had been nearest the railway had marks consistent with having being sawn through. The cut was not recent and the RAIB was not able to determine when the branch had been cut. It is possible that it was done on 2 January 2018 when a tree in the vicinity was cut back after a train crew reported that their train had struck a branch in that area; no damage was reported to that train. The sawn branch end did not show any signs of having been in contact with trains.

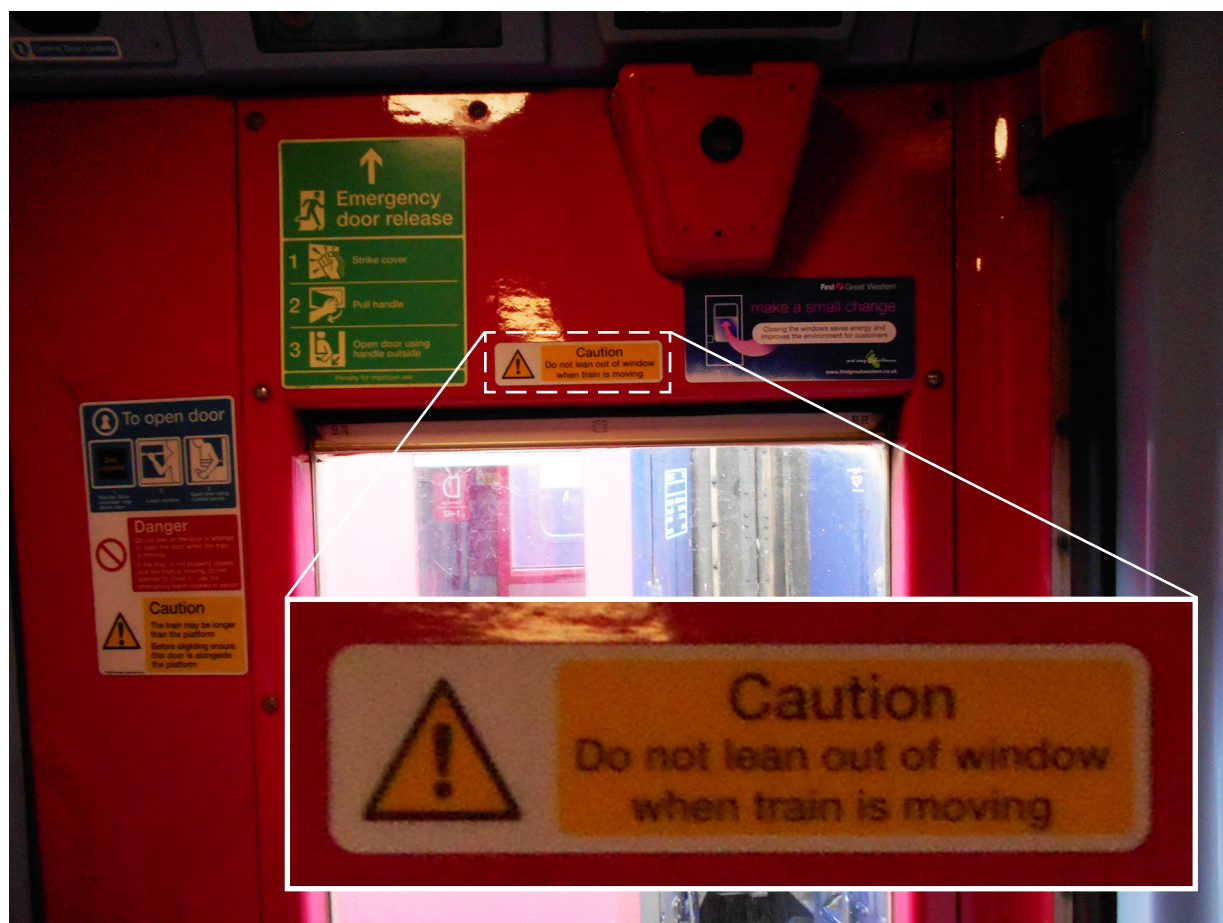
42 The warning signs provided and their arrangement did not deter the passenger from leaning out of the window while the train was moving. Their design and content, although in accordance with industry guidance, did not maximise the chances of passengers being fully informed about the risk.

43 The warning signs on display (figure 7) were fitted in 2007 following a refurbishment of the coaches. The signs relating to not leaning out of the window was the smallest of four signs on or around the door. One of the other related to the risks associated with trains stopping at short platforms and the dangers of leaning against or trying to operate doors while the train is moving. The other two related to emergency door operation and ventilation.

Figure 7: Warning signs (courtesy of the Office of Rail and Road)

- 44 The RAIB considers that the sign relating to the risk from leaning out of the window did not adequately convey the level of risk for the following reasons:
- the wording used, in particular the word 'caution'⁶, suggests that leaning out of the train window is something that may be done safely if a degree of care or precautions are taken⁷;
 - the use of a yellow background to the sign is a recognised characteristic of a warning sign as opposed to the more appropriate use of a red background to convey danger or a prohibited activity⁸; and
 - the sign is much smaller than the other signs around it, one of which is not safety related.
- 45 It is not possible to say with any certainty whether the content, colour and size of the signs was a factor in this accident. Even prominent, clear warning signs are not guaranteed to be effective.

- 4 *The intent of this recommendation is to ensure that the advice contained in the relevant Railway Group Standards or Railway Industry Standards in relation to warning signs on rolling stock, accurately reflects the level of risk associated with the hazard to be mitigated.*
