# Rail Accident Report

## **Passenger train collision with a derailed locomotive at Bromsgrove 23 March 2020**

Report 14/2020  
November 2020

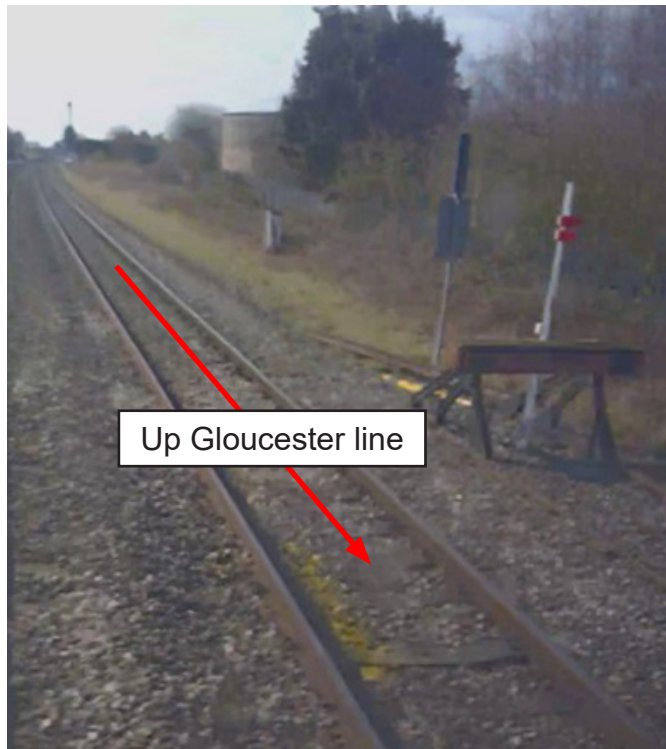
- 18 The buffer stop consisted of a metal framework that was fixed to the jointed rails. It did not contain any sliding friction elements or hydraulic buffers. It was fitted with two permanently illuminated red lights (figure 4).
- 19 The buffer stop was installed in its current location (figure 5) around 2004, as identified from historic satellite imagery. Prior to this, the siding had ended in a buffer stop located about 90 metres further south.

Figure 4: Up Bromsgrove neck buffer stop (image courtesy of CrossCountry)

- 67 The buffer stop was not subject to any specific maintenance regime, as defined by Network Rail standard NR/L2/TRK/001 module 18 'Inspection and Maintenance of Permanent Way – Buffer Stops'. Network Rail did not consider the up Bromsgrove neck to be a 'terminal track on a freight line', and so a specific buffer stop inspection regime was not required by the standard. However, Network Rail did expect routine visual inspections of the track to identify any significant defects with the buffer stop and to flag these for attention. There is no evidence to suggest that there was any defect with the buffer stop at the time of the collision.

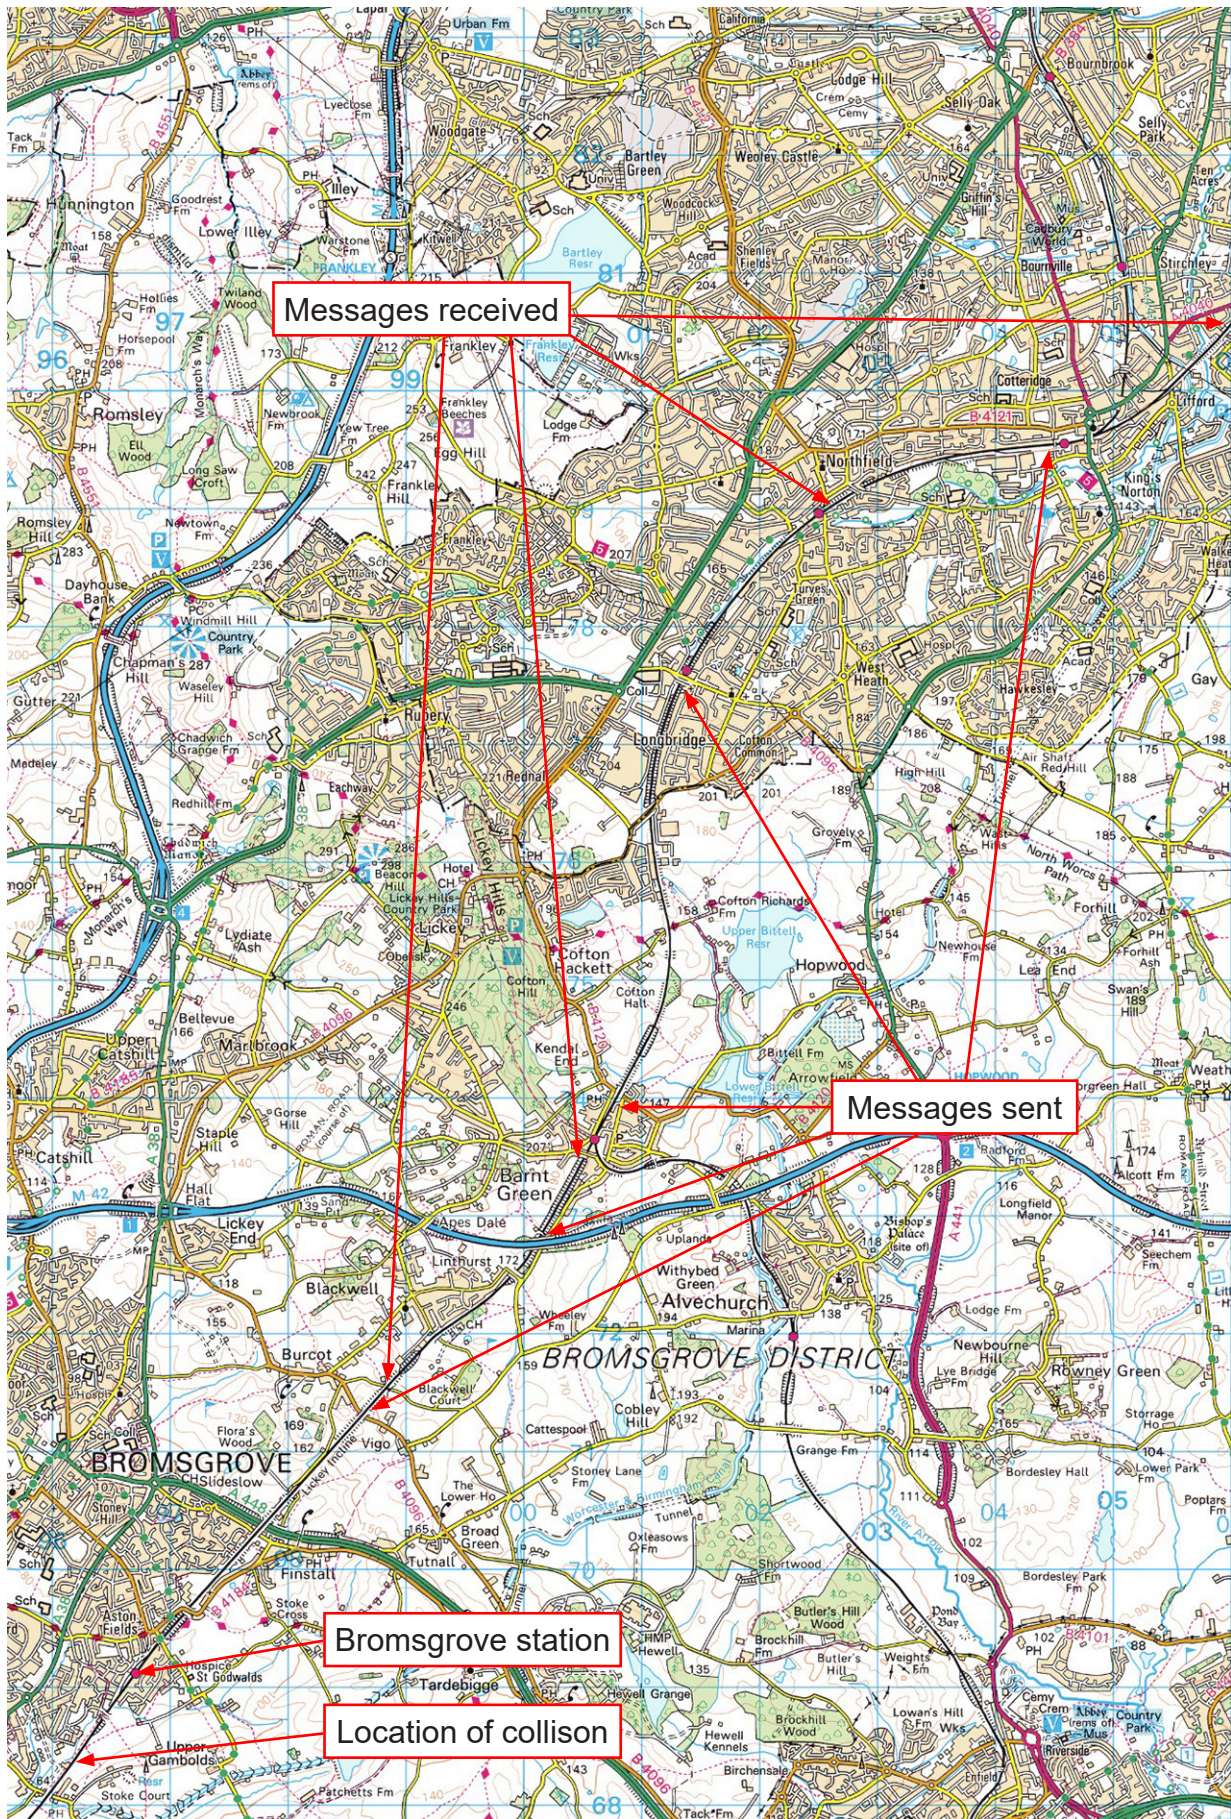
- 30 After passing Kings Norton, over a period of 11 minutes, the driver received three text messages on his personal mobile phone. These were from the same family member as the earlier phone call and all related to concerns about childcare and the closure of schools. The driver sent four text message replies to these. At 22:38 hrs he received a picture message showing advice from the school relating to school provision, and he sent a text reply. Table 1 and figure 6 show details of these timings and the approximate locations at which the messages were received.

- 33 After passing the signal, the driver's thoughts returned to the picture message that he had received at 22:38 hrs (paragraph 30). At 22:42:43 hrs, while travelling at 18 mph (29 km/h), he shut off the power, returning the controller to neutral. At this point the locomotive was travelling at less than the maximum permitted speed of 30 mph (48 km/h) for the first 350 metres towards the up Bromsgrove neck, although this limit subsequently reduced to 15 mph (24 km/h) for the last 350 metres along the siding itself.

Figure 6: Approximate locations of the locomotive when messages were received and sent

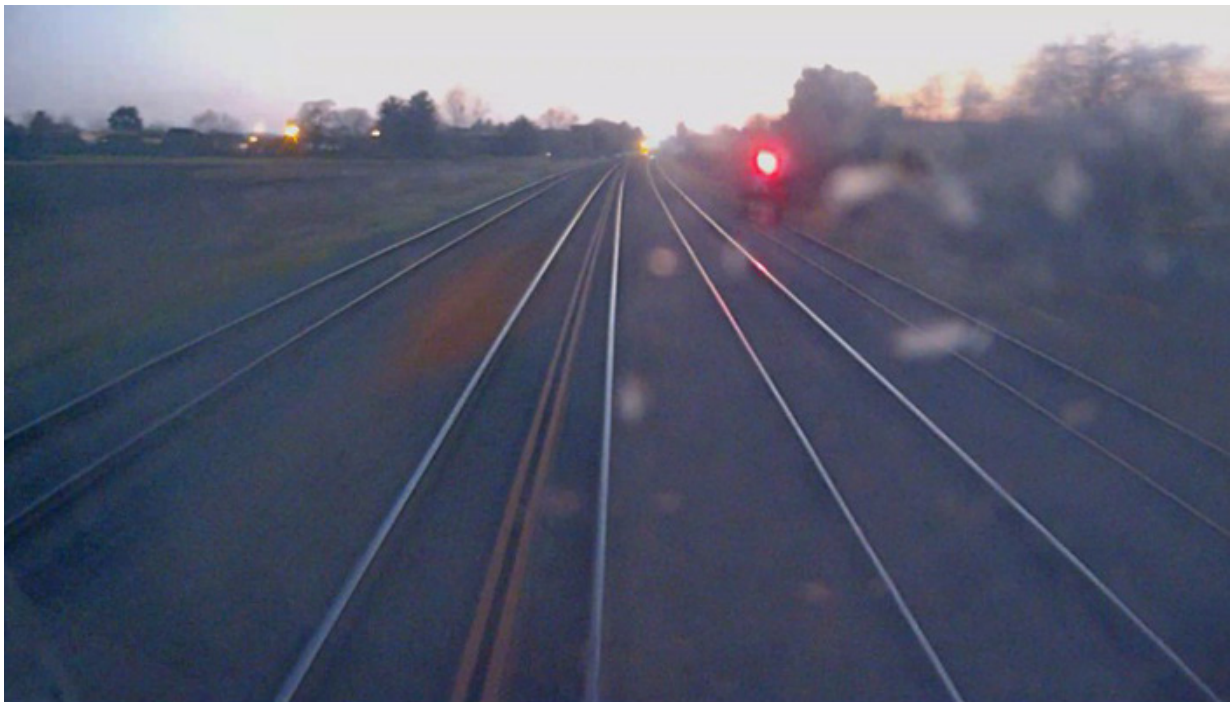
- 68 The red lights on the buffer stop were subject to regular inspection by Network Rail's Distribution and Plant team. This included replacement of the lamps every six months. Records show that this was being carried out. In addition, CCTV from a passing train shows that the buffer stop lighting was illuminated four hours before the accident (figure 7), indicating that it was almost certainly lit at the time of the accident.

Figure 7: Train CCTV image showing buffer stop light illuminated at 18:47 hrs on 23 March 2020 (image courtesy of CrossCountry)
