Rail Accident Report

Passenger injury at Ashton-under-Lyne tram stop 12 March 2019

Report 15/2019
November 2019

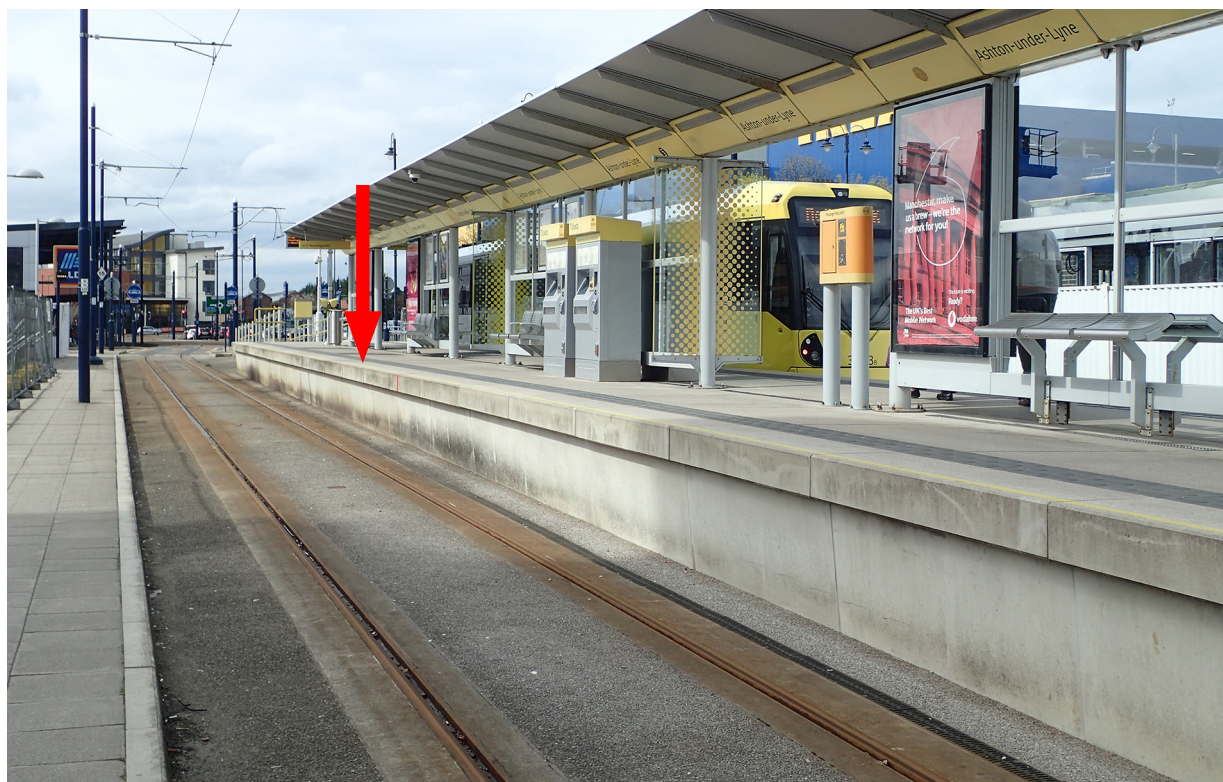
Figure 3: Platform B at Ashton. The red arrow indicates the point at which the passenger was standing when he fell from the platform.

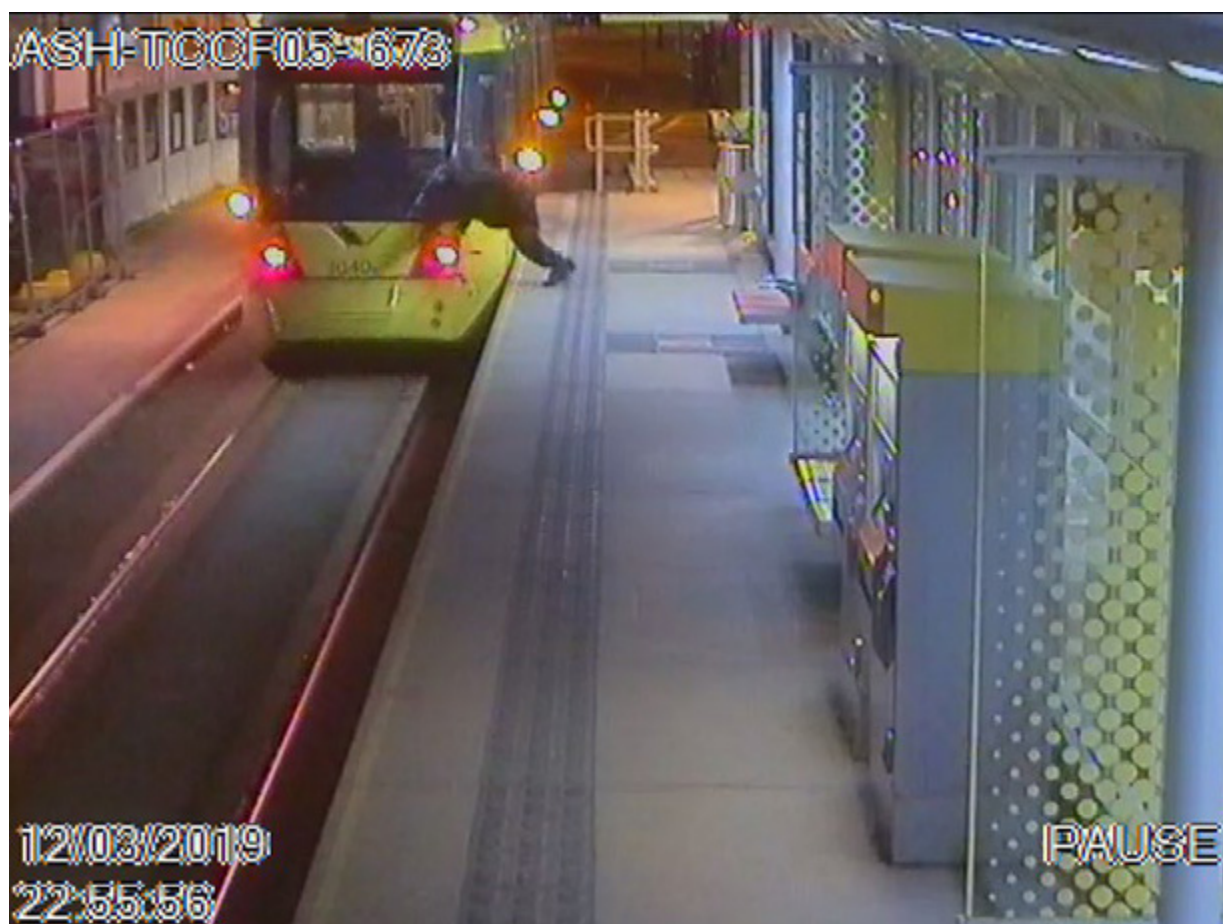
- 27 At 22:55 hrs, the tram started to move. At that moment, the passenger was standing on the platform, leaning on the side of the tram. When the tram initially started to move, the passenger moved slightly away from the tram. However, once the articulation section of the tram (figure 4) had passed him, the passenger moved back towards the tram and once again came into contact with its bodyside.
- 28 Once the tram had passed the passenger, he was no longer supported by the side of the tram and he fell from the platform (a height of 905 mm, paragraph 6) and landed on the track (figure 5). Tram stop CCTV shows the passenger lying motionless thereafter.

Figure 5: The passenger falling from the platform onto the track. Image taken from tram stop CCTV (courtesy Keolis Amey Metrolink)

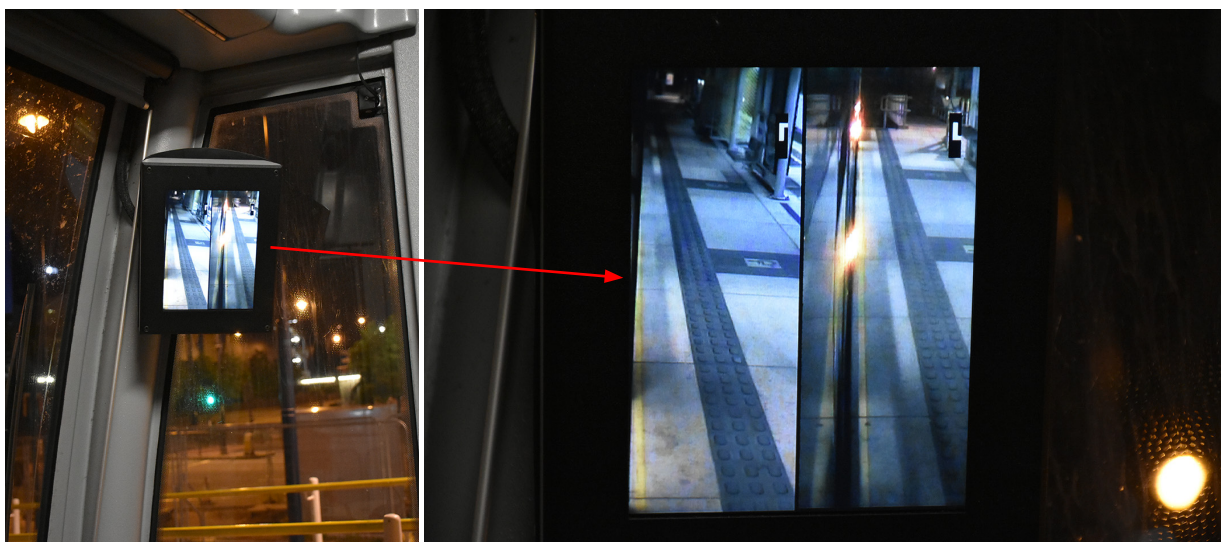
Figure 6: The CCTV screen which provides images to the driver from the side-view cameras. The image shows the screen displaying a 'split' view.

- 78 The tram driver believed that once the tram was moving away from the tram stop, he should not look in his side-view CCTV monitor because his attention should be ahead. Had the driver used his side-view CCTV monitor as he moved away from Ashton-under-Lyne tram stop, it is possible he might have seen the passenger leaning against the tram, although as explained at paragraph 59, the passenger was probably not clearly visible on the monitor. Nevertheless, in conditions of better visibility, appropriate use of the side-view CCTV monitors by drivers when leaving tram stops may prevent future accidents.

- 1 *The intent of this recommendation is to minimise the risk of accidents at the platform-tram interface by improving drivers' observation of the interface, as trams depart from tram stops.*

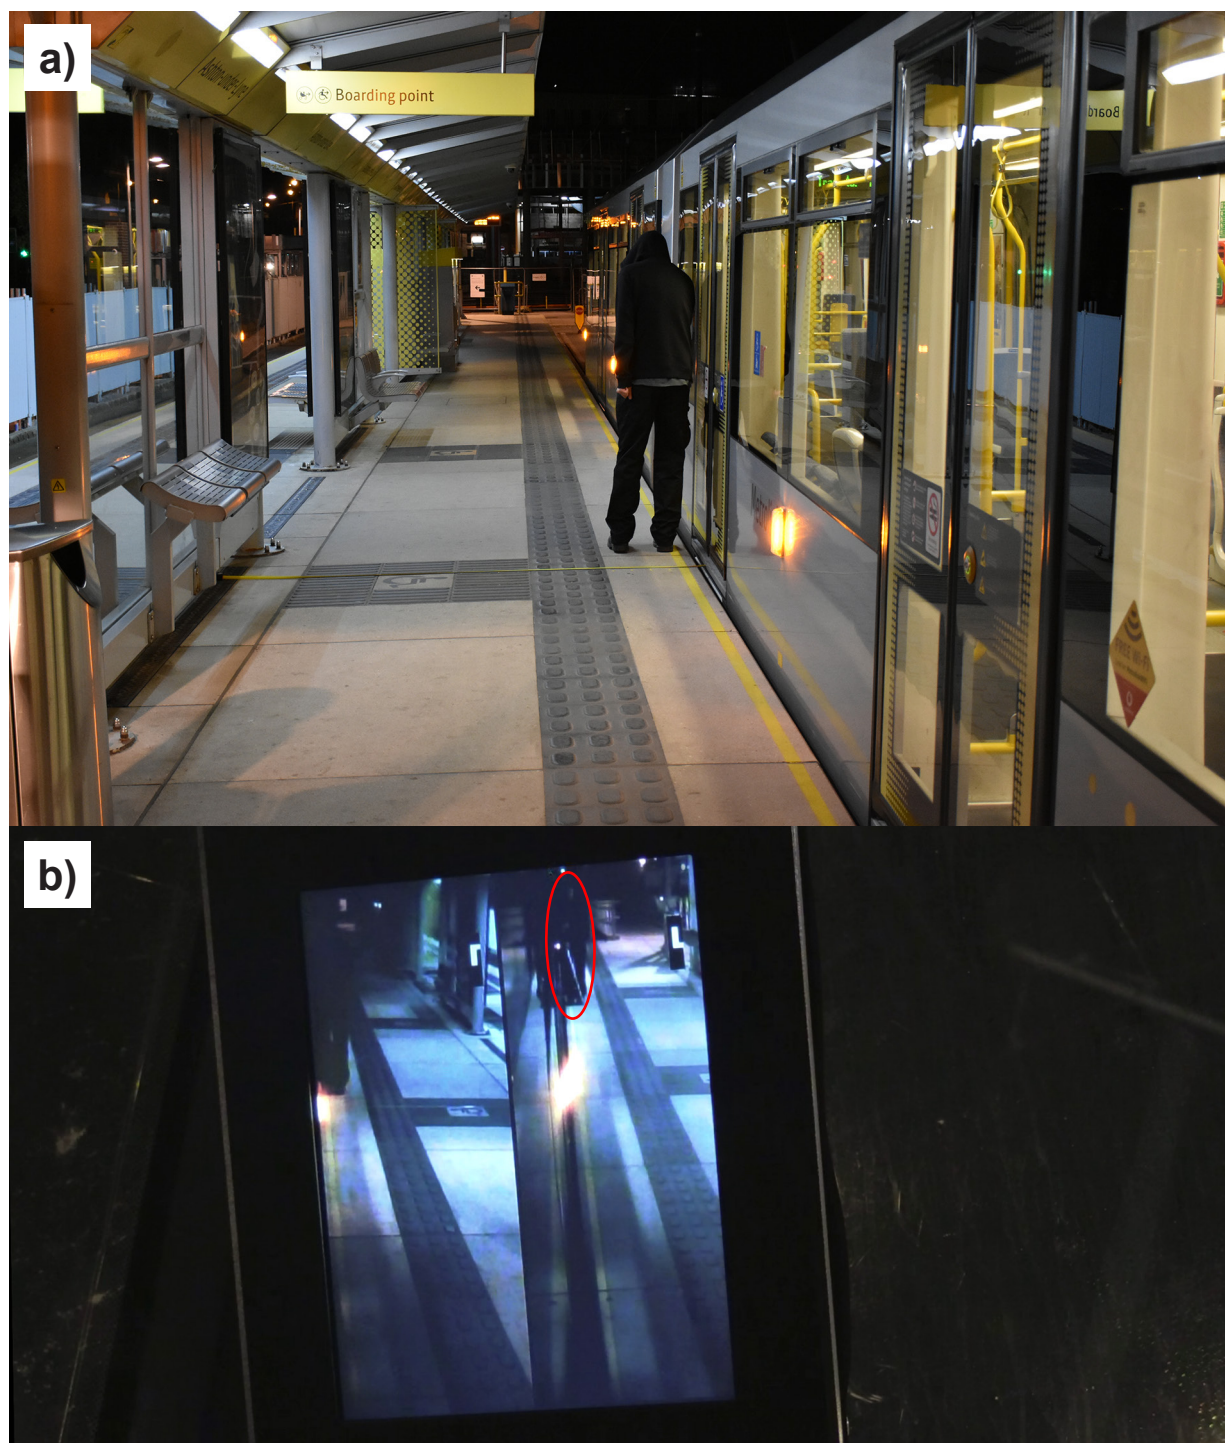
- 55 It was dark at the time of the accident and the passenger was wearing dark clothing. To assess the visibility of the passenger in the side-view CCTV screen, the RAIB carried out a reconstruction at Ashton-under-Lyne tram stop during the hours of darkness.

Figure 8: a) Photograph taken during the RAIB reconstruction of the accident; and b) CCTV image during the RAIB reconstruction showing the view available to the driver. The individual in the reconstruction is dressed and positioned in a similar location to the passenger at the time of the accident.

- 58 The reconstruction verified that the passenger would have remained within the field of view of the CCTV system regardless of the position of the door side selector switch (paragraph 36) and whether the screen was in 'split' or 'normal' mode.
- 59 However, the reconstruction also showed that a person wearing dark clothing was difficult to see in the CCTV image (figure 8b). Although Ashton-under-Lyne tram stop is well-illuminated, the area to the east of it is dark. Therefore, the CCTV camera looking along the side of the tram would have provided an image of a passenger in dark clothing against a dark background.

- 2 *The intent of this recommendation is for tram drivers to have improved visibility of any passengers near trams at tram stops.*

- (a) carry out a review of the lighting conditions at tram stops to identify any local lighting conditions, taking into account backgrounds, which may make it difficult for tram drivers to see passengers in close proximity to the tram, particularly during night-time operations.
- (b) implement the findings of the review, in conjunction with TfGM, to improve the visibility of passengers at the platform-tram interface (e.g. by improving platform lighting and/or tram CCTV systems).

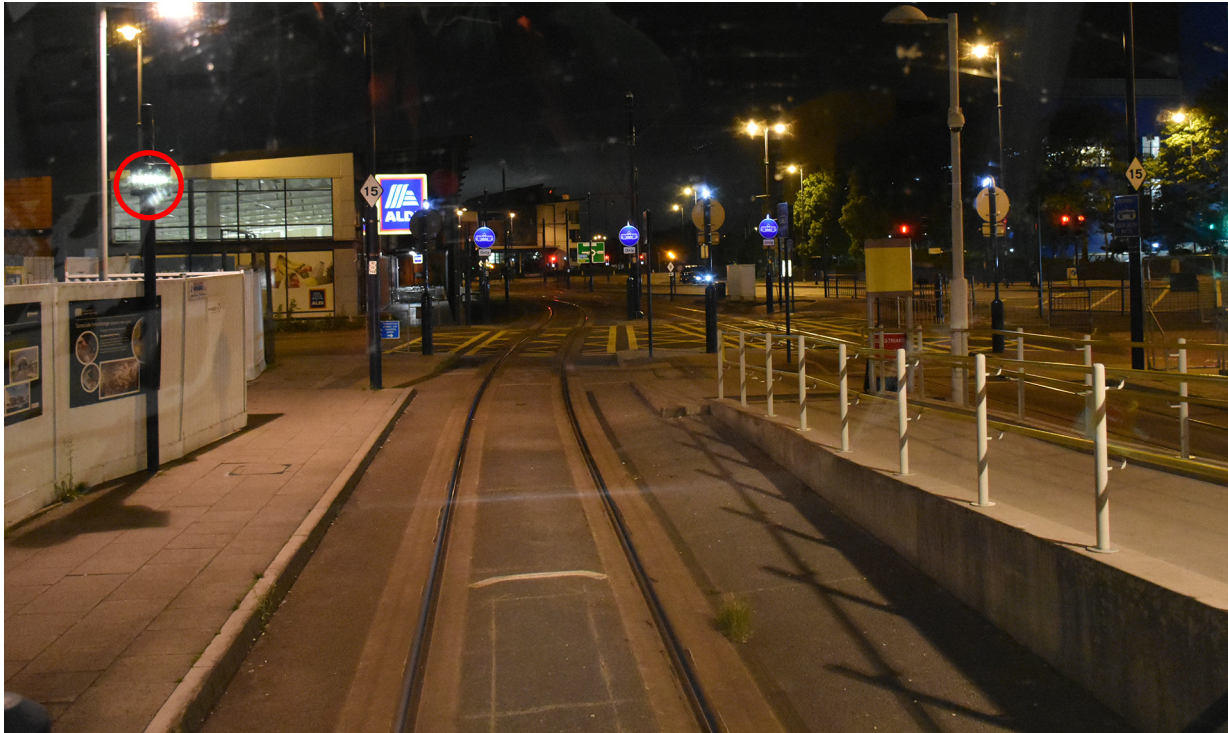
- 64 The tram signal for platform B at Ashton-under-Lyne is placed on the left side of the track (figure 9), whereas the screens providing the side-view CCTV images are on the right side of the cab. Therefore, the driver would have been required to split his attention between the signal and the CCTV screens. It is possible that this may have contributed to the driver not seeing the passenger in close proximity to the tram.

Figure 9: View from the cab at Ashton-under-Lyne platform B, showing the tram signal (circled)

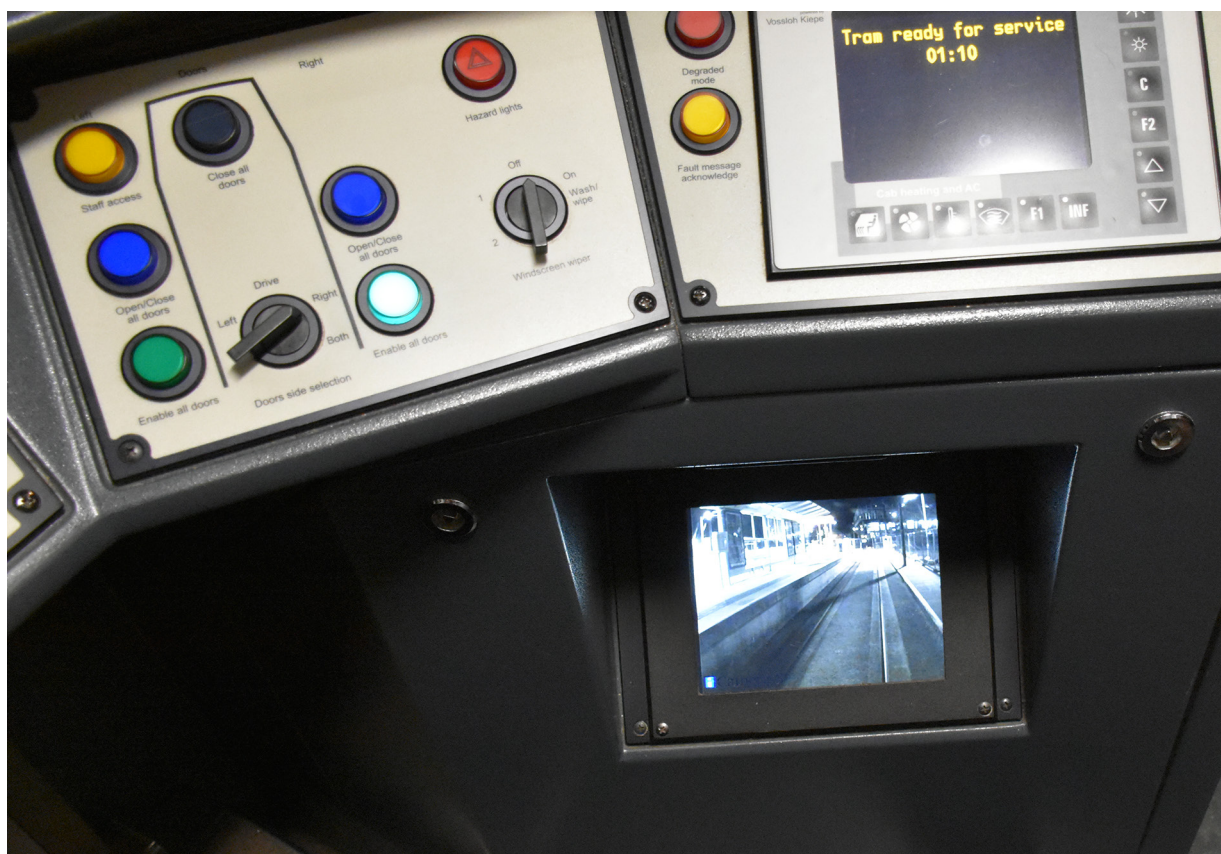
84 The tram operating Run 38 (vehicle 3040) is fitted with a rear-facing camera. This camera provides the driver in the leading cab with a view taken from the rear cab. The images are displayed on a monitor screen located to the right of, and at a lower level than, the main cab desk (figure 10). The purpose of this system is to detect, among other things, individuals who may be 'tram surfing'⁷. When trams reverse, as at Ashton-under-Lyne tram stop, the images should change so that the driver is shown the view from the rear cab. Vehicle 3040 had a defect such that the view shown to the driver located in the 'Manchester' end cab was obtained from the camera at the 'Manchester' end. Therefore, the monitor did not show the view of Ashton-under-Lyne tram stop as the tram departed.

Figure 10: positioning of rear-facing camera monitor screen
