# Rail Accident Report

**Near miss between a passenger train and lorry  
at Mucking AHB level crossing, Essex  
13 March 2019**

# Near miss between a passenger train and lorry at Mucking AHB level crossing, Essex, 13 March 2019

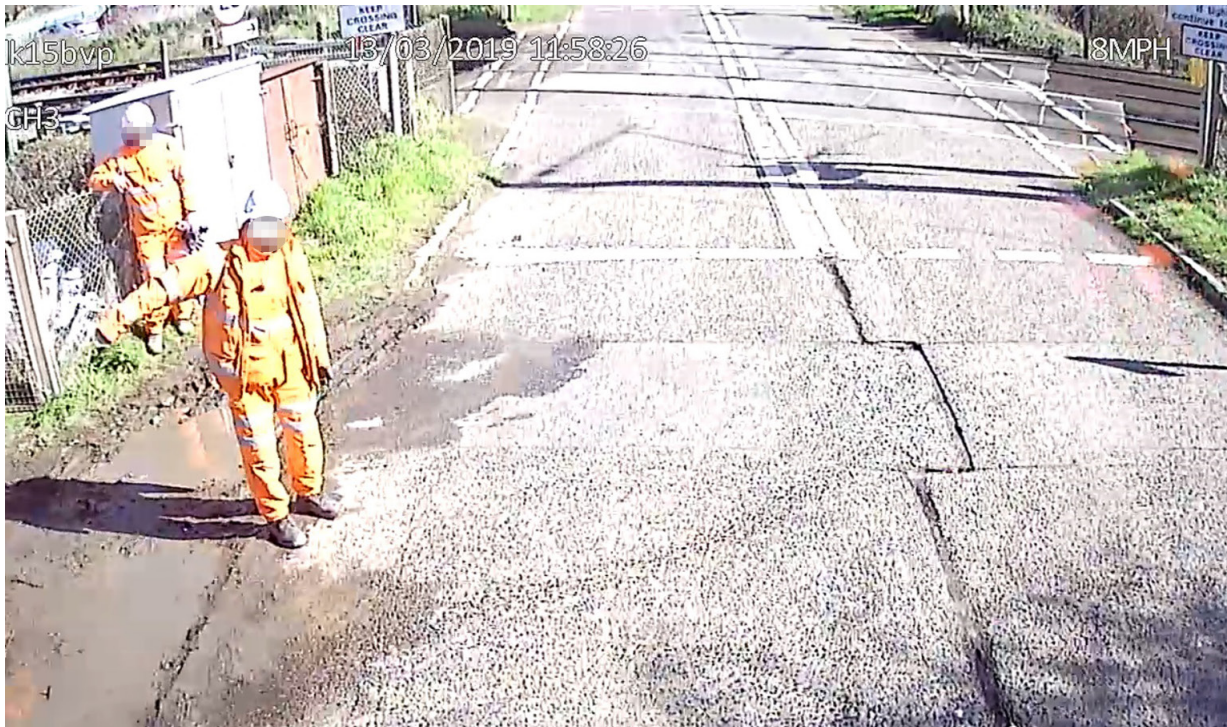
Figure 7: Lorry front camera view of banksman waving concrete delivery lorry forwards towards the level crossing (courtesy of Euromix Concrete)

- 39 At about the same time as the lorry passed the banksman at low speed, the amber lights on the level crossing illuminated and the audible alarm started to sound (Table 1). The red stop lights began flashing about one second before the lorry crossed the white line and moved onto the crossing and were visible to the lorry driver. At the same time, the pickup truck was being reversed into a side road on the far (east) side of the crossing (figure 8).

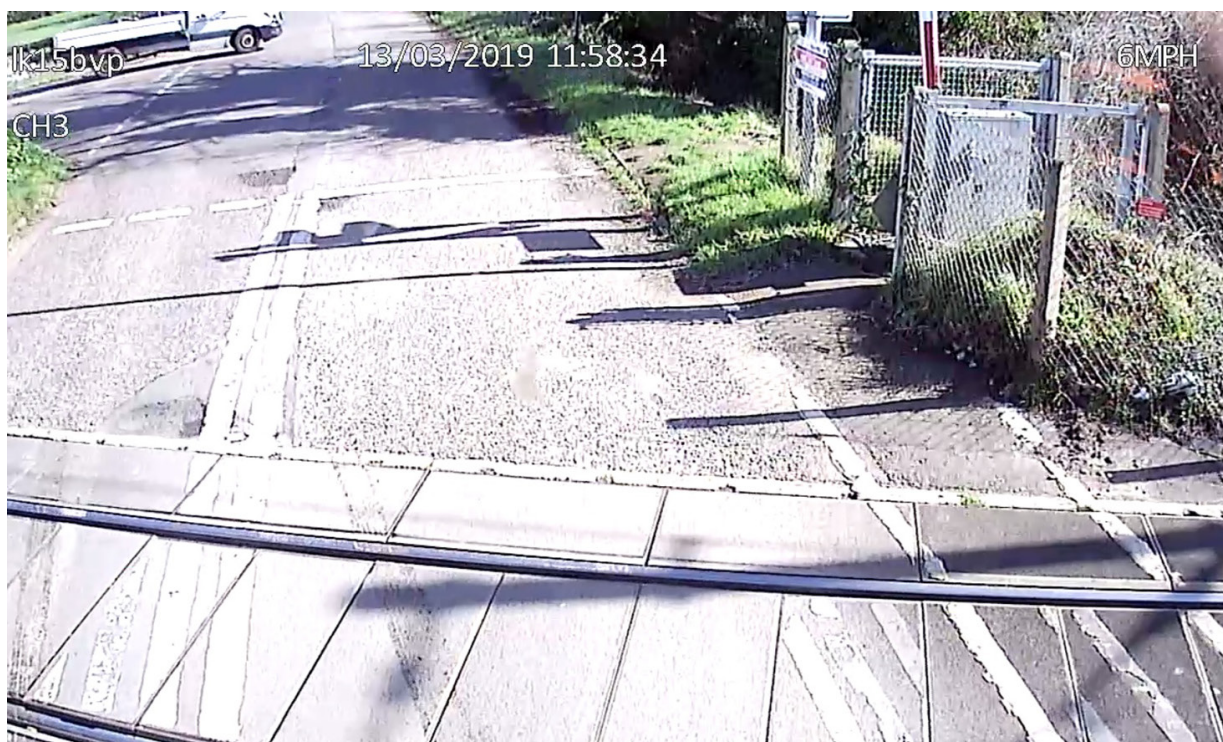
Figure 8: Lorry front camera view showing its position on the opposite carriageway ready for the reversing move. The site pickup truck (visible at top of image) is reversing into a side road (courtesy of Euromix Concrete)

- 52 The lorry driver understood this to mean he should pass the site entrance before reversing into the site, so he continued to drive forwards onto the crossing to position the lorry for the reversing manoeuvre. He then stopped, and started to reverse. He stated that it would not have been possible to turn the lorry on the other side of the crossing because there were vans and cars parked in the side road. Video evidence from the lorry shows the pickup truck being used by site staff reversing into the side road as the lorry drove onto the crossing, temporarily obstructing the road about 15 metres beyond the level crossing (figure 8).

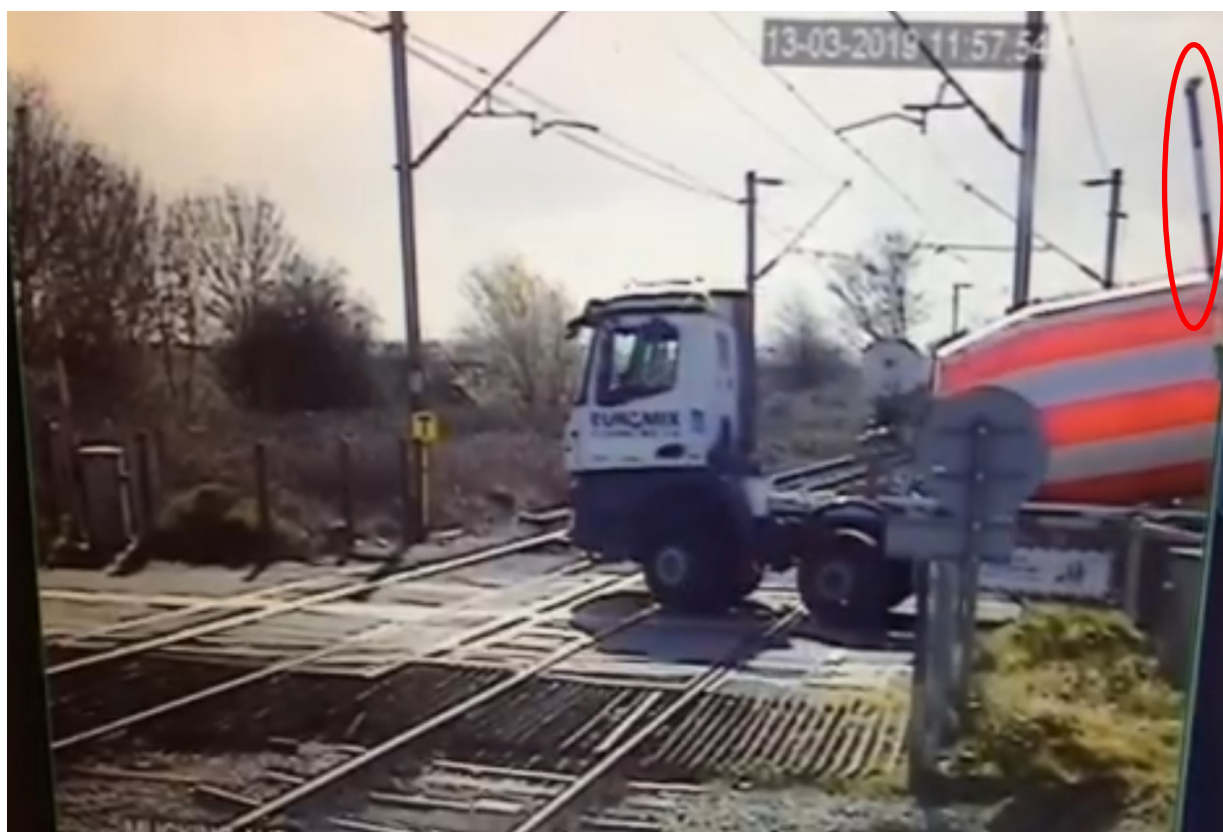
- 41 The lorry stopped on the crossing and began to reverse towards the site entrance (figure 9). Before the lorry cleared the crossing, the crossing barriers began lowering and caught between a water tank and the mixing drum on the back of the lorry (figure 10 and figure 11). The lorry stopped for eight seconds while the barrier was lifted by site staff (figure 12). It then reversed clear of the crossing six seconds before the train arrived.
- 42 Train 2D26 was approaching the crossing at 57 mph (92 km/h), travelling on the line which had been obstructed by the lorry while the barrier was lifted (figure 13 and figure 14).

Figure 9: Level crossing camera view showing lorry stopped and about to start reversing manoeuvre. The crossing barrier (highlighted) has started to lower (courtesy of Network Rail)

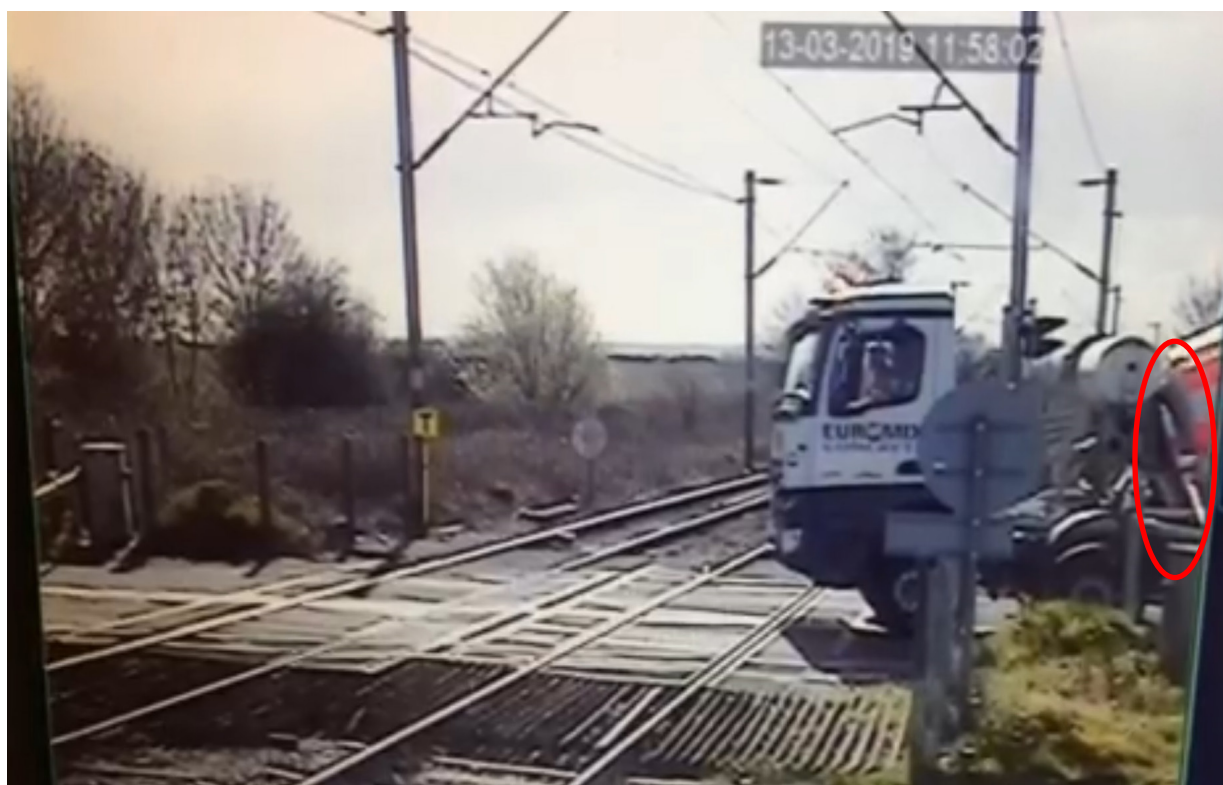
Figure 10: Level crossing camera view of the stationary lorry and partly lowered level crossing barrier (highlighted) caught by equipment on the back of the lorry. The approaching train is hidden by the lorry (courtesy of Network Rail)

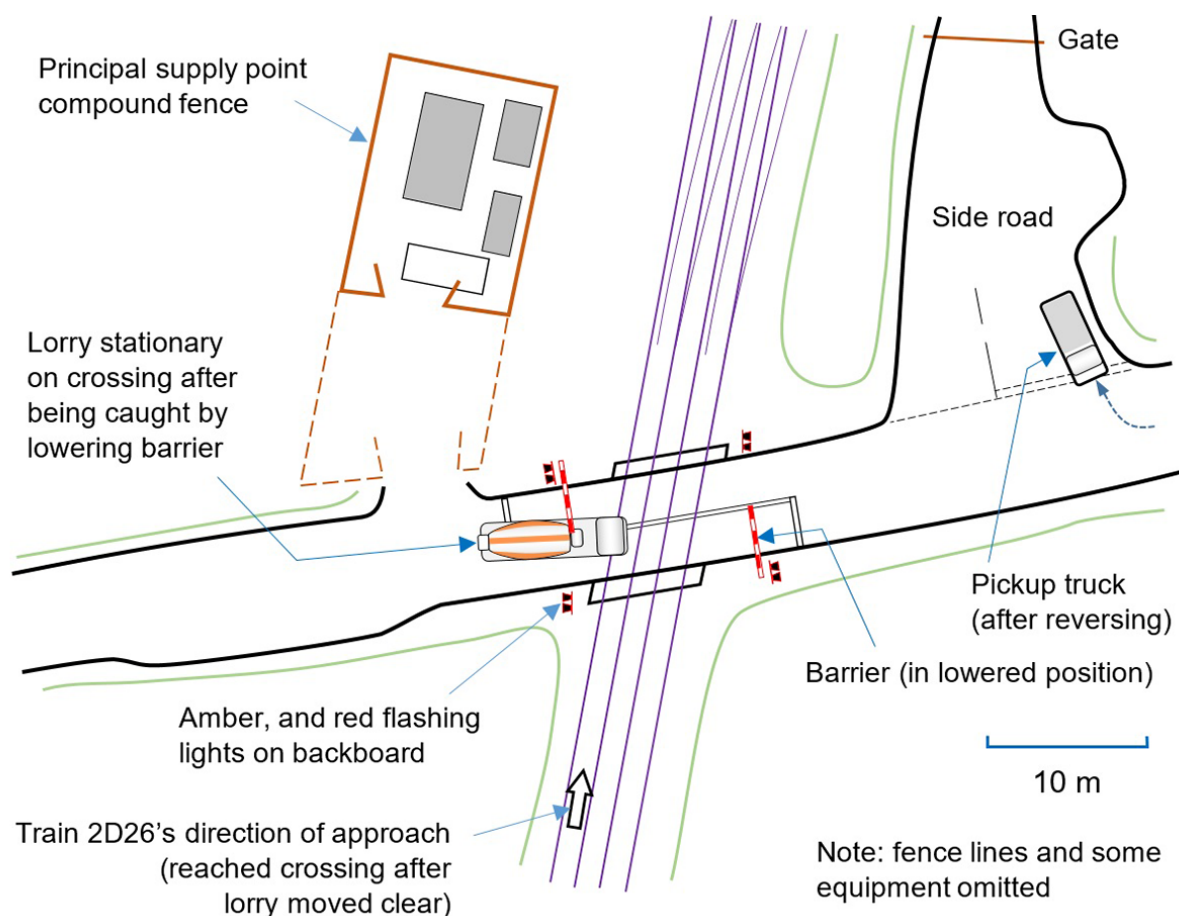
Figure 11: Diagram showing lorry's position when caught by the lowering barrier

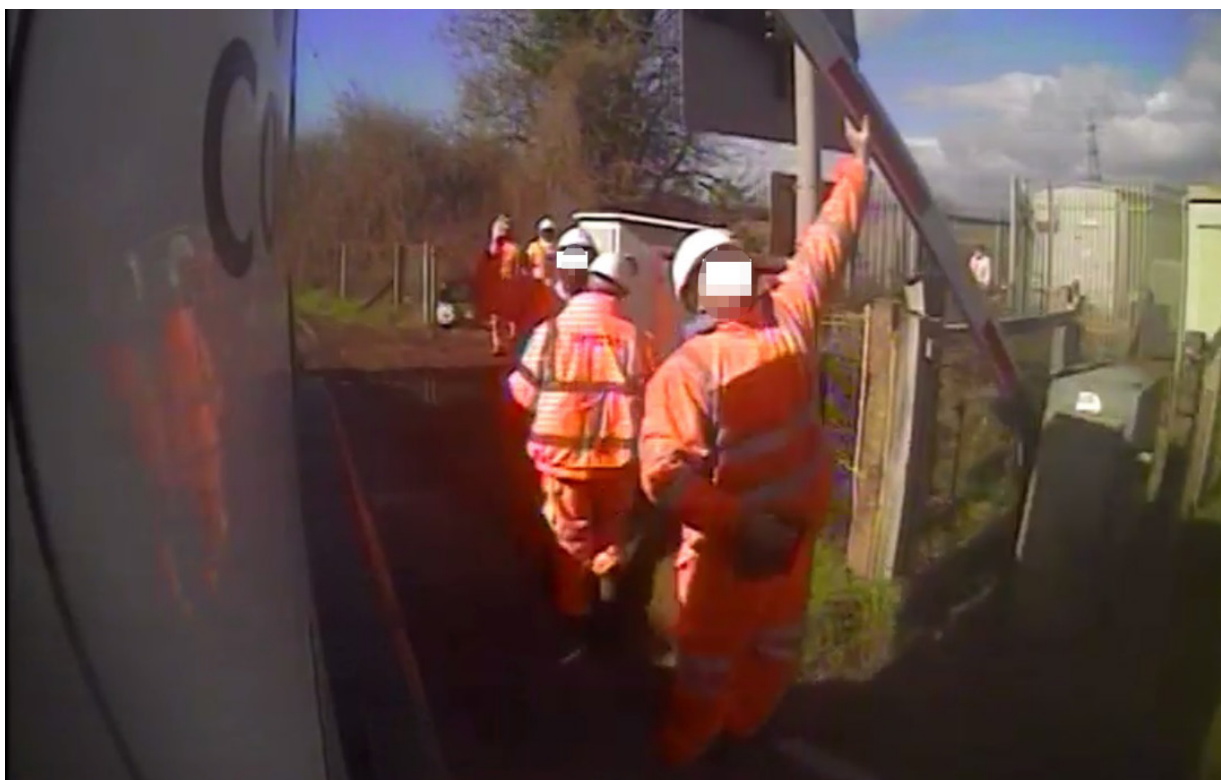
Figure 12: Level crossing barrier being lifted by site staff to free lorry (courtesy of Euromix Concrete)

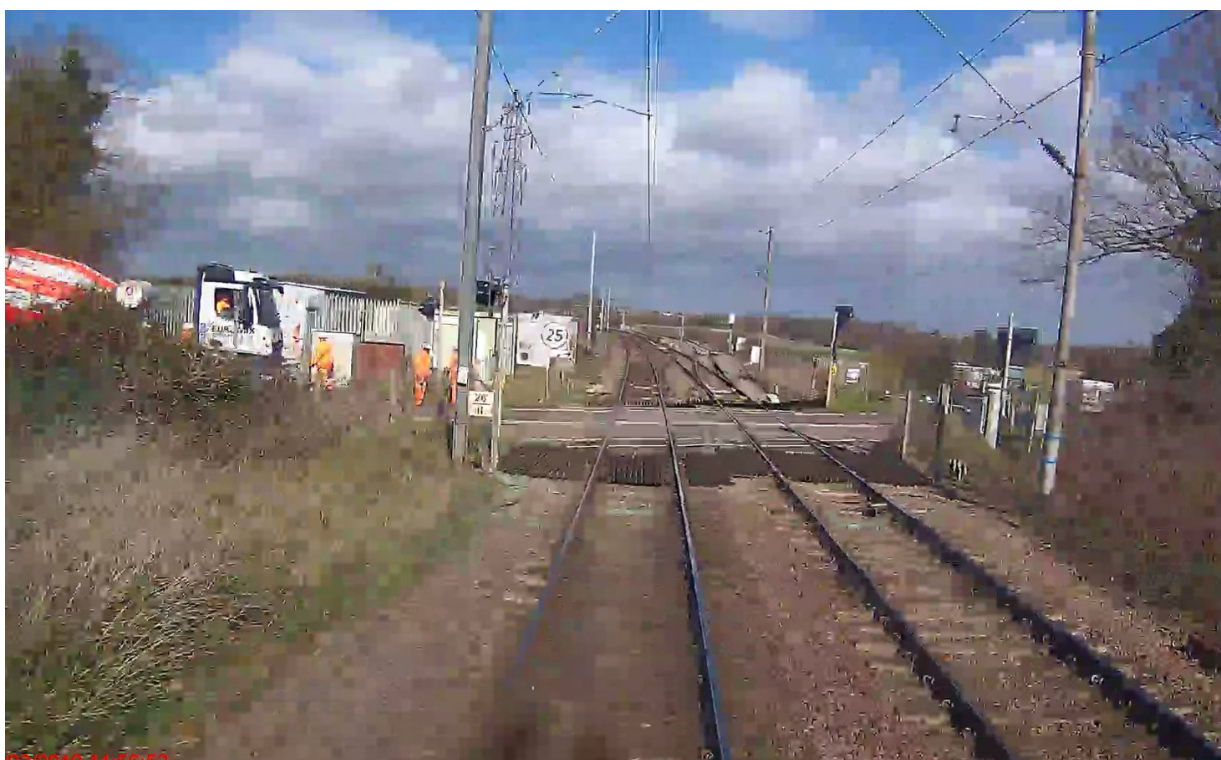
Figure 13: view from train 2D26 showing lorry reversing away from level crossing (courtesy of c2c)

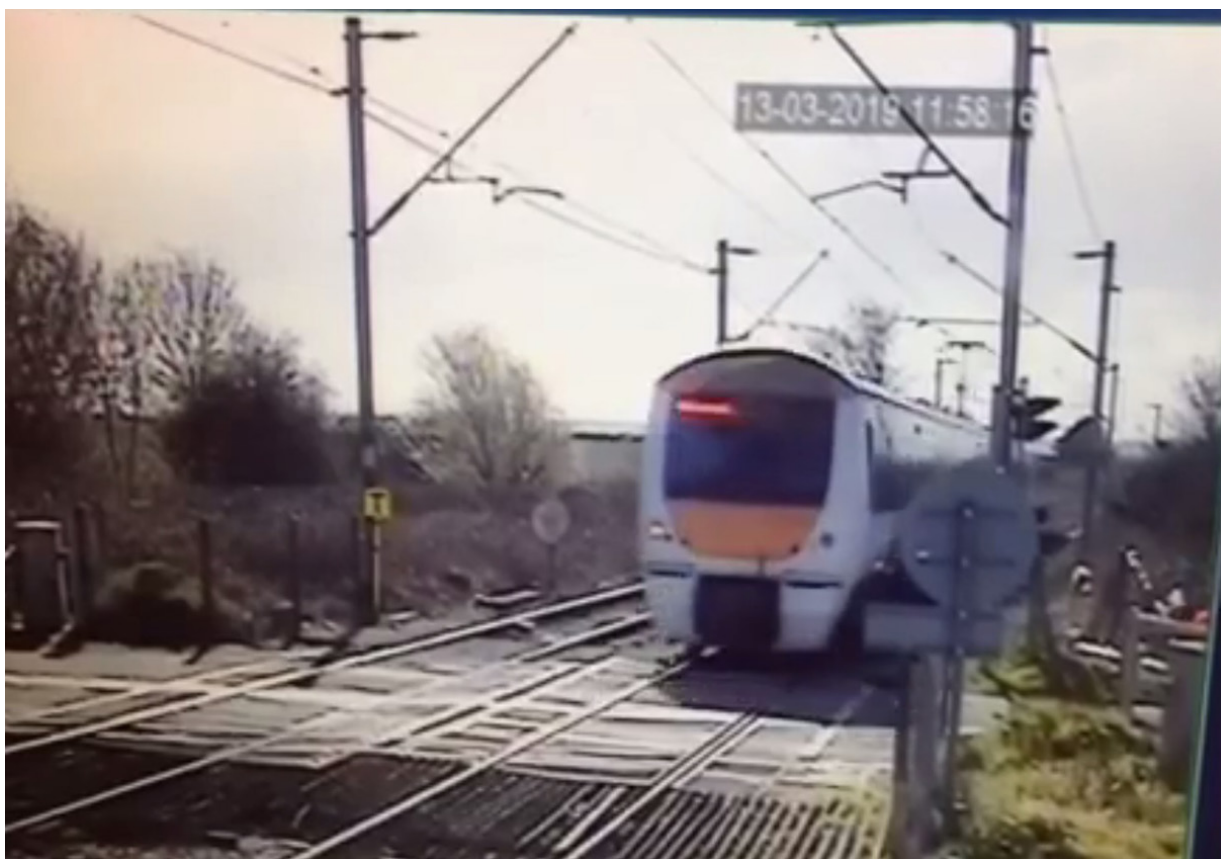
Figure 14: level crossing camera view of train 2D26 approaching at 57 mph (92 km/h) (courtesy of Network Rail)

- 43 The train driver did not apply the brake or sound the train's horn before passing the crossing, probably because the lorry was already reversing away from the railway when it first became visible. The train driver's view of the level crossing was restricted by the curve in the track (paragraph 6) until about 7 seconds before the train reached the crossing.
