JB Report: 2007/02

**REPORT ON SERIOUS RAILWAY INCIDENTS AT SLEPENDEN
BLOCK STATION DUE TO WRONG-SIDE SIGNALLING AT
SANDVIKA STATION ON THE DRAMMEN LINE 20 APRIL 2005**

Date
February 2007

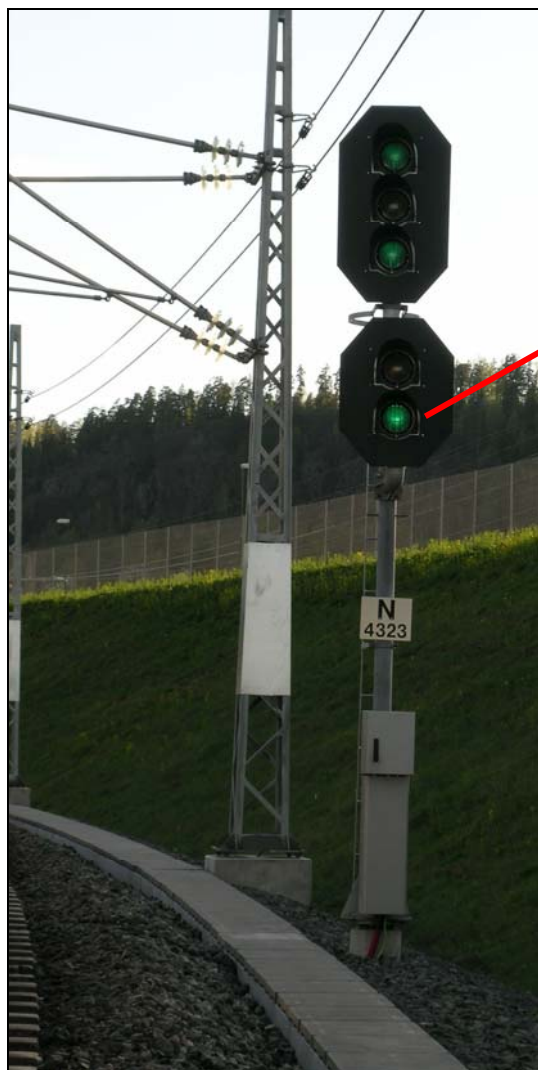
Figure 1: The distant signal for Slependen block signal station (located at Main Exit Signal N 4323 at Sandvika station) was showing an "expect to proceed" signal.

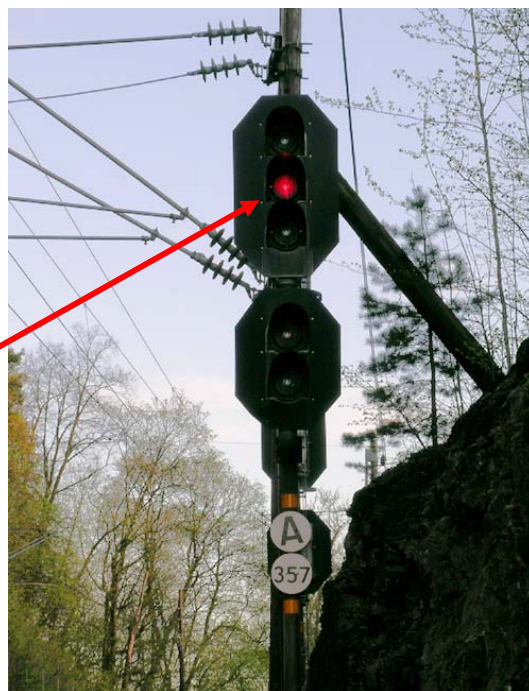
Figure 2: Block signal A Slependen was showing a "stop" signal. (Not corresponding with the signal aspect of the distant signal)

The reason for block signal A 357 at Slependen block signal station showing a "stop" signal for airport express train 13905, was that airport express train 13903 had been given a "stop" signal ahead of entrance signal A at Billingstad station and was on the block section between Slependen block signal station and Billingstad station (see fig. 3). Airport express train 13903 had been given a "stop" signal in the main entrance signal at Billingstad station because train 51006 was carrying out maintenance work on the railway line between Billingstad and Hvalstad stations. The train controller was therefore unable to send airport express train 13903 on towards Asker station. The distance between airport express trains 13903 and 13905, positioned on the block section, was around 670 metres. During this incident, there was no danger of a collision between these two trains. (see fig. 4)

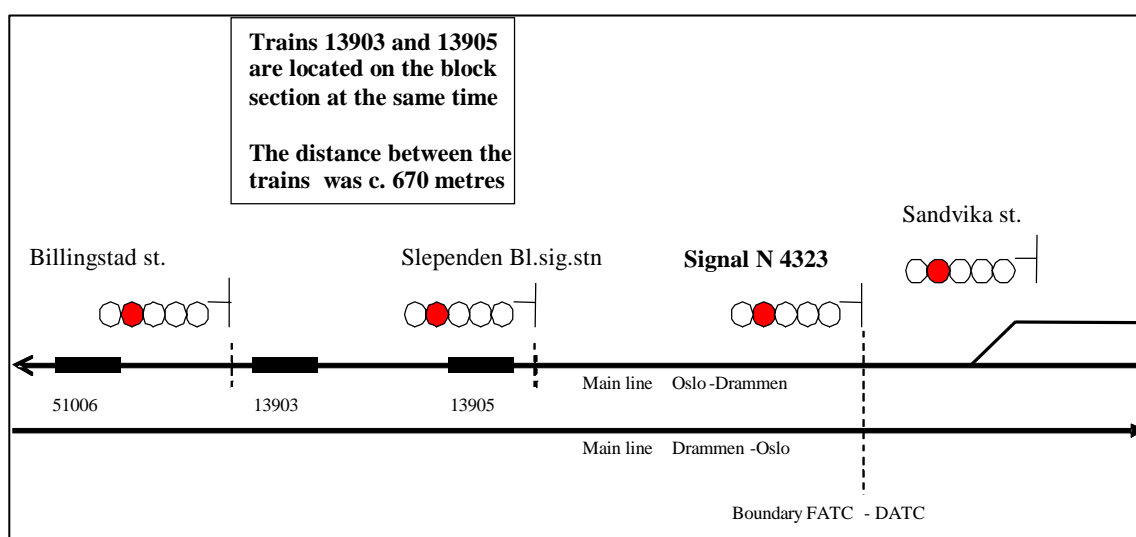
Figure 4: Airport express trains 13903 and 13905 are located on the same block section at time 0419

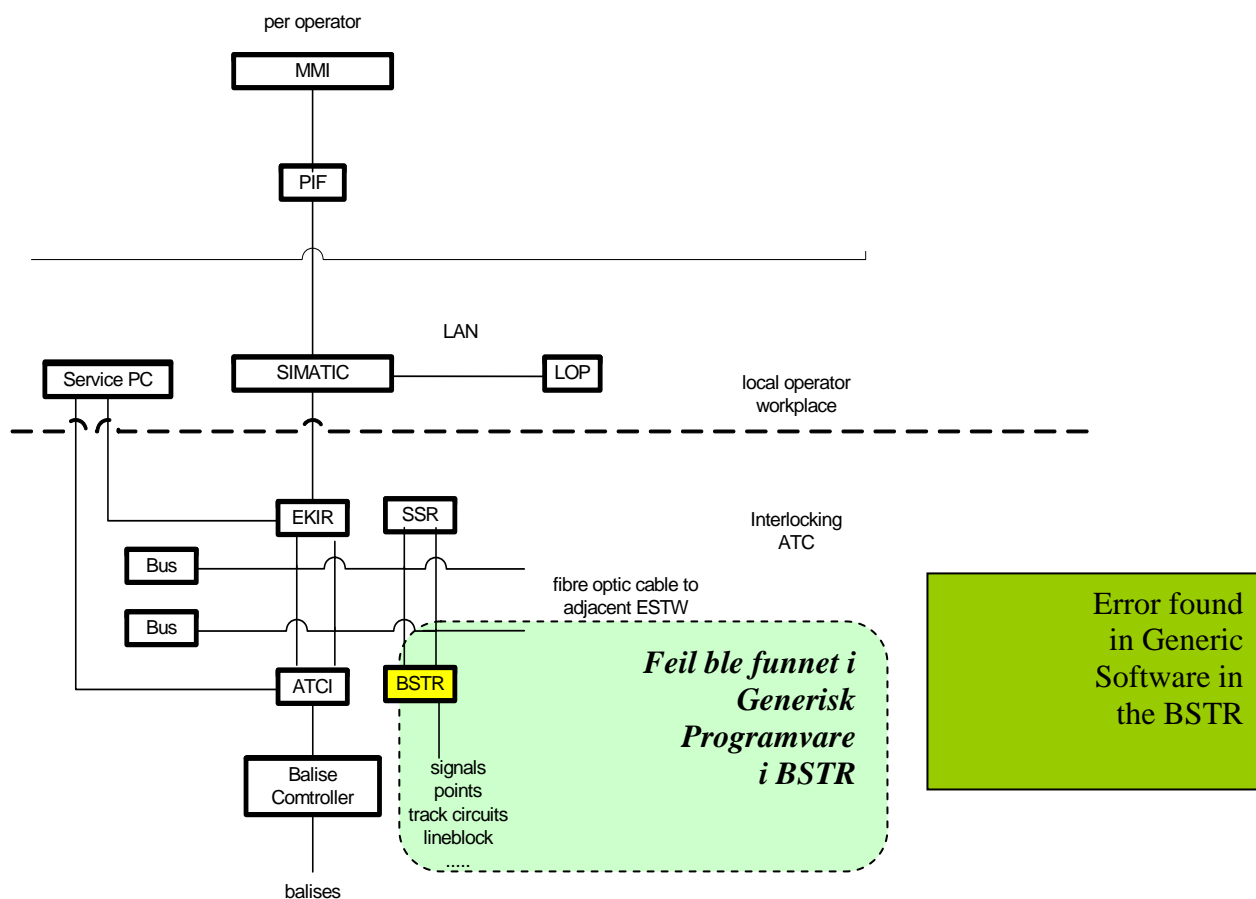
Figure 8: Showing how the fault was identified in the computer-controlled interlocking system

The cause of the fault situation at Slependen was found in the generic software in BSTR. This software was developed for the SIMIS-C on the Gardermobanen railway line (GMB) and was not subject to specific validation and approval in conjunction with the Sandvika project.

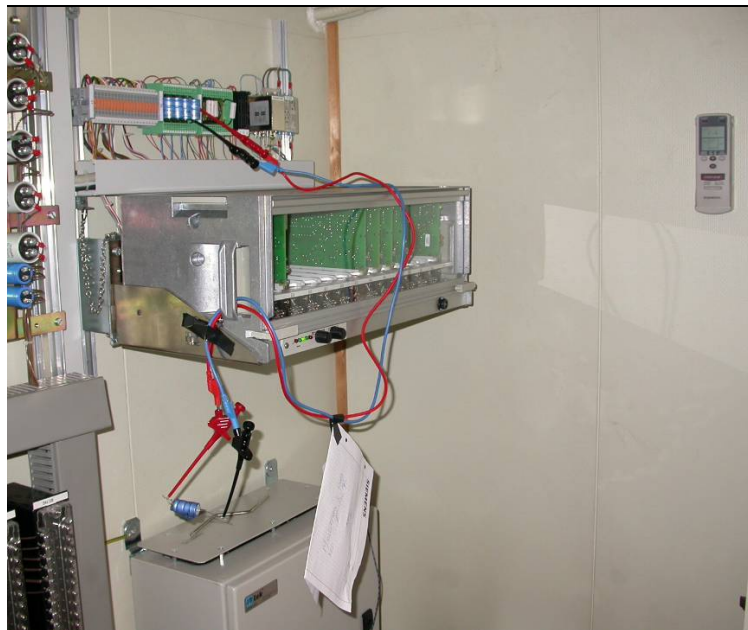
Figure 9: Interface system EF 180 at Slependen block signal station. This transmits signal information between the relay system at the block signal station and the computer-controlled interlocking system at Sandvika station via a telecommunications cable.

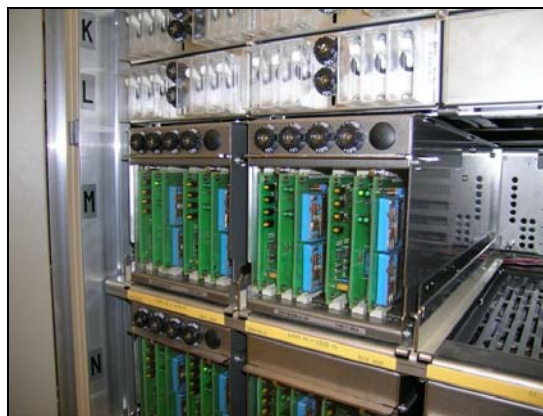
Figure 10: Picture of object controller for signal N 4323

4. At the same time as the BSTR (see fig. 10) was reset, block signal A 357 at Slependen block signal station was showing the “expect to proceed” signal.

On these four criteria were satisfied in the sequence outline above, the signal system and control of the distant signal were locked in the status they had when the system was reset, in other words “permission to proceed” in the distant signal for block signal A 357. This happened as a consequence of the error in the generic software for the BSTR.

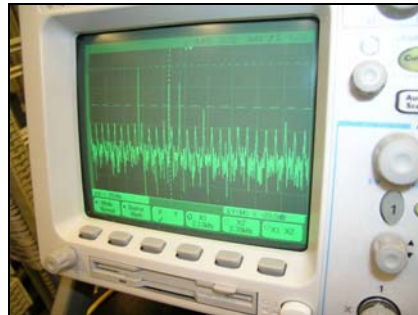
Figure 11: Oscilloscope measurement of noise conditions from cable to interface EF-180

During the course of the AIBN's investigation, abnormal flashing frequencies were observed in the LEDs in the EF-180 interface system. During test measurements, it was confirmed that there was variable noise on the interface with Slepden block signal station (see fig. 11). EF-180 is an interface for transferring signal information between the safety system at the block signal station and the interlocking system at the station.

Unnecessary flashing LEDs were observed on the interface at the Slependsen block signal station. Using measurements it was established that variable noise was present on the interface. This could have been linked to the frequent faults (element locks) that had occurred. The interface is sensitive to noise, and it is therefore important that cables used for data transfer to this interface are of a good standard, in order to avoid operating failures. Loose gauge wires and temporary connections at Slependsen block signal station,

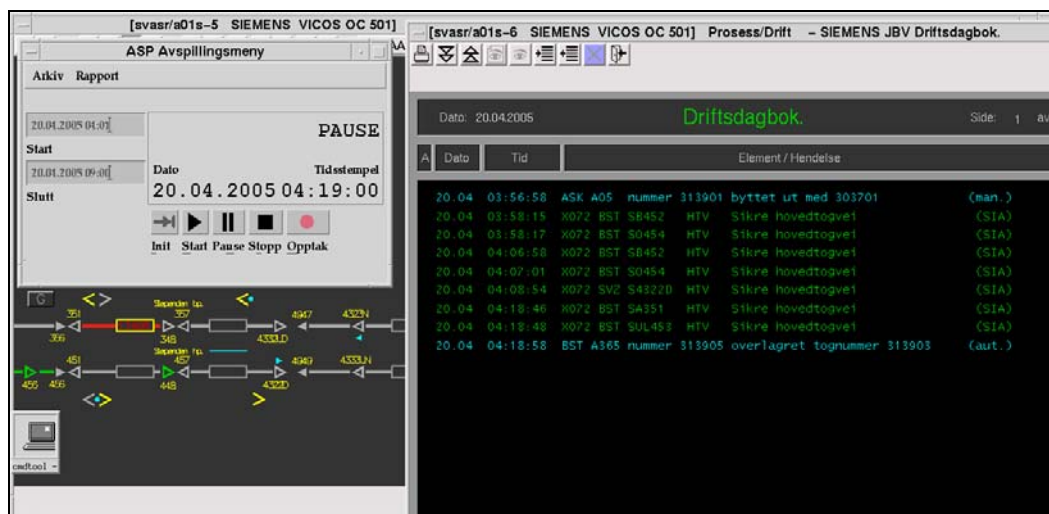
Figure 12: Signal log printout

The printout of the signal log in figure 12 shows the time when train 13905 entered the same block section as train 13903, and the display of train numbers on the screen were placed on top of one another.

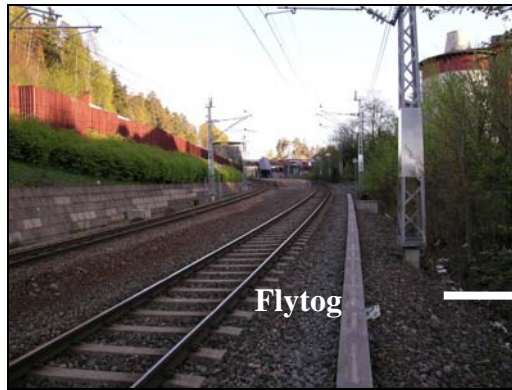
There could have been serious consequences if the locomotive driver in train 12207 had not applied the emergency brake and managed to stop the train in time. He only had a time window of around 2 seconds to detect the airport express train’s 2 red direction lights (end signals) in the area to the left of the superstructure at Slependen holding point. This is illustrated in figure 15.

Figure 15: The line of sight from the locomotive driver's cab in the direction of Slependen block signal station. Airport express train 13905 had stopped and was located behind the superstructure at Slependen holding point.

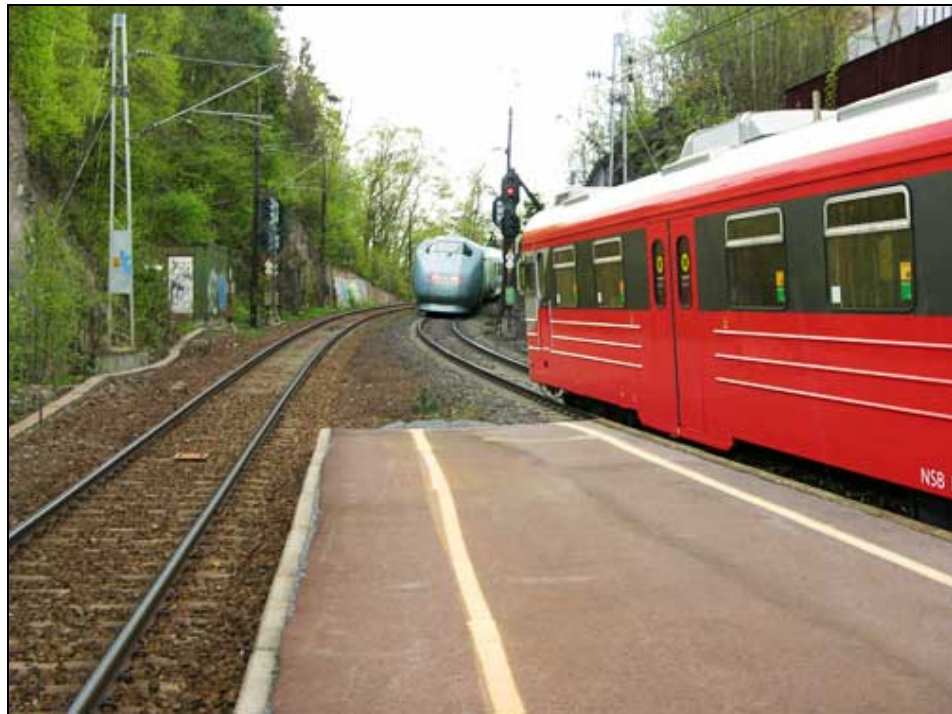
Figure 16: The trains' stopping positions after incident 2. This photo is a photomontage showing the estimated distance between the trains.
