# Rail Accident Report

## **Passengers struck by a flying cable at Abergavenny (Y Fenni) station 28 July 2017**

# Passengers struck by a flying cable at Abergavenny (Y Fenni) station, 28 July 2017

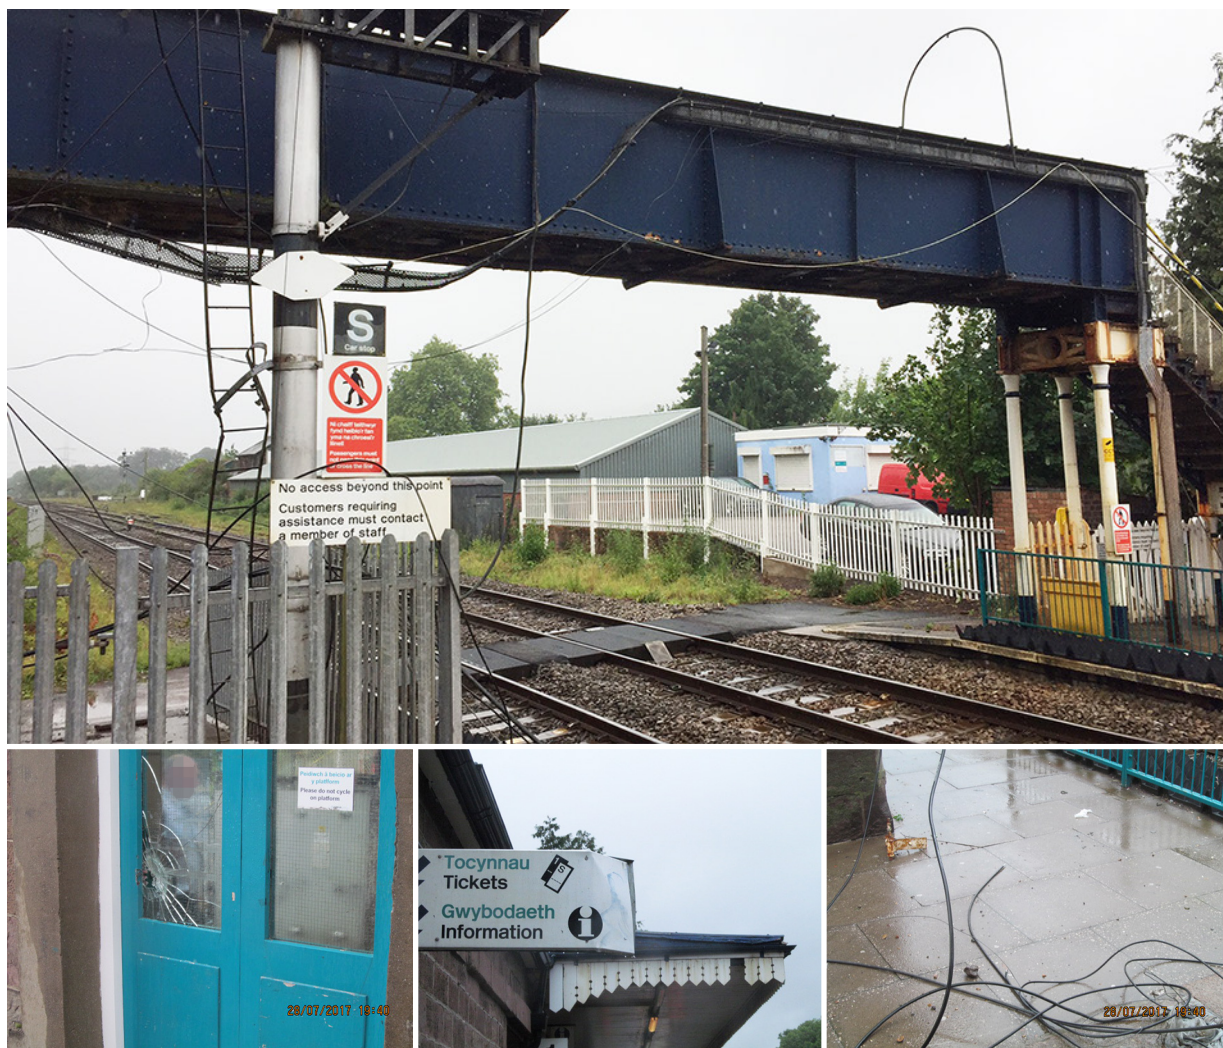
- 4 The free end of the cable whipped round, and it struck a group of passengers on the footbridge stairs and caused minor injuries to three of them. A member of station staff who was on the platform and close to the footbridge, reported hearing a noise as the cable broke free and ducking just as the flying cable end passed over his head. The accident caused damage to cables and the cable tray running over the footbridge, station buildings and to other equipment on the station (figure 2).

Figure 2: Damage to the cable tray running over the footbridge, station buildings and to other equipment on the station (main image courtesy of Network Rail and inset images courtesy of British Transport Police)

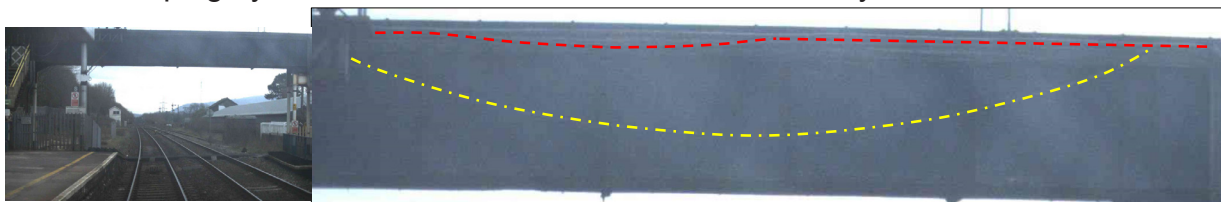
**26 February 2016: Image from Network Rail infrastructure measurement train**  
Cable drooping by ~0.1 metres, telecommunications cable by ~1.0 metres

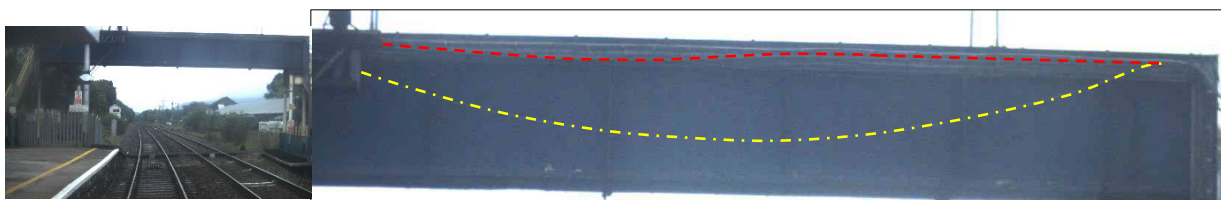
**7 October 2016: Image from Network Rail infrastructure measurement train**  
Cable drooping by ~0.15 metres, telecommunications cable by ~1.0 metres

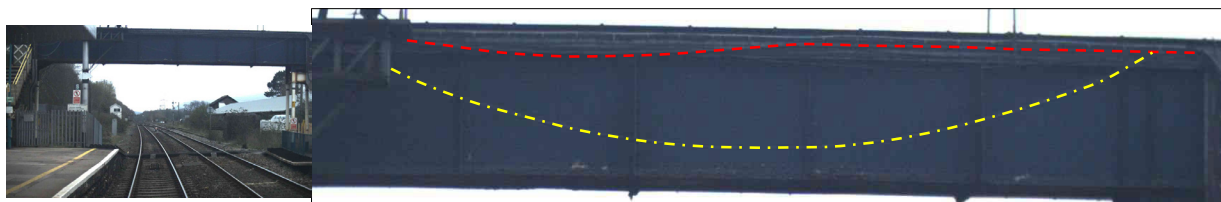
**24 March 2017: Image from Network Rail infrastructure measurement train**  
Cable drooping by ~0.15 metres, telecommunications cable by ~1.15 metres

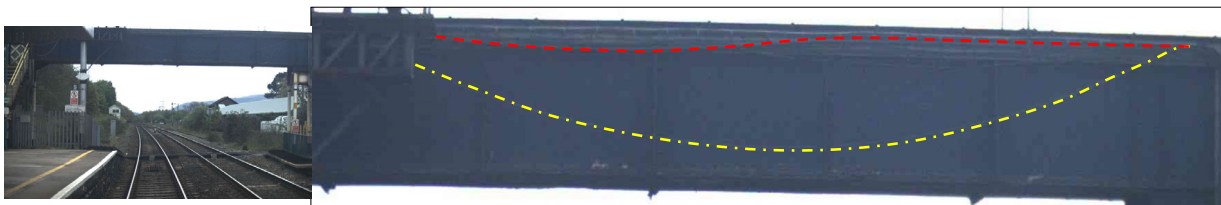
**21 April 2017: Image from Network Rail infrastructure measurement train**  
Cable drooping by ~0.17 metres, telecommunications cable by ~1.15 metres

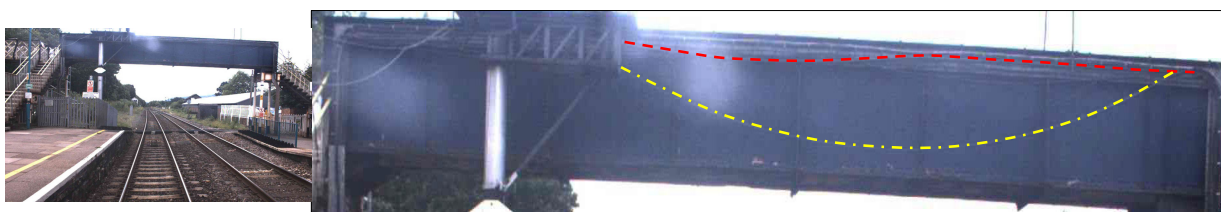
**14 July 2017: Image from Network Rail infrastructure measurement train**  
Cable drooping by ~0.17 metres, telecommunications cable by ~1.15 metres

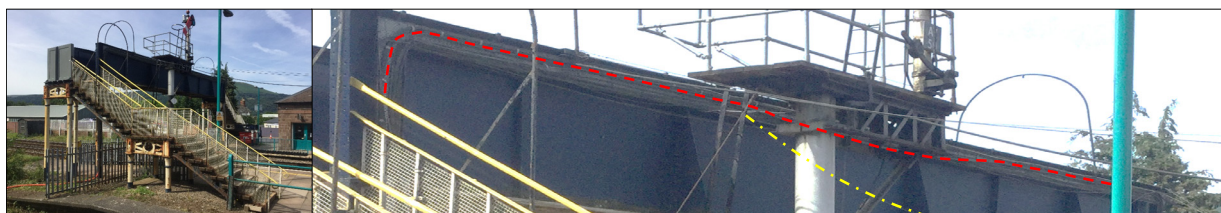
- 14 Photographs of the footbridge from 2011 onwards show a grey cable increasingly drooping below the cable tray over time. This cable was a telecommunications cable, not the electrical supply cable. The first image found that shows the electrical supply cable starting to droop was recorded by one of Network Rail's infrastructure measurement trains in February 2016. It shows the electrical supply cable drooping by about 0.1 metres from its nominal position, whereas the telecommunications cable was drooping by about one metre. Figure 7 shows images of both cables drooping, starting in February 2016 through to July 2017.

**17 July 2017: Image from Network Rail site visit to station**  
Cable drooping by ~0.17 metres, telecommunications cable by ~1.15 metres

*Figure 7: Images of the electrical supply (highlighted in red) and telecommunications (highlighted in yellow) cables drooping from the footbridge from February 2016 to July 2017 (images courtesy of Network Rail)*

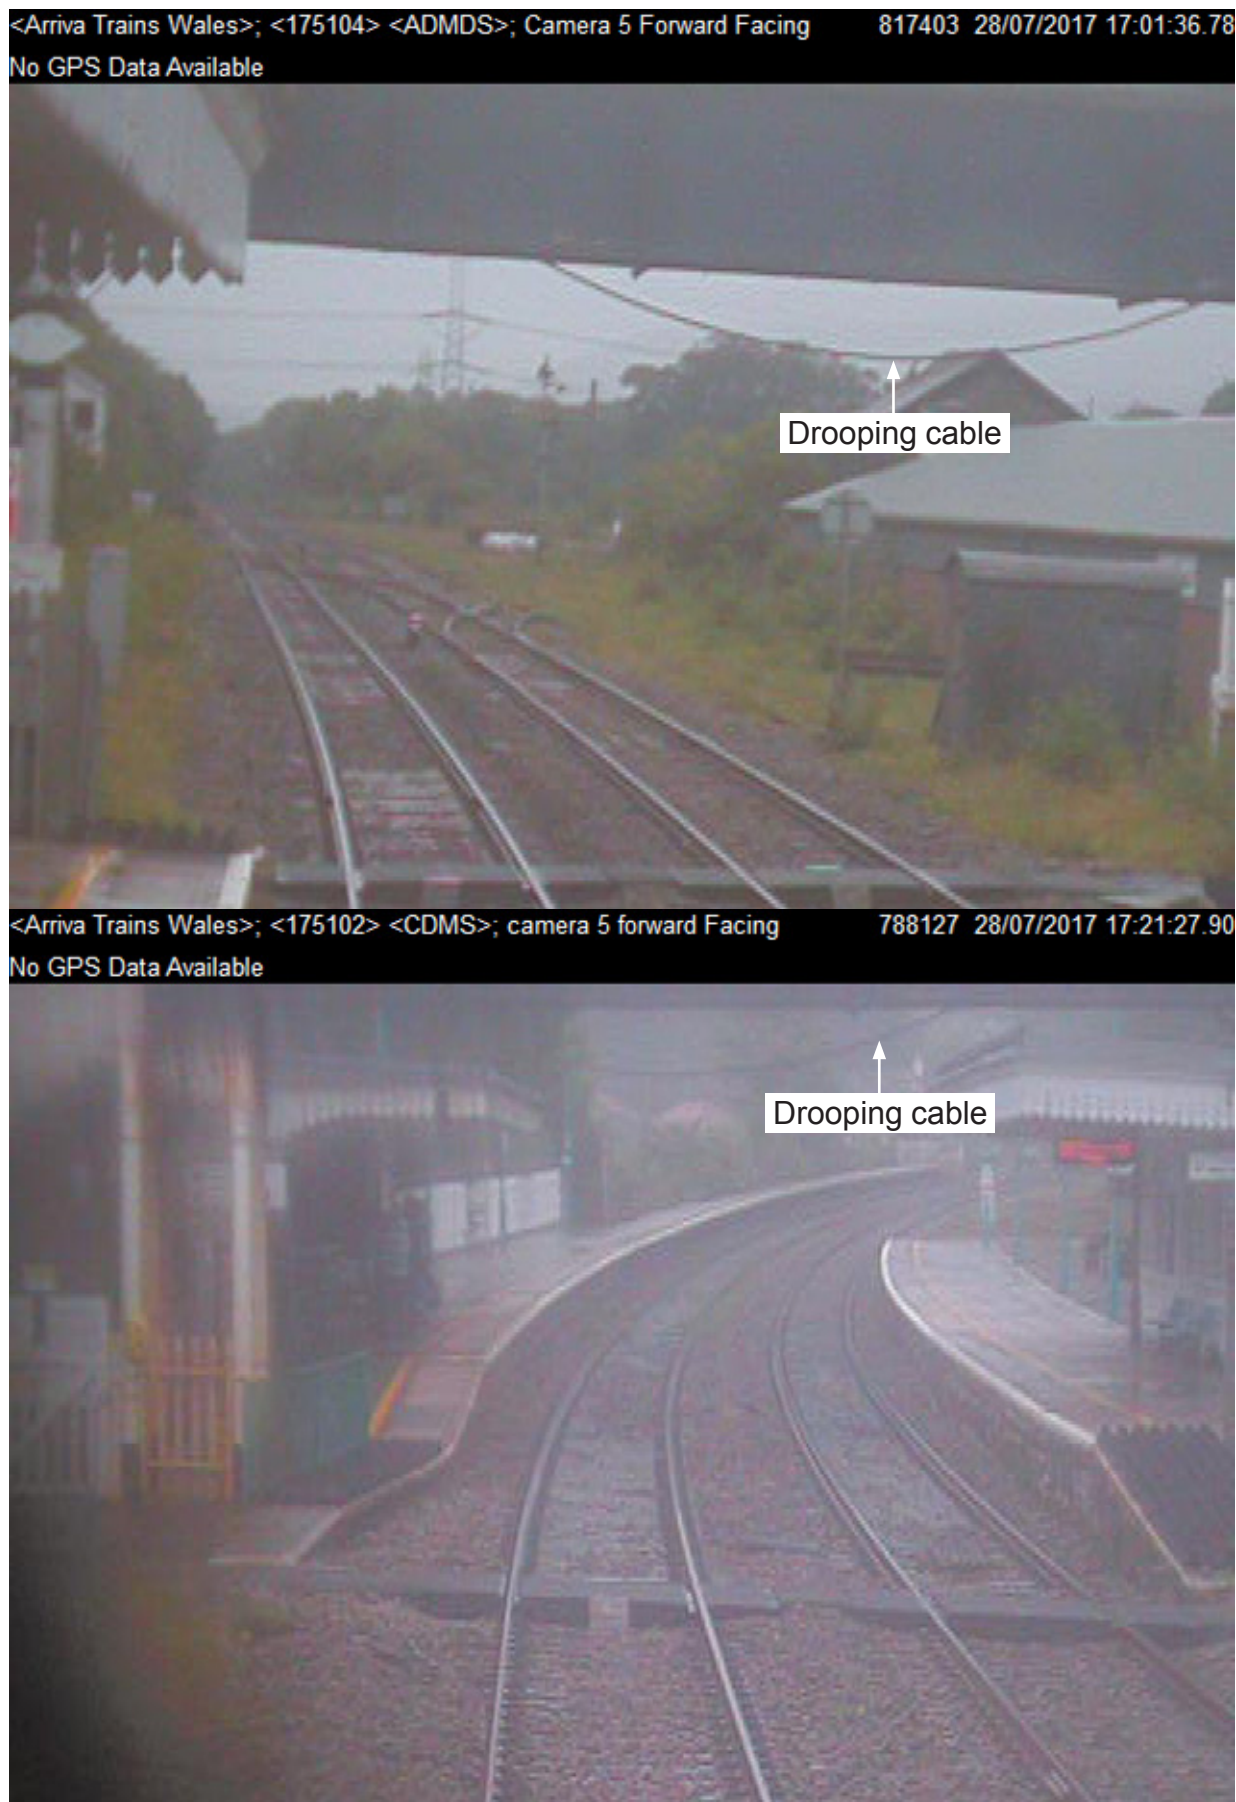
- 17 At 17:01 hrs on 28 July, about one hour before the accident, a southbound Arriva Trains Wales service stopped at Abergavenny station. Forward facing CCTV footage recorded by this train shows the cable drooping below the bottom of the footbridge (figure 9). At 17:30 hrs, the last northbound train prior to train 1W96 arrived at Abergavenny station and CCTV footage from this train also shows the cable drooping below the bottom of the footbridge (figure 9).

Figure 9: CCTV images recorded by the last southbound train (top image) and last northbound train (bottom image) at Abergavenny prior to train 1W96 (images courtesy of Arriva Trains Wales)

- 29 CCTV footage recorded by trains in the hour before train 1W96 arrived at Abergavenny station, shows the electrical supply cable drooping about 0.55 metres below the bottom of the footbridge (figure 9). At this height, the cable was able to strike the roof of train 1W96 and then snag on it (paragraphs 18 to 20). The position of the telecommunications cable cannot be seen in the CCTV footage as the image quality was affected by the poor level of ambient light. However, this cable was not reported to have caused any of the injuries.

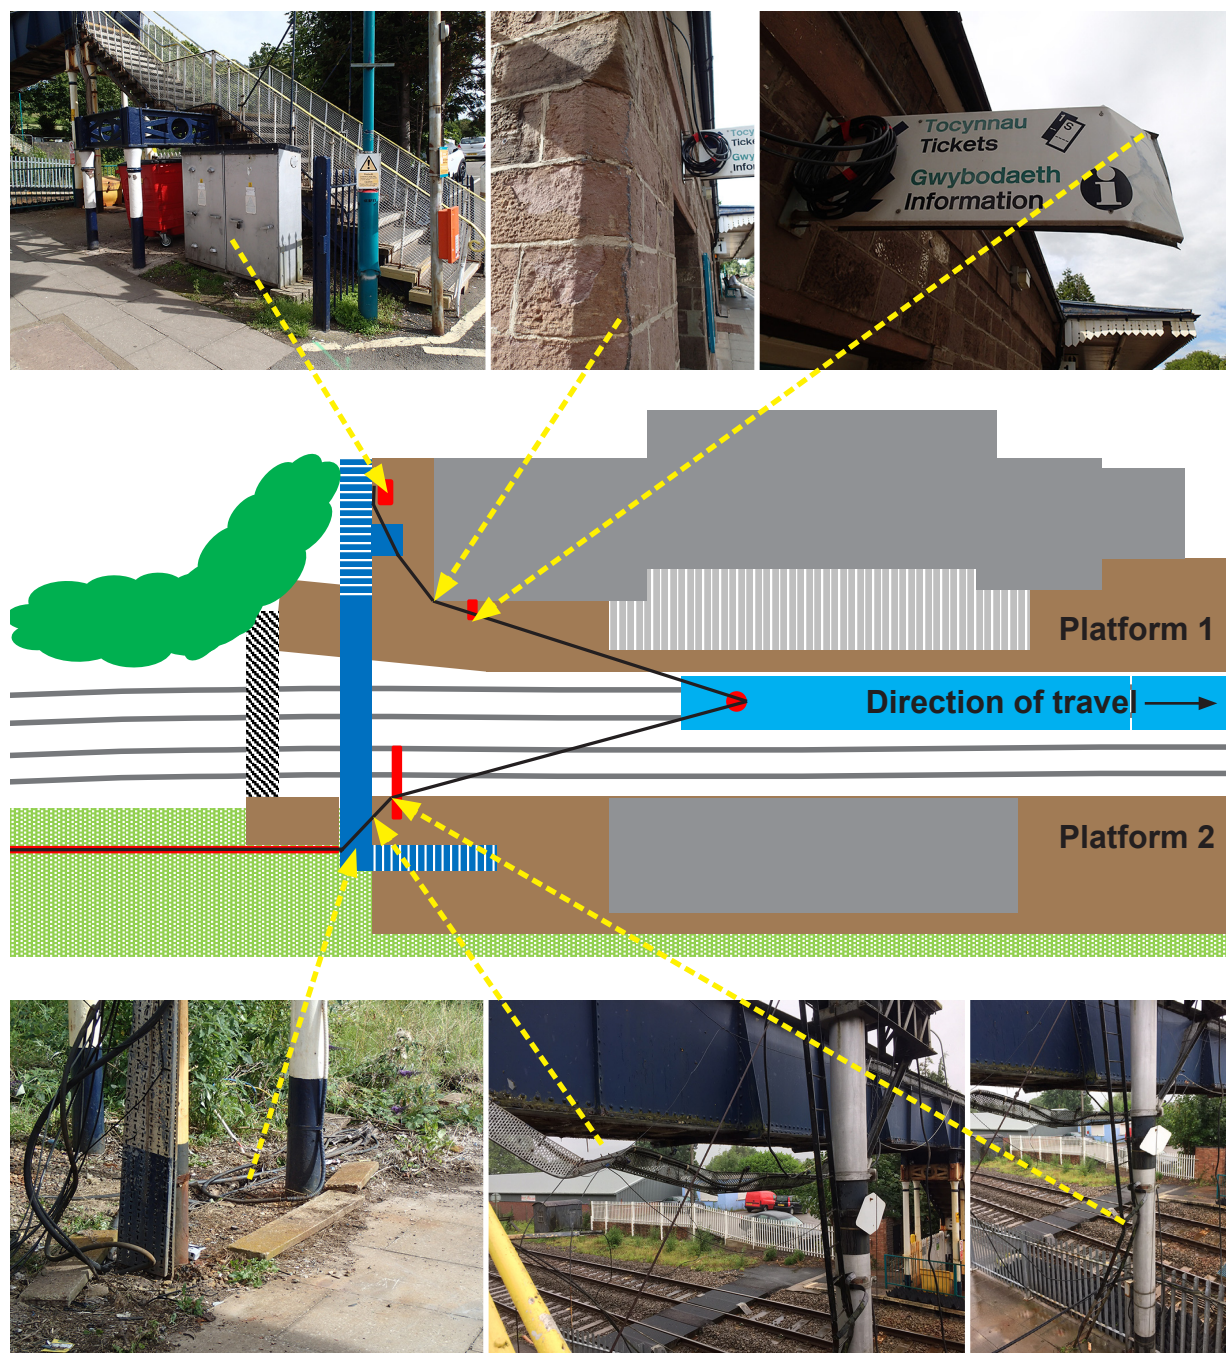
- 19 A witness standing on platform 1 was watching the train as it arrived and noticed both the electrical supply and telecommunications cables snag on the roof of the rearmost vehicle of the train. Once snagged, these cables were pulled off the cable tray they were attached to. The electrical supply cable was pulled from its fixings on the footbridge stairs and out of a cable trough (figure 10). While being pulled, this cable caused damage to other cables, the cable tray, a signal ladder and a station sign (figure 10). It also moved a wheeled bin which struck and broke a pane of glass in the waiting room door (figure 2).

Figure 10: Diagram showing the position of the electrical supply cable as the train pulled it and photographs of the damage caused to various items (bottom middle and bottom right images courtesy of Network Rail)

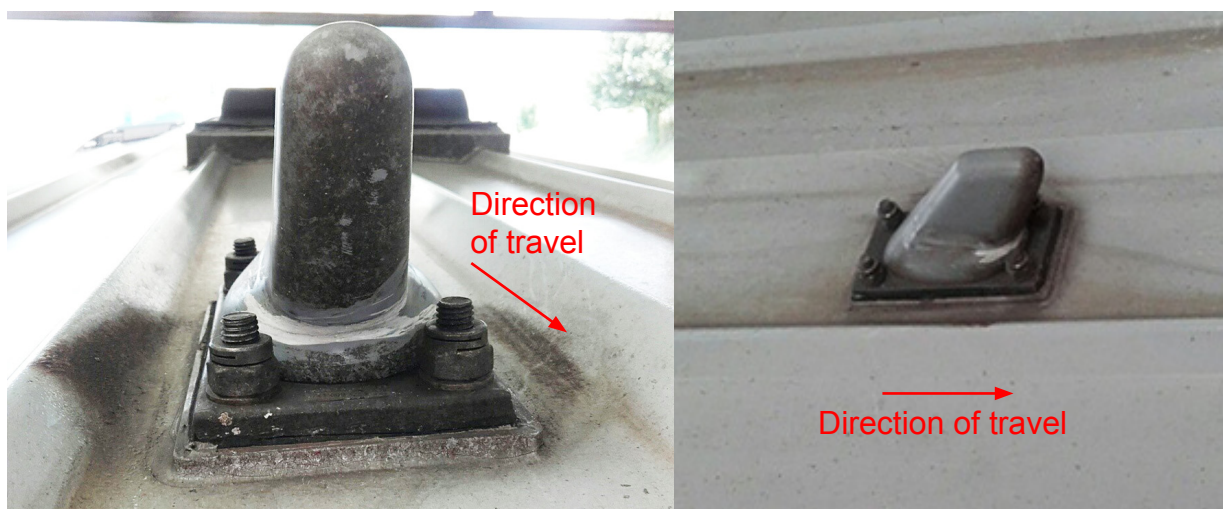
- 33 On Monday 31 July, Arriva Trains Wales maintenance staff carried out an examination of the train at roof level. Staff found no obvious marks on the roof of the locomotive's leading cab but did find minor damage and witness marks on the roofs of the coaches which continued to the DVT at the rear of the train. The final witness mark found was on the radio antenna (figure 14). The shape of the antenna, which was raked forwards in the direction of travel at the time, increased the likelihood of the cable becoming snagged. The antenna is the highest point on the vehicle, mounted just off the centre line of the roof.

Figure 14: The radio antenna on the roof of the DVT (images courtesy of Arriva Trains Wales)

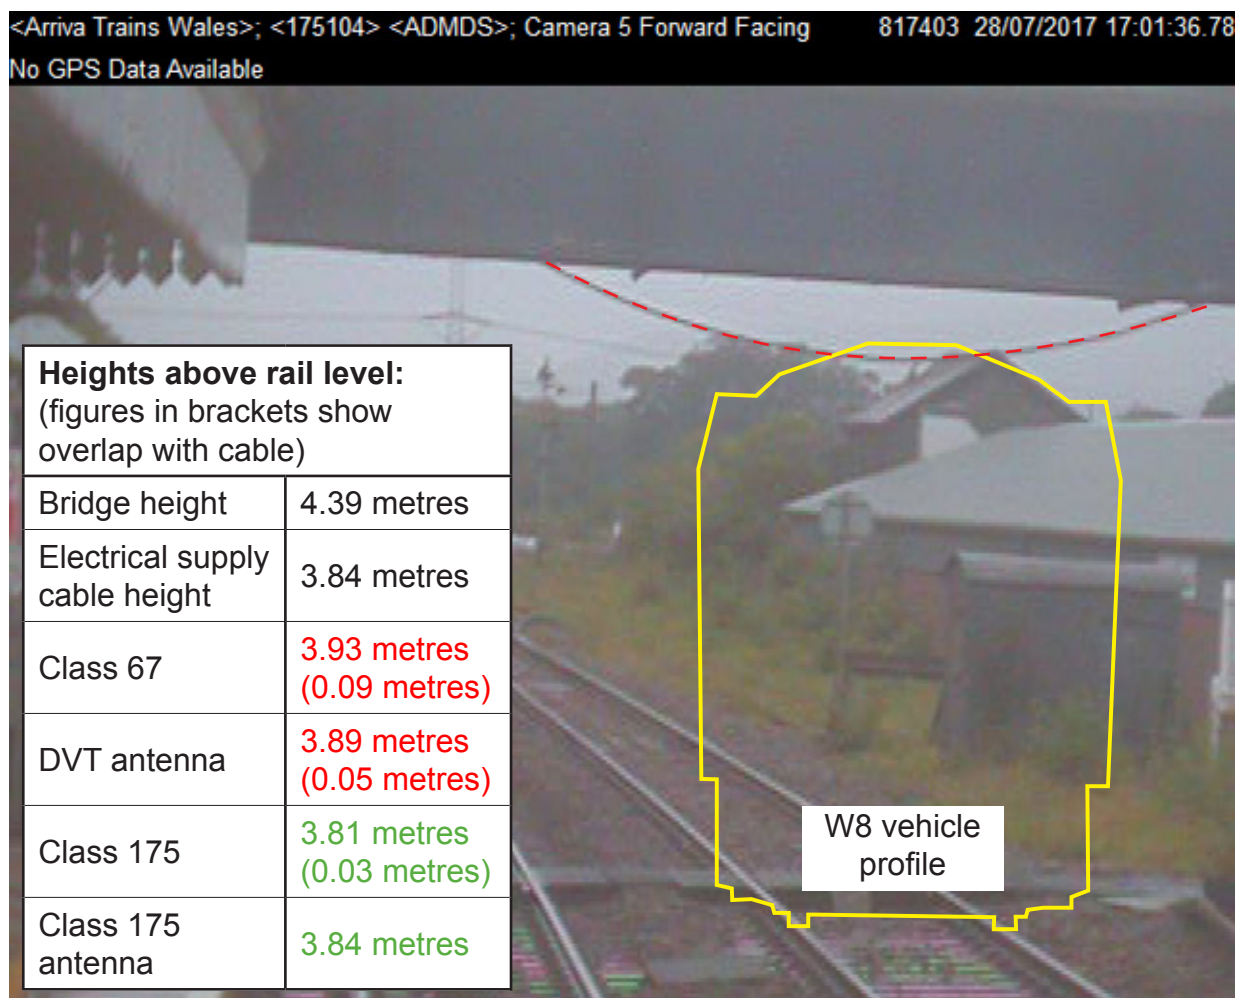
- 39 Figure 16 shows the nominal heights above rail level for the locomotive and the DVT. It also shows the nominal height above rail level for a class 175 unit, which was the type of train that had formed the previous passenger services through Abergavenny and had recorded CCTV footage showing the drooping cable (paragraph 15). The lower height of the class 175 unit probably explains why the previous train did not snag the cable as it passed under the footbridge.

Figure 16: Vehicle heights above rail level in relation to the electrical supply cable drooping from the footbridge (background image courtesy of Arriva Trains Wales)

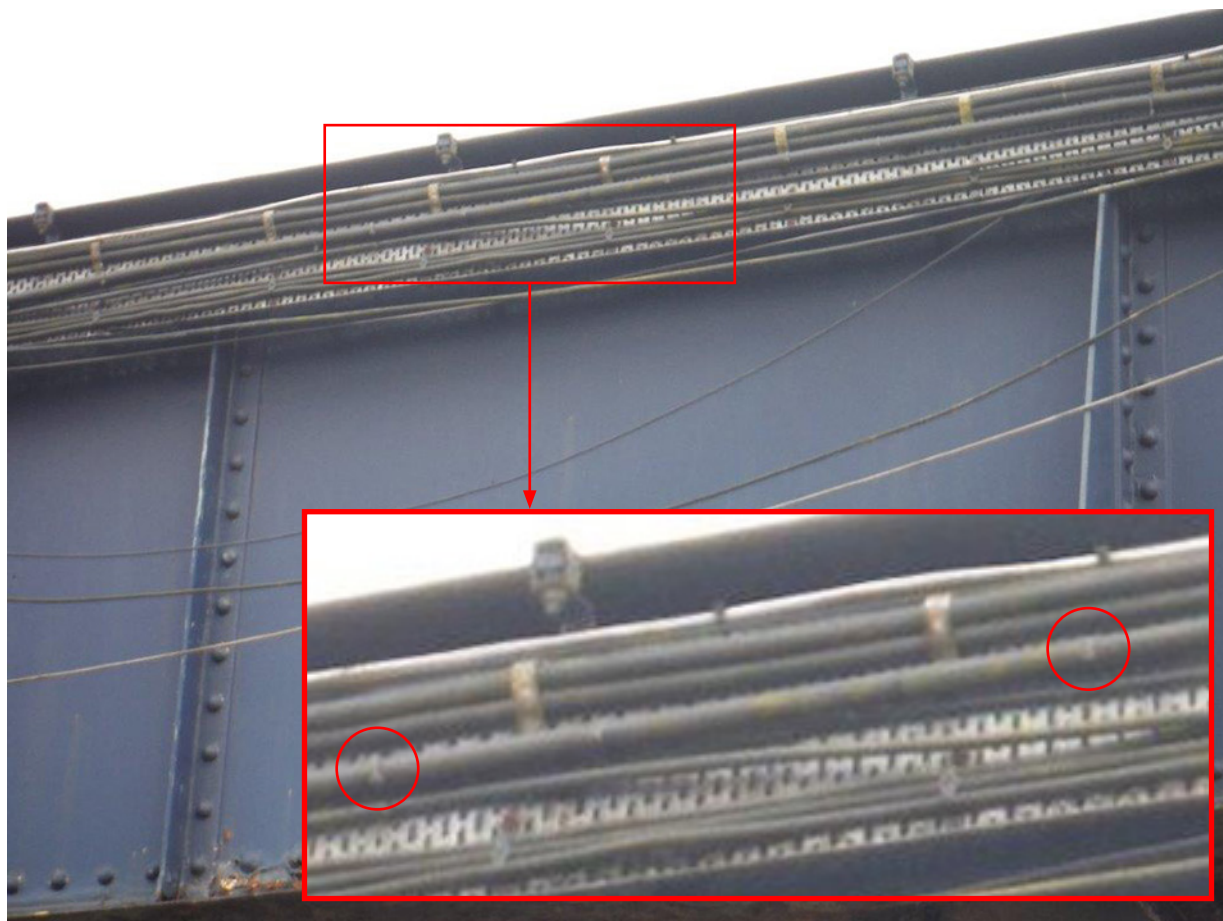
41 The cable was attached to the cable tray using 4.6 mm wide black nylon cable ties which were spaced about every 0.4 metres (figure 17). The vertical orientation of the cable tray meant that the cable ties directly supported the weight of the cable (paragraph 30).

Figure 17: Photograph taken in December 2016 showing the electrical supply cable attached to the cable tray by cable ties (image courtesy of Centregreat Engineering)

- 42 Advice from the manufacturers of nylon cable ties often states that this type of cable tie is not suitable for outdoor applications. This is because the ties become brittle over time when used in an outdoor environment, because the nylon degrades when subjected to ultraviolet radiation, temperature cycles and moisture.
- 43 Once one cable tie had broken, the cable ties either side would have had to support a greater weight. The increased load on these cable ties would have caused them to break, probably more quickly than the first, leading to the successive failure of the cable ties, and the cable drooping further with each failure.

- 44 The installation of the cable did not comply with the requirements in British Standard BS7671:1992, 'Requirements for Electrical Installations', commonly referred to as the 16<sup>th</sup> edition of the Institution of Engineering and Technology wiring regulations. The 16<sup>th</sup> edition of the wiring regulations applied from 1991<sup>4</sup> to 2007; it is thought that a replacement cable tray was installed in the early 1990s (paragraph 13). The installation was also not compliant with the current (17<sup>th</sup>) edition of the standard which has applied since 2008. BS7671 is not prescriptive about what cable fixings should be used for an electrical installation, but within chapter 52, section 522 covers the selection and erection of wiring systems<sup>5</sup> in relation to external influences. In section 522.11, titled 'Solar radiation and ultraviolet radiation', paragraph 522.11.1 states 'Where significant solar radiation or ultraviolet radiation is experienced or expected, a wiring system suitable for the conditions shall be selected and erected or adequate shielding shall be provided'. The installation did not comply with this requirement as nylon cable ties are not suitable as fixings when exposed to ultraviolet radiation and these fixings were not shielded.

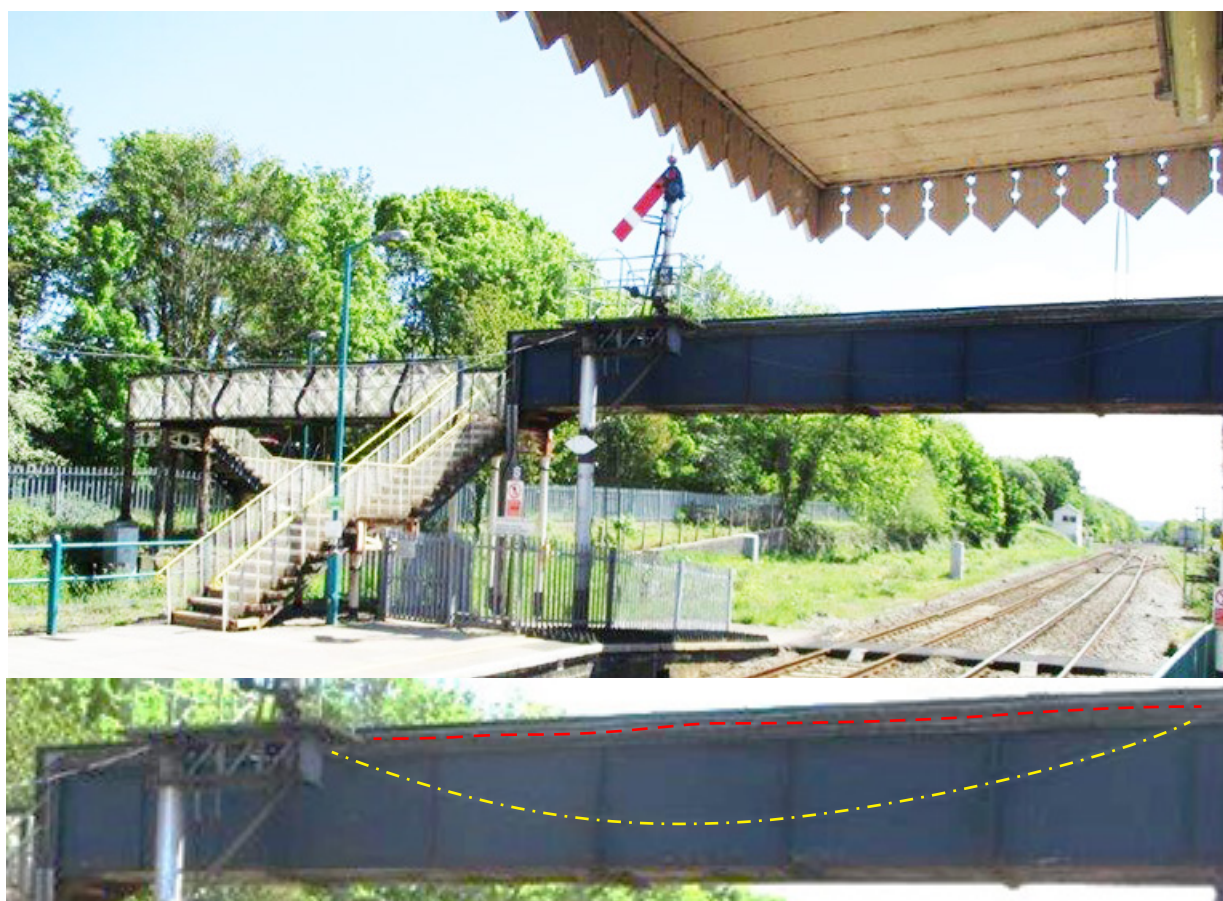
- 55 The footbridge structure at Abergavenny forms part of the station lease between Network Rail and Arriva Trains Wales (paragraph 8). This meant that it was subject to a detailed operational property inspection by Network Rail every five years, with yearly visual inspections in between. The last detailed inspection took place in May 2016, no visual inspection has taken place since then.
- 56 A photograph taken during the last detailed inspection in May 2016 (figure 20) shows the cable had begun to droop. It was drooping by about 0.1 metres from its normal position, over a length of about 3 metres. The telecommunications cable can be seen drooping about one metre from the top edge of the footbridge.

Figure 20: Photograph of the footbridge taken during the last detailed inspection in May 2016 with drooping electrical supply (red) and telecommunications (yellow) cables (image courtesy of Network Rail)

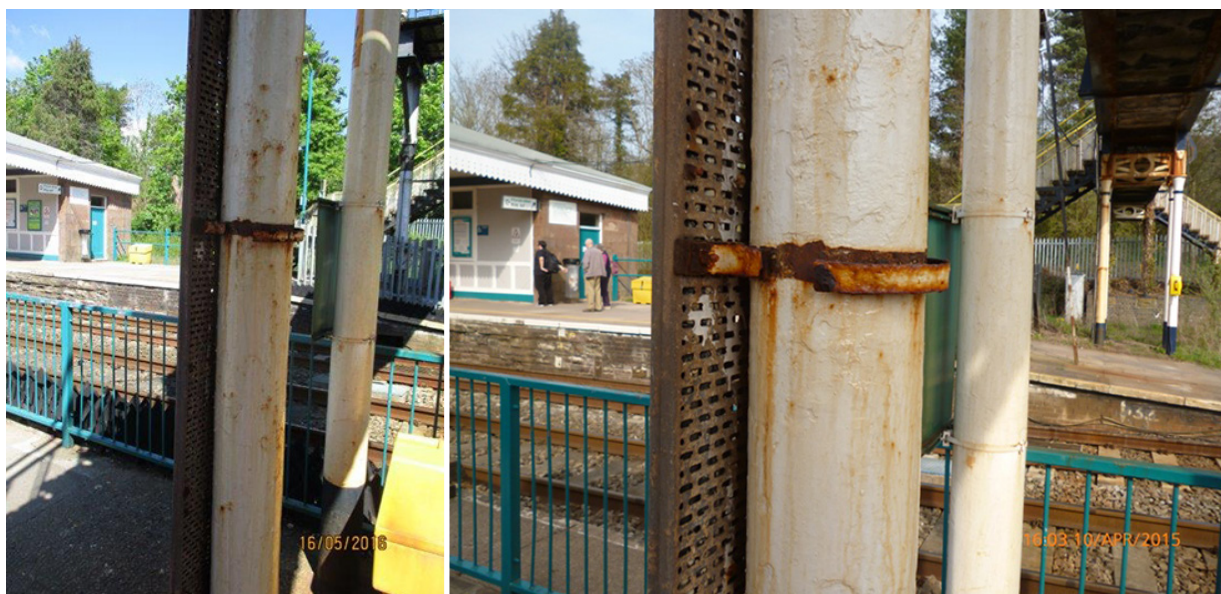
- 59 The records from the last detailed operational property inspection in May 2016 included three defects related to how the cable tray was attached to footbridge. Brackets that fasten the cable tray to the footbridge were found to be corroded and broken (figure 21).

Figure 21: Photographs of the cable tray bracket defects found during the last detailed inspection in May 2016 (images courtesy of Network Rail)

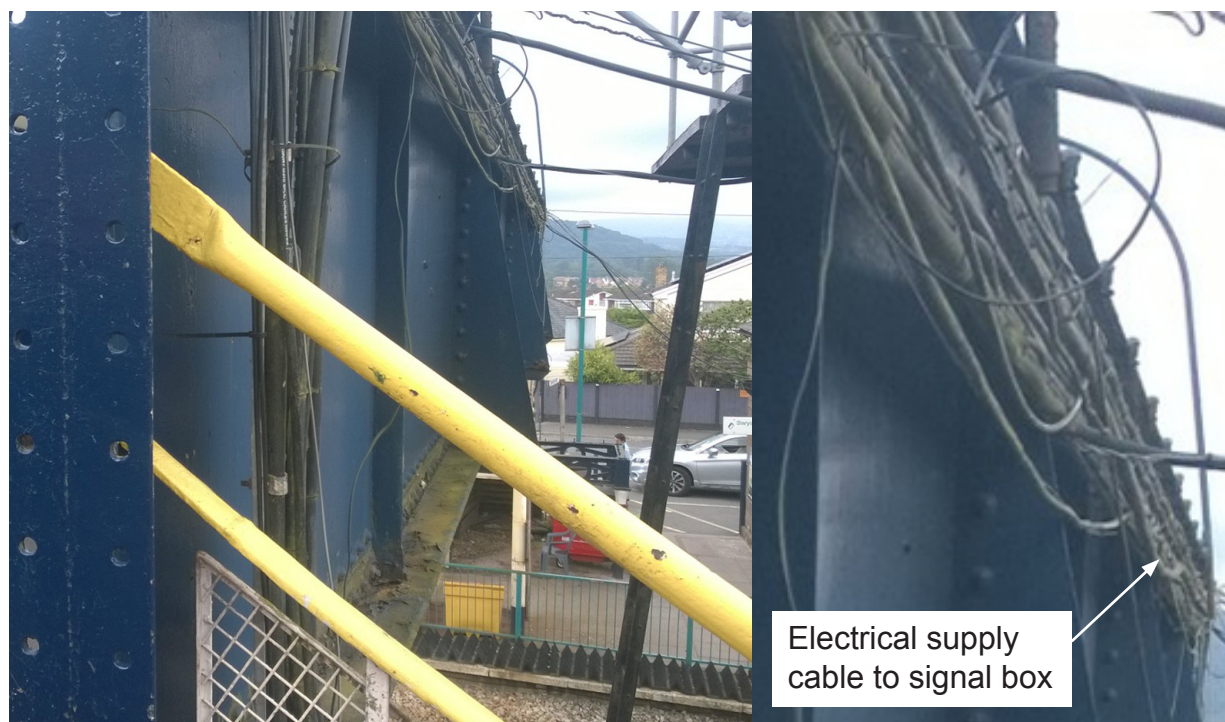
- some cables were not attached to the cable tray, but instead to other cables by nylon cable ties.
- 69 Requirements for cabling that crosses the operational railway underneath the track are set out in Network Rail company standard NR/SP/SIG/19812 'Cross Track Cable Management'. Network Rail had identified that it needed to manage the risks associated with the installation of cables passing under the track, primarily to ensure track, and in particular its geometry, can be maintained appropriately. There is no directly equivalent standard to manage the risks associated with routing cables over the operational railway via structures.

Figure 22: Photograph of the cables and cable tray running over the footbridge at Abergavenny station on 19 July 2017 (images courtesy of Centregreat Engineering)

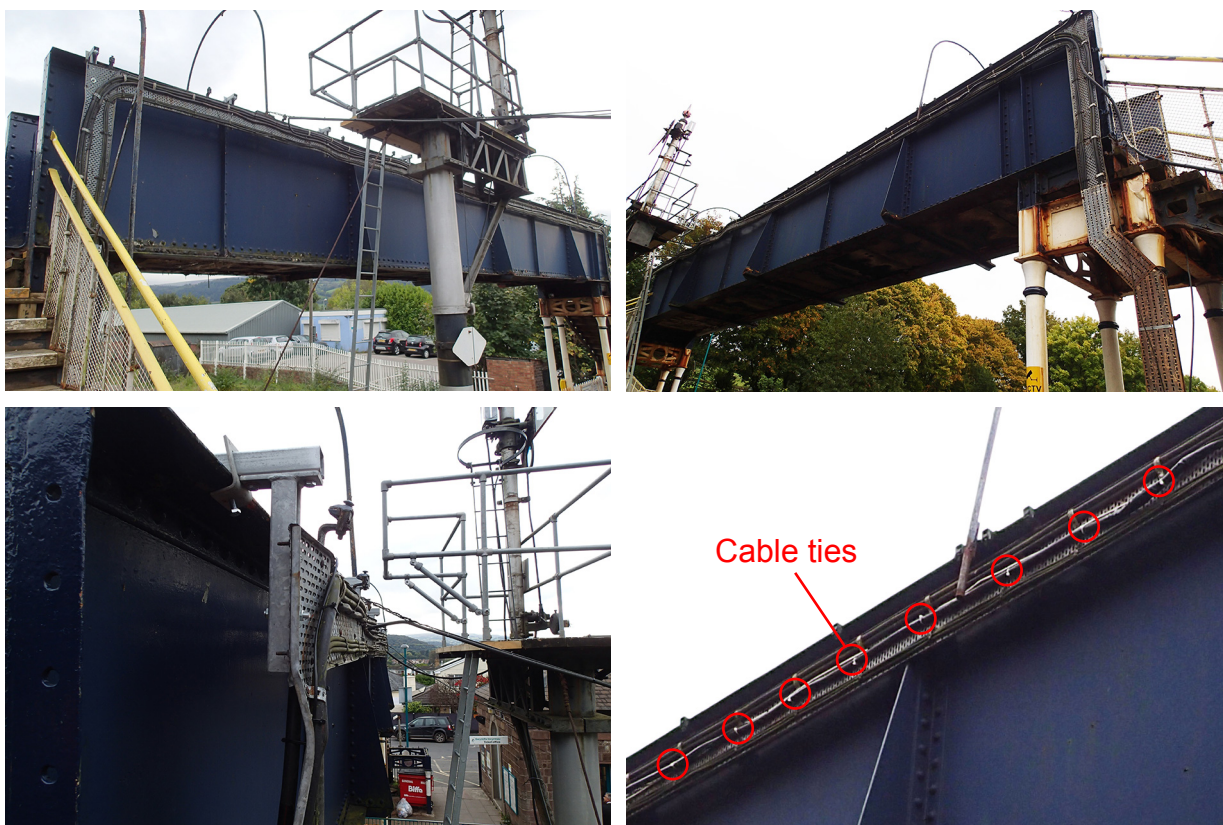
Figure 23: The repairs made to the footbridge cable tray after the accident

- 81 After the accident, Network Rail made temporary repairs to support the cable tray using rope so that the railway could reopen that evening. Network Rail carried out further work during August to provide new brackets to support the cable tray. However, these repairs resulted in the cable again being fixed to the cable tray using nylon cable ties (figure 23).

- 83 Network Rail is planning to replace the cable tray on the footbridge with a new electrical containment during the 2018/2019 financial year. The new containment will run underneath the footbridge, with all of the cables supported by it and fully enclosed within it. Access to the cables within the containment will be via the footbridge floor. However, Network Rail's plans for this work are linked to decisions about how to progress the work to refurbish the lattice span (paragraphs 15 and 16).

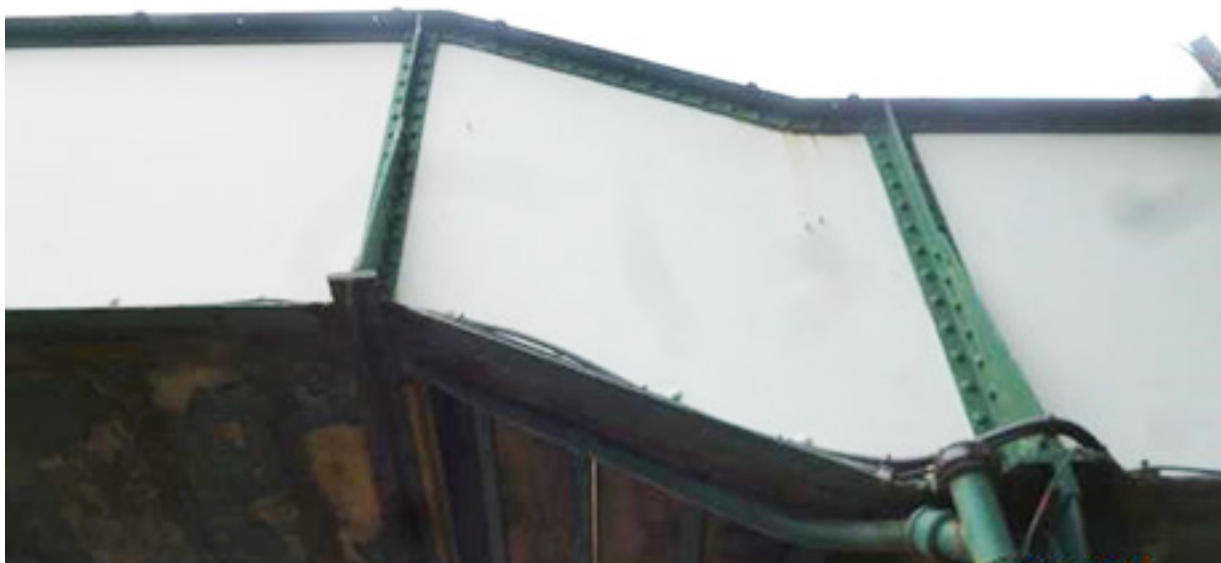
- 84 As a result of the accident, Network Rail Wales Route carried out a review of cable and cable containment running over its station footbridges. It reviewed its inspection photographs for 85 station footbridges and identified that 55 of these had cables running over them. Of these, nine had cables attached to the external structure of the footbridge; in eight of these cases the cable routing was contained within the footbridge structure such that the cable could not droop significantly if any fixings broke. The only example found of a cable with the potential to droop was the footbridge at Helsby station (figure 24). Network Rail has reported to the RAIB that work is underway to refurbish this footbridge and that the cables will be rerouted during this work.

*Figure 24: Cables routed on the outside of the footbridge at Helsby station (image courtesy of Network Rail)*

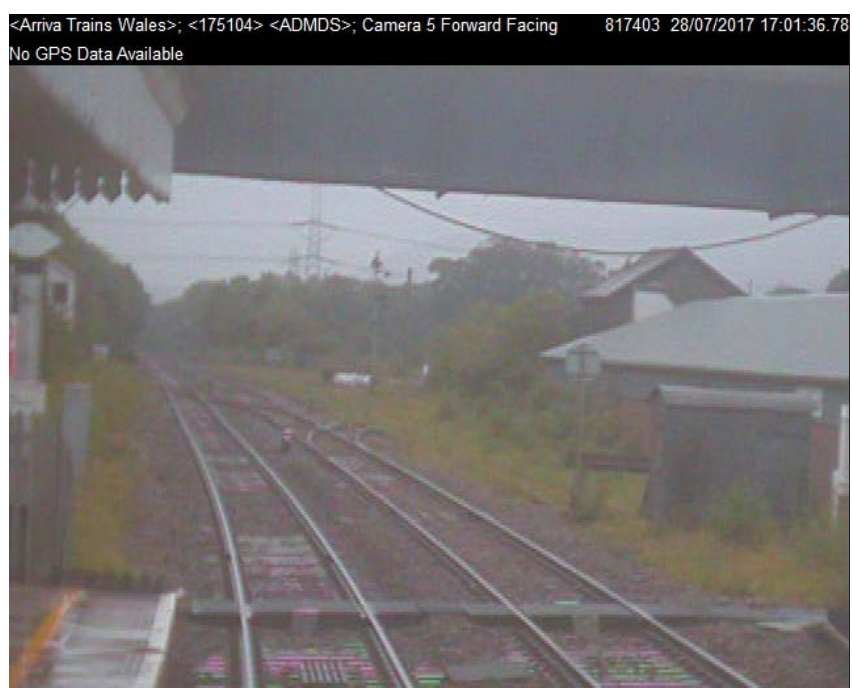
Figure 1: FFCCTV footage from a preceeding train, showing the drooping power cable.
