Rail Accident Report

**Fatal accident at Trenos footpath crossing near
Llanharan, Rhondda Cynon Taf, South Wales,
1 June 2017**

Report 07/2018
May 2018

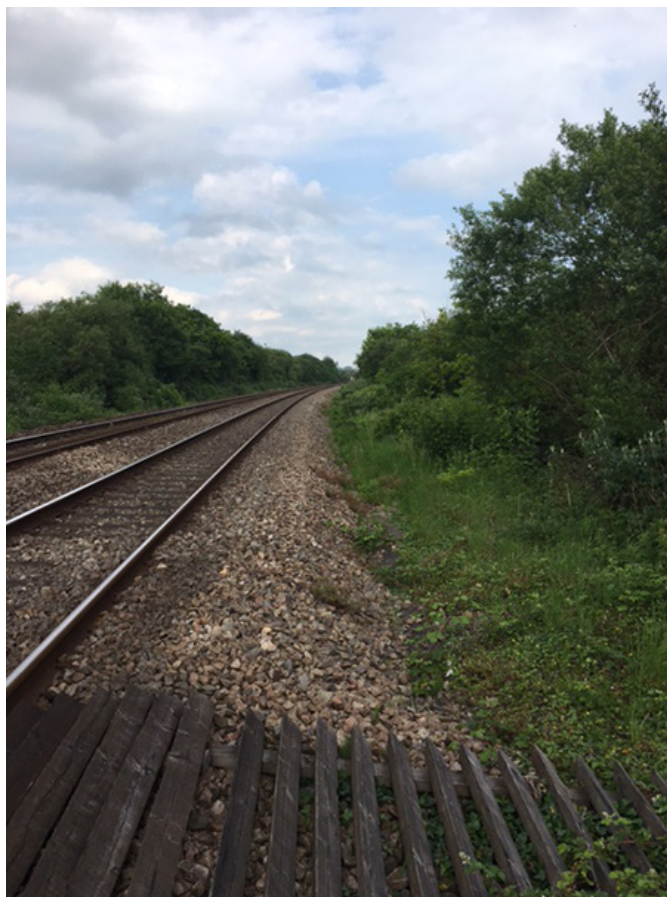
- 13 The approach from the south side is up a sloping path (figure 3 and figure 4). A pedestrian's view from this side of the railway looking towards trains approaching on the down line, the line used by the train which struck the pedestrian, is shown in figure 5.

Figure 5: View from south side of crossing looking east towards down trains on 1 June 2018 (photograph courtesy of Network Rail)

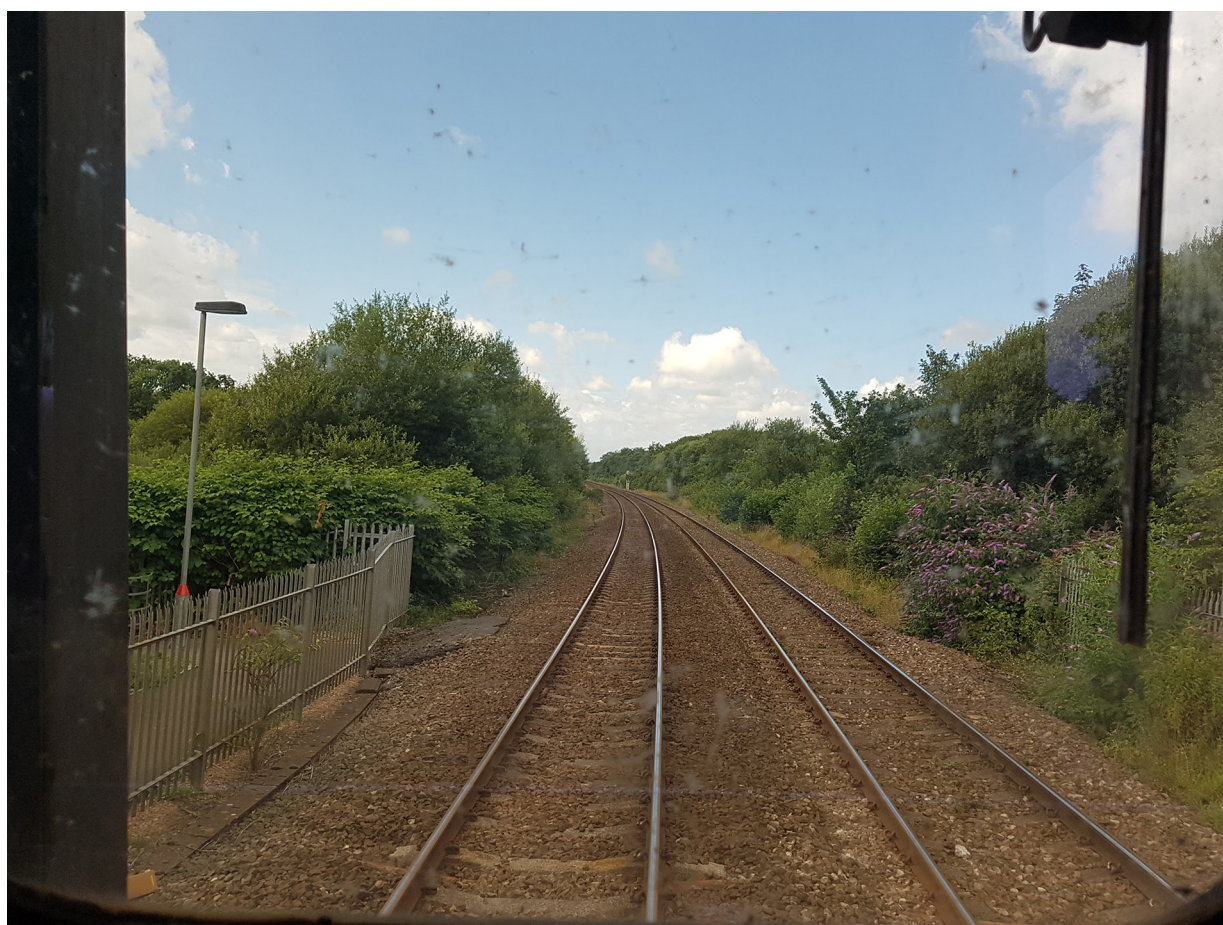
Figure 6: driver's cab view showing site of former Llanharan crossing, photographed in July 2017

59 The display screen used by signallers operating Port Talbot signal box panel 'A' continued to show Llanharan crossing despite it having been closed in 2007 and removed in 2009 (paragraph 18). The signaller's display was not updated to reflect the removal of the crossing when this happened. Network Rail's Signalling Design Handbook, standard NR/L2/SIG/11201⁸, stipulates that design, such as the removal of level crossings, should be complete and fit for purpose. To be considered complete, the design for the removal of Llanharan crossing should have specified the removal of Llanharan crossing references from the complete signalling system, including the signaller's display.

Network Rail Wales Route should check that signallers' displays for level crossings accurately reflect changes to level crossing arrangements made since the displays were designed. It should take suitable risk mitigation measures where this is not the case, and inform other Routes of the extent of inconsistencies found (paragraph 68b).

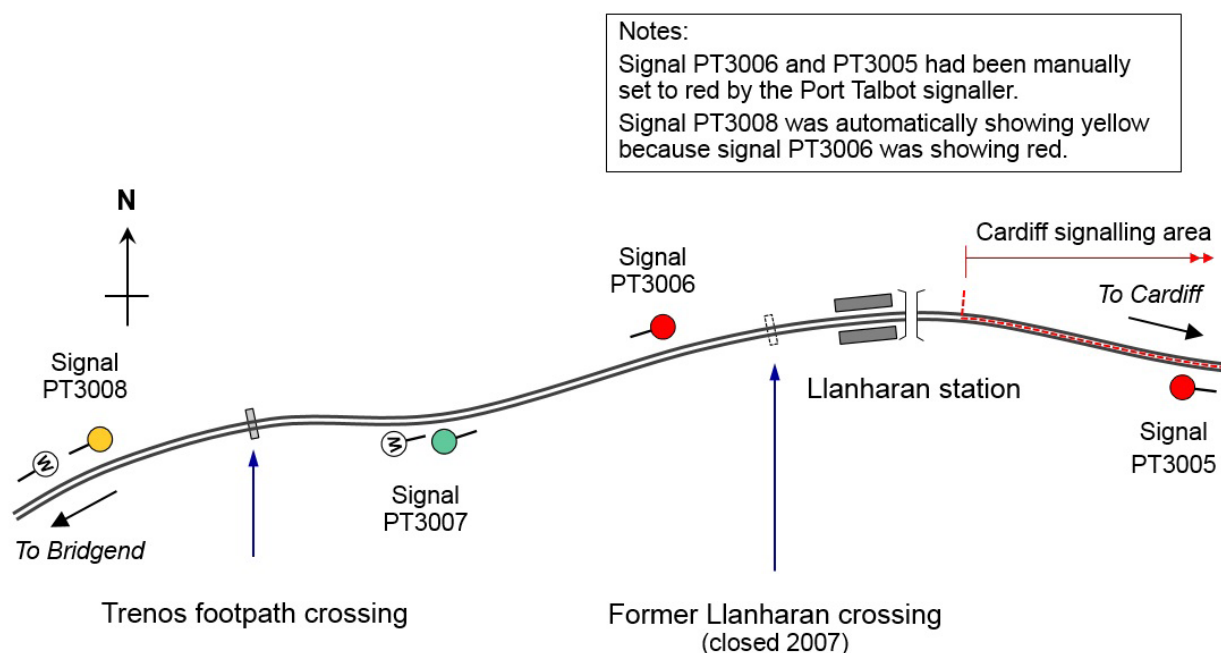
Figure 10: diagram at about 15:38 hrs

- 34 At about 15:38 hrs (figure 10), the Port Talbot signaller put signals PT3006 (up line) and PT3005 (down line), either side of Llanharan station to red so that he could caution trains. When trains are to be cautioned, they are first stopped. The driver is then instructed by the signaller to proceed at caution until the specified hazard is passed. A driver may be instructed to report back to the signaller.

- 35 Signals PT3006 and PT3005 would have been the correct signals to caution trains for the former Llanharan crossing, but the signals needed to protect Trenos crossing were signal PT3007 (down line) and signal PT3008 (up line).

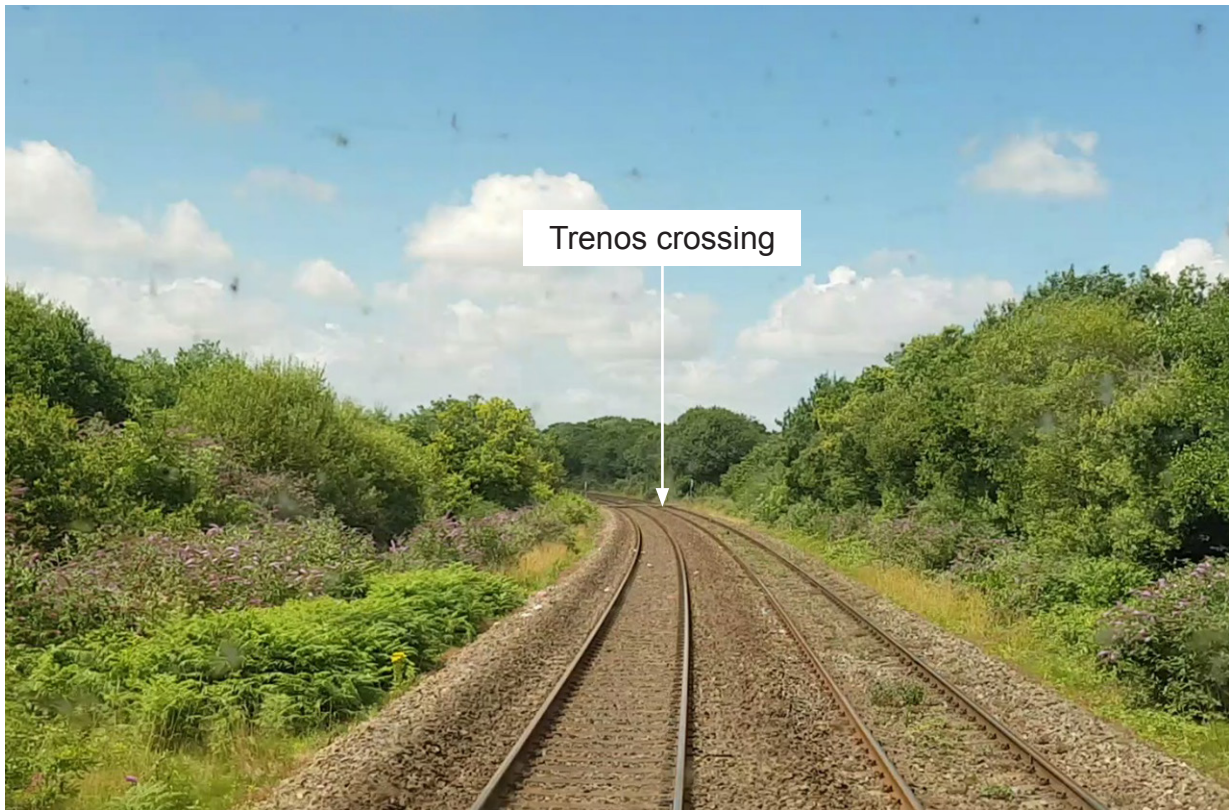
- 41 The train was 130 metres (5.5 seconds) from the crossing (figure 14) when the driver applied the train's emergency brake. The train was travelling at 54 mph (87 km/h) on a section of line where the maximum permissible speed was 75 mph (121 km/h).

Figure 14: Driver's cab view from a similar train travelling on the down line used by the incident train. Trenos crossing is about 130 metres ahead (5.5 seconds for a train travelling at the speed of the incident train).
