Rail Accident Report

Freight train collision near Logan, East Ayrshire 1 August 2015

Report 13/2016
July 2016

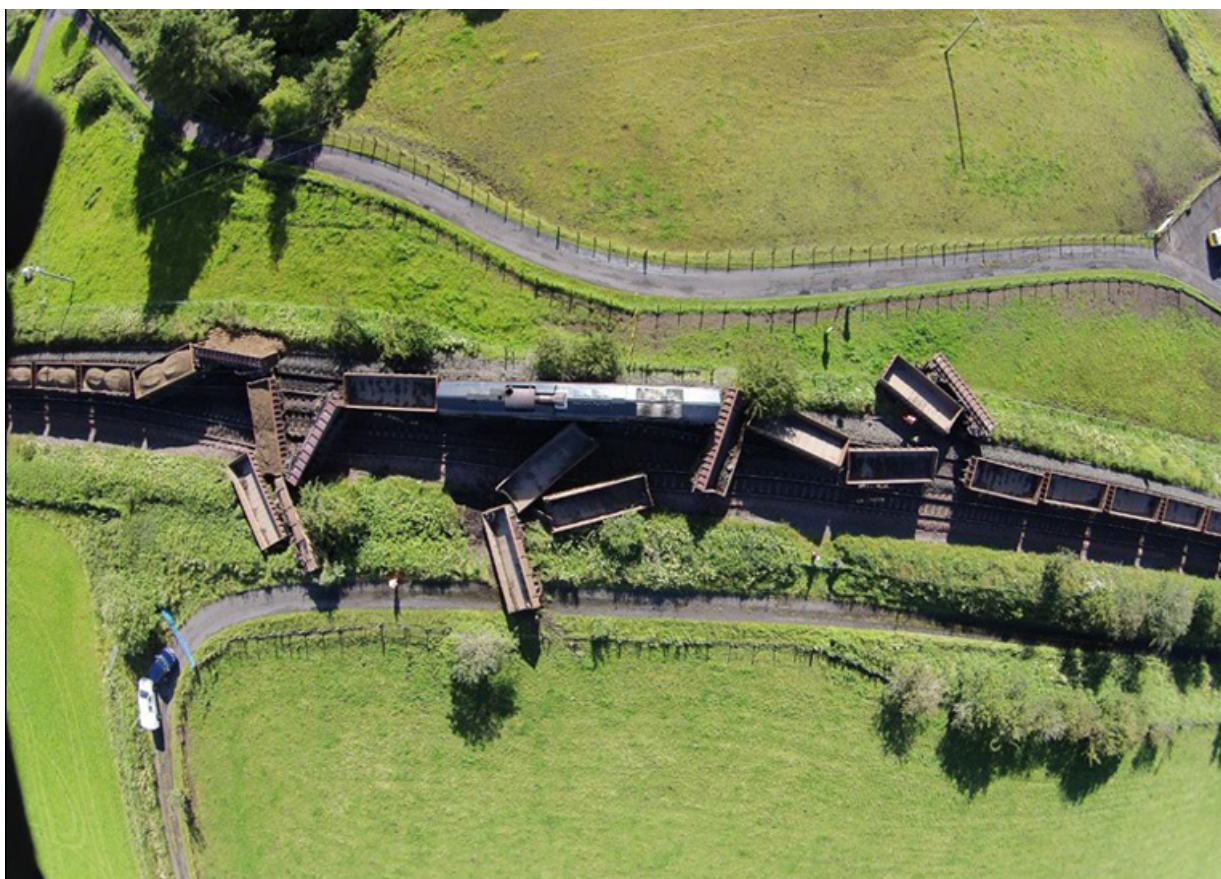
Figure 7: Aerial view of the derailed locomotive and wagons

- 33 Train 6K06 was stationary with just the brakes on the locomotive applied. When struck, train 6K06 was pushed forward and its rear nine wagons derailed (figure 7). The 20th and 21st wagons towards the middle of the train also derailed after overriding (figure 9).

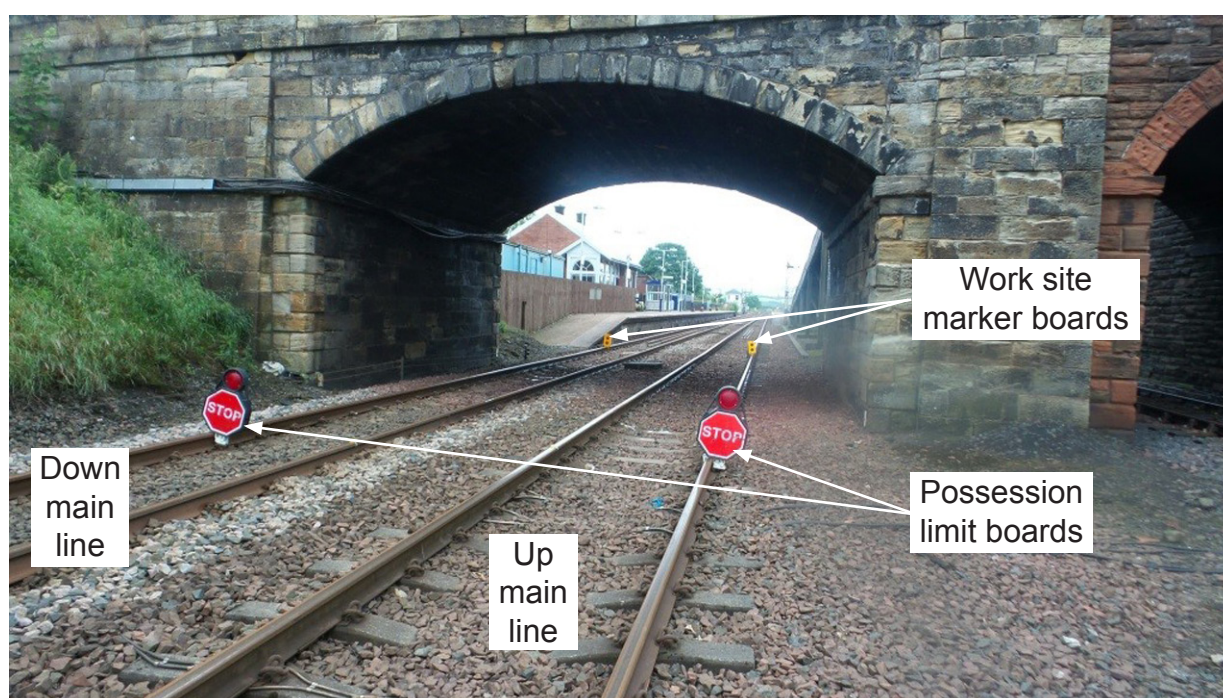
Figure 11: The possession limit and work site marker boards at New Cumnock (image courtesy of Network Rail)⁶

- 64 Section 3.4 of GE/RT8000/HB12 states that the work site marker board will normally be placed at least 100 metres from the possession detonator protection. It also states that if this distance cannot be achieved, the work site marker board should be placed at the detonator protection along with the possession limit board. At New Cumnock, the work site marker board was placed next to the last detonator, so was placed about 20 metres from the possession limit board which was located at the middle detonator. However, only the possession limit board was visible to the driver of train 6K07.

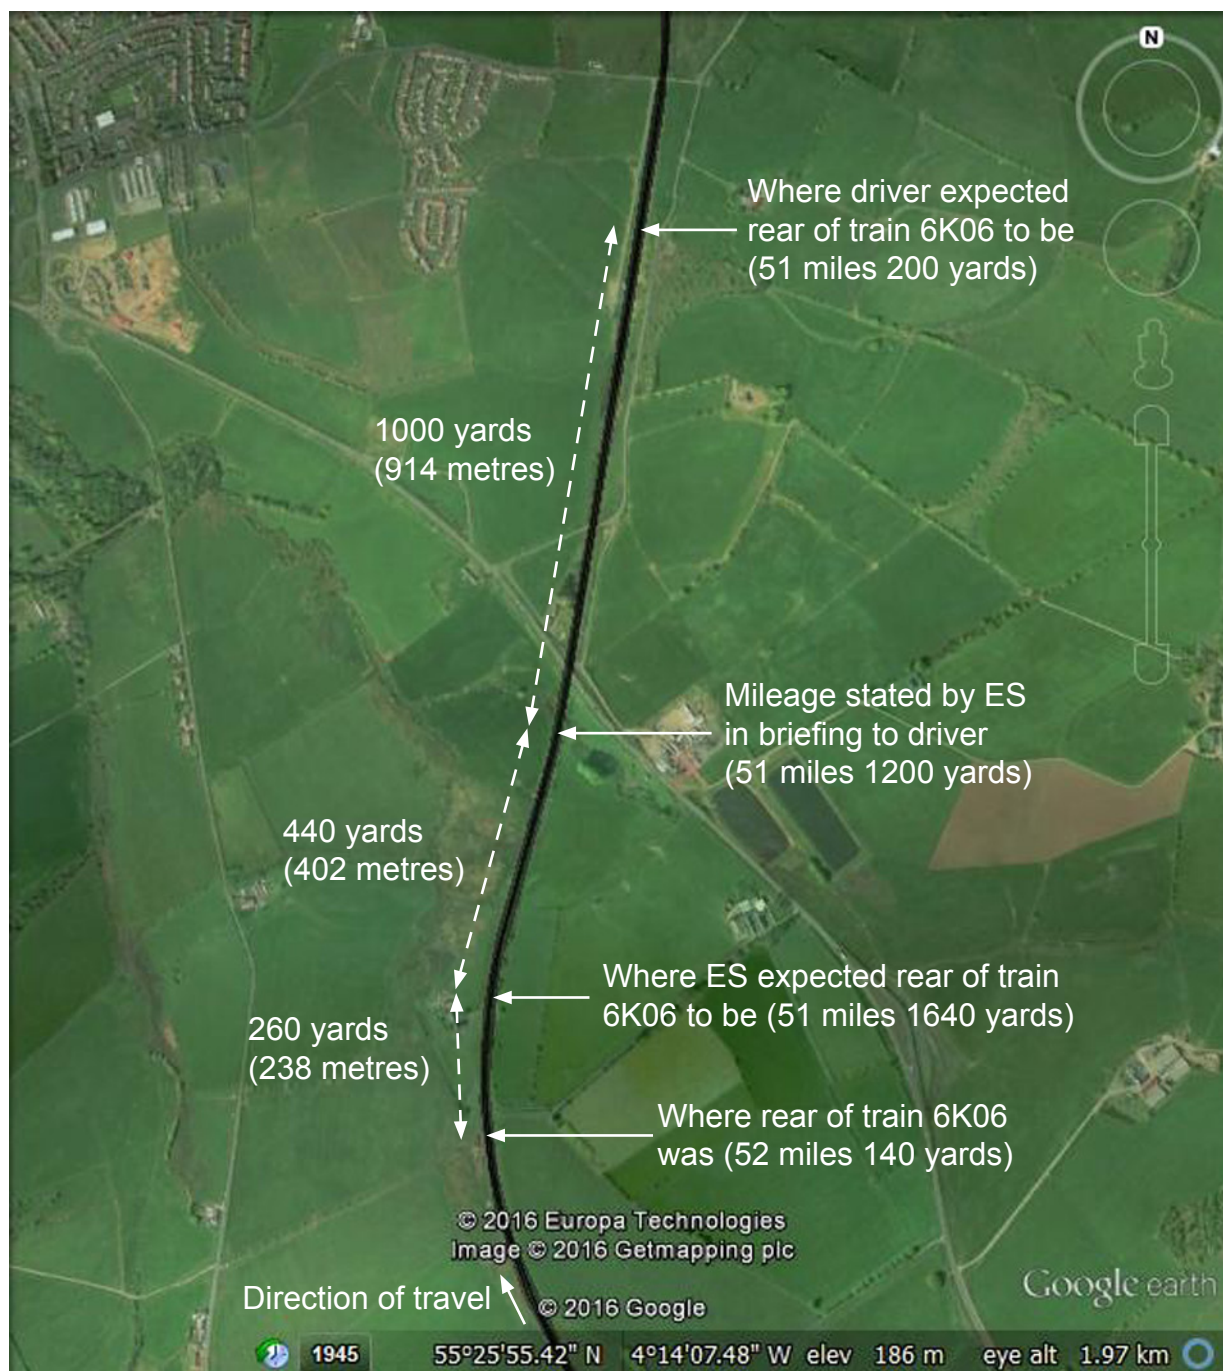
Figure 14: Location of train 6K06 and locations where driver and ES believed the train was standing.

- 77 **The driver of train 6K07 believed that train 6K06 was further away than it actually was due to a misunderstanding about the location of train 6K06.**
- 78 When the ES briefed the driver before train 6K07 entered the work site, he told the driver to go to 51 miles 1200 yards but stop short of a train ahead that was waiting to go into the track renewal. However, during this briefing a misunderstanding arose and the driver formed the view that 6K06 was standing in the vicinity of 51 miles 200 yards (figure 14). The driver stated he wrote this mileage down, but the RAIB has been unable to locate the paper that this was recorded on.

- 79 When the ES took over responsibility for the work site (paragraph 23), he was told that train 6K06 was waiting to move up into the track renewal site. Based on this information, the ES expected the rear of train 6K06 to be about 440 yards (about 400 metres) short of the start of the track renewal (at 51 miles 1200 yards), which would place the rear of the train at about 51 miles 1640 yards (figure 14). The rear of train 6K06 was actually nearer to New Cumnock at 52 miles 140 yards (figure 14), which was about 1 mile (1.6 km) closer than the driver thought.

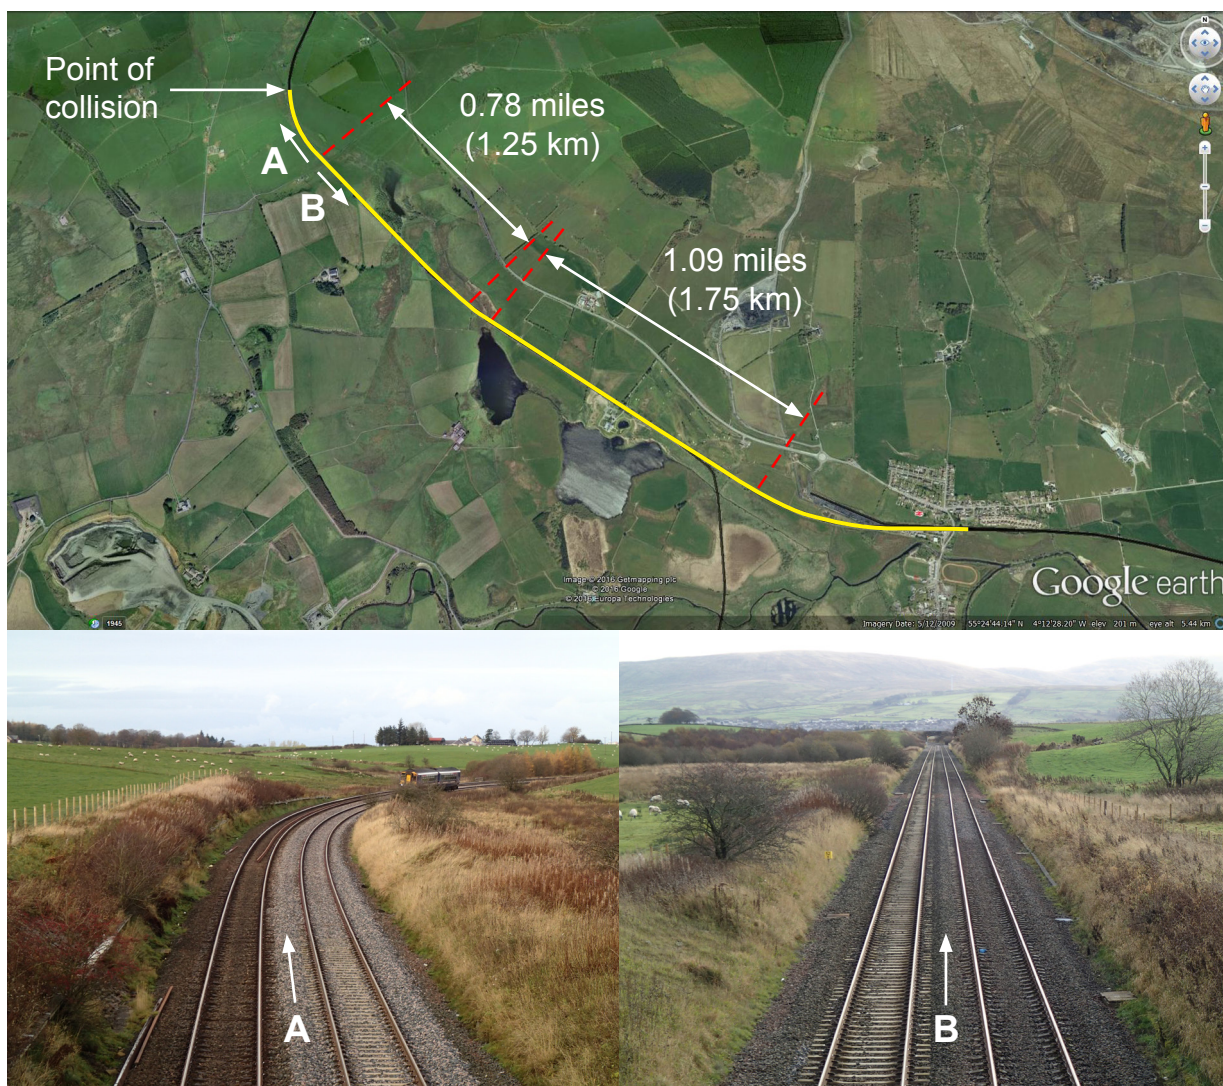
Figure 16: Views of the track from New Cumnock to the track renewal site

104 When possessions and work sites are so long, often there will be sections of railway in which no work will be taking place, so a driver will not see anyone on the track. This was the case when train 6K07 travelled the 3 miles (4.7 km) from New Cumnock to the track renewal site. In many instances, long possessions and work sites will include lengthy straight sections of track. The journey from New Cumnock to the track renewal site included two long straights (figure 16). In daylight and fine weather conditions visibility will be good, so a driver can see a long way ahead to the end of these straights. If drivers can see a long way ahead that the line is clear with no one working on it, it may alter a driver's perception of the risk of moving within the work site and cause some drivers to question the reason for travelling a long distance at such a slow speed. This may therefore encourage a driver to travel faster than the 5 mph (8 km/h) default speed limit and in violation of the rules. Once some drivers view a rule as unnecessary it is likely that they will be more likely to travel in work sites at higher speeds. Since there is no monitoring in place (paragraphs 98 to 102), this behaviour is most often not detected by driver managers or corrected.

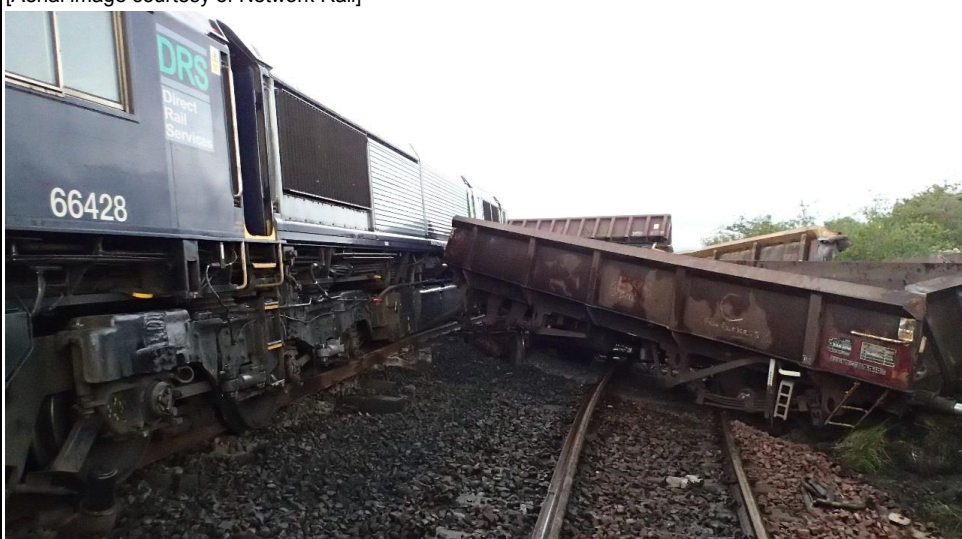
<p>[Close up view of the locomotive from train 6K07 and wagons from train 6K06]</p>
